## **CITY OF CARMEL-BY-THE-SEA CITY COUNCIL AGENDA**

## CITY OF CARMEL-BY-THE-SEA CITY COUNCIL Staff Report

# CARMEL-BY-THE-SEA POLICE DEPARTMENT ASSESSMENT REPORT

Prepared by: Indigo | Hammond + Playle Architects, LLP.

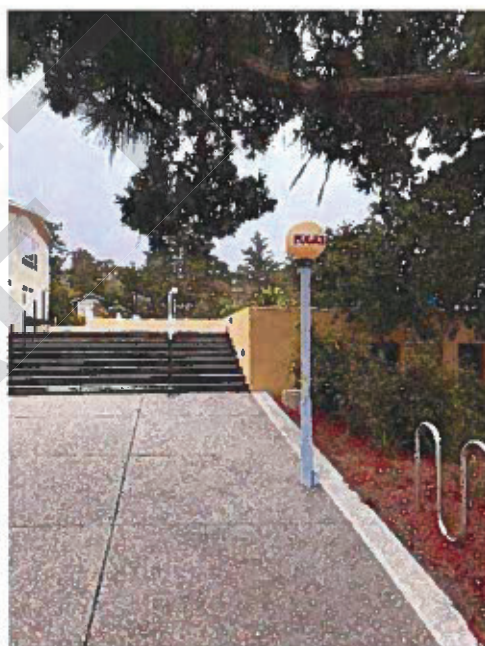
*Figure 1 – Existing Plaza Entry Path & Steps*

Additionally, Junipero Street, where the primary site access is located, is on a greater than 5% slope all across the frontage. This makes it difficult, if not impossible, for people with disabilities to access the Police Station from whichever crowded street they've parked on nearby.

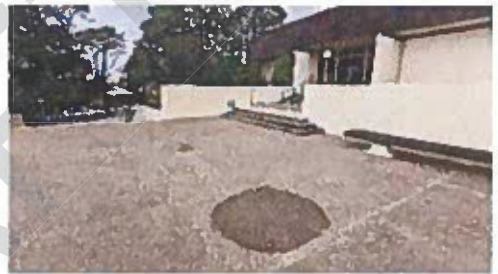
Figure 6 – Existing Garage Roof Paving

*The storm drainage system serving the courtyard and roof of the Public Works Service Garage needs inspection to determine the source of water leaks into the garage below (Figs. 2-3).*

*The city should have the garage roof and courtyard drainage system inspected to see if it can be determined how water may be entering the garage below and make necessary repairs.*

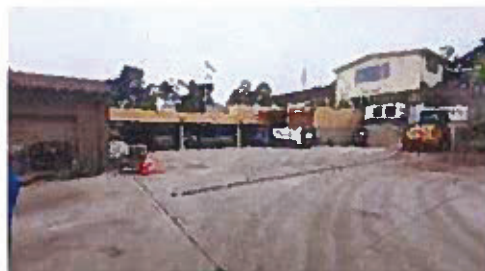
Figure 8 – Existing site paving

The site paving is in good condition, with only minor surface cracks (Figs. 4-6).

- ◆ Site Paving - No immediate action is to be taken at this time. Regularly monitor all areas of site paving and take remedial action when warranted by changed site conditions that may present a hazard for people and/or operations.

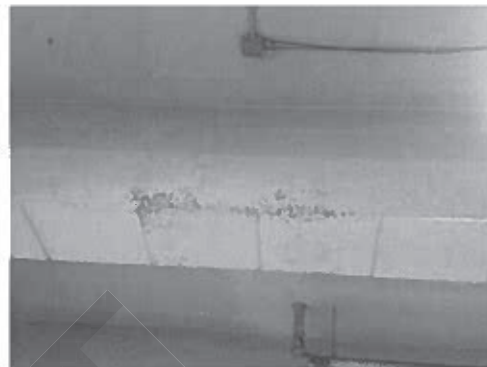
- ◆ The structure of the 2nd floor PD concrete and wood roof structure is in good condition with no evidence of structural deterioration or damage.
- ◆ Numerous cracks were observed in the concrete slab at the roof (1st floor suspended slab) of the garage along with staining near cracks that might be indicative of water infiltration in the concrete. (See Figures)
- ◆ Significant rock pockets were observed in concrete roof beams of garage and evidence of lack of adequate consolidation of concrete during original construction. (See Figures)
- ◆ Multiple full height vertical cracks with widths between 1/16" to 1/8" were observed in the North

Figure 13 – Rock Pockets in Existing Parking Structure

- ◆ *Conduct additional testing to determine the extent of damage to the garage roof structure and the north concrete retaining wall.*
- ◆ *Remove loose concrete and patch the concrete roof beams of the garage.*
- ◆ *Repair the cracks in the north concrete retaining wall.*

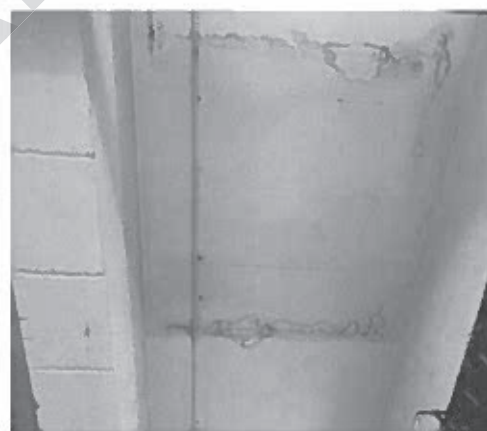
Figure 14 – Moisture stains through cracks in existing concrete slab

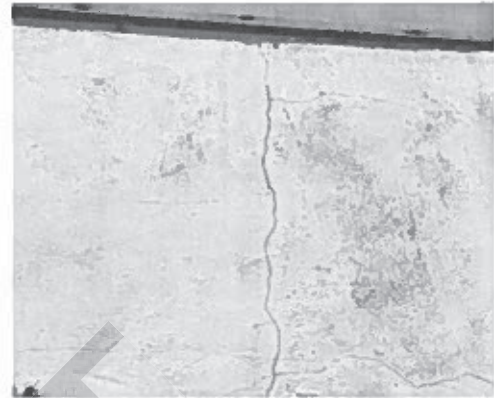
*Figure 15 – Cracking in Existing Retaining Wall*

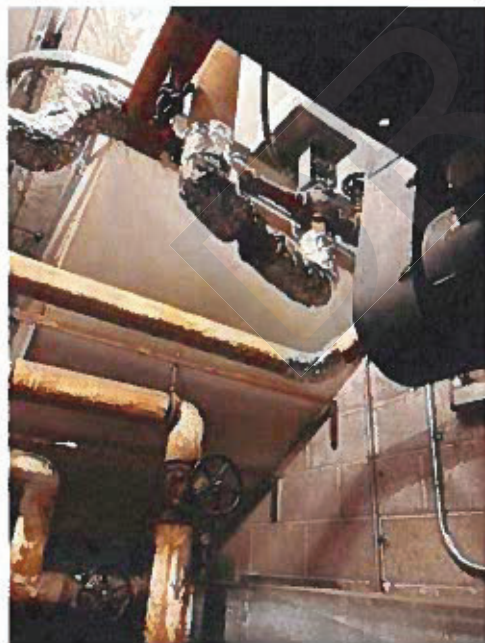
*Figure 20 – Existing (Damaged) Hot Water Heating Piping Insulation*

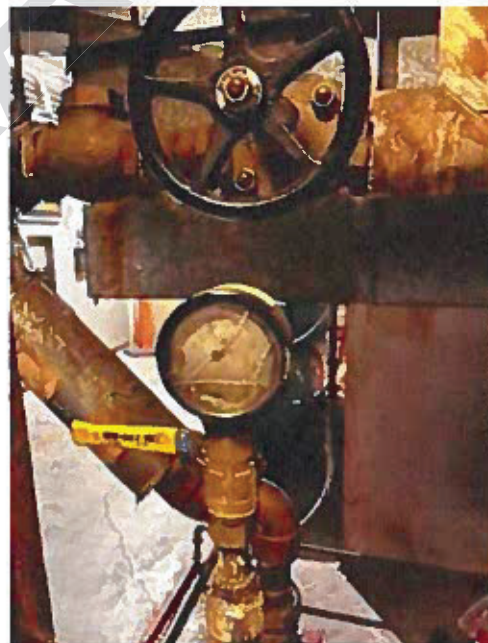
*Figure 21 – Existing (Damaged & Non-Functional) Pressure Gauge*

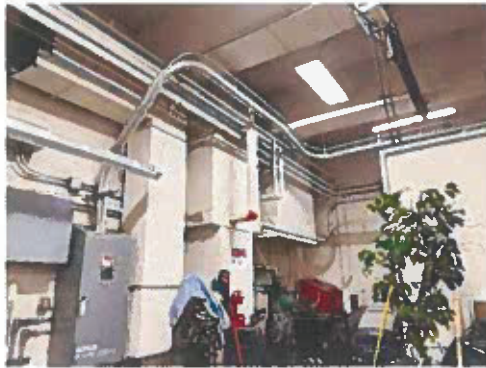
*Heating hot water pipes in the Garage are located almost directly above electrical panels and generator ATS. These pipes need to be relocated for safety.*

Figure 23 – Existing Hot Water Pipes Over Transfer Switch

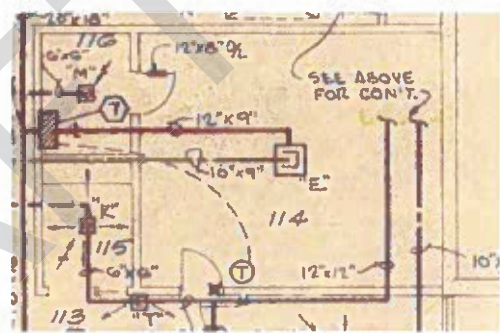
Figure 24 – Existing Evidence Room

The existing evidence room needs to have additional exhaust due to the products stored. The room needs to be negative and 100% exhausted at a rate no lower than 12 air changes per hour.

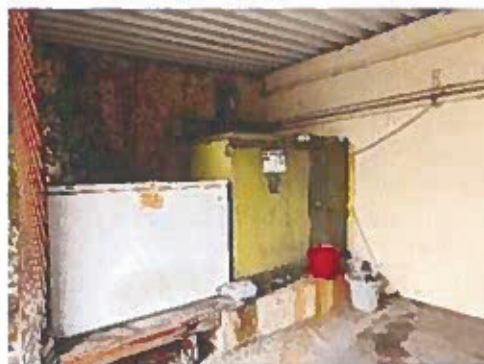
Figure 30 – Existing utility company transformer location

*If the existing service size remains as-is then the existing transformer and location may be able to remain unless specifically directed otherwise by PG&E. If the electrical service is upsized then the utility company transformer will need to be replaced and relocated to meet current standards.*

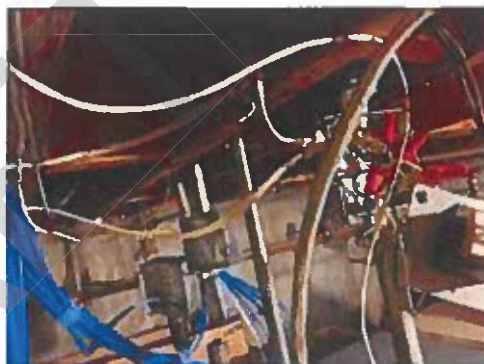
Figure 31 – Electrical box missing cover

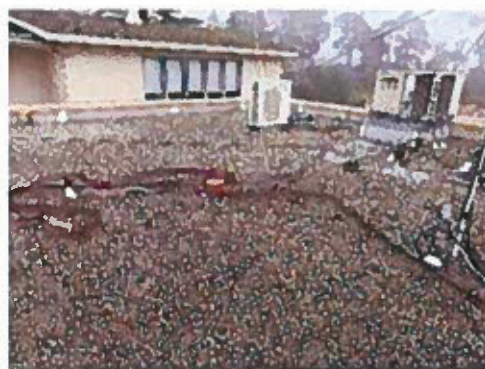
*The roof top lightning protection system has failed. The installation is antiquated and no longer complies with NFPA 780, the standard reference by the electrical code for lightning protection. This presents a current safety risk to life and property.*

*Figure 33 – Existing disconnected lightning protection*

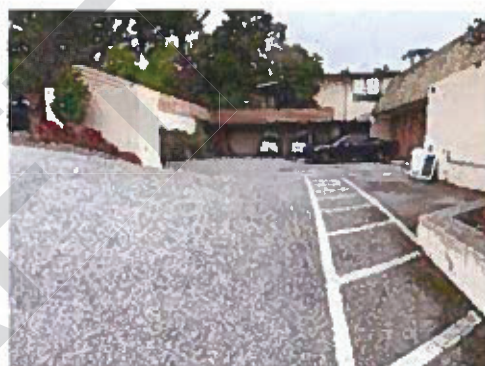
*Figure 34 – Existing parking area*

*The lighting in the Police parking area is insufficient and is a safety risk. The existing lighting needs to be replaced and supplemented.*

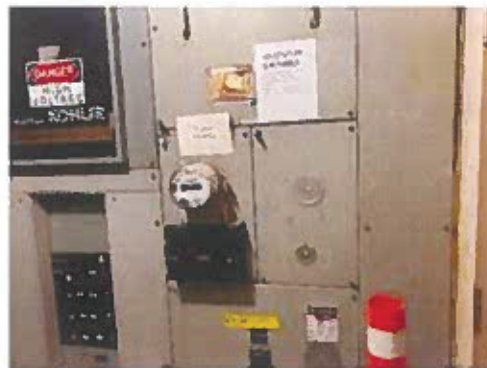
Figure 36 – Existing Switchboard

*The existing 400-amp main switchboard installed in 1966, per the nameplate, is clean and in fair condition. The switchboard is at the end of its useful life. After 50 years the grease in the breakers is usually hardened, creating the potential for the breakers to not operate properly. The insulated bracing supporting the bussing tends to become brittle and starts to lose its resistive properties after 50 years. There are no spaces for future breakers. There is no evidence of maintenance testing as recommended by NETA, International Electrical Testing Association and ANSI, American National Standards Institute. The main switchboard should be replaced.*

Many of the panelboards are of the same vintage as the main switchboard and should be replaced. Most have limited space or capacity for the addition of breakers or load. Most of the panel nameplates have amperage ratings greater than the feeder size. There are no labels on the panels to indicate the limited feeder rating.

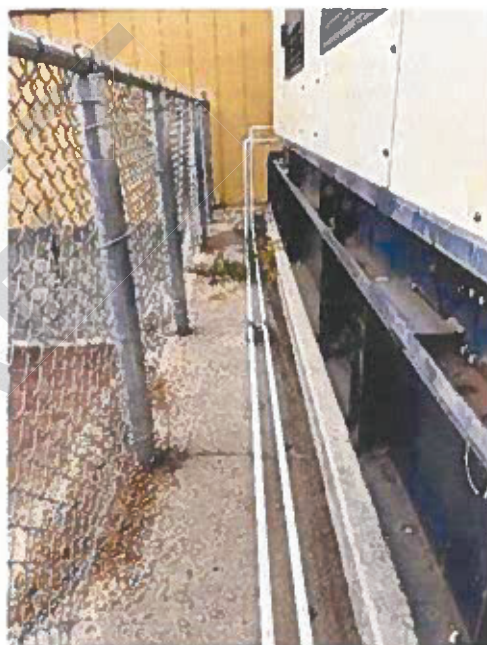
Figure 37 - Clearance in front of existing generator

The building is supported by an emergency generator, automatic transfer switch and emergency power distribution switchboard. The system is fairly new. The generator's weatherproof enclosure tends to leak moisture when it rains. The raised platform for the generator has insufficient working clearance along the sides. An extension of the platform is required to meet working space requirements per the manufacturer and OSHA.

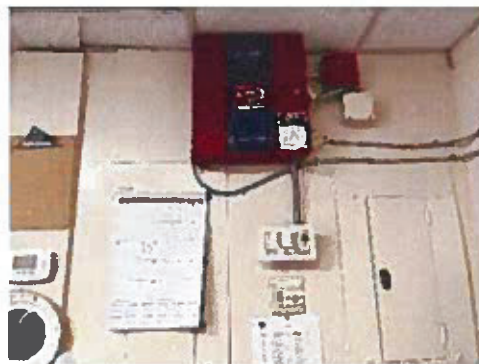
*Figure 39 - Existing Fire Alarm Control Panel*

*The mounting heights of the existing fire alarm control panel and manual pull station do not meet code.*

*There is no remote annunciator located in the lobby. The remote annunciator listed for the existing fire alarm control panel is no longer available. Recommend the replacement of the existing fire alarm panel with a listed remote annunciator, placing the fire alarm panel at the code required height. Relocate pull station to meet current requirements.*

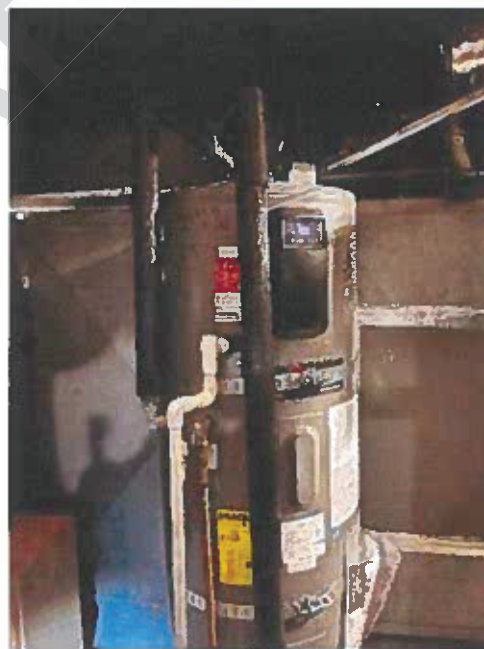
*The water heater in the mechanical room was replaced recently but, there was no expansion tank installed. This is code requirement and if not installed could result in pipe leaks when the water is heated and expands.*

*Figure 41 – Existing Hot Water Heater (No Expansion Tank)*

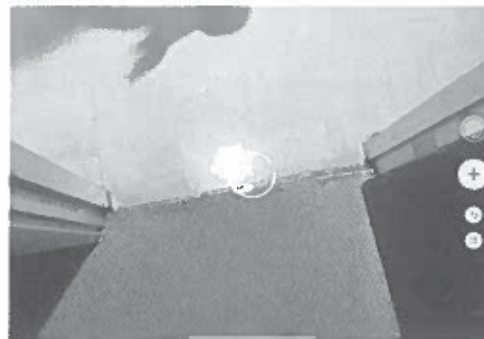
Virtually all interior partition walls encroach on horizontal accessibility requirements, whether on the circulation clearance side or the interior room clearance side, or both. Most doors are at least slightly narrower than the 32-inch minimum clear opening width. Hardware on those doors generally

Figure 43 – Existing 31.5-inch opening

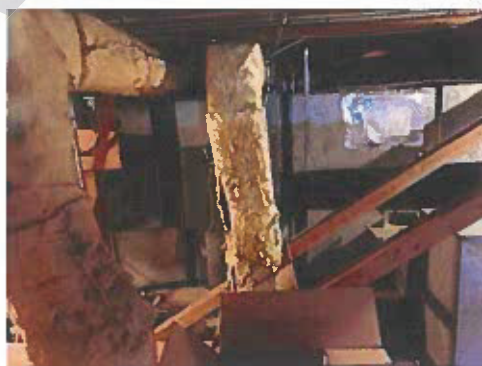
Figure 48 – Existing Duct Insulation

- ◆ *The exterior walls are uninsulated.*
- ◆ *The single-paned glazing fails to meet current energy code and has poor acoustic properties.*
- ◆ *The built-up roofing and coping is in poor condition.*
- ◆ *The original mansard shingles are beyond failing and some are now missing, exposing bare roof deck.*
- ◆ *Hazardous materials like lead and asbestos are present in the building.*
- ◆ *Water intrusion is causing damage to equipment and creating environmental hazards.*

- ◆ *Demolition and Hazardous Materials Removal.*
- ◆ *New Flooring Throughout – see also Building Accessibility.*
- ◆ *New Elevator – see also Building Accessibility.*
- ◆ *New Stairs – see also Building Accessibility.*
- ◆ *New Doors Throughout – see also Building Accessibility and Security.*
- ◆ *New Partitions Throughout – see also Building Accessibility and Security.*
- ◆ *New Windows Throughout.*
- ◆ *New Skylights where feasible.*
- ◆ *New Roofing and Insulation.*
- ◆ *New Exterior Wall Insulation.*
- ◆ *New Finishes Throughout, including Exterior Finishes.*
- ◆ *New Firing Range.*
- ◆ *New Mechanical, Electrical, Plumbing, Security, Telecom, and Structural for the above as applies.*

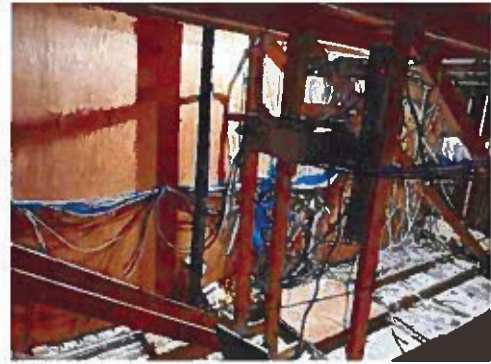
This location can be re-used for new cabling and patch panels, but it is highly recommended that additional plywood flooring be placed for easier / safer access.

Figure 52 - Existing attic IDF with unsafe floor

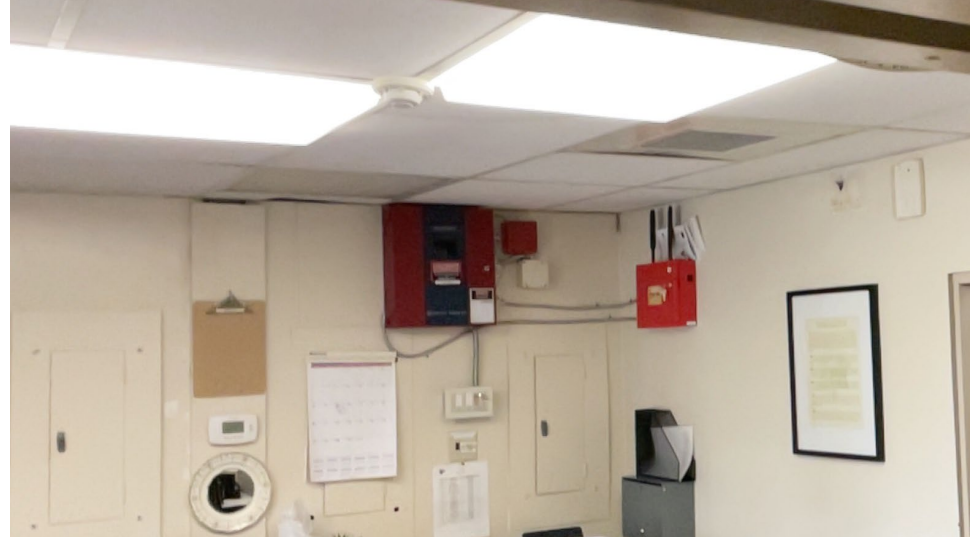
Water intrusion at electrical equipment
