CITY OF CARMEL-BY-THE-SEA CLIMATE COMMITTEE

1. Receive a presentation from Integral Corp./Haro Kasunich & Associates/EMC Planning Group regarding the results of the Coastal Engineering Condition Evaluation, Task 1, and Shoreline and Beach Change Analysis, Task 2, which is part of the Coastal Engineering Study
2. Review list of Adaptation Strategies for Climate Action and Adaptation Plans and Provide Feedback for Monitoring the Implementation of the Plans

TO:	Climate Committee Members
SUBMITTED BY:	Mary Bilse, Environmental Programs Manager
SUBJECT:	Receive a presentation from Integral Corp./Haro Kasunich & Associates/EMC Planning Group regarding the results of the Coastal Engineering Condition Evaluation, Task 1, and Shoreline and Beach Change Analysis, Task 2, which is part of the Coastal Engineering Study

27 April 2023
Coastal Protection Evaluation 22 December 2022 thru 30 January 2023
Carmel Adaptation Plan - Carmel Beach All Areas
Project No. 12176
Page 19

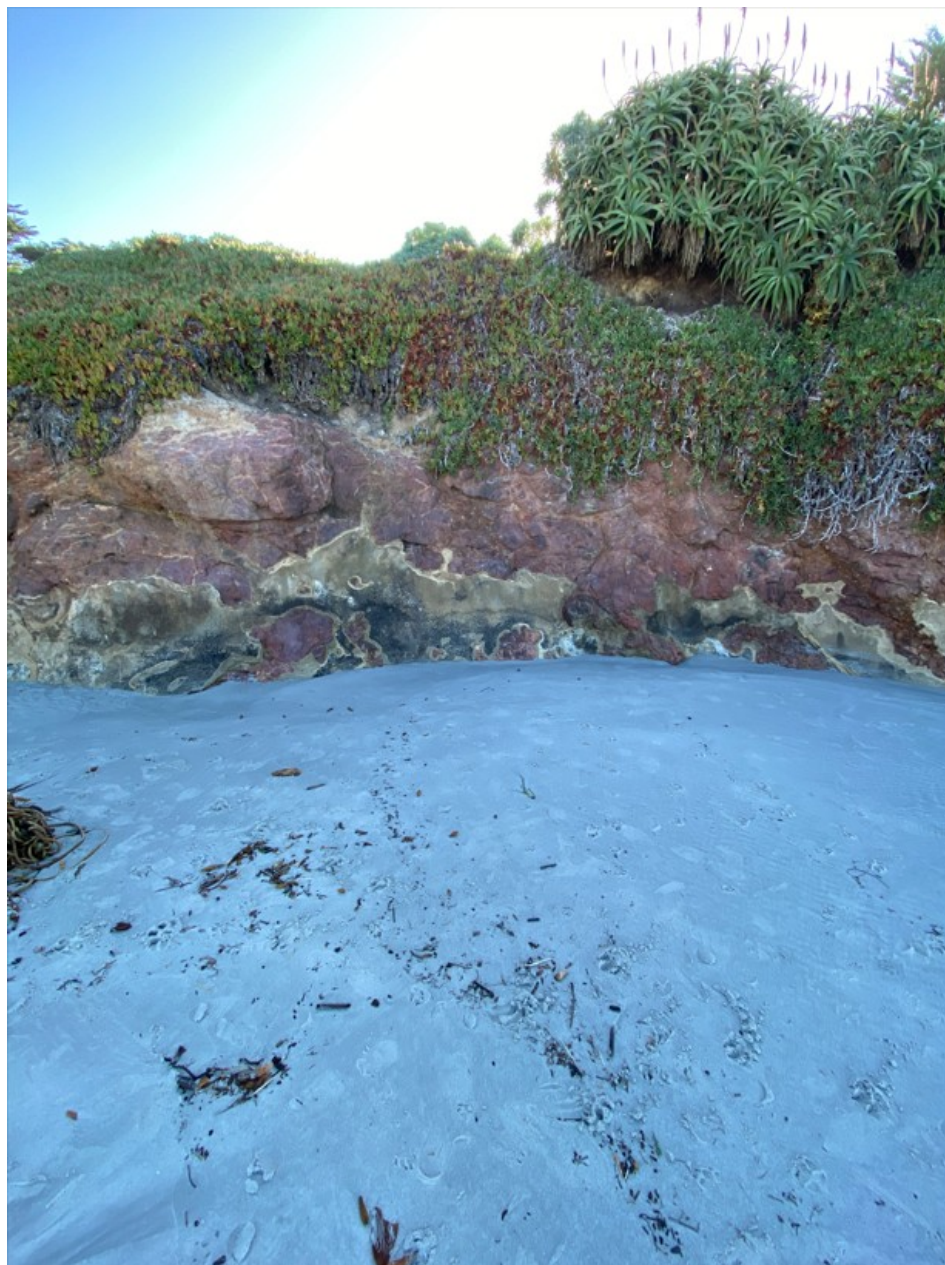
Photograph 2: Unnamed shotcrete between S1 and S2 on December 22, 2022

Photograph 2 shows some shotcrete or gunite fascia exists on the bedrock portion of the coastal bluff face between S1 and S2 (where located on the map contained in Appendix B) north from the Frank Lloyd Wright home on December 22, 2022. Its age, origin, and position relative to the boundary between the privately owned and publically owned upland parcel's common boundary line is unknown. It looks to be in good condition.

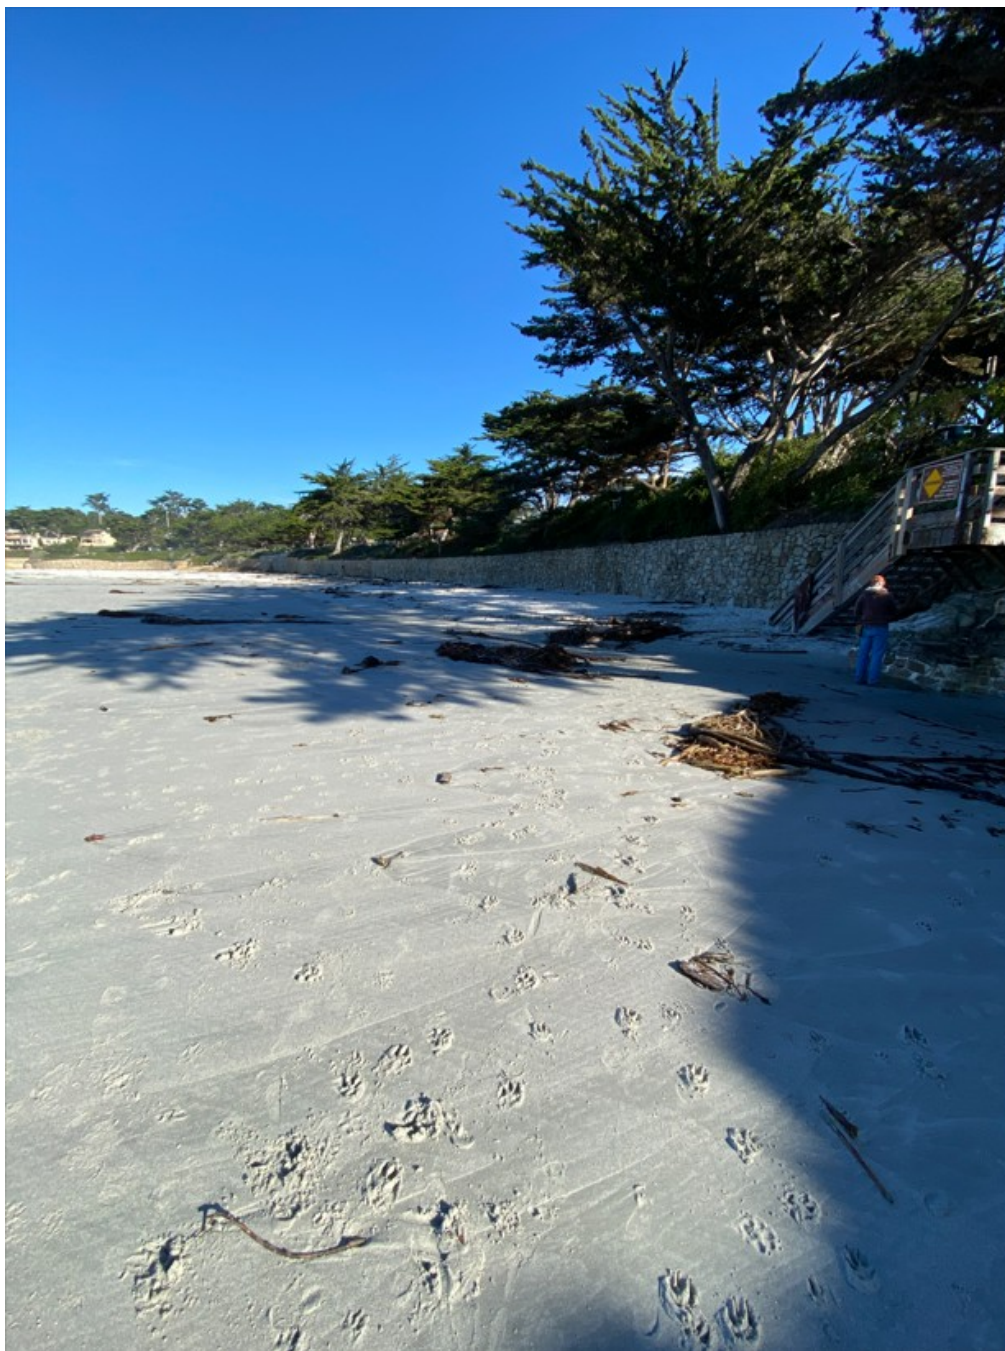
Photograph 3: Seawall S2 on December 22, 2022

Photograph 3 shows a view looking north at Seawall S2, which extends from the Frank Lloyd Wright home to Santa Lucia Avenue, on December 22, 2022. This seawall is in good condition.

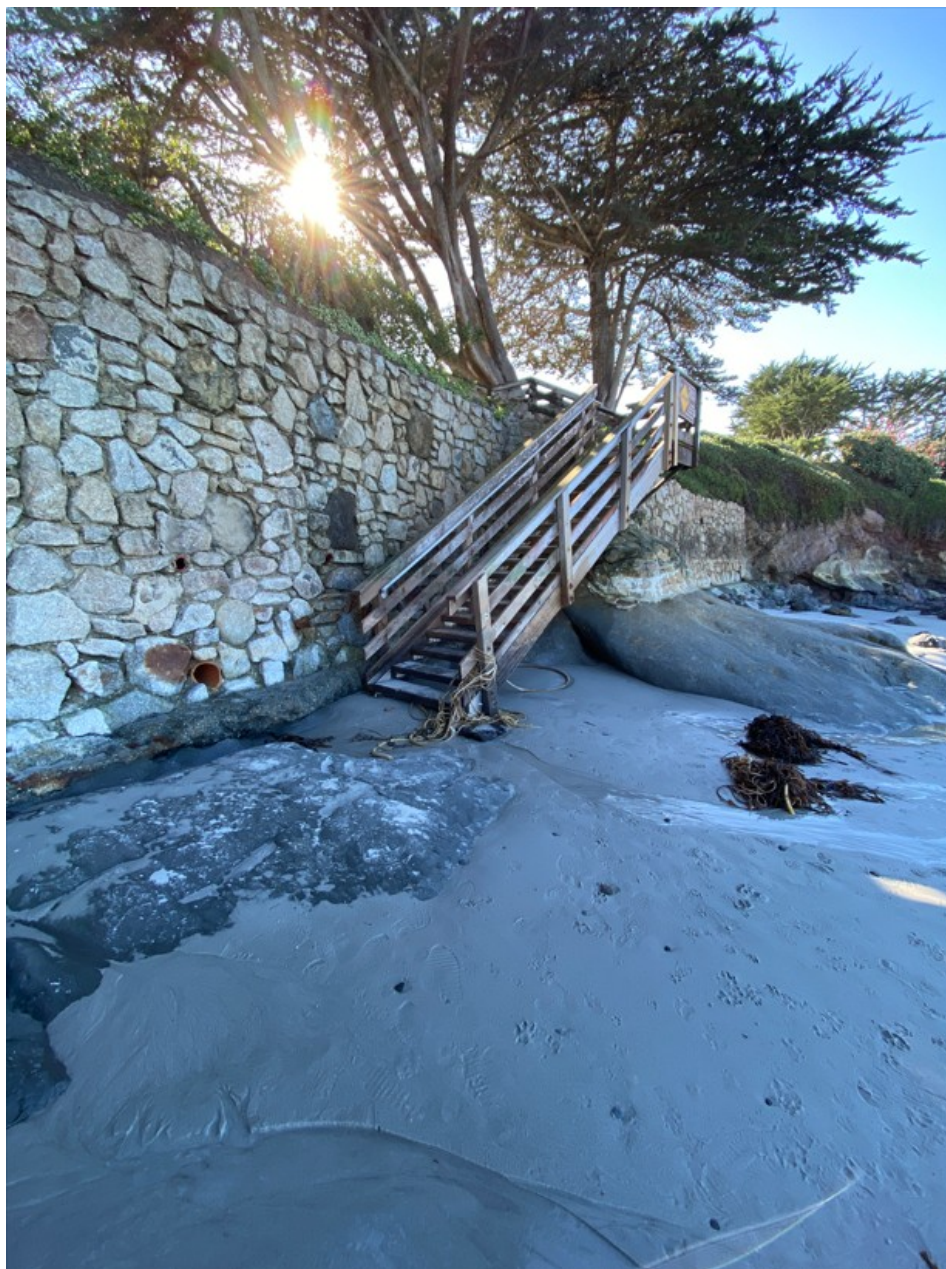
Photograph 6: Showing Stairway ST1 on January 30, 2023

Photograph 6: shows Stairway ST1 along Seawall S2 on January 30, 2023. The beach sand level was scoured lower compared to December 2022. The Seawall S2 foundation is exposed and is bearing upon sandstone bedrock; no maintenance is presently recommended.

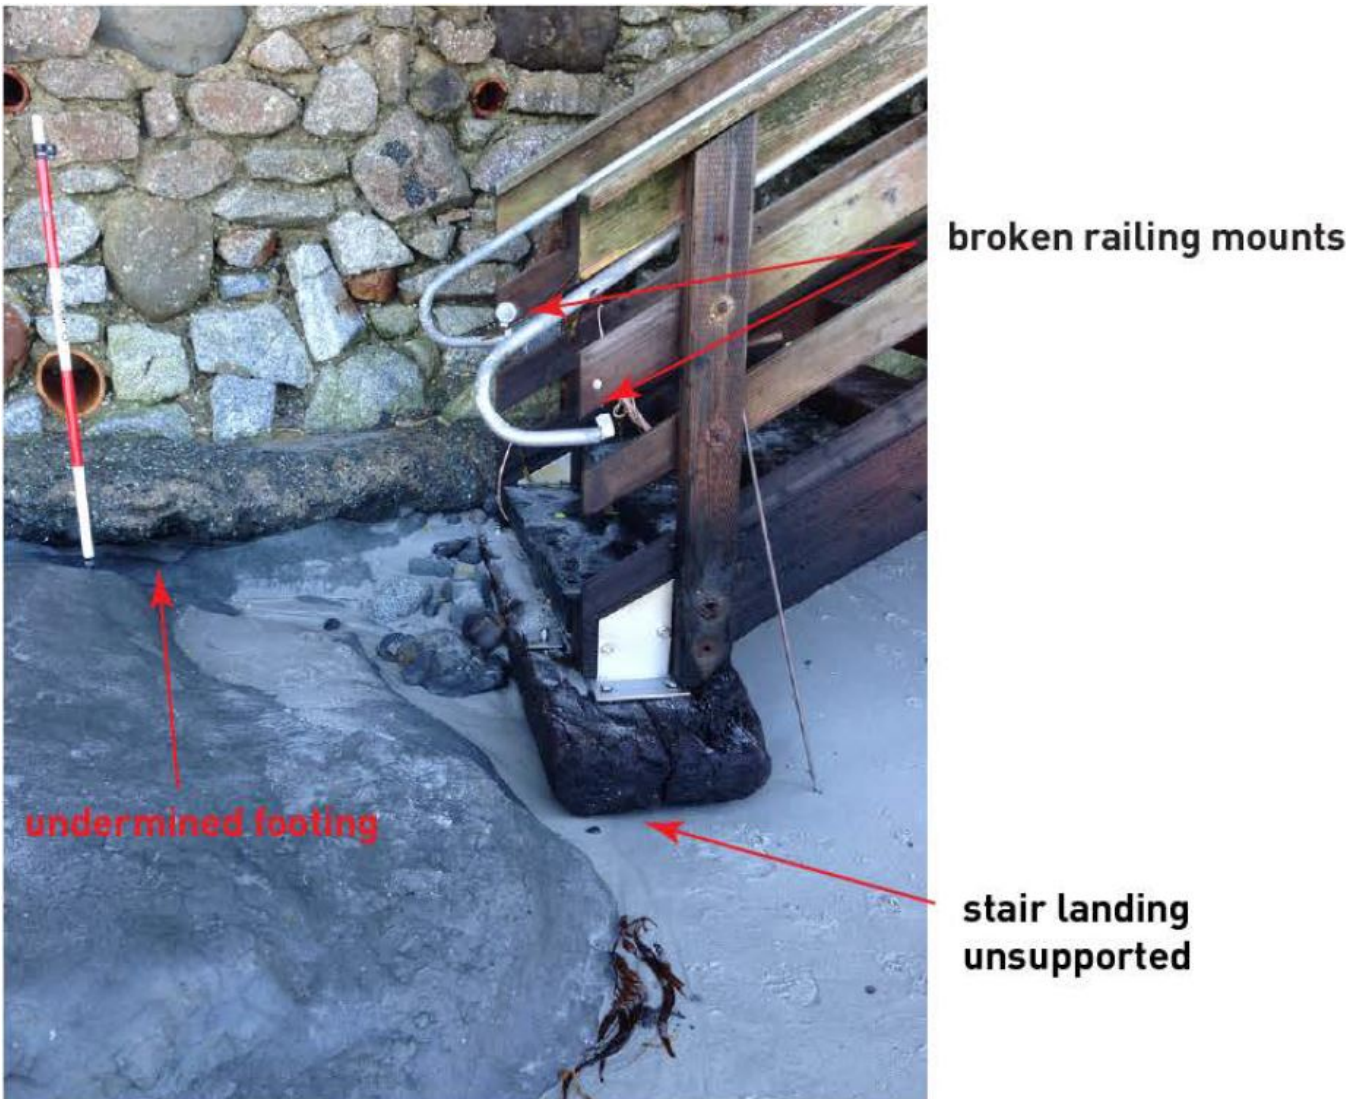
Photograph 7: Showing Stairway ST1 in February 2016 (Photo from Easton Geology)

Stairway ST1 was unsupported in 2016 as shown in Photograph 7 by Easton Geology. The landing area is an irregular surface and the seawall footing is slightly undermined. We recommend it be verified that the stairway structure is presently founded upon bedrock. Repairs appear to be needed due to corrosion of fasteners and hardware. We rank the repair as a medium priority, pending structural and corrosion inspection, which we rank as a high priority. There is an unknown risk to users of the stairs.

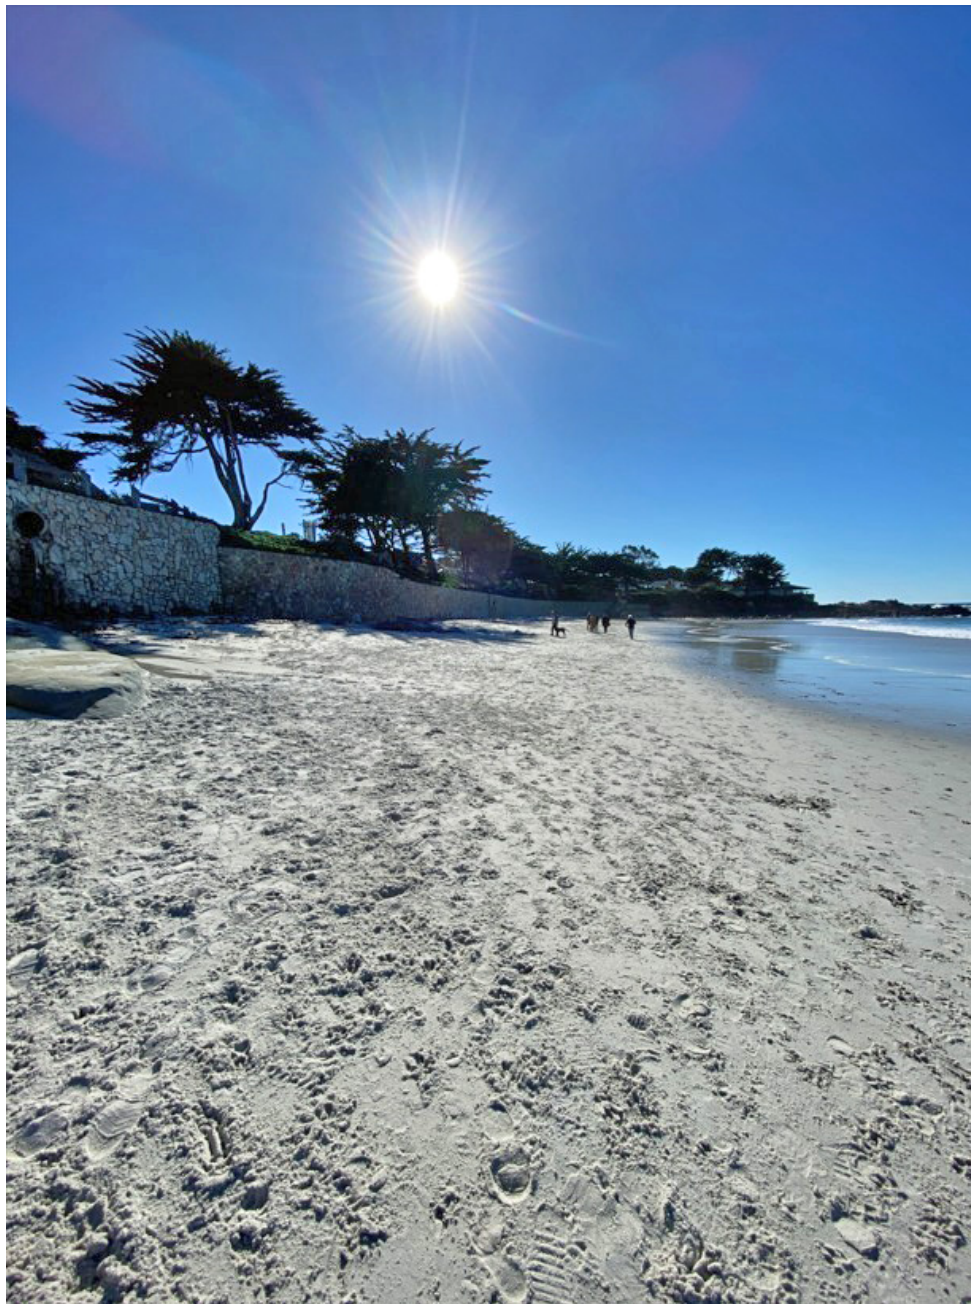
Photograph 8: Showing Seawall S2 on January 30, 2023

Photograph 8 shows Seawall S2 on January 30, 2023 inspection. No rip riprap revetments seaward of the seawall were evident during our inspection. Some bedrock platform exposures are observed seaward of seawall, indicating scour levels were near the bottom of the sand deposit.

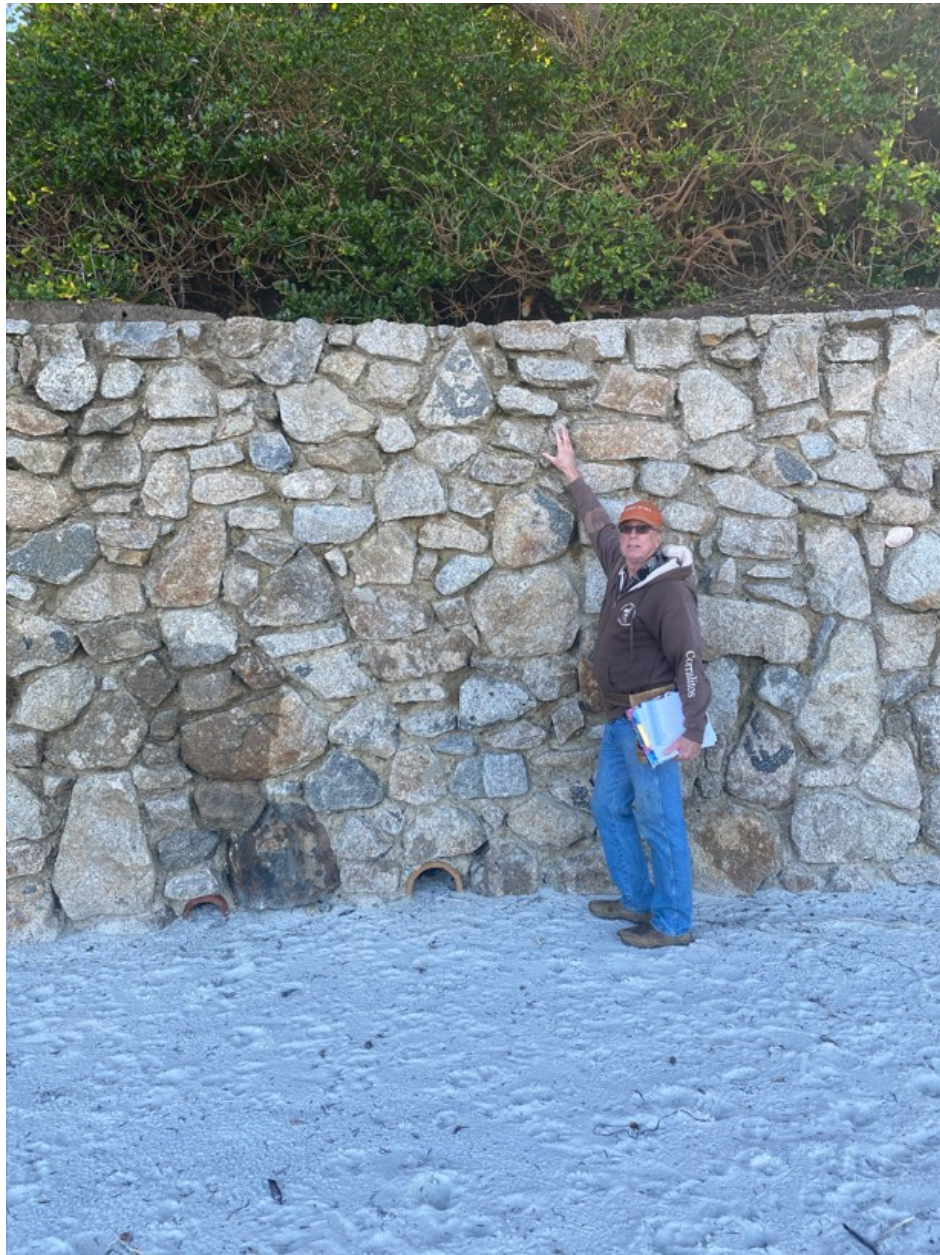
Photograph 9: Seawall S2 on December 22, 2022

Photograph 9 shows Public Access Seawall S2 on December 22, 2022. The exposed portion is in excellent condition. The seawall foundation is buried by beach sand, which is normal. After severe ocean storms in January 2023 we revisited this location and almost all of this seawall's foundation was still buried by beach sand. Whenever it is next exposed by natural beach sand scour processes, it should be inspected. That may not be for a decade, but could be possible this winter. No repairs appear needed at this time and the seawall does not pose any extraordinary risks to beach users. This seawall appears to have more than 30 years of remaining life.

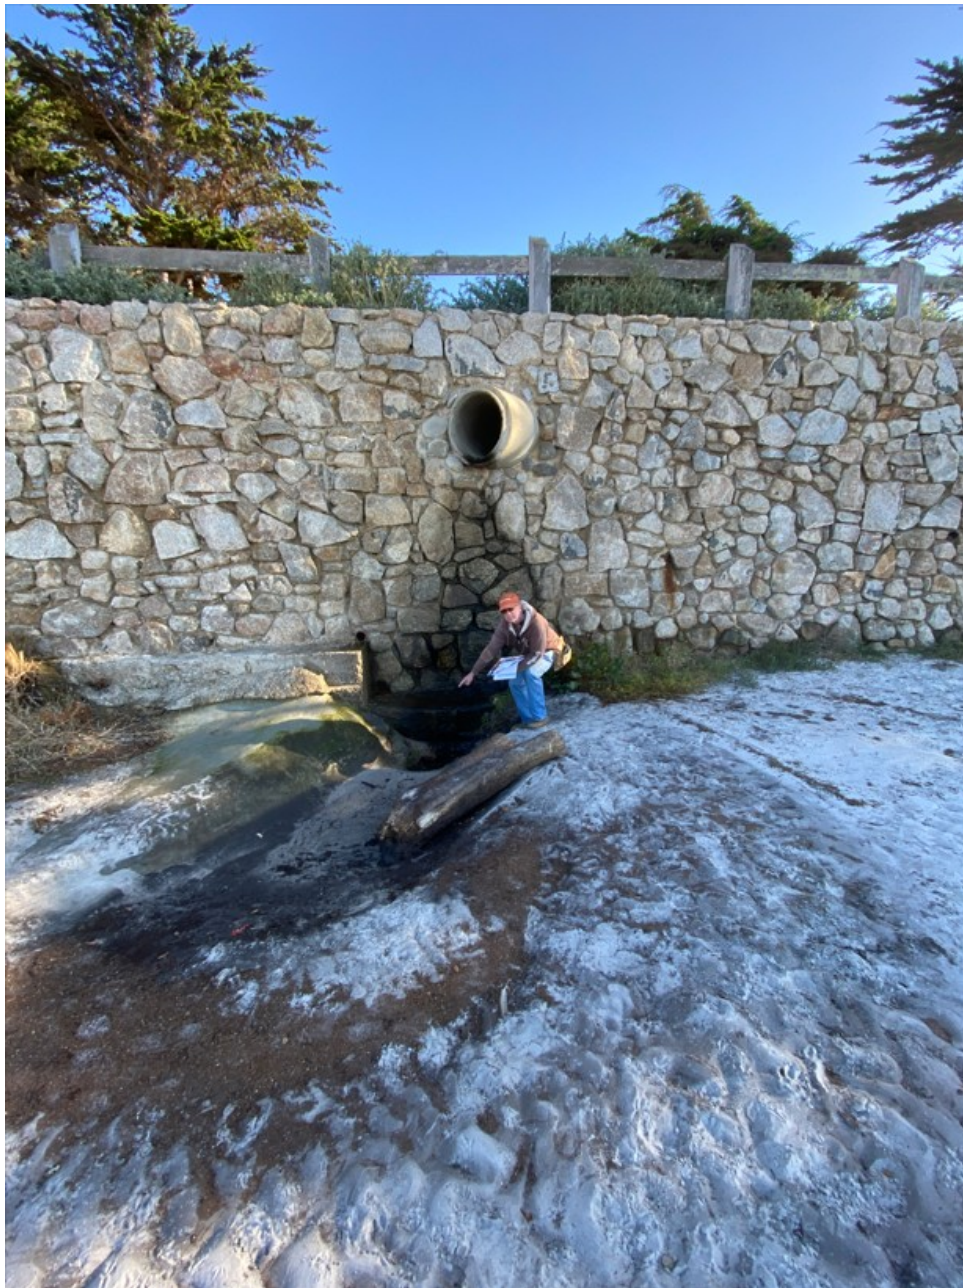
Photograph 10: Storm Drain near NorthNorthern End of Seawall S2 on December 22, 2022

Photograph 10 shows a Storm Drain Outfall near the north end of Seawall S2 on December 22, 2022. Storm runoff had gullied the beach sand at that location. Minor erosion had occurred adjacent to the seawall foundation footing. This location should be periodically monitored as time passes, so that if repairs are needed (such as plugging cavity under the footing) they can be done in a timely manner. No repair work is presently needed.

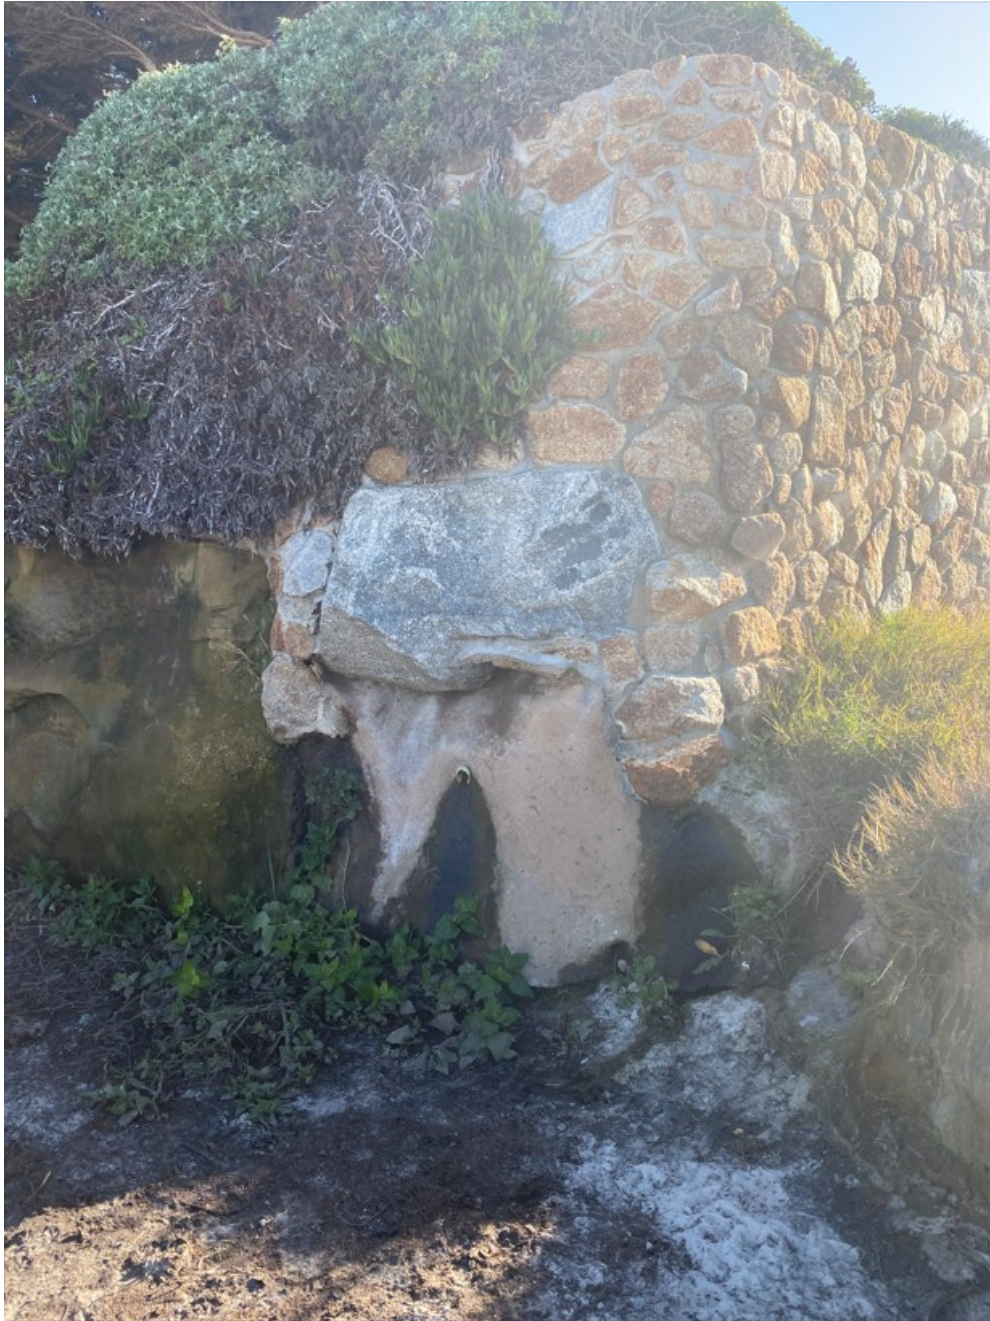
Photograph 13: North End of Seawall S2 on December 22, 2022

Photograph 13 shows the very northern tip of Seawall S2 on December 22, 2022, where noticeable groundwater seepage is present. The end of the seawall was historically undermined and a repair consisting of a small concrete patch was done in the past. This area appears to be in reasonable condition, and the seawall appears to be stable.

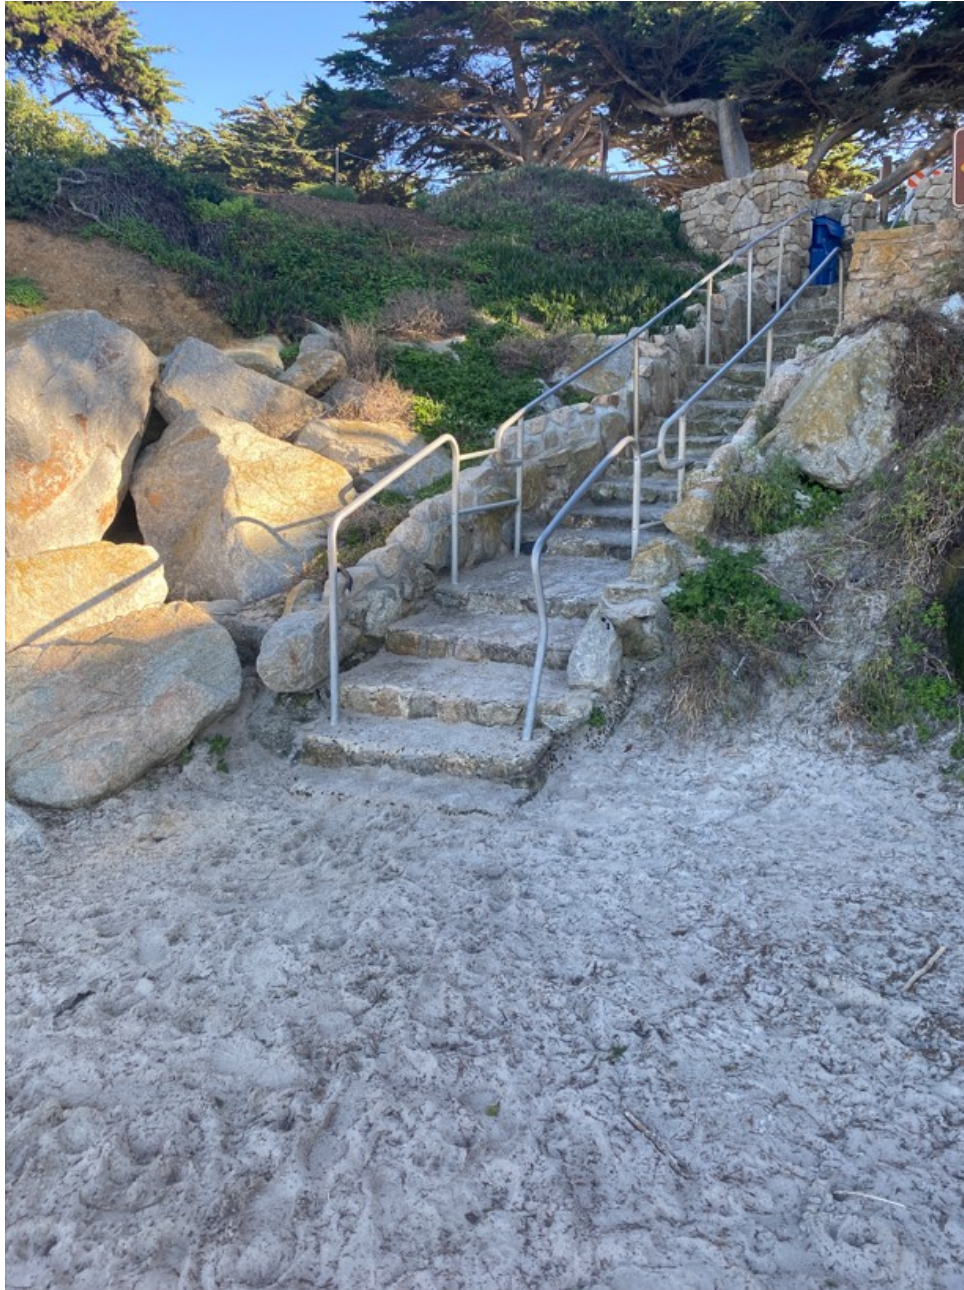
Photograph 14: Public Access Stairway ST2 on December 22, 2022

Photograph 14 shows the seaward portion of Public Access Stairway ST2, located at Santa Lucia Avenue, on December 22, 2022, which is in good condition. The south handrail of ST2 is bent; likely from a wave carried log impacting it. The stairway seems functional despite this minor damage. The bottom of the stairway foundation is buried by beach sand, which is the normal condition.

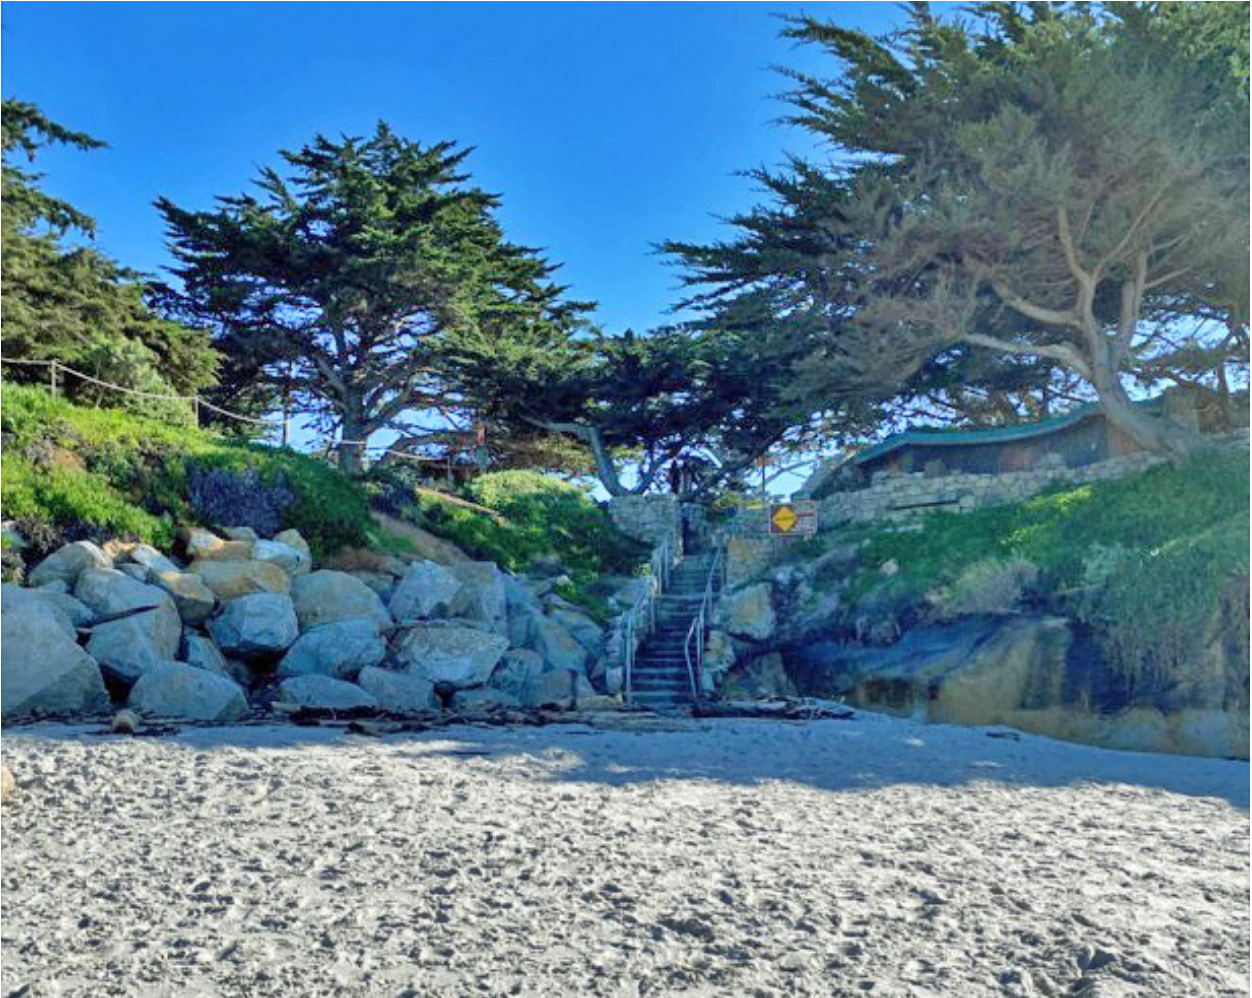
Photograph 15: Showing Revetment R1 and Stairway ST2 on January 30, 2023

Photograph 15 shows Revetment R1, which is located between Seawalls S2 and S3, and shows Stairway ST2 during our January 30, 2023 inspection after severe ocean storms occurred in January 2023 and it was still buried by beach sand. Whenever it is next exposed by natural beach sand scour processes, it should be inspected. That may not be for a decade but could be possible this winter. The estimated life of Stairway ST1 is 30 years or more. The south railing is bent from floating log impact. This does not pose a substantial risk to users of the stairs. We rank the repair as a low priority.

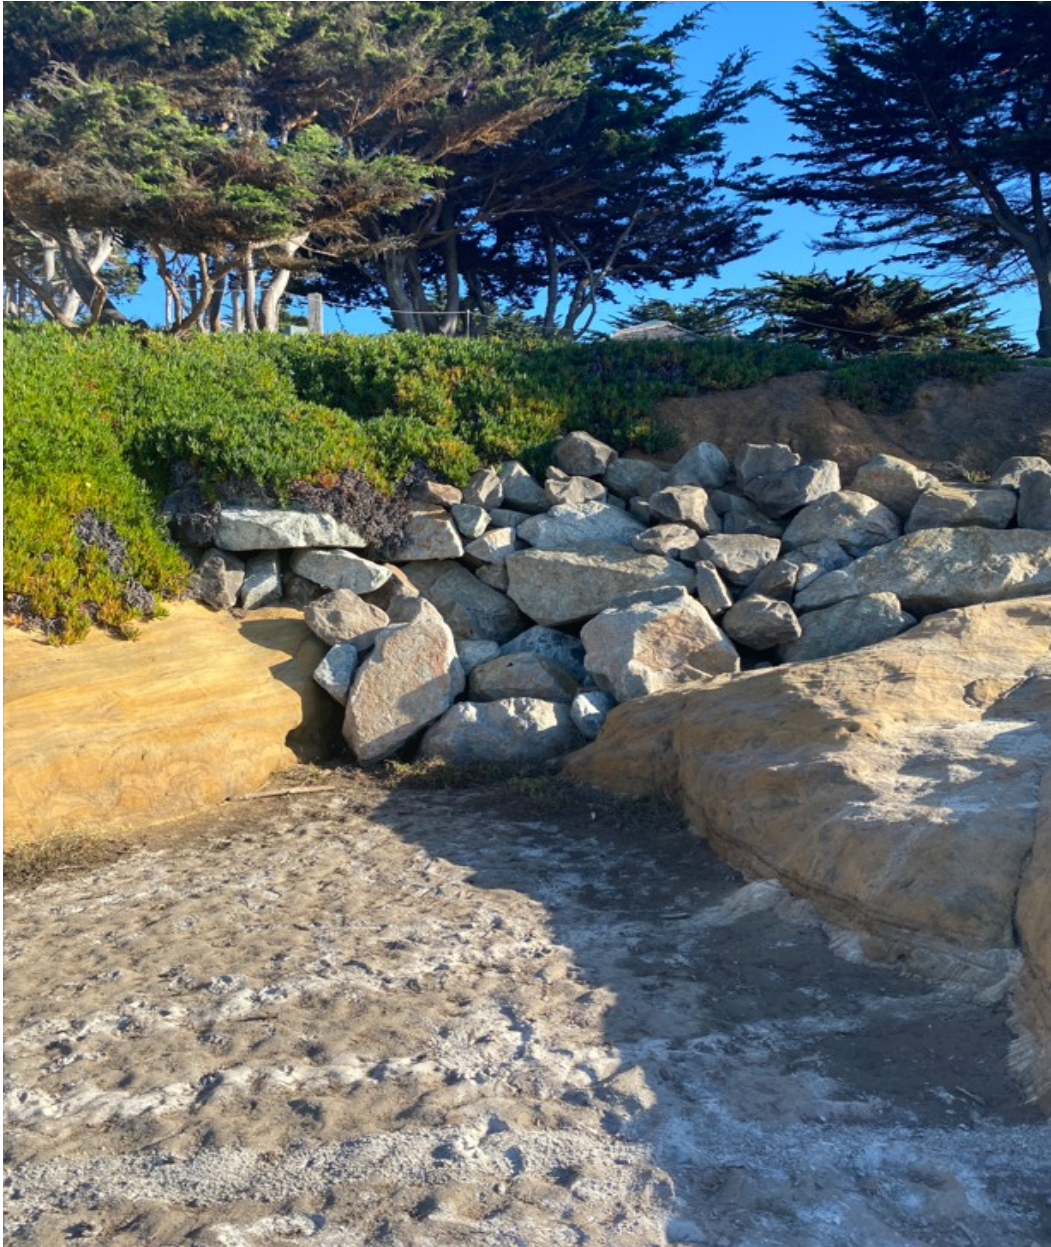
Photograph 19: Revetment R1 on December 22, 2022

Photograph 19 shows the northern end of Revetment R1 on December 22, 2022, which consists of overly steep riprap at a 0.5:1 (H:V) gradient. The northern 1/3 of the Revetment R1 riprap is unstable, poses risks to beach users, and we recommend it has a high priority for repair. We recommend bringing in additional larger riprap quarrystone boulders to lower the revetment gradient. Alternately the revetment could be removed and replaced with a vertical seawall to match the appearance of the other nearby seawalls along Carmel Beach.

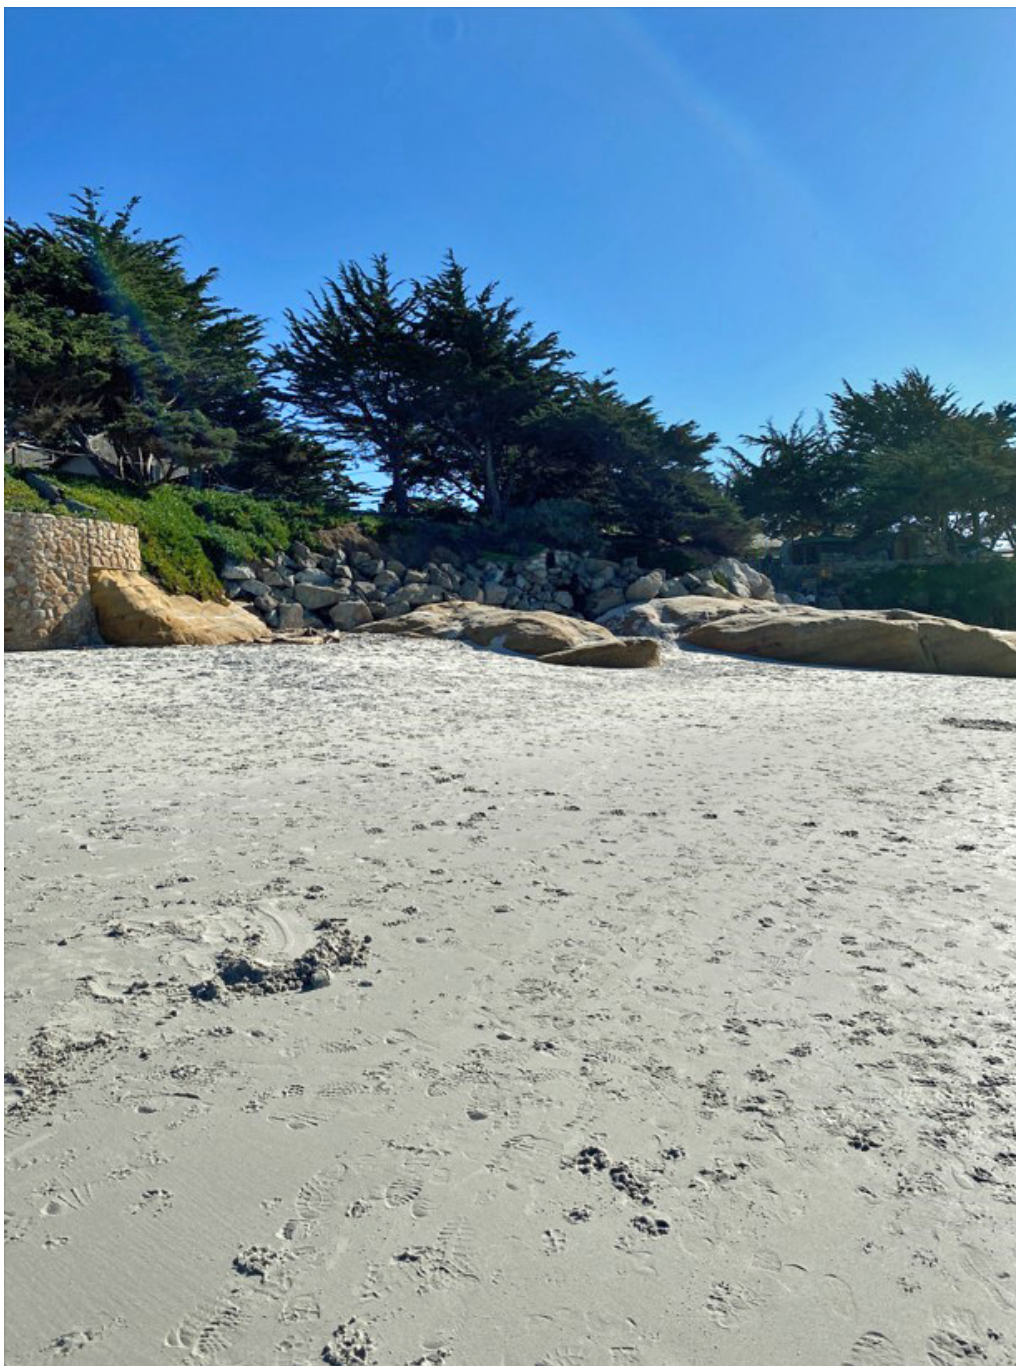
Photograph 20: Showing Revetment R1 and the Southern End of Seawall S3 on January 30, 2023

Photograph 20 shows Revetment R1 and the South End of Seawall S3 on January 30, 2023.

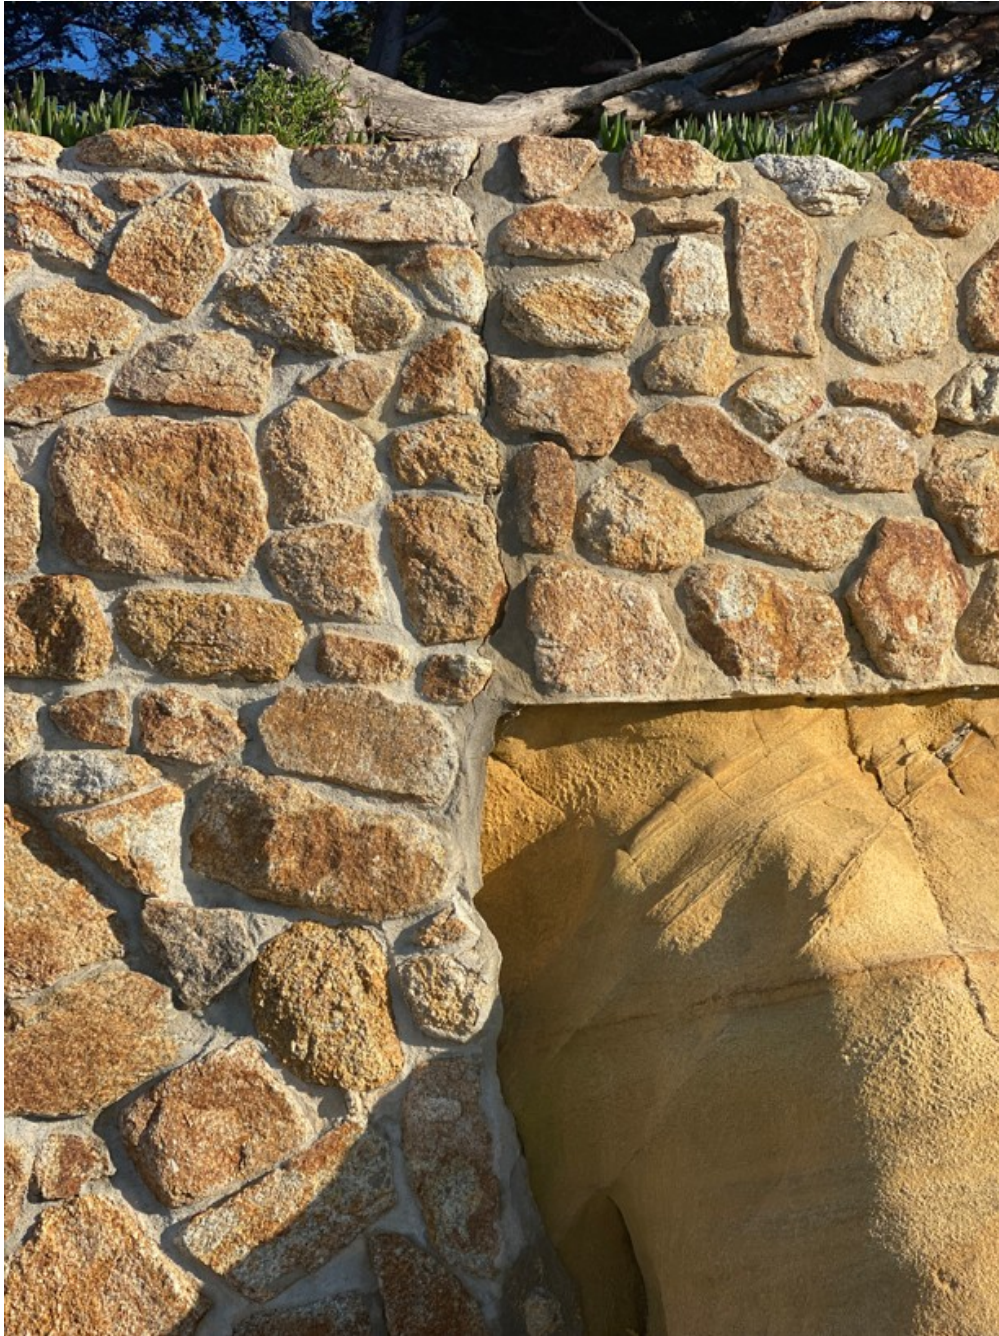
Photograph 21: Very Southern End of Seawall S3 on December 22, 2022

Photograph 21 shows Seawall S3 where its foundation is founded on bedrock and steps upward at the very southern end of Seawall S3, which is located near 13th Avenue, on December 22, 2022. A vertical crack, which appears to be a shrinkage crack or expansion crack, is visible, but is not of concern.

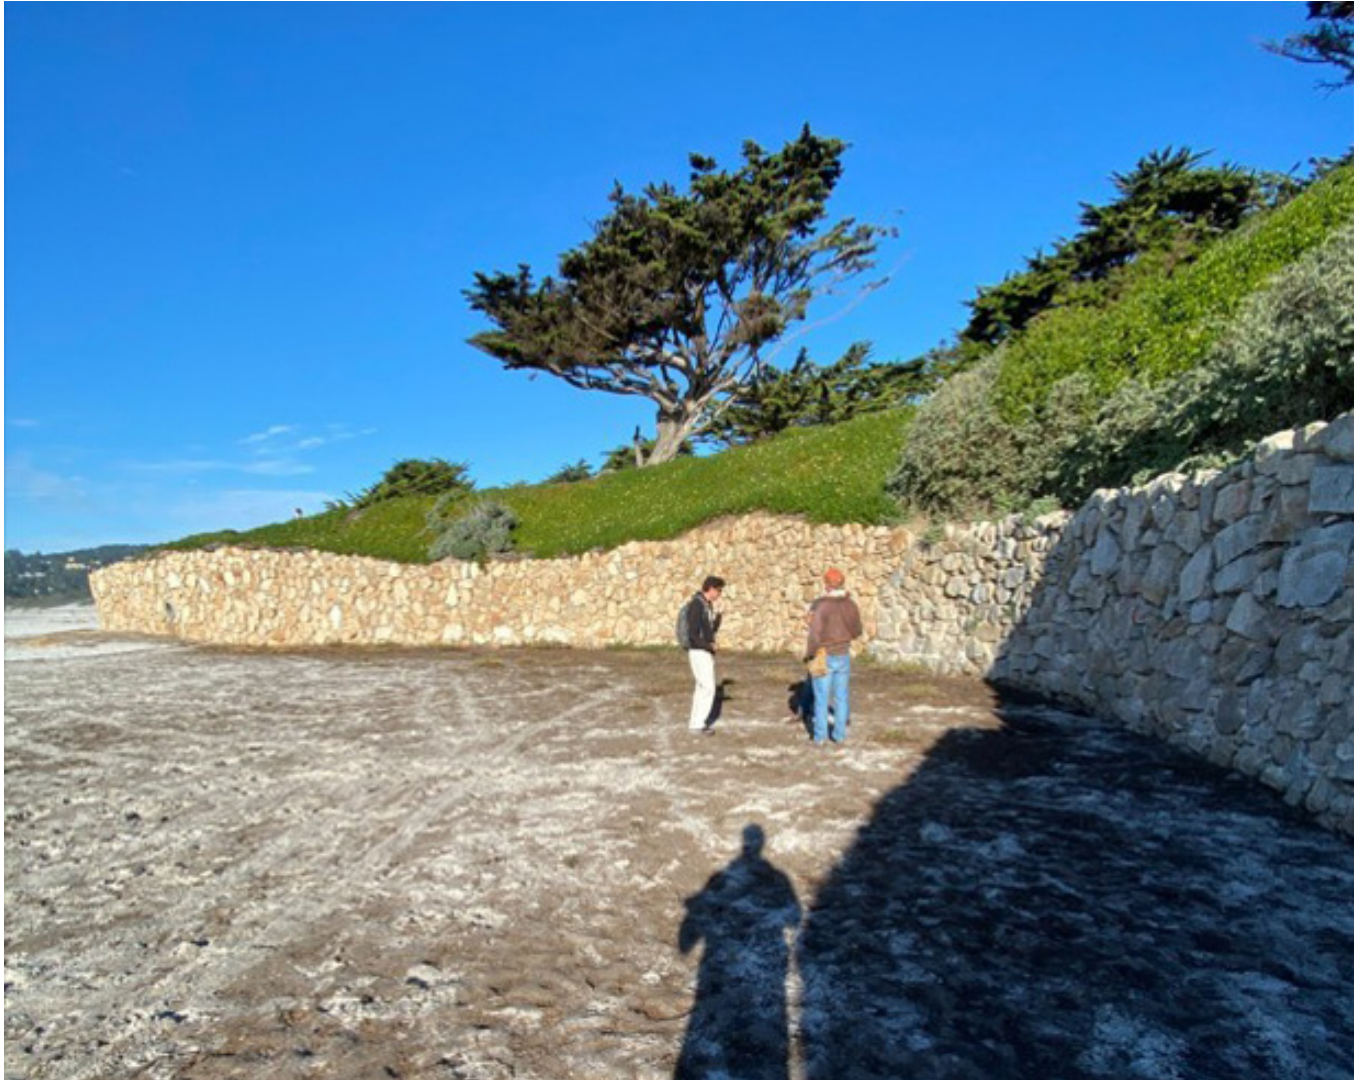
Photograph 25: Looking North at Seawall S3 on December 22, 2022

Photograph 25 is looking north along Seawall S3 on December 22, 2022. At that time the seawall foundation was buried by beach sand, which is normal. After severe ocean storms in January 2023, we revisited this location and it was still partially buried by beach sand. This seawall, including the portion of the foundation we were able to inspect, appears to be in satisfactory condition. Whenever it is next exposed by natural beach sand scour processes, it should be inspected. That may not be for a decade but could be possible during any winter. Except for the possible removal of some of the pumped concrete on the beach at the southern end, no repairs appear needed at this time, and the seawall does not pose any significant risks to beach users. This seawall appears to have more than 30 years of remaining life.

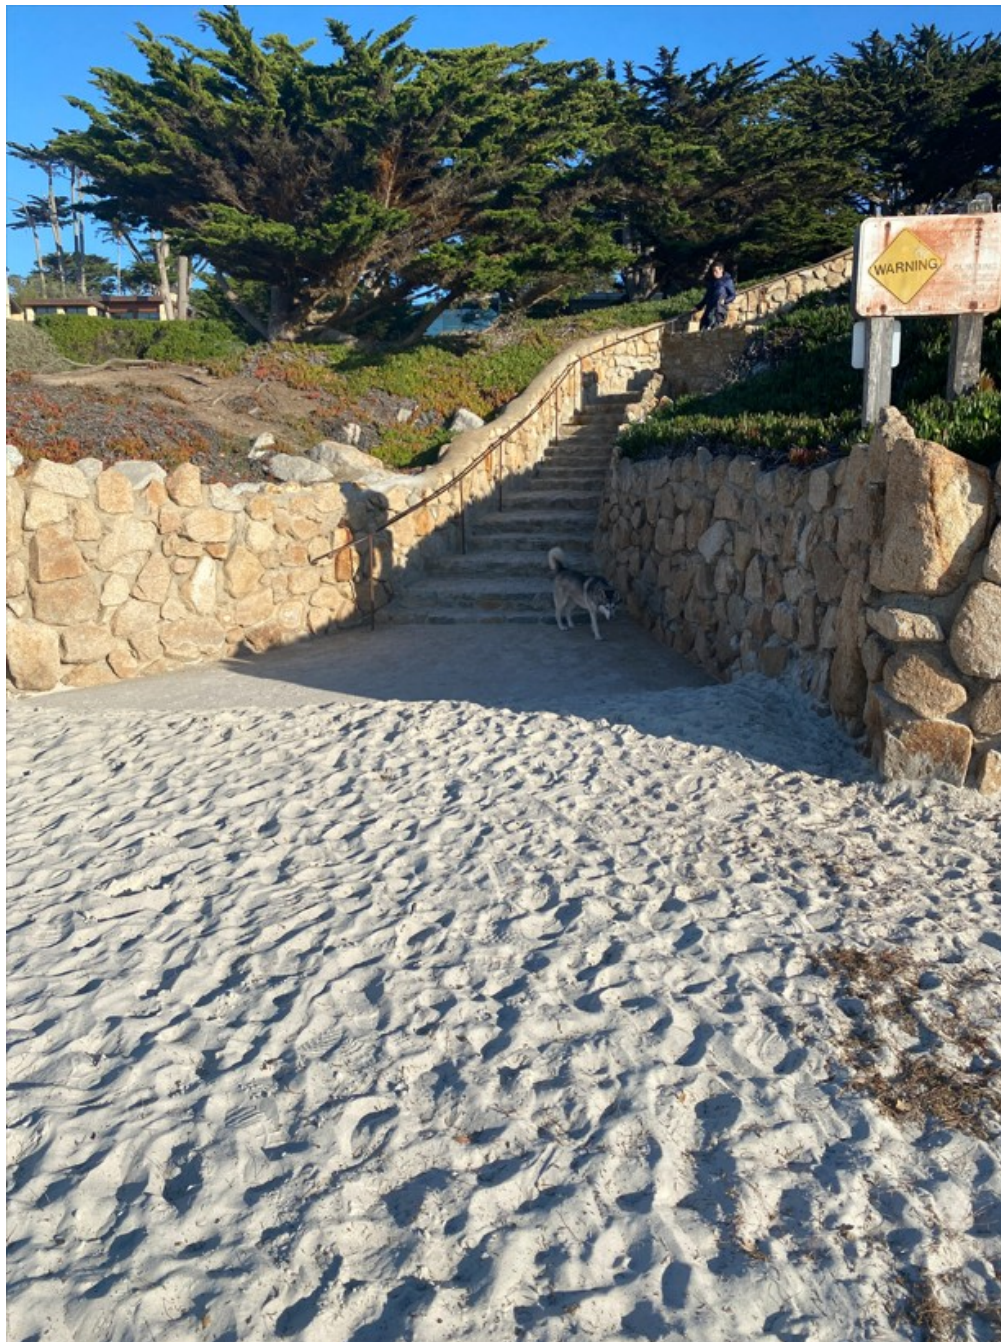
Photograph 27: Public Access Stairway ST3 on December 22, 2022

Photograph 27 shows the seaward portion of Public Access Stairway ST3 located at 13th Avenue, on December 22, 2022, which is in good condition. Seawall S3 is on both sides of ST3.
