CITY OF CARMEL-BY-THE-SEA CLIMATE COMMITTEE

1. Receive a presentation from Integral Corp./Haro Kasunich & Associates/EMC Planning Group regarding the results of the Coastal Engineering Condition Evaluation, Task 1, and Shoreline and Beach Change Analysis, Task 2, which is part of the Coastal Engineering Study
2. Review list of Adaptation Strategies for Climate Action and Adaptation Plans and Provide Feedback for Monitoring the Implementation of the Plans

TO:	Climate Committee Members
SUBMITTED BY:	Mary Bilse, Environmental Programs Manager
SUBJECT:	Receive a presentation from Integral Corp./Haro Kasunich & Associates/EMC Planning Group regarding the results of the Coastal Engineering Condition Evaluation, Task 1, and Shoreline and Beach Change Analysis, Task 2, which is part of the Coastal Engineering Study

27 April 2023
Coastal Protection Evaluation 22 December 2022 thru 30 January 2023
Carmel Adaptation Plan - Carmel Beach All Areas
Project No. 12176
Page 19

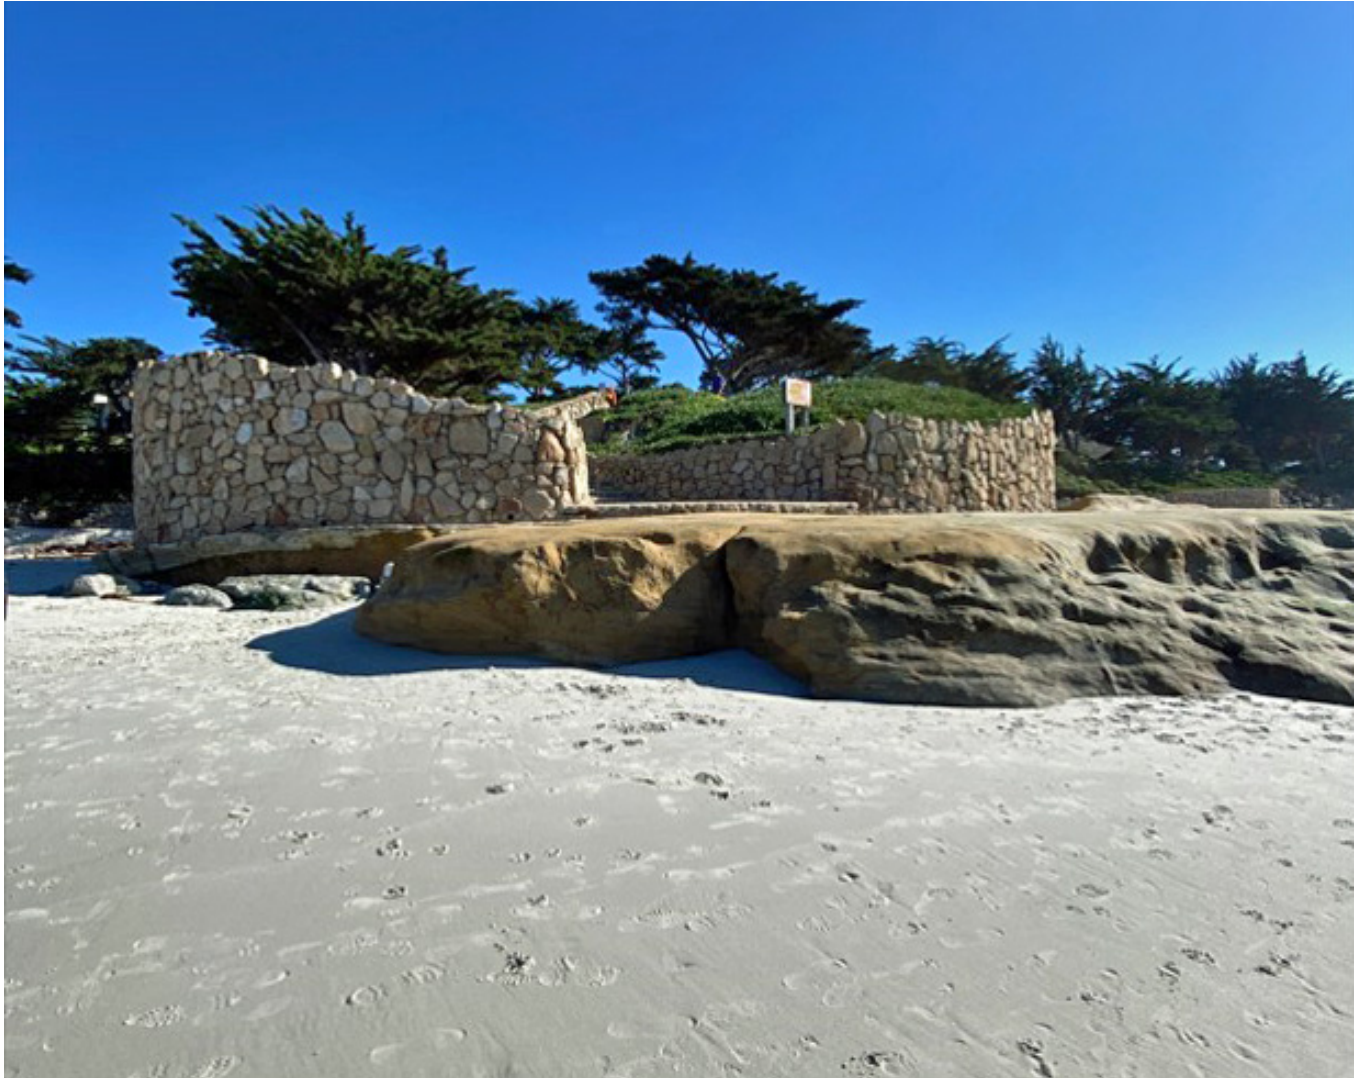
**Photograph 28: Showing Public Access Stairway ST3 with Seawall S3 on Both Sides
On January 30, 2023**

Photograph 28 shows the seaward portion of Public Access Stairway ST3 on January 30, 2023, when beach sand levels were scoured much lower in elevation than in December 2022. Stairway ST3 is primarily a rock and mortar set of steps that appear to be performing well. This staircase terminates onto a bedrock platform that was an approximately 5 feet vertical height drop from the platform down to beach level at the time of the photograph. This is not a safe transition for public use and it should be investigated for a safer alternative stair termination that accounts for scoured beach conditions. Stairway ST3 repairs do not appear to be needed, but extension of the stairs does appear to be prudent. There is risk to users of the stairs because they do not extend to beach level during periods of low sand levels from scouring. We rank extension of the stairs to beach level as a low priority if they are securely closed off at both the top and bottom during times of low beach levels.

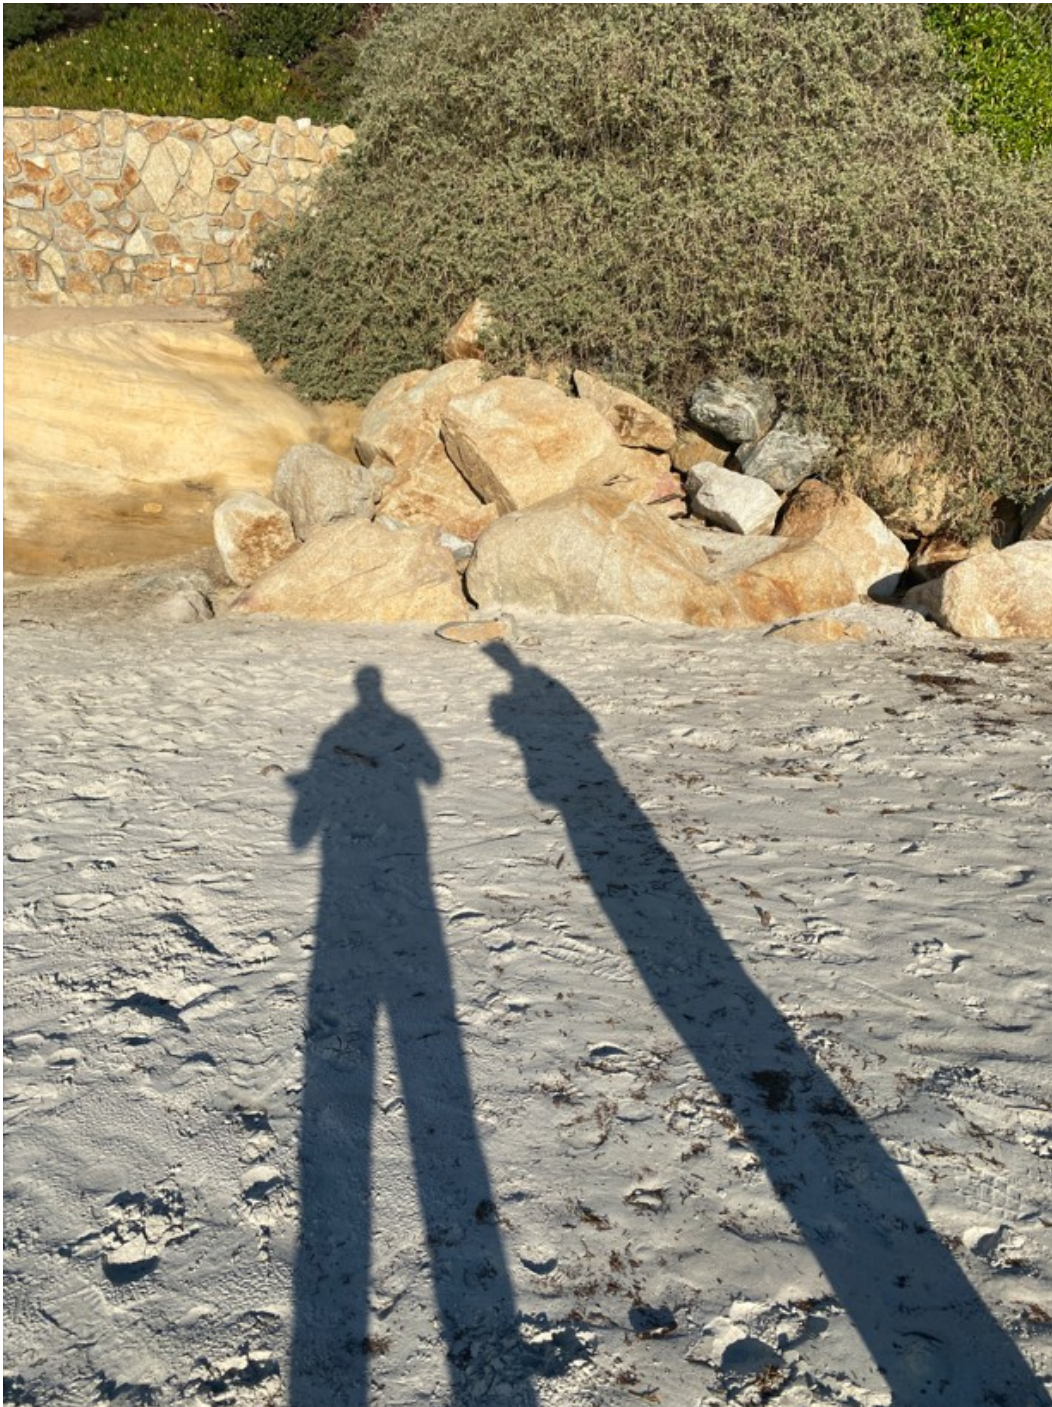
Photograph 34: Showing North End of Revetment R2 on December 22, 2022

Photograph 34 shows the north end of Revetment R2 on December 22, 2022,

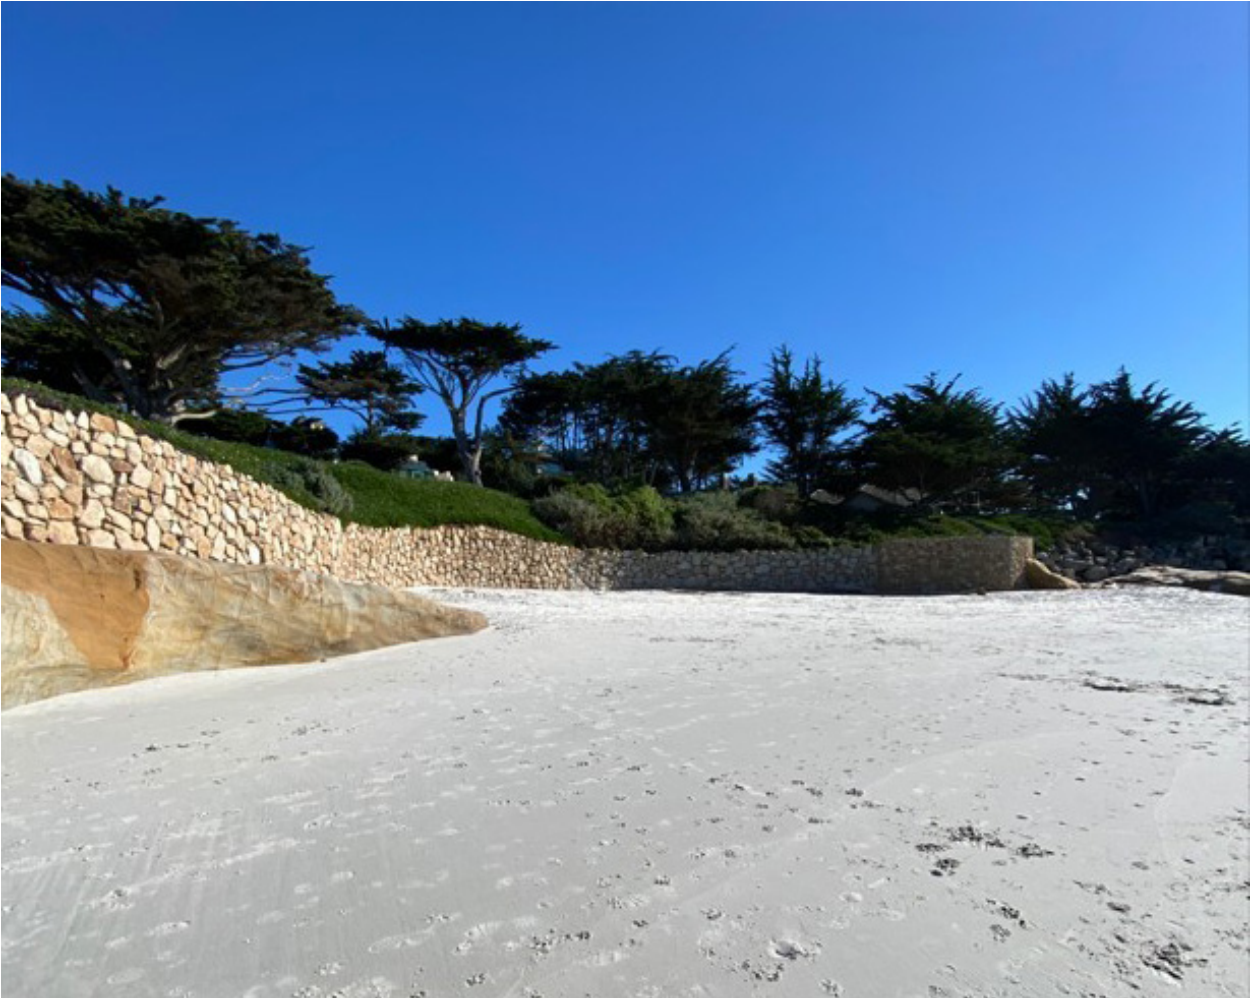
Photograph 35: Showing Seawall S4 on January 30, 2023

Photograph 35 shows the southern portion of Seawall S4 on January 30, 2023 which is in similar conditions to when our December inspection was done. This seawall is in good to excellent condition and is founded on the bedrock platform. No repairs appear to be needed.

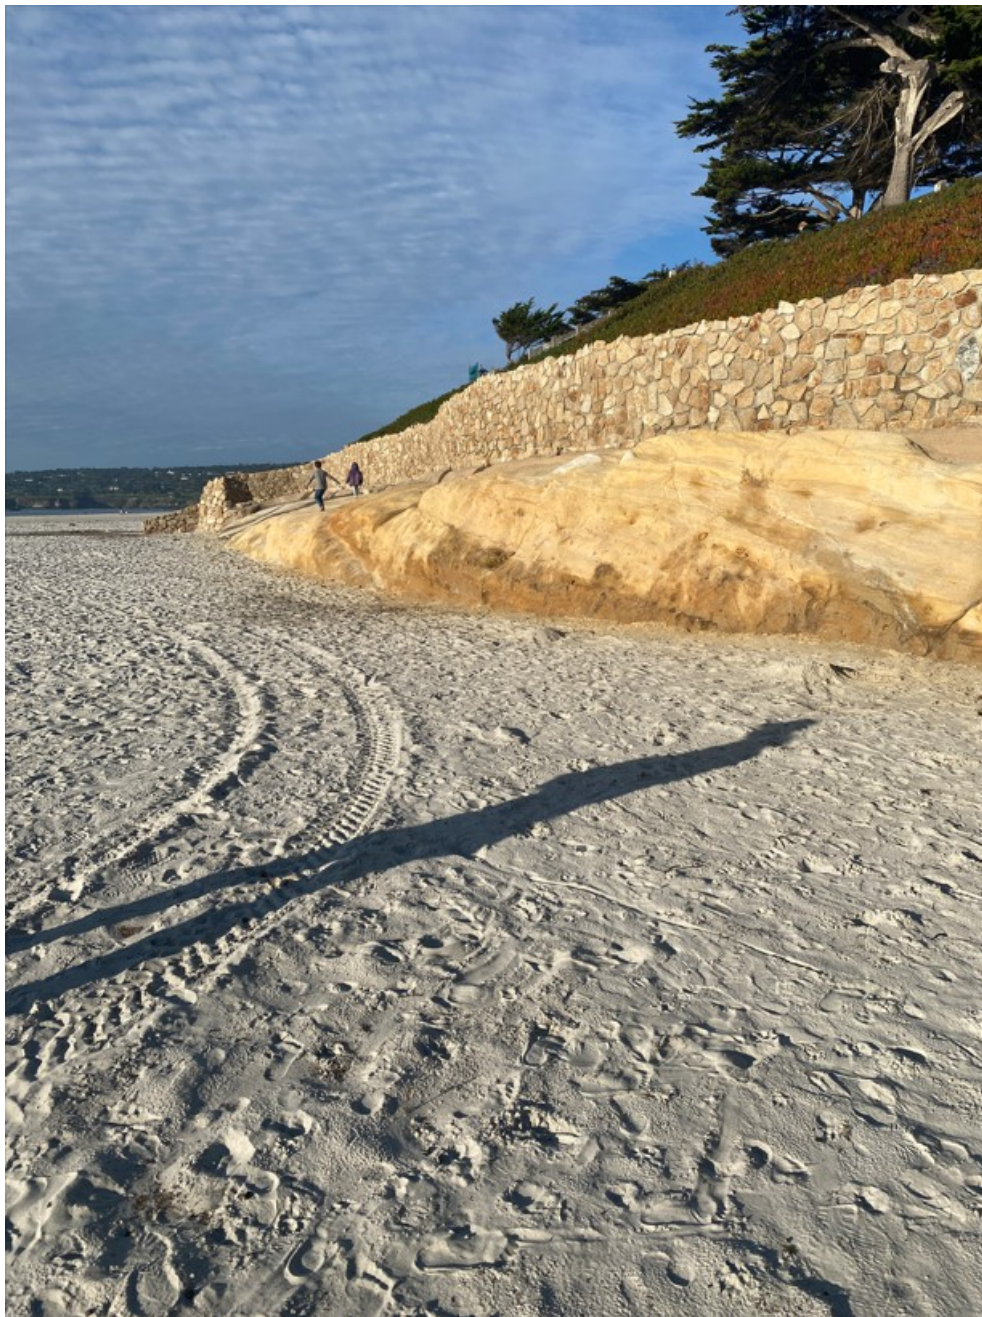
Photograph 36: Showing North Portion of Seawall S4 on December 22, 2022

Photograph 36 shows the north portion of Seawall S4 on December 22, 2022, which is founded on a natural bedrock platform that is elevated above the beach level. This wall was designed by Neill Engineers and constructed in 2001.

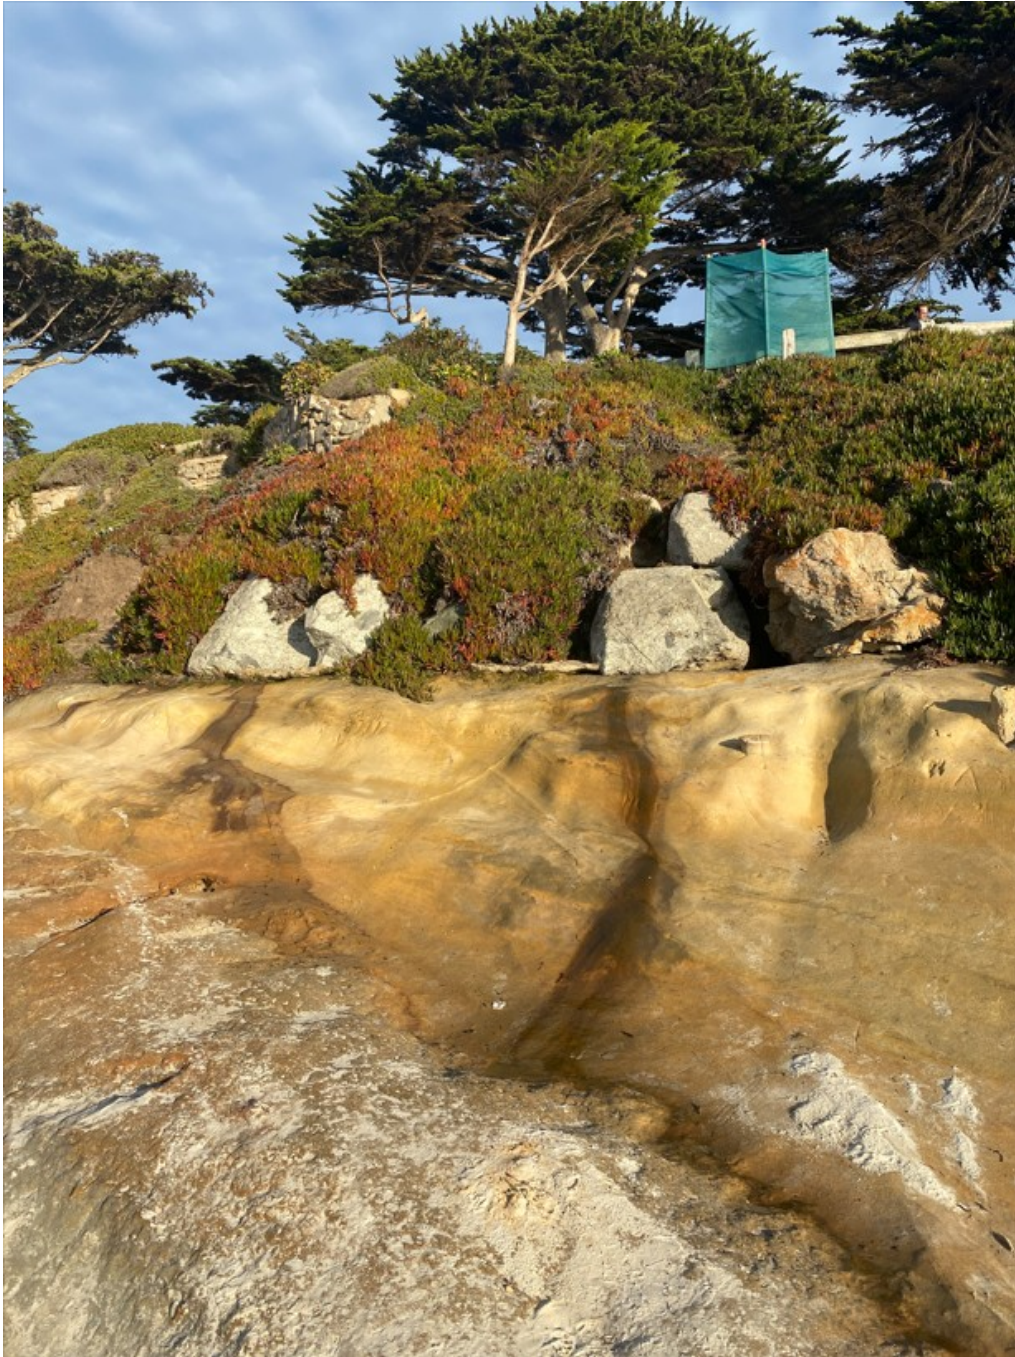
Photograph 37: Showing Unnamed Rip-rap Boulders North of Seawall S4 on December 22, 2022

Photograph 37 shows a few rip-rap boulders located north of Seawall S4 and south of Public Access Stairway ST4 on December 22, 2022. These boulders are founded on a natural bedrock platform that is elevated above the beach level. They presently appear stable.

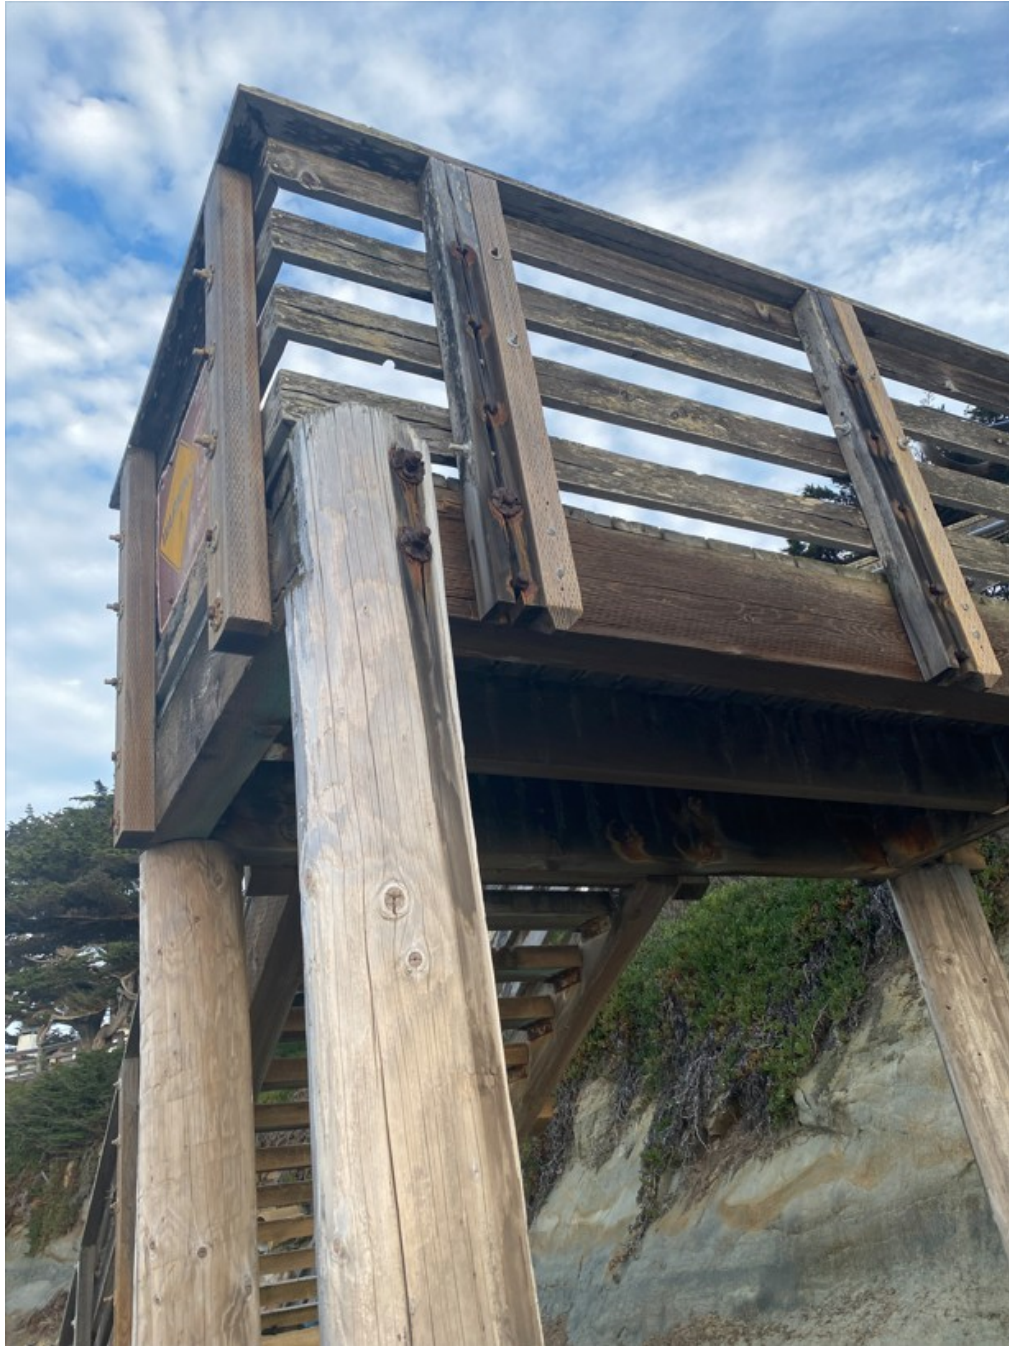
Photograph 41: Showing Corroded Hardware and Split Timbers on Stairway ST4 on December 22, 2022

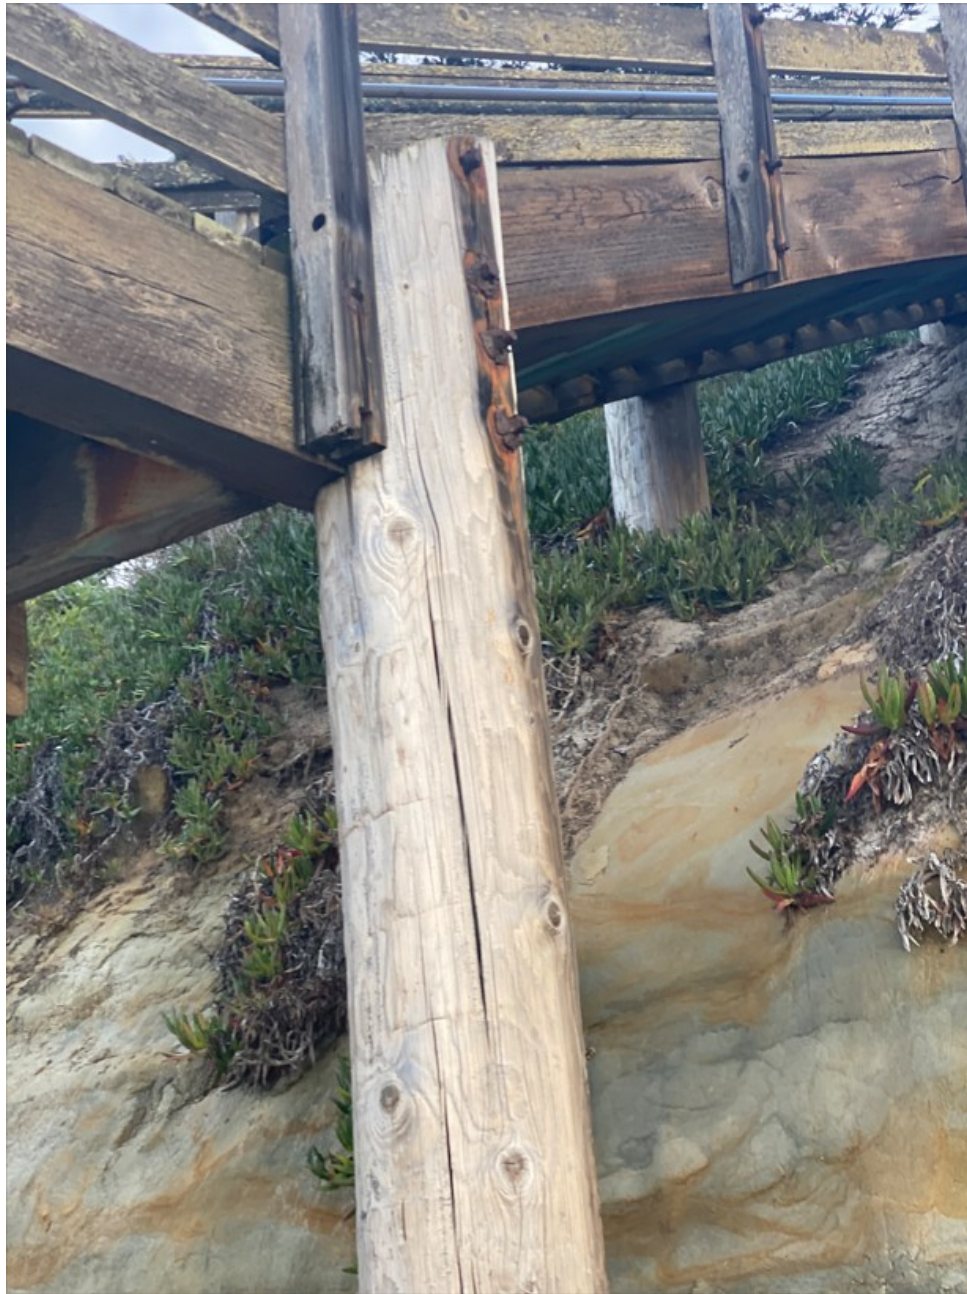
Photograph 42: Showing Corroded Hardware and Split Timbers on Stairway ST4 on December 22, 2022

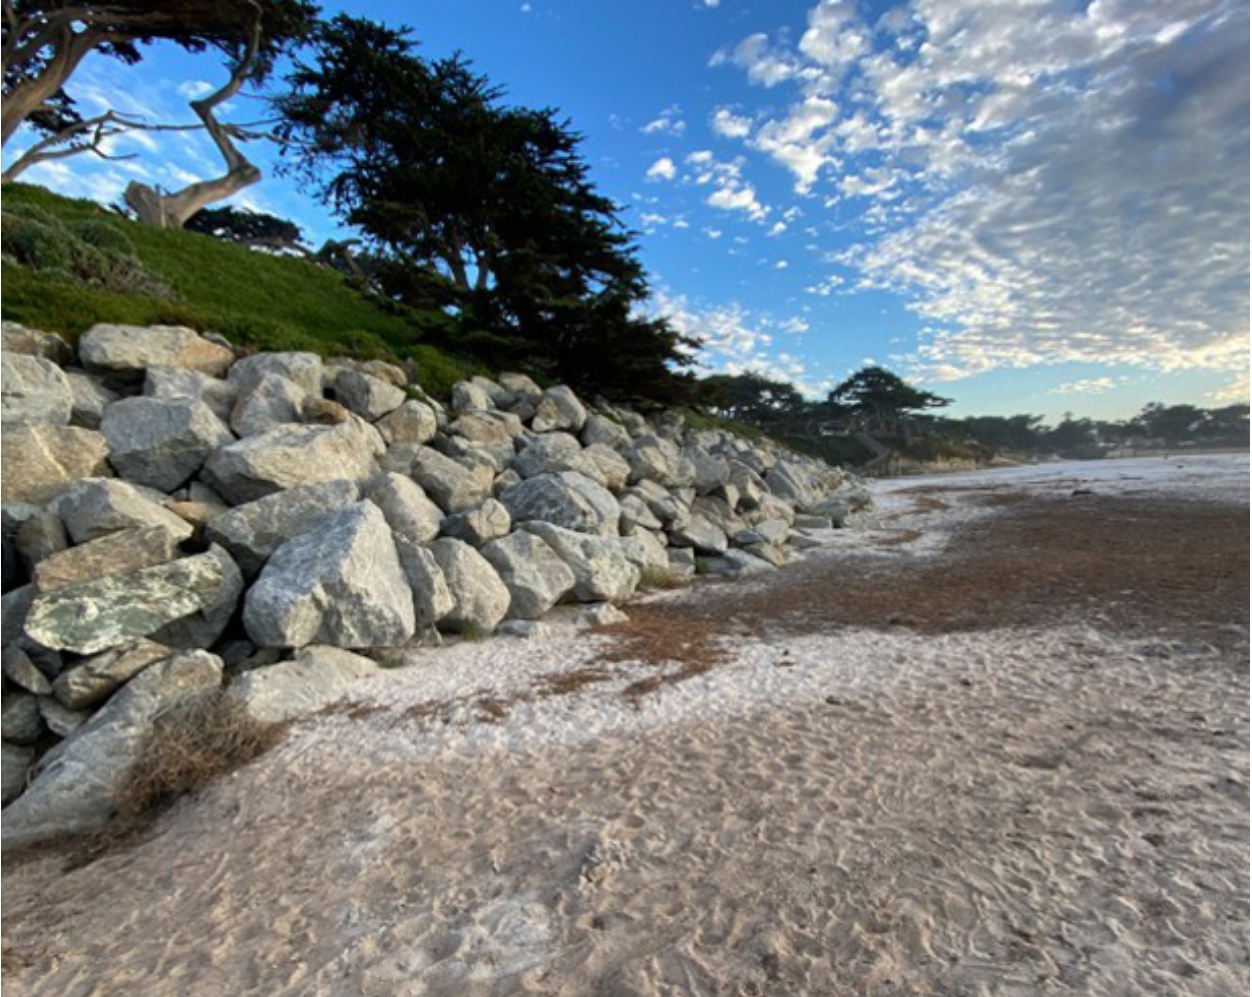
Photograph 54: Over-steepened portion of Revetment R3 on December 22, 2022

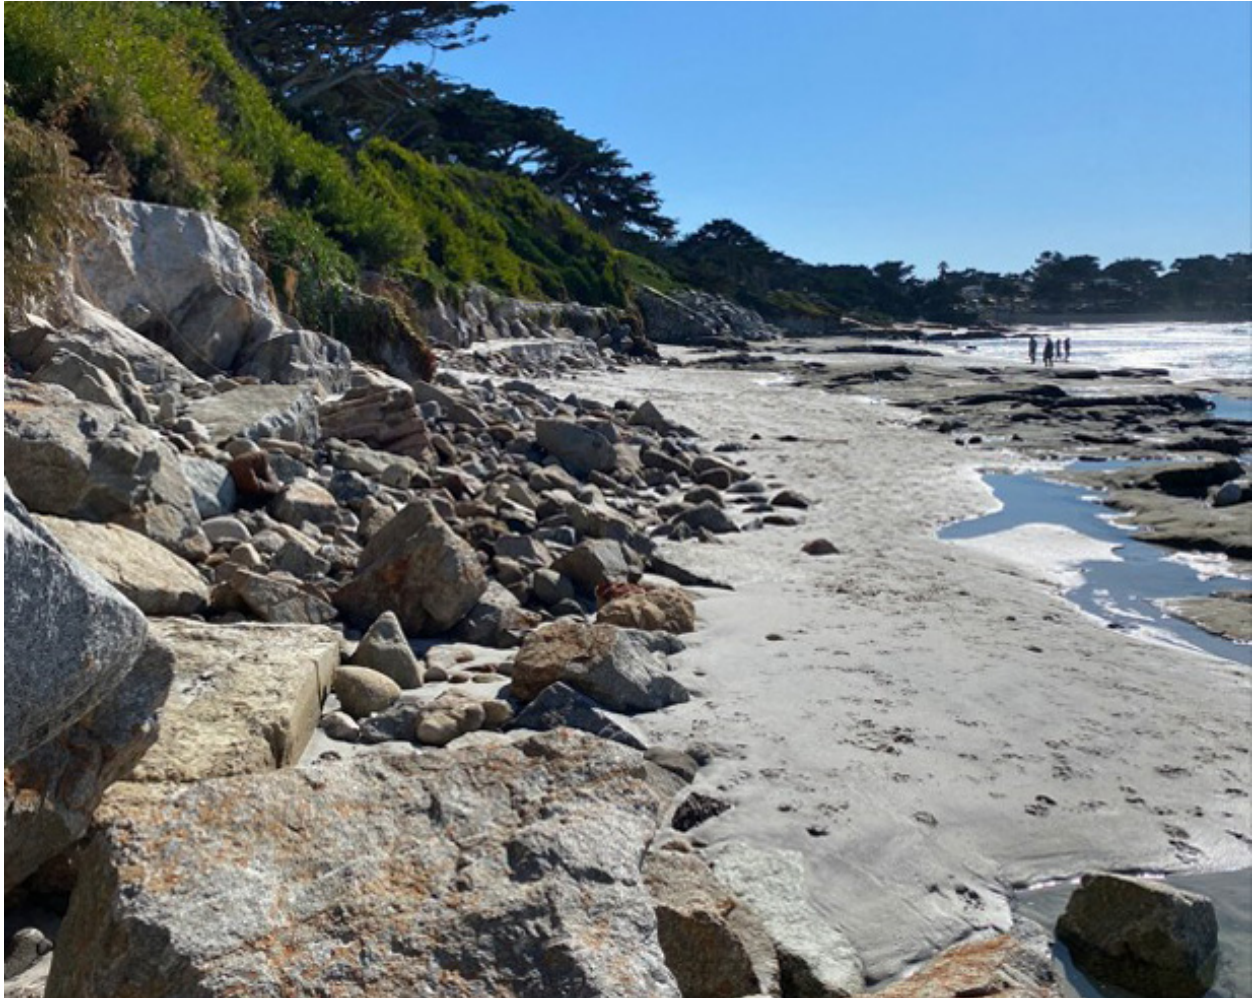
**Photograph 61: Northern 1/3 of Revetment R4 Showing Scattered Undersize Riprap Boulders
on January 30, 2023**

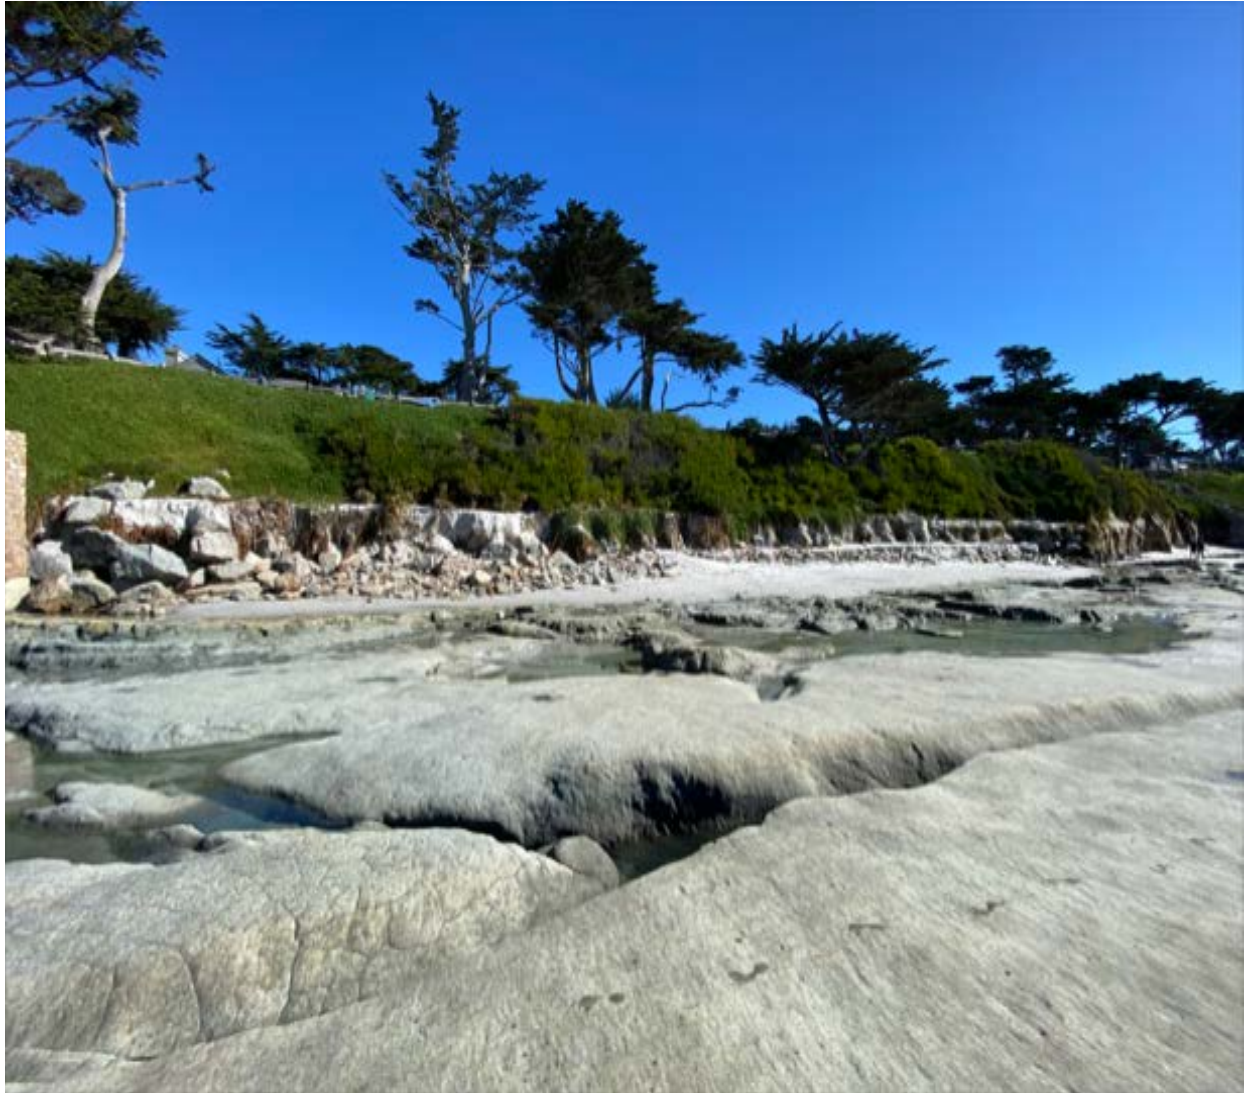
**Photograph 62: Northern 1/3 of Revetment R4 Showing Very Undersized Scattered Rock
on January 30, 2023**

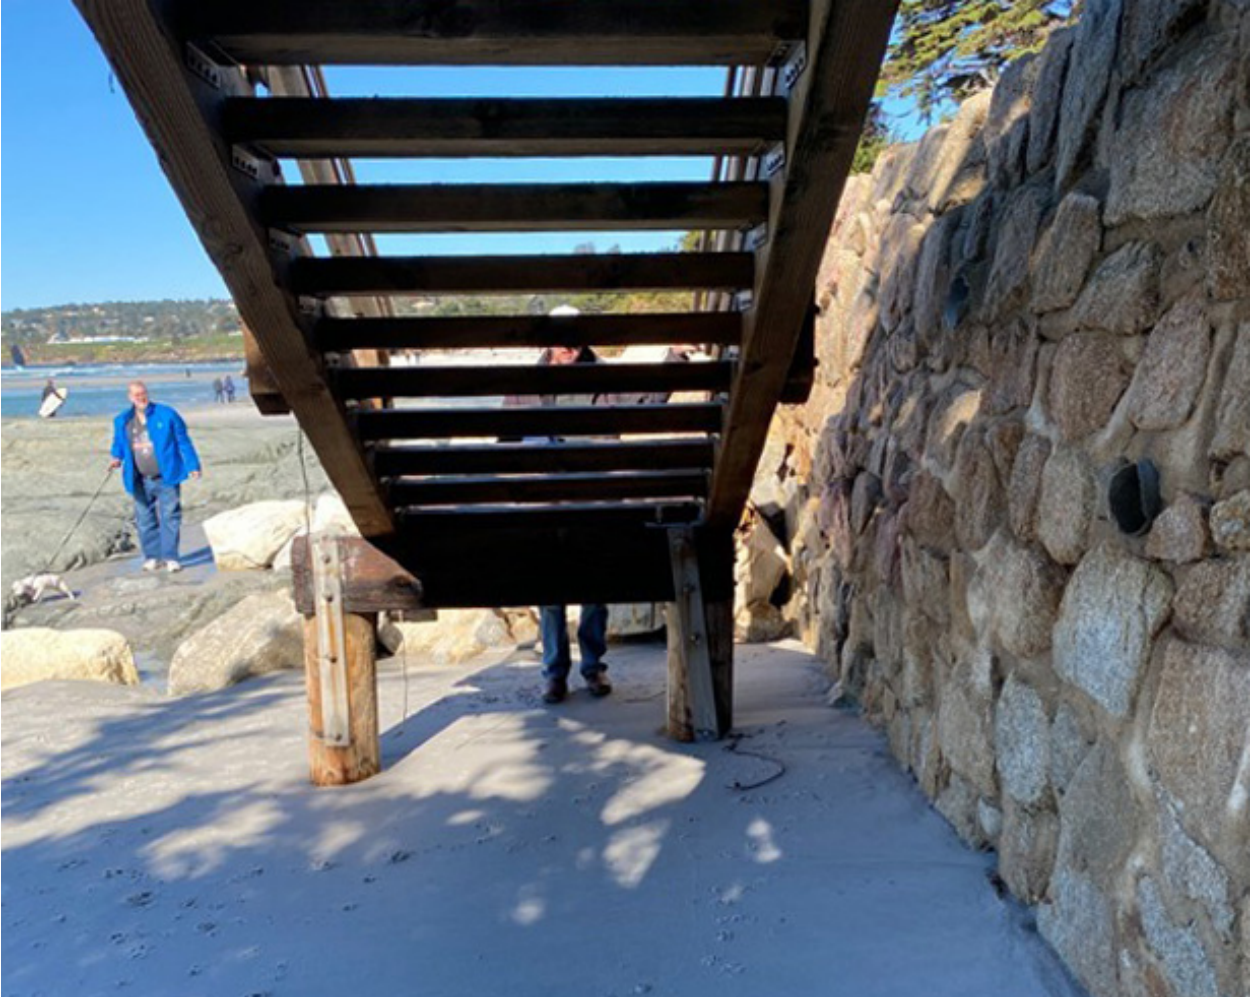
Photograph 74: Stairway ST7 on January 30, 2023 Showing Undermining

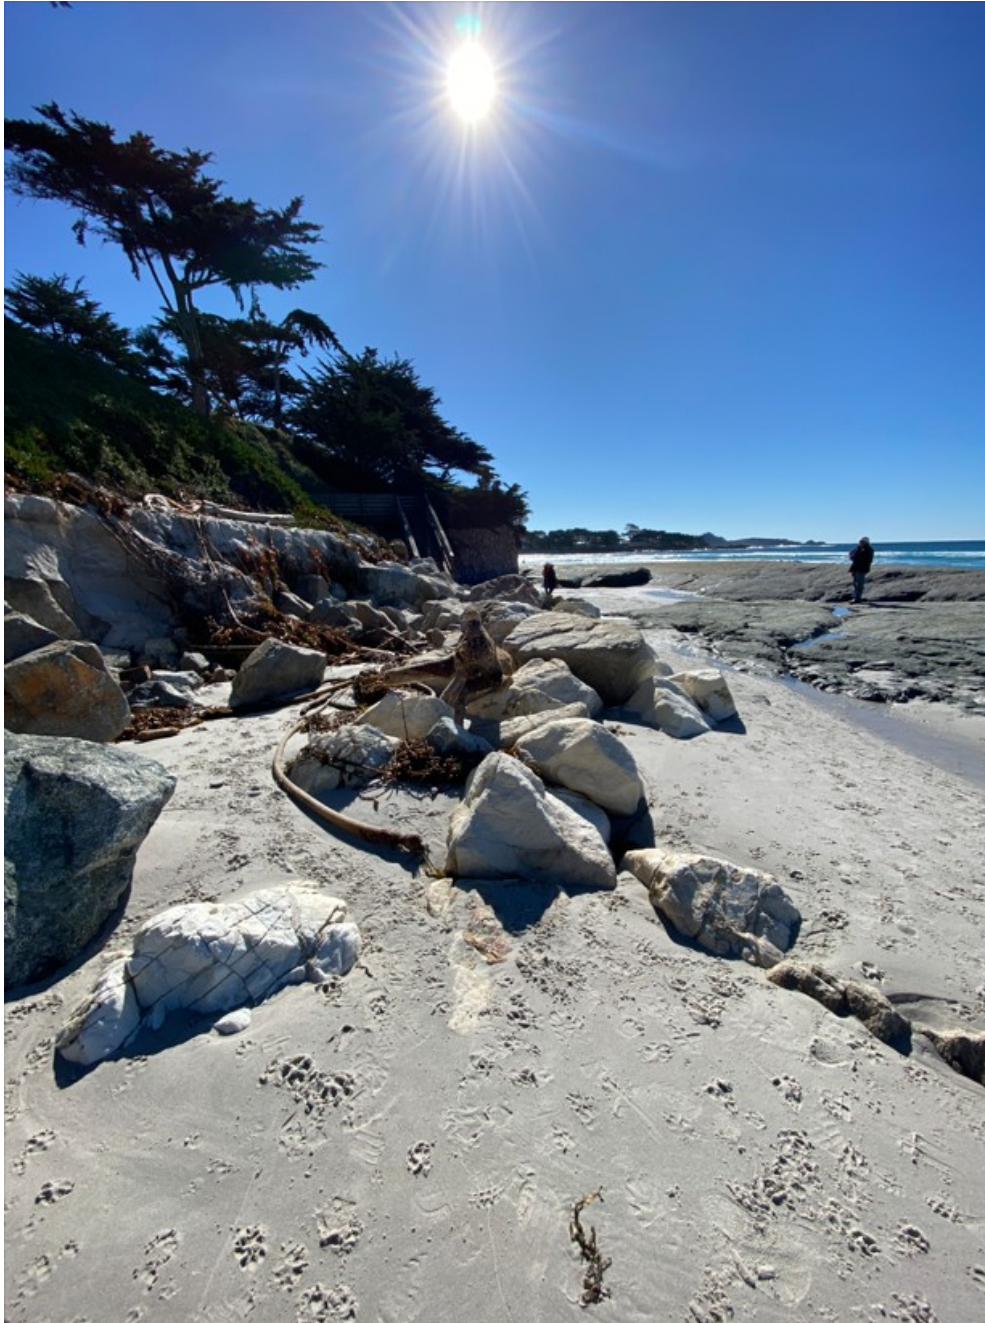
Photograph 76: Showing Collapsed Southern End of Revetment R5 on January 30, 2023

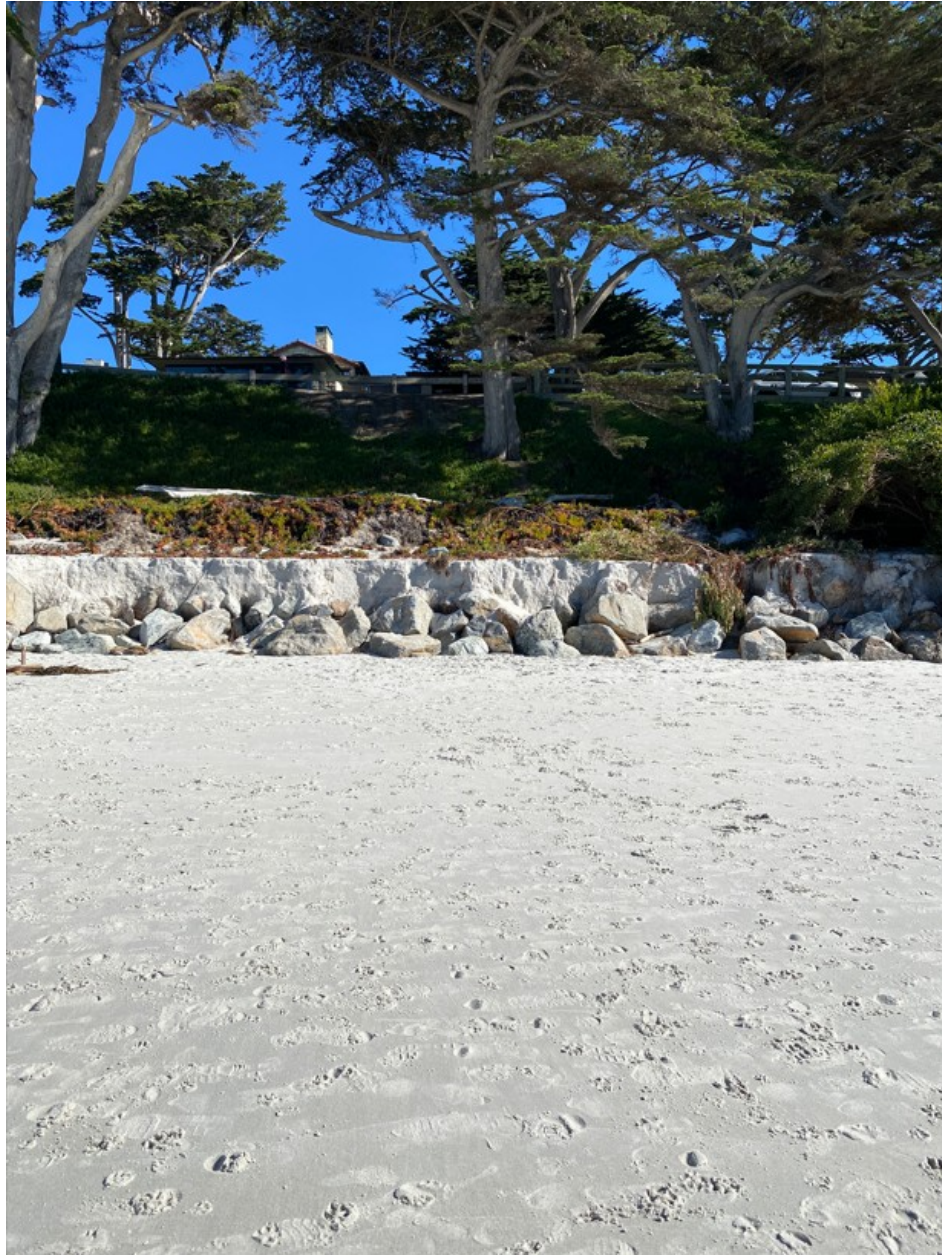
Photograph 77: Southern Portion of Revetment R5 on January 30, 2023 Showing Steep Slope

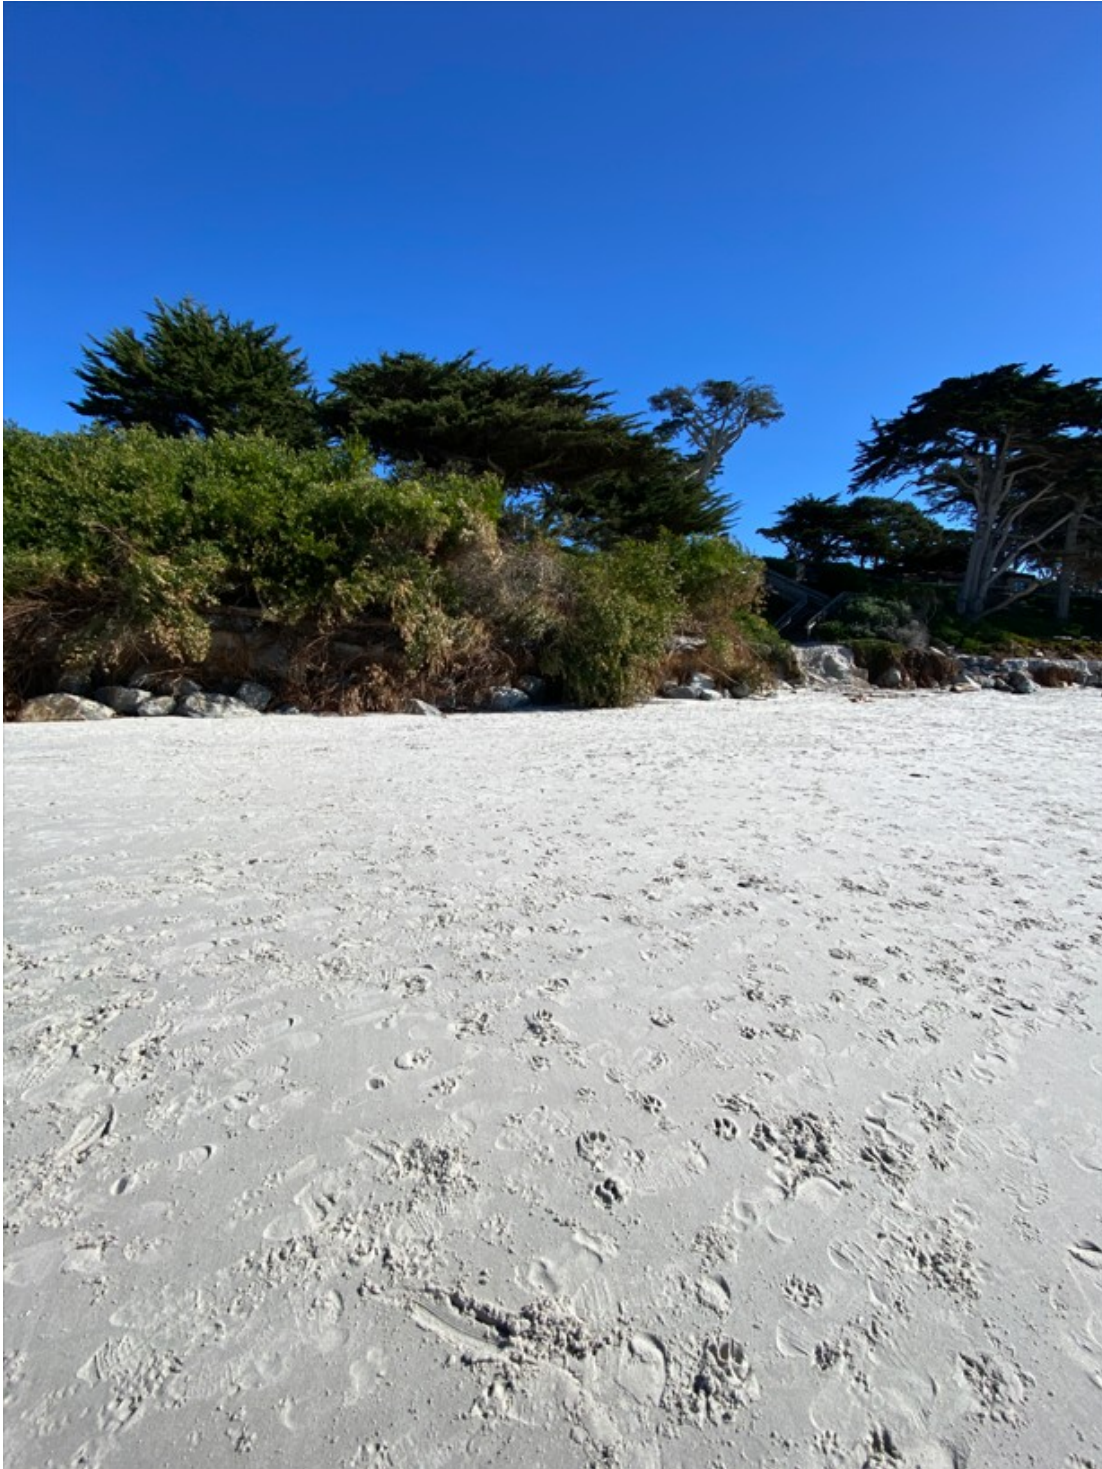
Photograph 82: Showing A Small Amount of Additional Revetment R5 Riprap on January 30, 2023
