# CITY OF CARMEL-BY-THE-SEA FOREST AND BEACH COMMISSION AGENDA

**CITY OF CARMEL-BY-THE-SEA**  
**Forest and Beach Commission**  
**Staff Report**

Staff recommends that the Forest and Beach Commission deny the appeal to remove the 'Significant' Monterey Pine tree at Junipero Street, 6 NE 8<sup>th</sup> Avenue (TR 25-332)

Albert Weisfuss  
ISA Certified Arborist #WE-1388A  
ISA Tree Risk Assessment Qualified  
(831) 869-2767  
[albertweisfuss@gmail.com](mailto:albertweisfuss@gmail.com)  
[montereybaytreeworks.com](http://montereybaytreeworks.com)

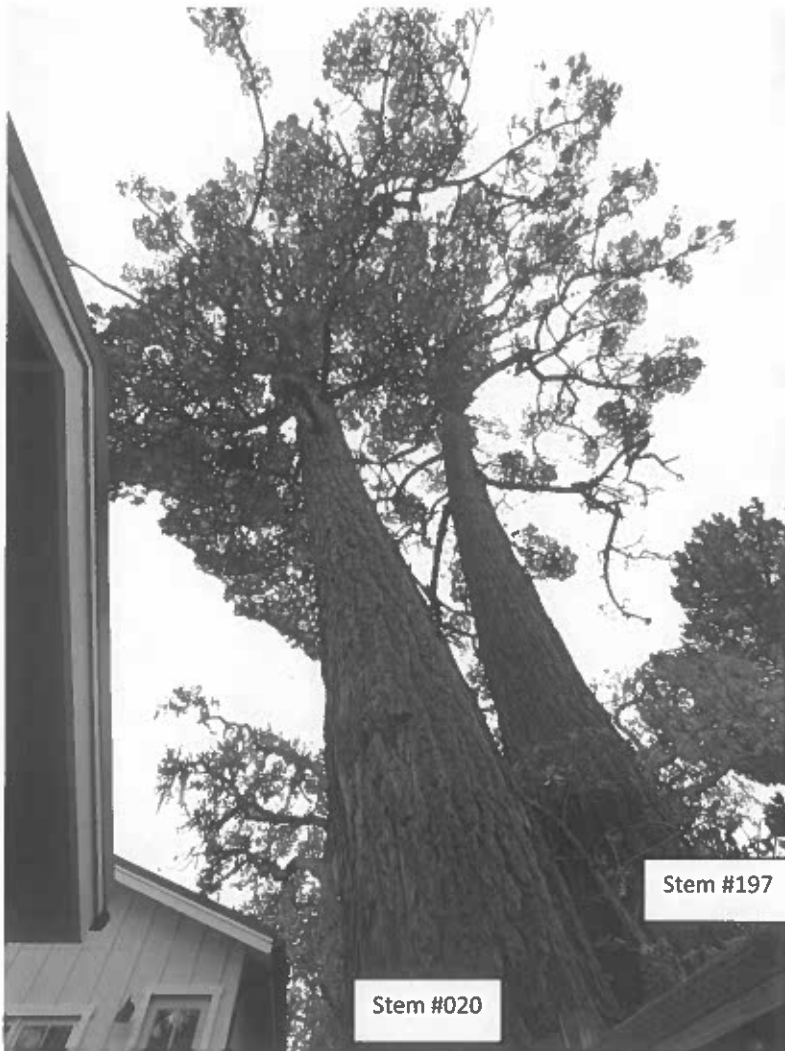
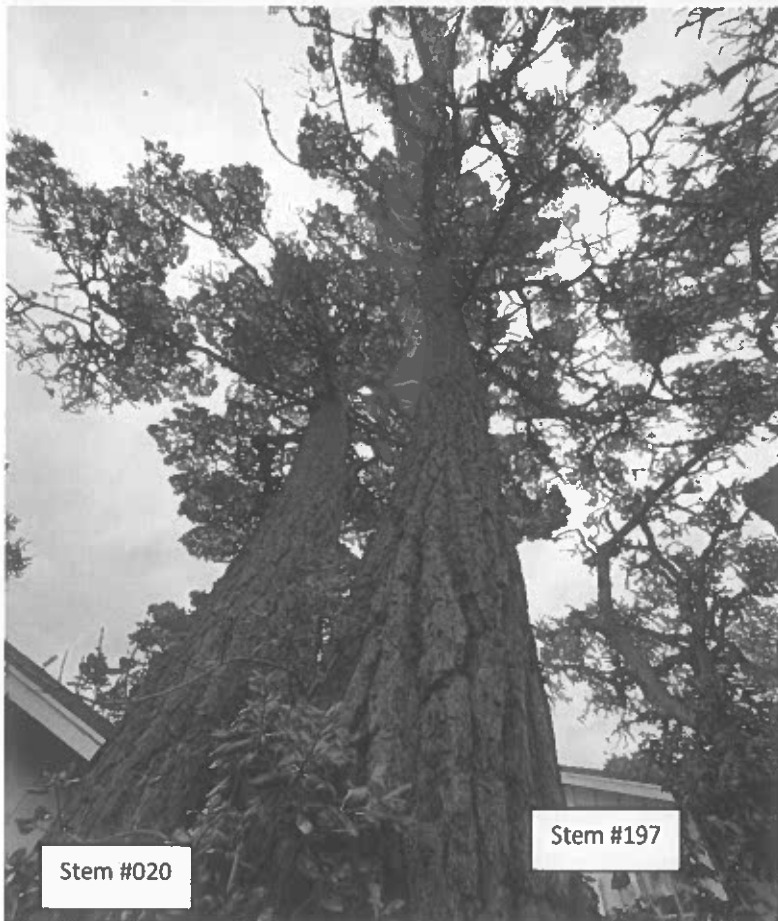
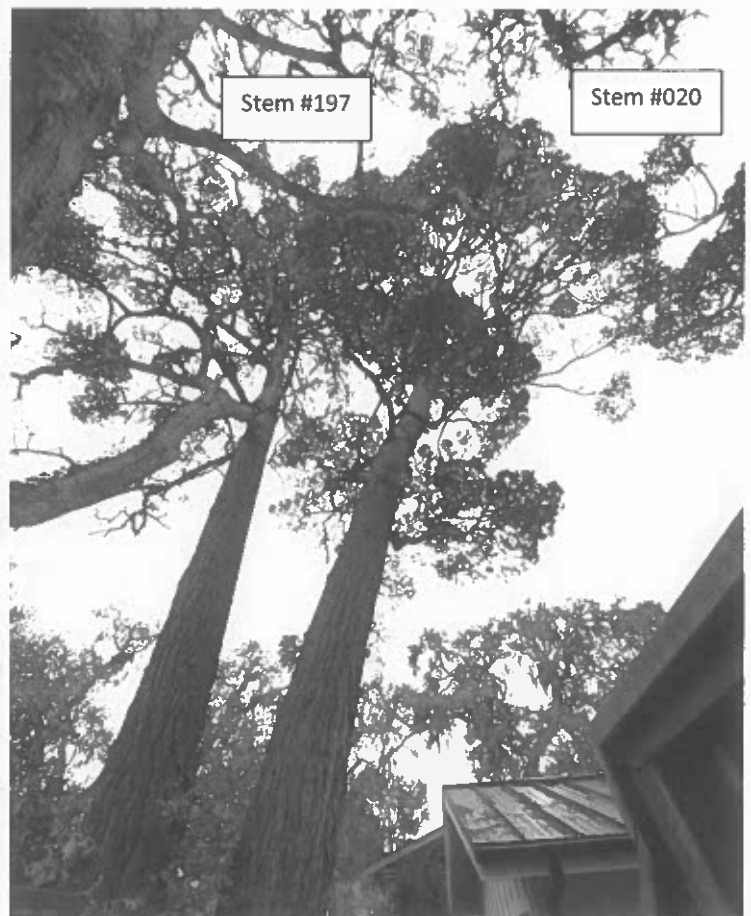
This Monterey pine tree exhibits a live crown ratio of approximately 40%, with both stems displaying sparse foliage and retained deadwood throughout the crown. Reduced live crown ratio and overall thinning indicates stress conditions, which may be a combination of factors such as environment or natural age related decline. The trees large size also indicates that it has reached an advanced age, reaching the final stages of its natural life cycle. When trees are struggling, their ability to resist pests and decay can decrease, which also increases its susceptibility to structural weakness.

With the trees compromised health, a growth pattern like a lean or a double stemmed tree can increase the trees likelihood of failure. Decline affects a trees ability to produce ample response growth, leading to overall weakening of the tree. Weakened trees are unable to resist wood decaying organisms, pests or resist increased structural loads, like the tree's double stems. A double stemmed Monterey pine presents some structural concern due to both stems sharing the same root system, and overtime, they develop dependency on one another for support. Neither stem could be removed without the other, as this would cause weight imbalances and additional loads on the remaining stem, increasing the potential for failure.

This does commonly result in the two stems growing away from one another, leaning toward available sunlight and vertical spacing. This growth can increase the structural load on each stem, especially with the branches growing mostly on one side, causing weight loads unequally distributed over the trunks and root system.

It is important to consider the nearby residences as targets, which could be affected if either stem were to fail. Both stems lean toward occupied residences and with their size and location, they have a high potential to impact these targets during partial or whole tree failure. Because this tree is in close proximity to two residences, the consequences of failure range from significant to severe. These risks are increased during heavy winds, rain and abnormal weather conditions. In combination with the trees decline and structural growth patterns that are prone to lead to failure, this tree should be mitigated.

I recommend removal as the primary mitigation option for this Monterey pine tree, as removal would eliminate all possible risk to the targets. This tree exhibits poor health, and structural issues that could lead to partial or whole tree failure. It is likely that this tree will continue to decline overtime, and will become more brittle, and prone to breakage. The failure of this tree could impact the targets and should be removed.

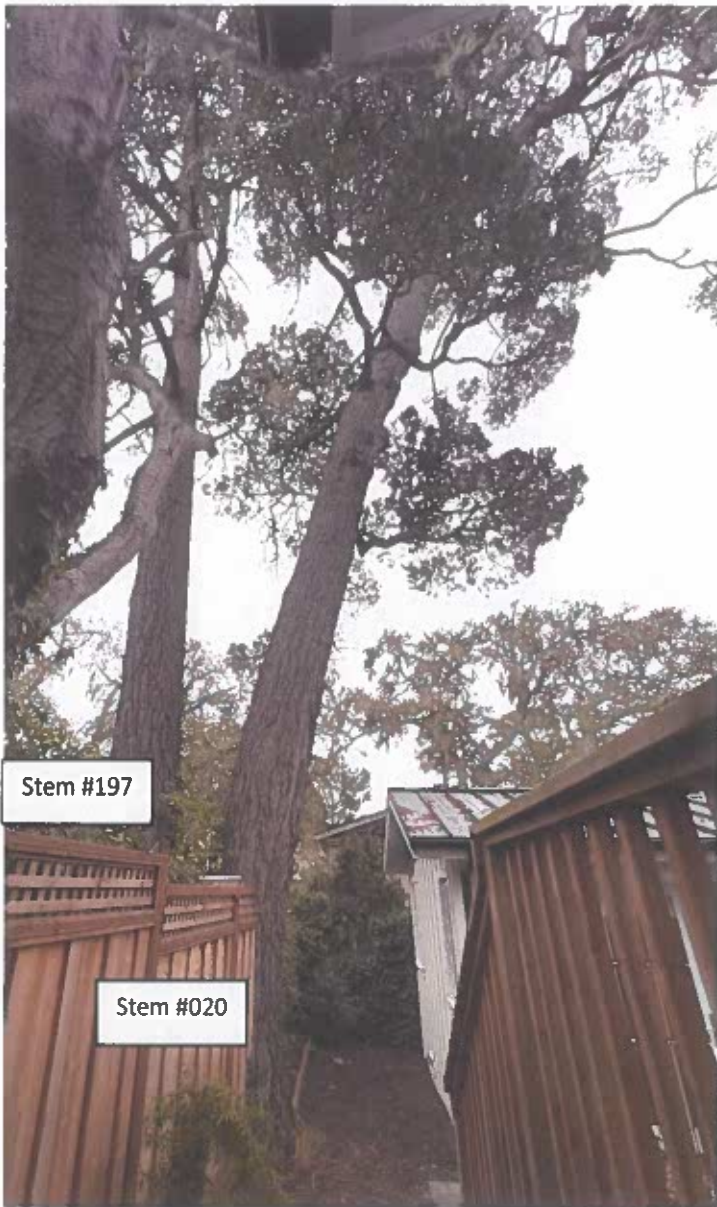
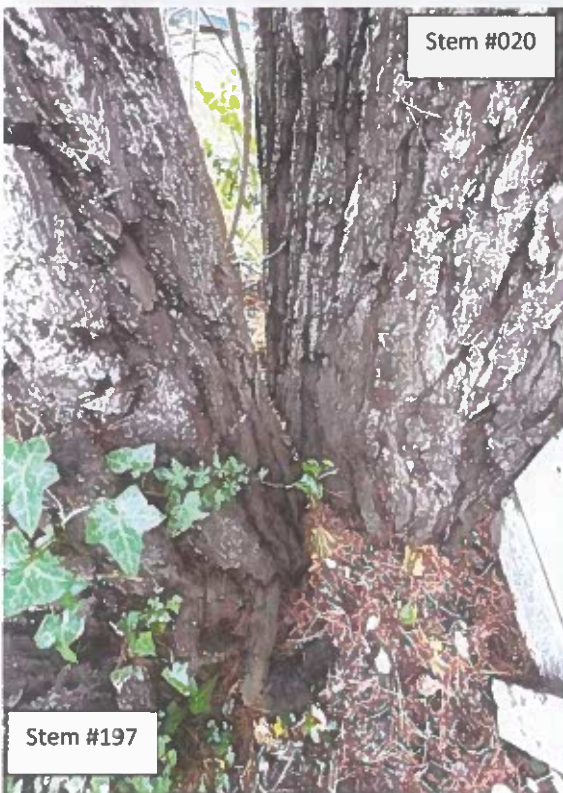
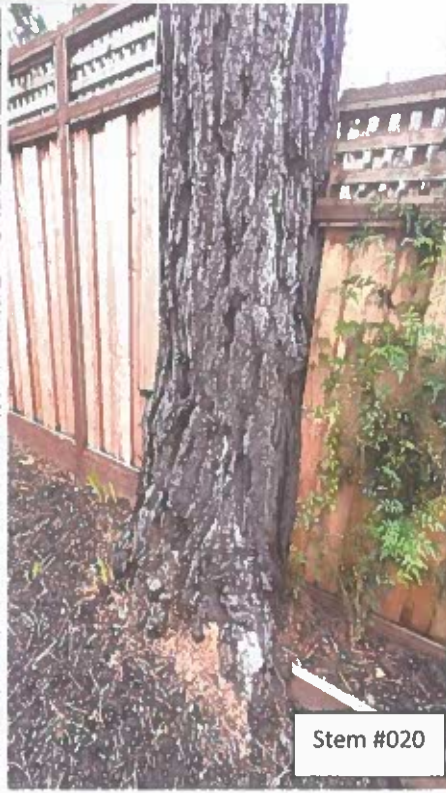
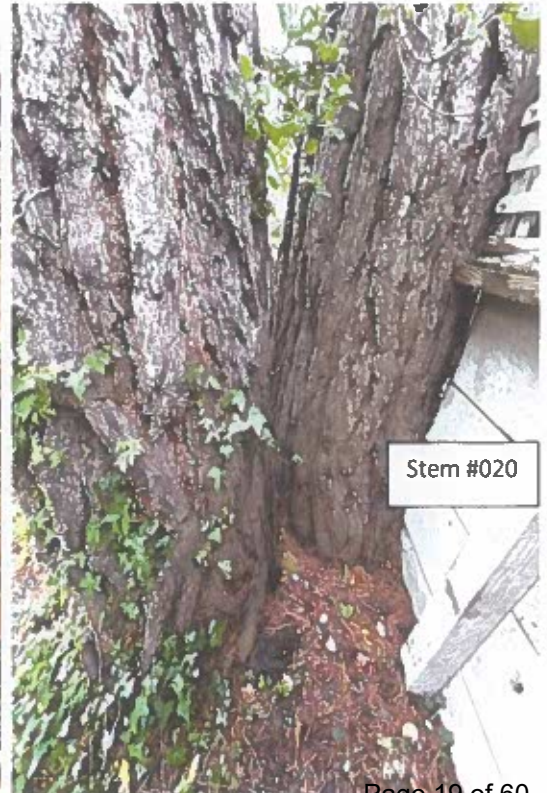
### Monterey pine- Photos Continued

It is common for stressed trees to be accompanied with a complex of stressors; which at first is the initial primary stressor like poor site conditions, drought, or age and then a secondary stressor can be introduced contributing the trees decline. These secondary indicators can normally be the first notable sign of tree stress and are commonly blamed for the primary cause of the decline. The secondary indicator of tree stress is the observed pine bark beetle frass. These boring pests normally attack trees that are stressed and declining. Since pine bark beetles are secondary indicators of stress, their activity provides important information that the tree is declining. General tree decline can increase chances of failure. These pine bark beetles can girdle a tree from the damaging feeding activity on the trees phloem, which can eventually result in tree death. Although there was only a small amount of frass, there was also woodpecker activity which indicates that pests are present. Woodpeckers typically create small holes along stems to forage for insects beneath the bark, looking for bark beetles, borers and other pests. These pests will commonly occupy trees that are already stressed, which is why woodpecker activity can be an indication of tree stress. These holes do not commonly cause hazards, they are just an indicator that the tree is experiencing decline conditions and is compromised.

With the trees compromised health, a growth pattern like a lean or a double stemmed tree can increase the trees likelihood of failure. Decline affects a trees ability to produce ample response growth, leading to overall weakening of the tree. Weakened trees are unable to resist wood decaying organisms, pests or resist increased structural loads, like the tree's double stems. A double stemmed Monterey pine presents some structural concern due to both stems sharing the same root system, and overtime, they develop dependency on one another for support. Neither stem could be removed without the other, as this would cause weight imbalances and additional loads on the remaining stem, increasing the potential for failure.

Another contributing factor is the restricted root zone. Soil compaction and hardscape can affect the trees growing space and reduces the amount of oxygen, water, and pore space available. Restricted roots struggle to take up nutrients and moisture, which can contribute to canopy decline and further weaken the overall structure. For a large species like Monterey pine, limited space can be a factor that increases the likelihood of both partial and whole tree failure.

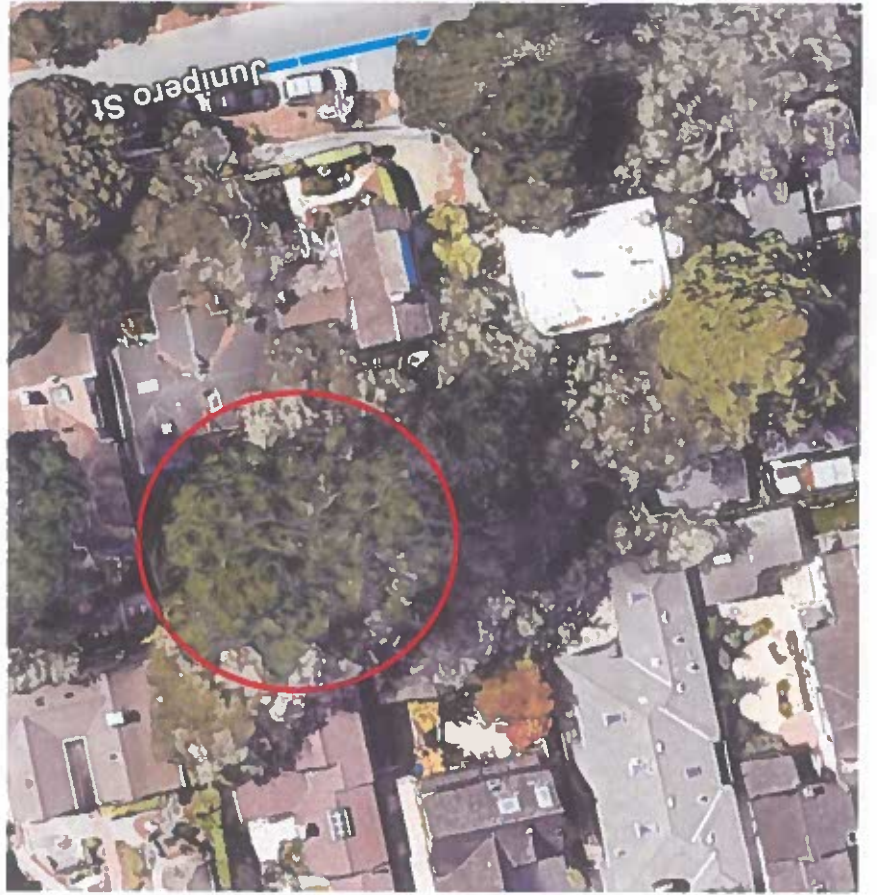
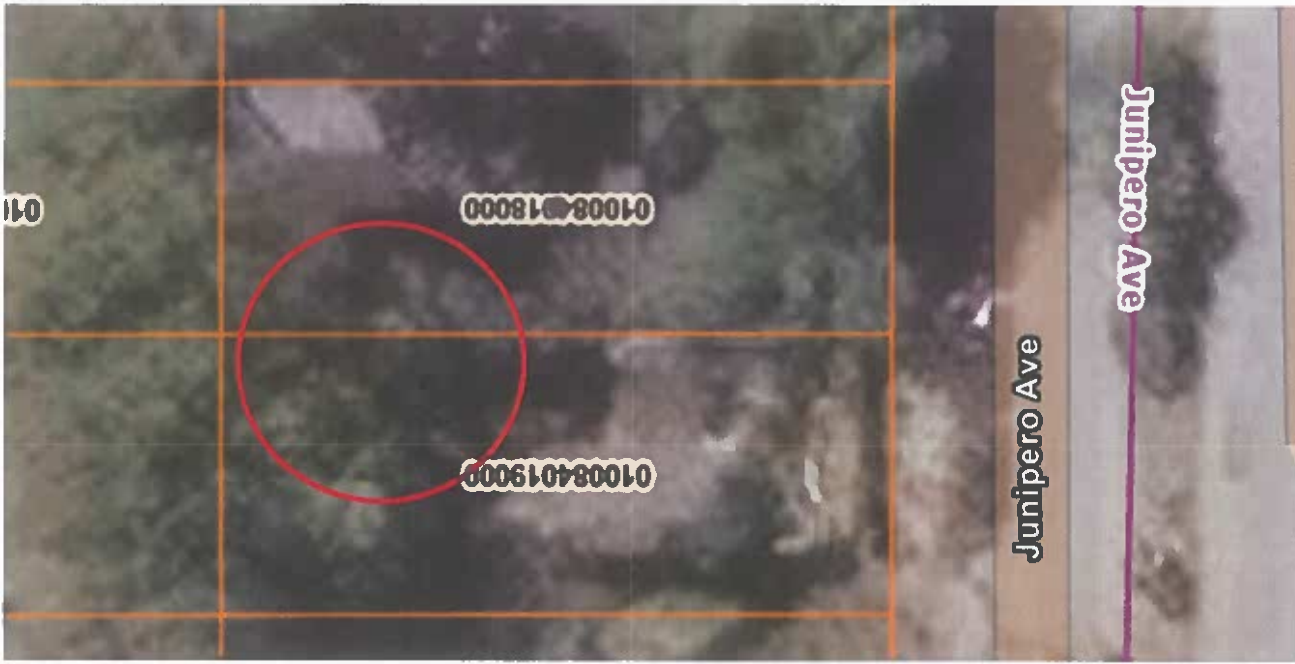
Site Plan

The red circles indicate the approximate location of the tree within this report.

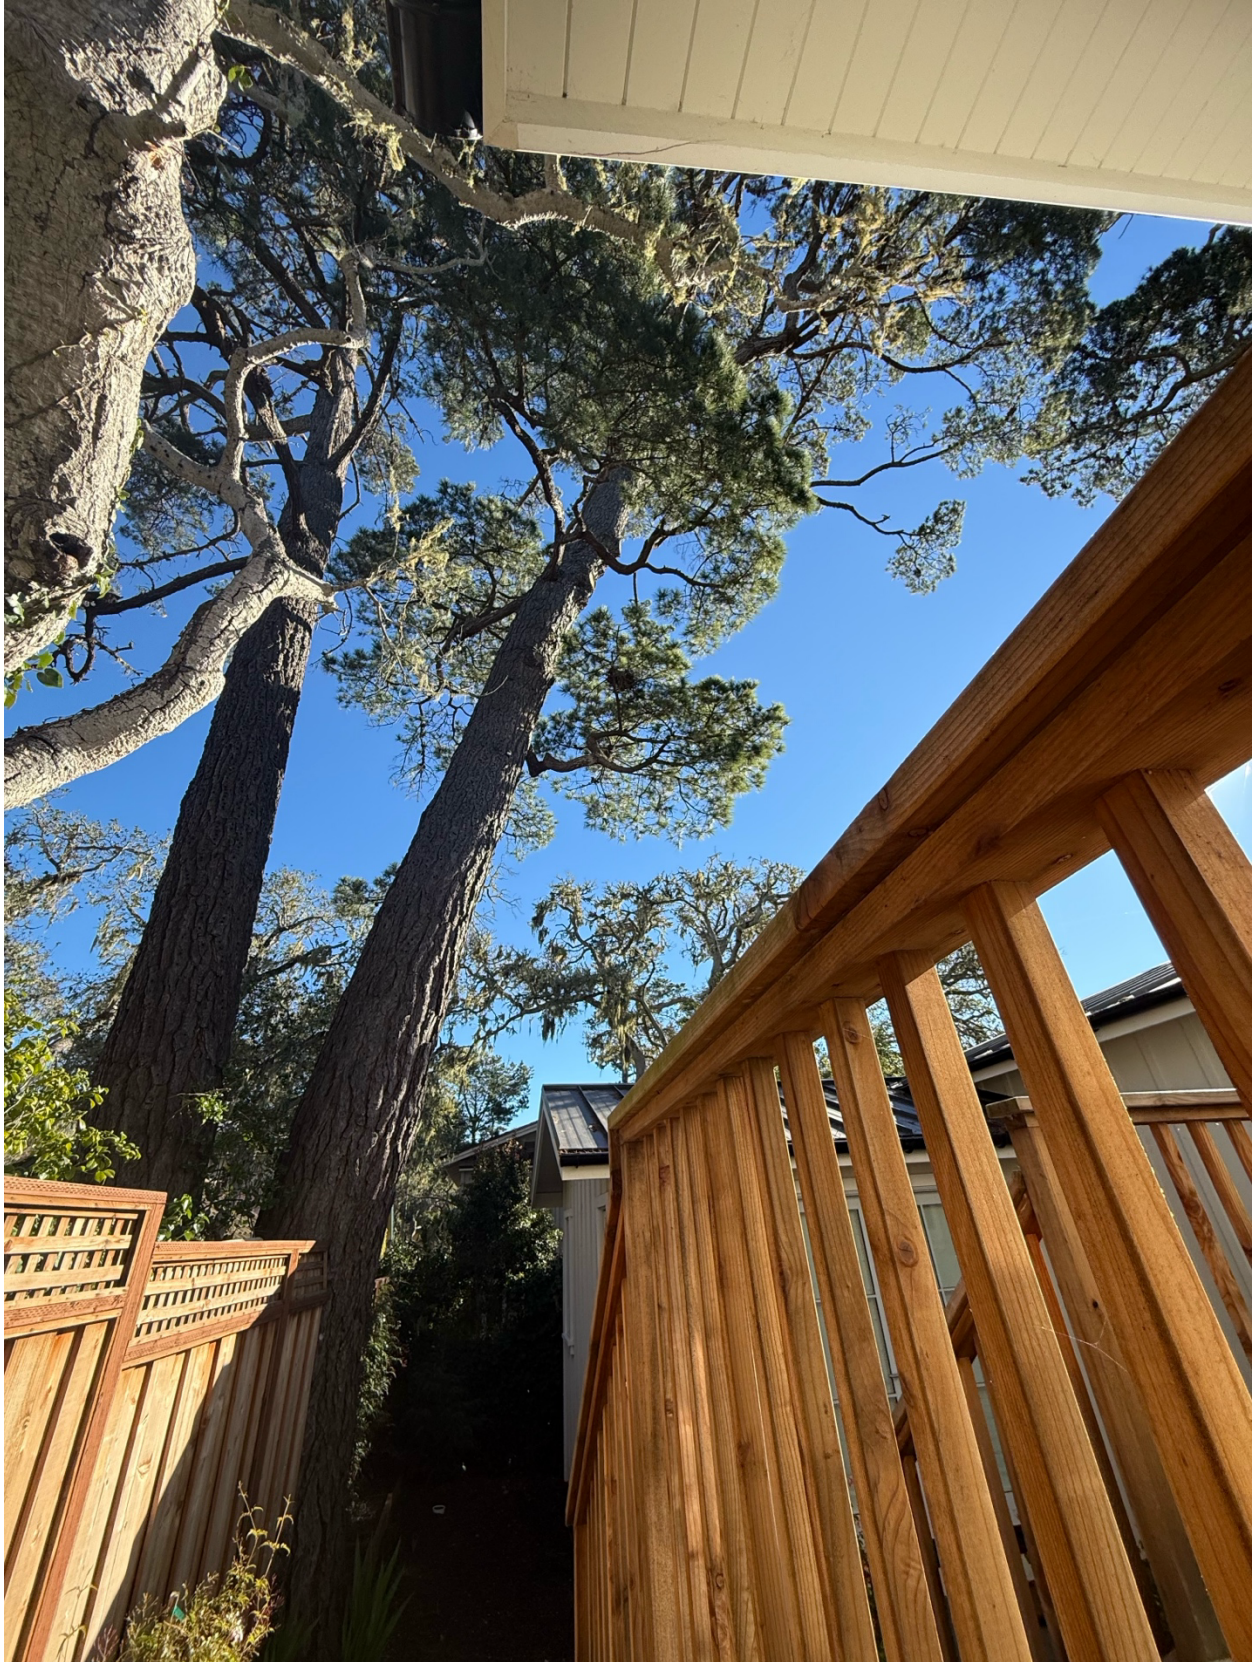
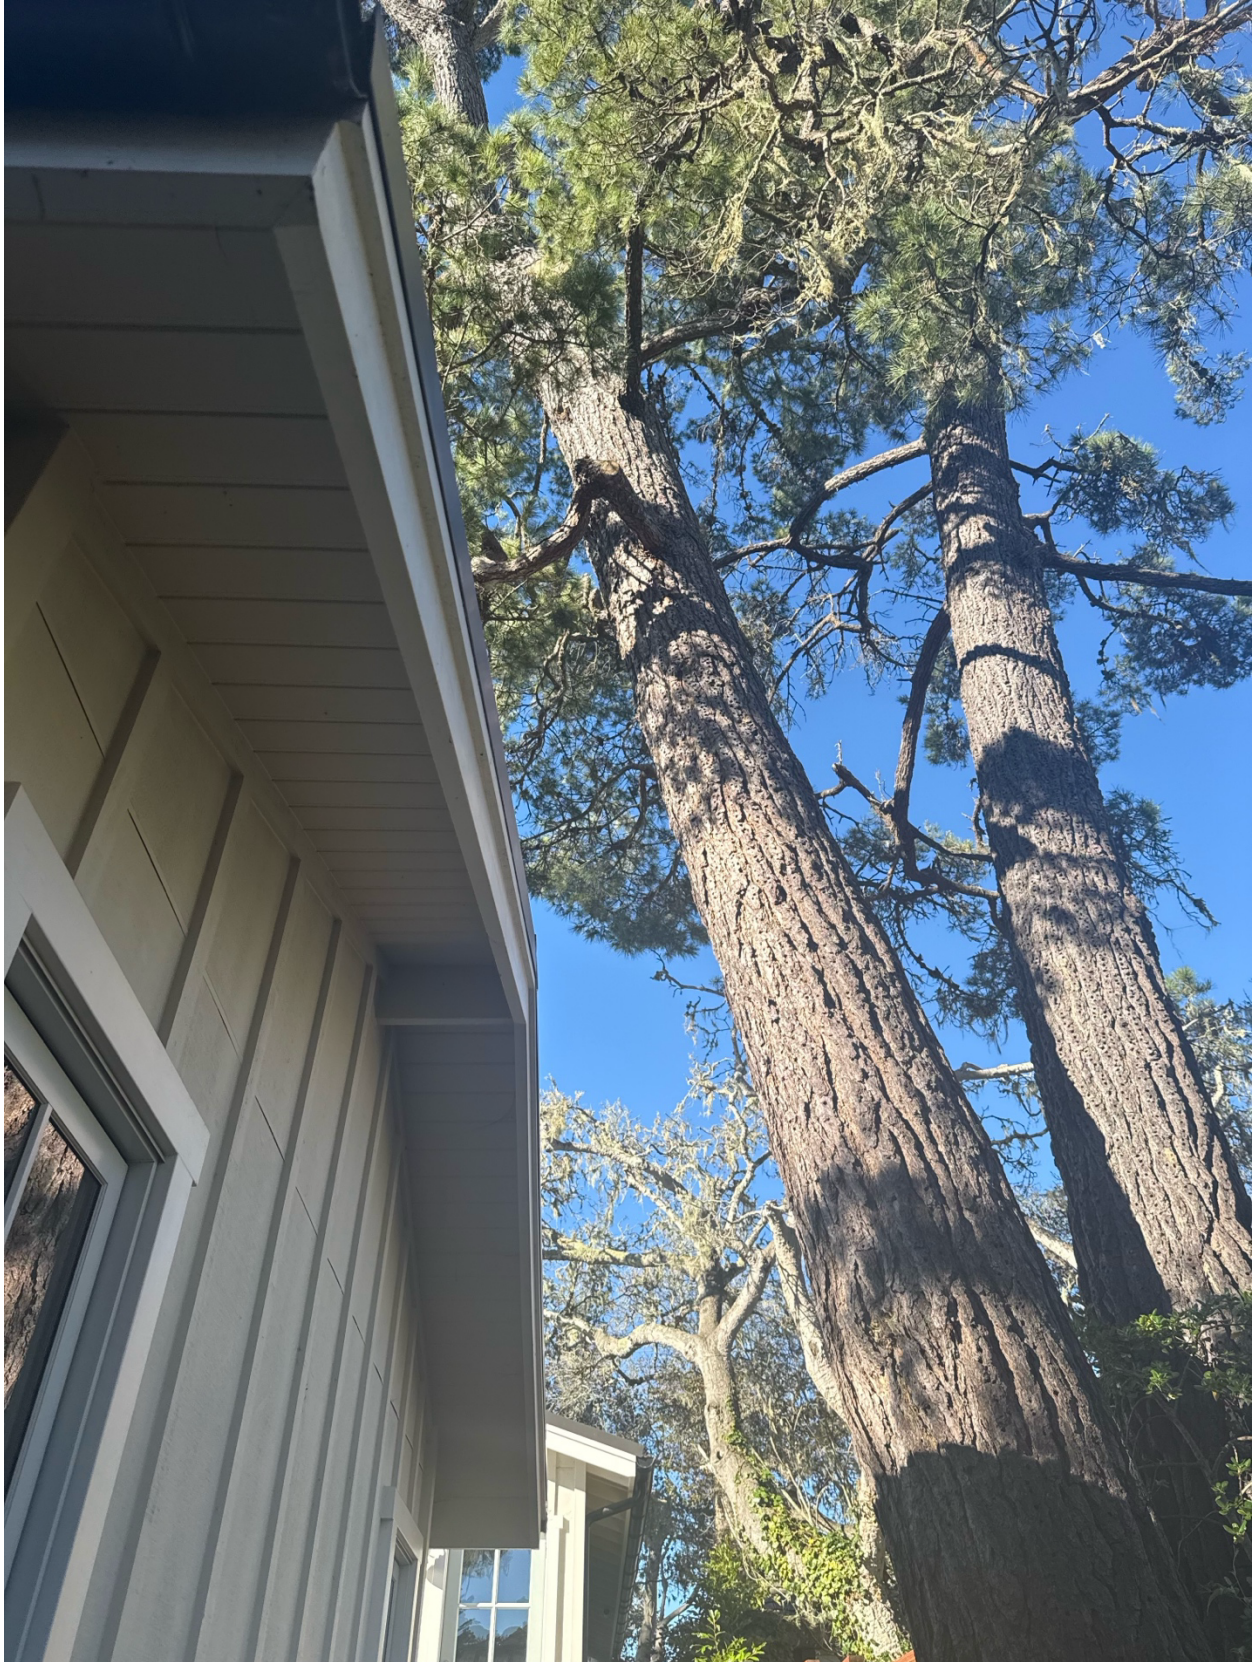
A few pictures of the tree in question at Junipero 6 NE of 8th: The canopy of the tree extends over nearly the entire width of the house.

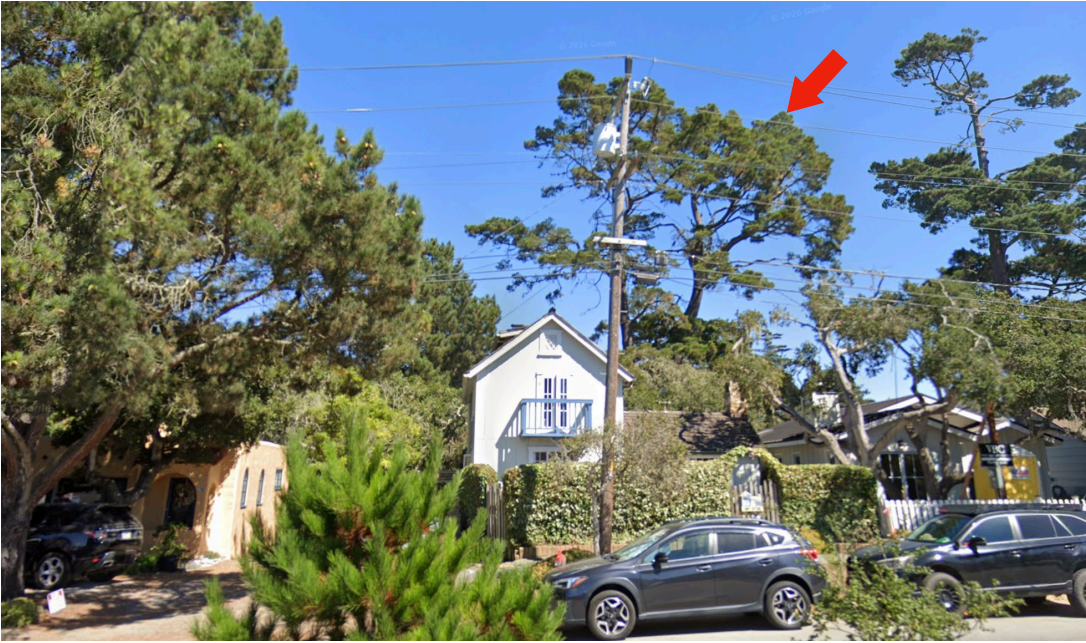
*The subject tree develops on the north property line approximately 10 feet north of the residence.*

*Two trunks are visible from Junipero Avenue, with both canopies extending above surrounding trees. Upon entering the property the subject tree was observed developing directly on the north property line, while a second trunk was located behind a fence running east to west*

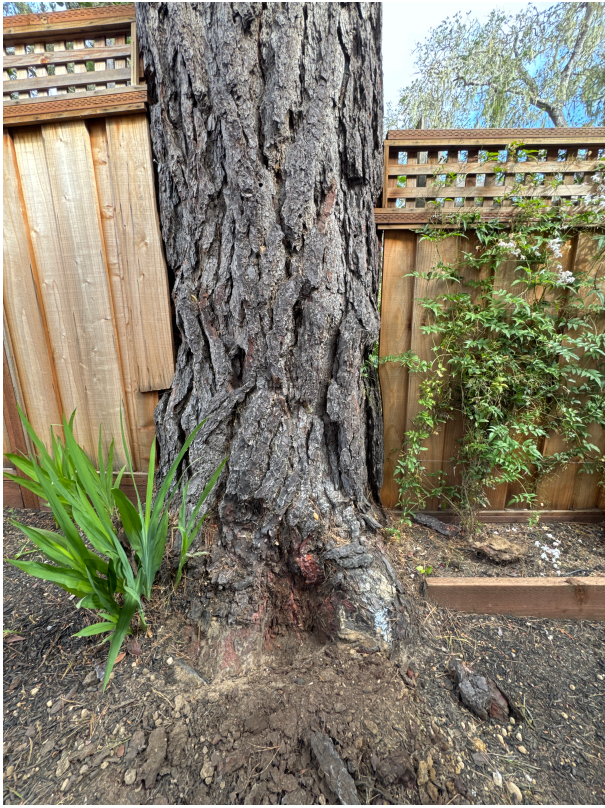
*Inspection of the root collar south side revealed areas of compressed wood development, indicating long-term mechanical stress at the base of the trunk.*

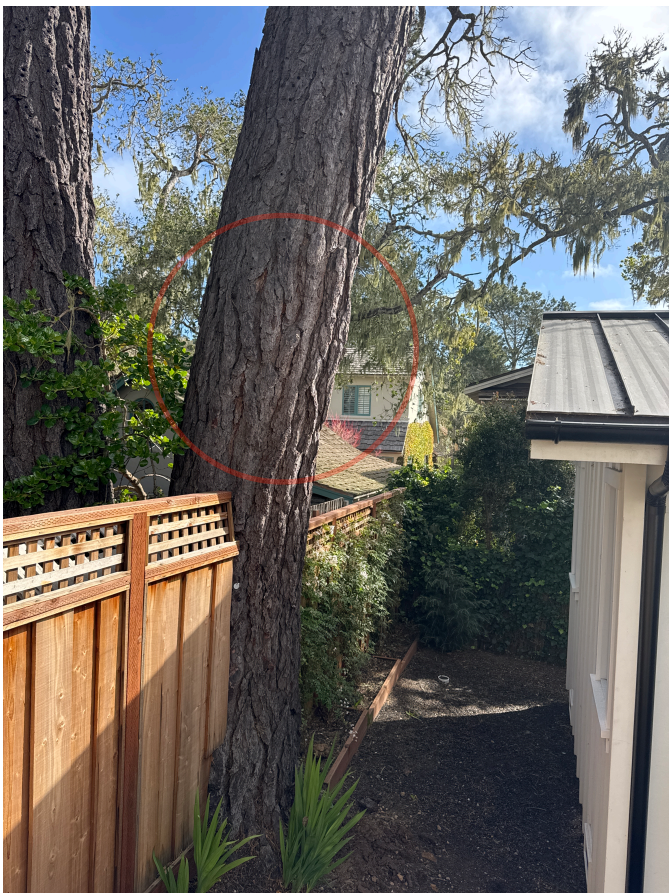
*At the first bend, abnormal swelling and deformation are present.*

*This swelling is consistent with possibly an old infection of Western Gall Rust (*Endocronartium harknessii*) that likely occurred when the tree was young.*

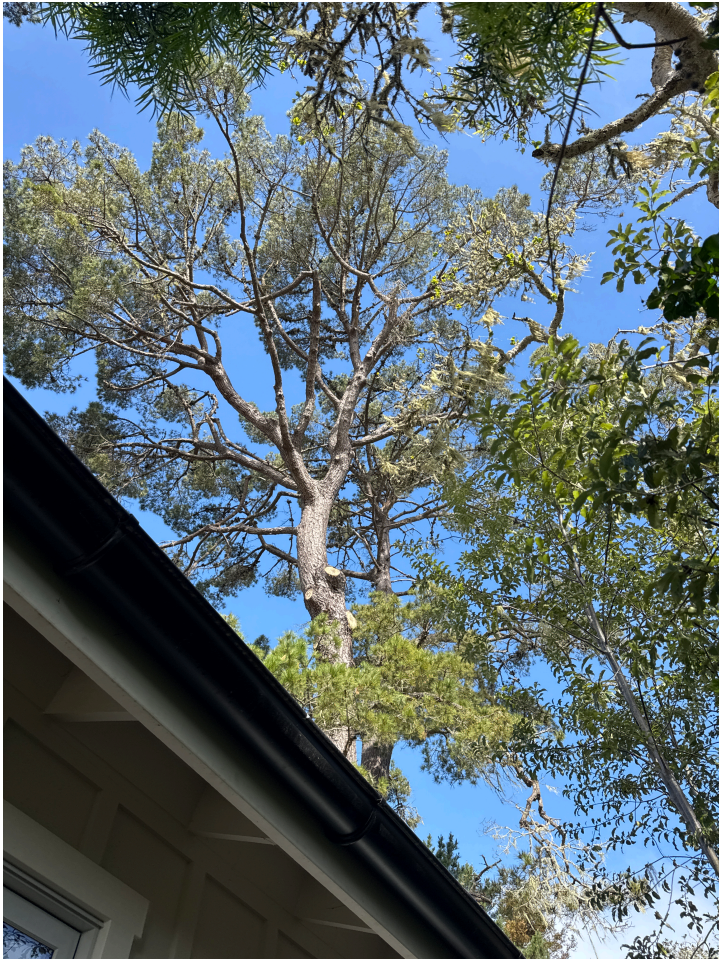
*Poorly compartmentalized pruning wounds in pine species often serve as entry points for decay fungi, weakening structural wood over time*

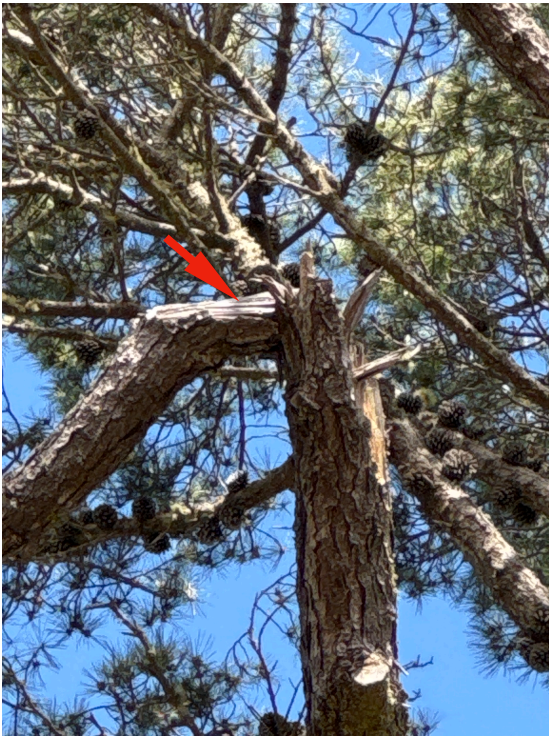
*Evidence of current and historical storm damage was present throughout the canopy.*

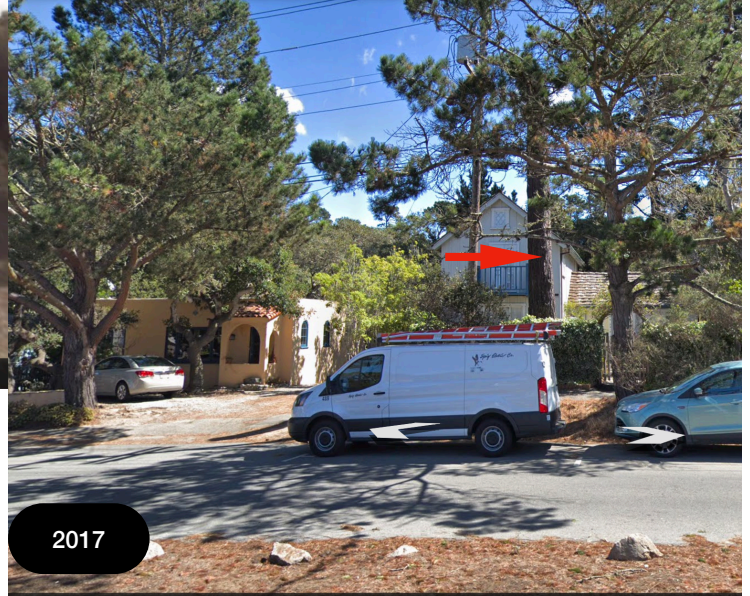
- a large mature Monterey Pine directly in front of the residence was removed in 2017 for utility clearance

*Loss of surrounding canopy coupled with existing structural defects has likely accelerated the current decline and structural vulnerability observed today.*

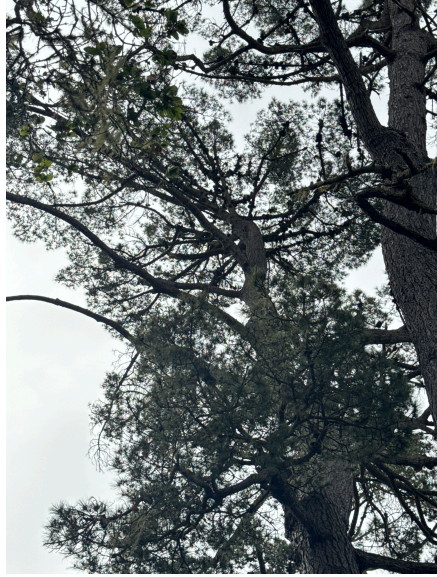
*Subject tree viewed from neighboring property.*

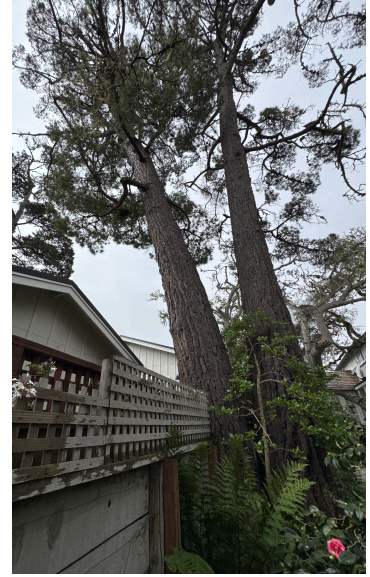
*A circular root pattern confirmed that two independent trees are present, not a single bifurcated trunk as previously assumed.*

*No active insect galleries were observed, suggesting the resin production may be related to internal wood deterioration rather than insect activity.*

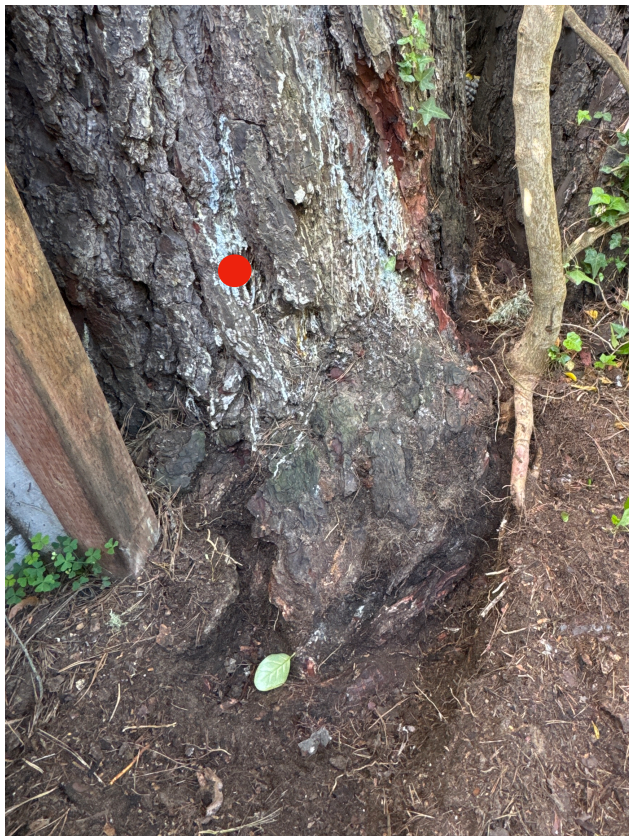
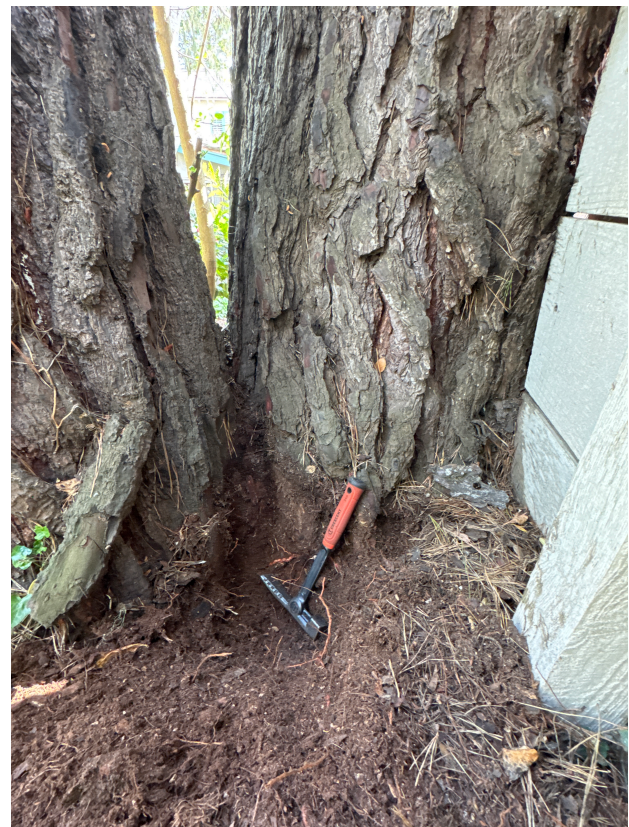
*To further investigate the condition of the trunk, resistance testing was performed at the location of heavy resin flow.*

Resistance results indicates beginning stages of decay with cavity between 1 & 3 inches.

Removal is therefore recommended to reduce the potential for property damage and personal injury.

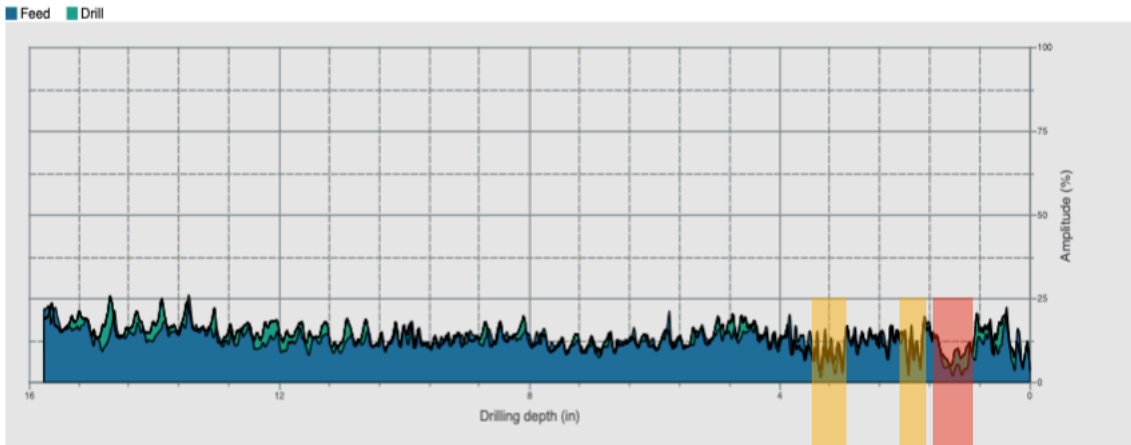
Yellow represents decay

Red represents cavity
