## **CITY OF CARMEL-BY-THE-SEA CITY COUNCIL AGENDA**

### **REGULAR MEETING Tuesday, August 3, 2021**

1. Receive a report and provide direction to staff on generating a request for proposals (RFP) for a public/private partnership to build a parking structure and mixed-use

development at the north lot of the Sunset Center

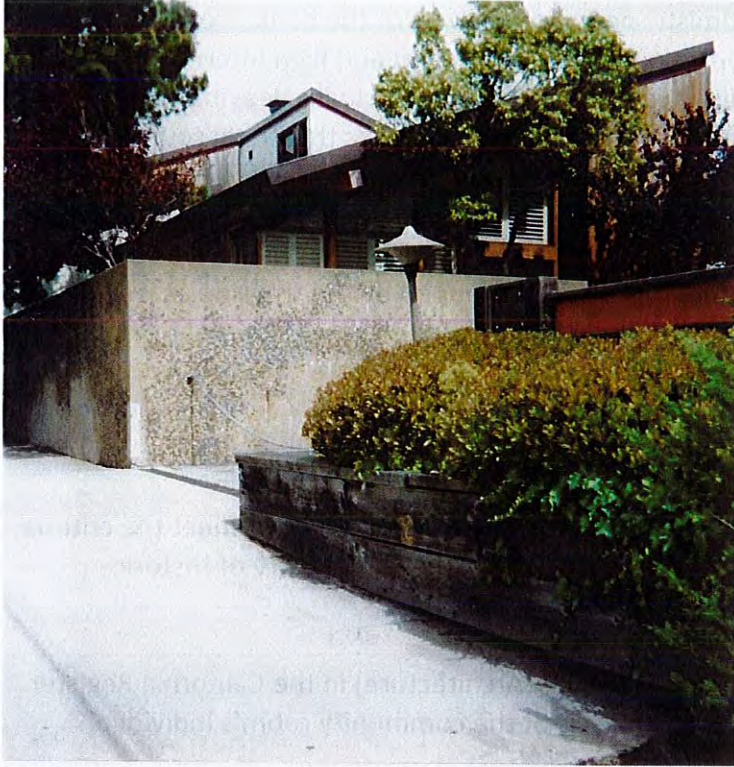
Views showing original window design, 1999.

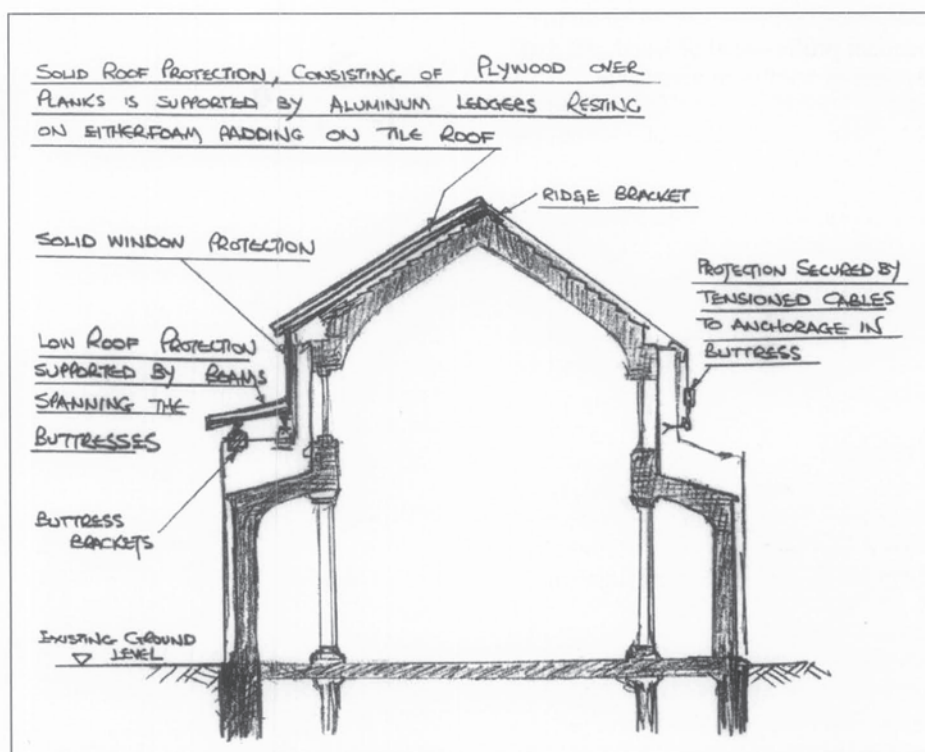
Figure 1. Before new construction was undertaken to the left of this church, a subcontractor was hired to design a protective system for the tile roof and clerestory windows. Drawing: Alan Shalders, Universal Builders Supply, Inc.

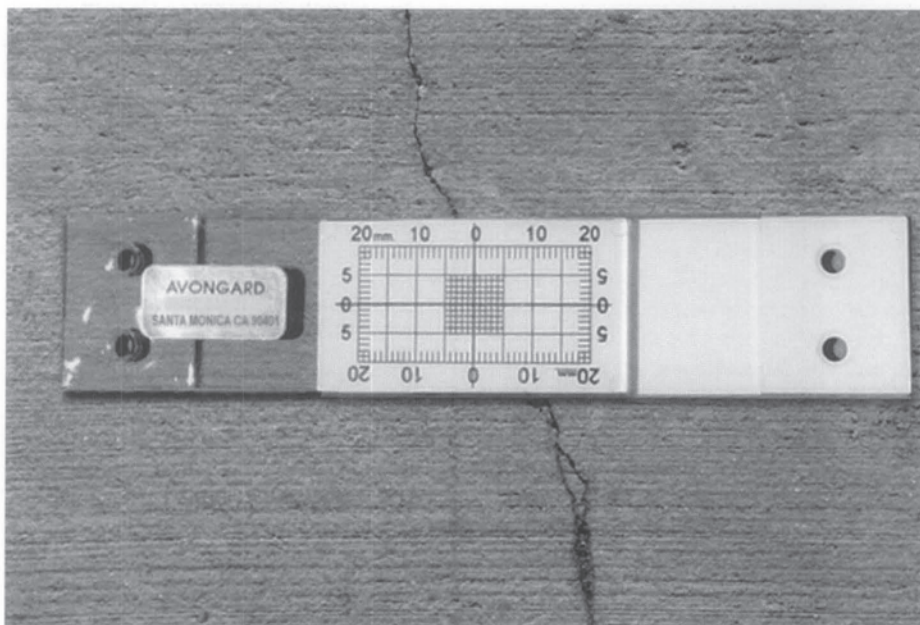
Figure 2. With advanced notice of adjacent construction activity, a crack monitor can be used to determine whether existing cracks in the historic building are stable or still experiencing movement. Compared with measurements taken during the monitoring phase, such information can help determine if subsequent movement resulted from work on the neighboring site. Photo: Avongard Products U.S.A., Ltd.

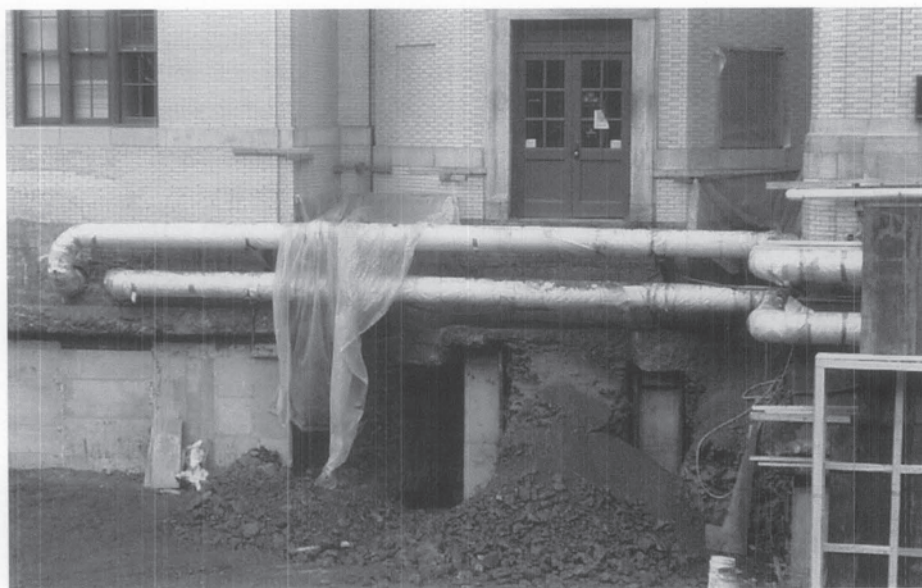
Figure 3. Concrete pier underpinning to an existing building may be necessary when adjacent construction occurs. In this example, pits are hand dug beneath the foundation of the historic building to provide space for wood forms. After concrete is poured into the forms, the space between the top of the pier and the bottom of the original foundation is packed with a quicksetting grout. The historic building owner should retain an independent engineer to ensure that the underpinning plan adequately protects the historic structure. Photo: Professor Arpad Horvath, Department of Civil and Environmental Engineering, University of California, Berkeley.

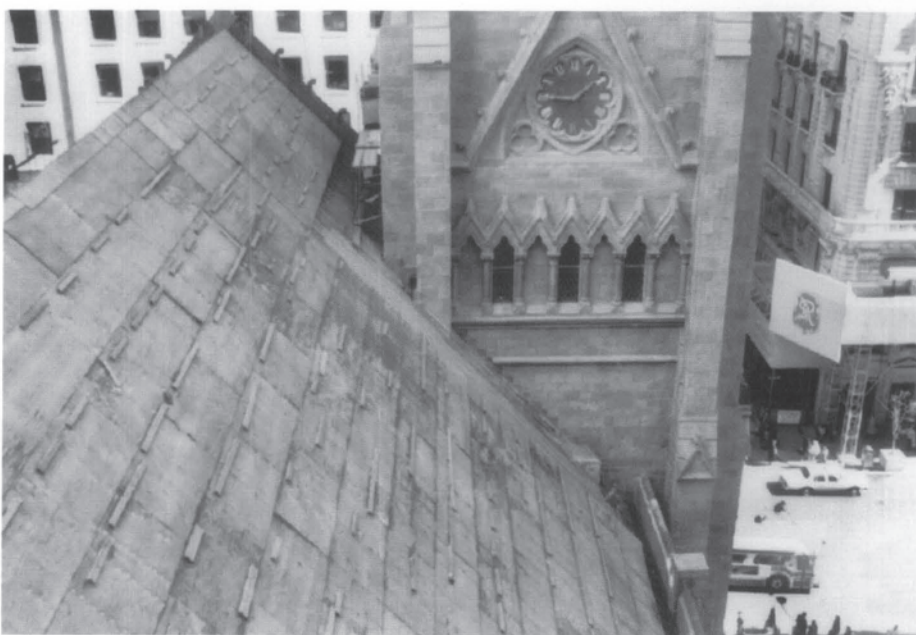
Figure 4. Dropped equipment, tools, and materials all present risks when new construction rises above neighboring historic structures. In this case, the historic slate roof was completely covered with sheets of exterior grade plywood. Photo: National Park Service files.

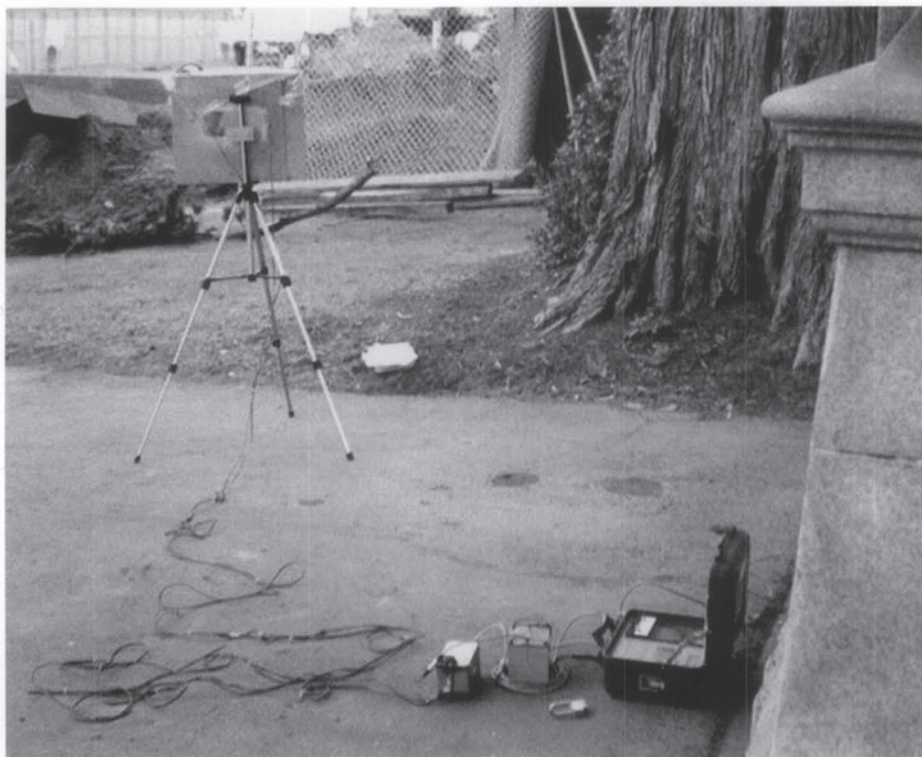
Figure 6. A seismograph records vibrations transmitted at the ground level of an historic building. The instrument is wired to a light and siren designed to warn the excavation crew that vibration levels are approaching preset limits. Additional sensors are often installed in the basement and on sensitive features such as stained glass windows. Photo: Wilson, Ihrig & Associates, Inc.

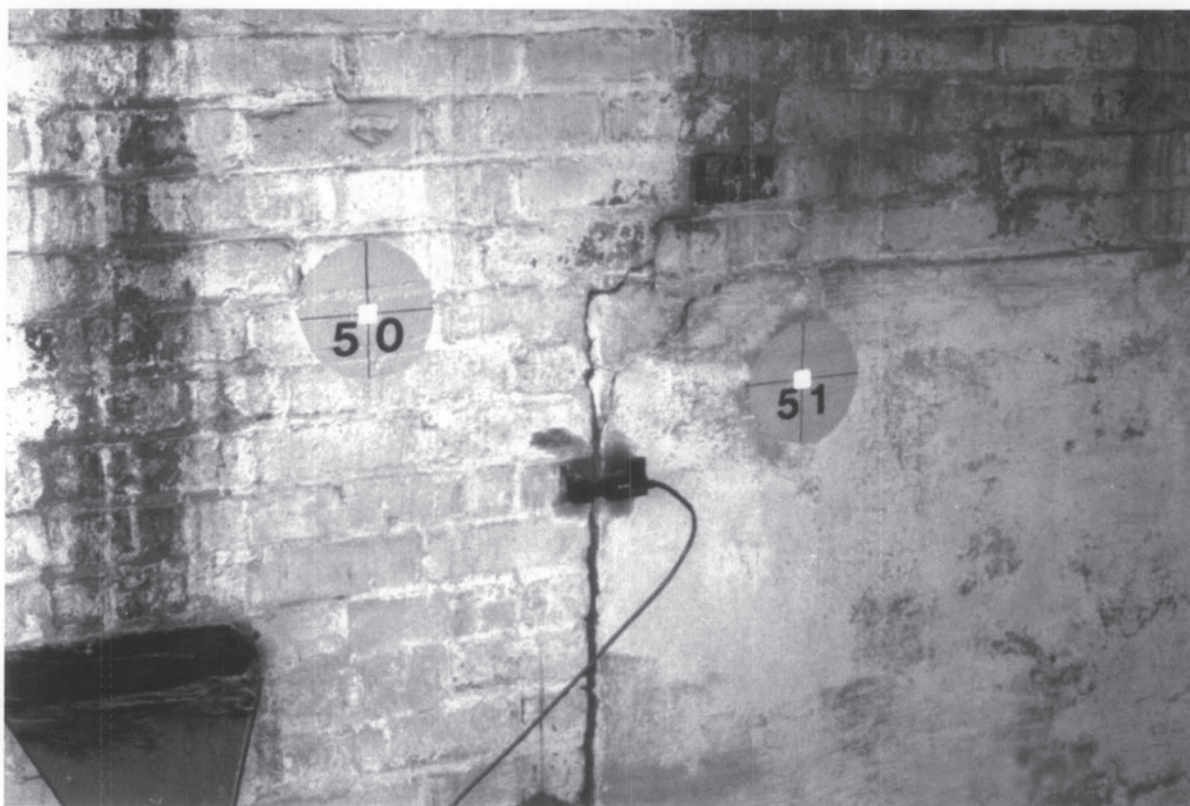
Figure 7. Electronic crack monitor and survey targets are shown installed on an existing wall. The crack monitor feeds movement data to a laptop computer. The targets are aligned and measured with optical survey equipment to determine the degree and direction of movement. Photo: McMullan and Associates, Inc.

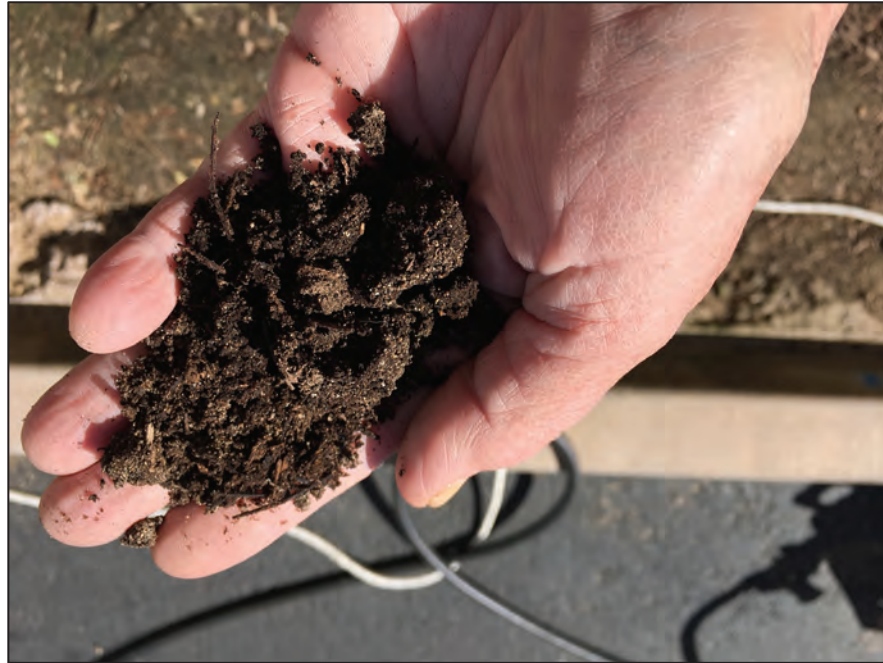
Figure 7: Soils along the eastern perimeter of the parking lot are sandy loam with no cultural materials observed.

The soils of the project parcel are exposed in numerous locations around the parcel. **Figure 7** is a close up of a handful of soils from the northern parcel, APN 010-145-023. The USDA Web Soil Survey classifies soils in this neighborhood as OaD--Oceano loamy sand, 2 to 15 percent slopes. Oceano loamy sands are stabilized eolian soils (<https://websoilsurvey.sc.egov.usda.gov>). These soils are found on marine terraces. The soil of the project parcel is dark brown to dark yellowish brown, 10YR 3/3 to 3/4, sandy loam, darkened by recent rains. There are no marine shell fragments, there are no cobbles or cobble fragments (burnt or unburnt), bone or flaked stone on the project parcel that would indicate a prehistoric site, nor are there traces of these materials. There are no fragments of old glass, or ceramics, or metal that would represent an historic site.

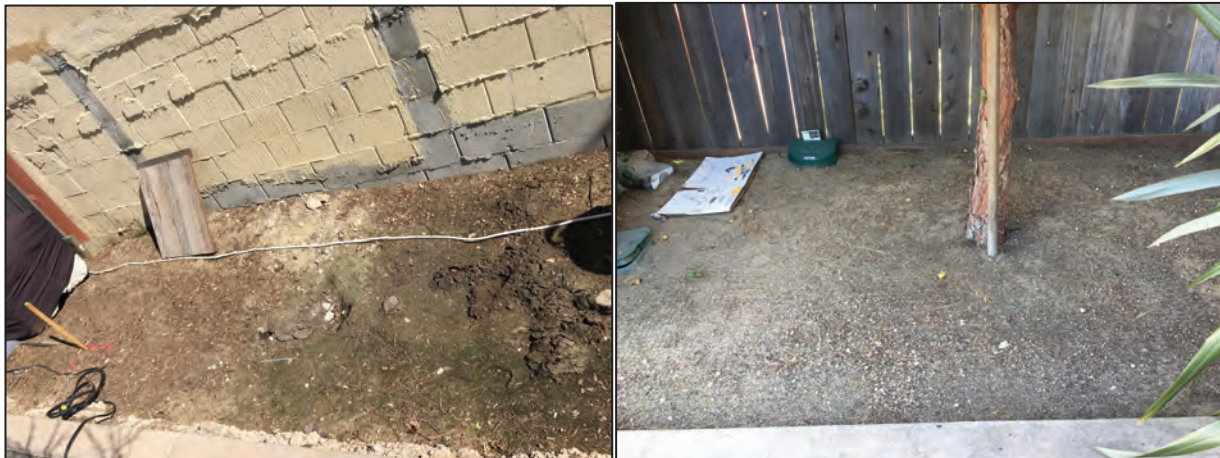
Figure 8: Soils near the eastern margins of the project parcels are exposed. The photo on the left is the northern parcel APN 010-145-023. The photo on the right is the southern of the two parcels, APN 010-145-023.

**Figure 8** shows the eastern margin of the both parcels. On all three sides of these two parcels the soils are clearly exposed and more than adequate for determining the presence of cultural materials. **Figure 9** shows the soils exposed along the south margin of APN 010-145-024.
