## **CITY OF CARMEL-BY-THE-SEA FOREST AND BEACH COMMISSION**

### **REGULAR MEETING Thursday, March 14, 2024**

| <b>SUBJECT:</b> | Receive a presentation from Integral Corp./Haro Kasunich & Associates/EMC Planning Group providing the preliminary findings of the Shoreline and Beach Erosion Exposure Modeling, Task 3, and Coastal Hazard and Sea Level Rise Vulnerabilities, Task 4, which are part of the Coastal Engineering Study |

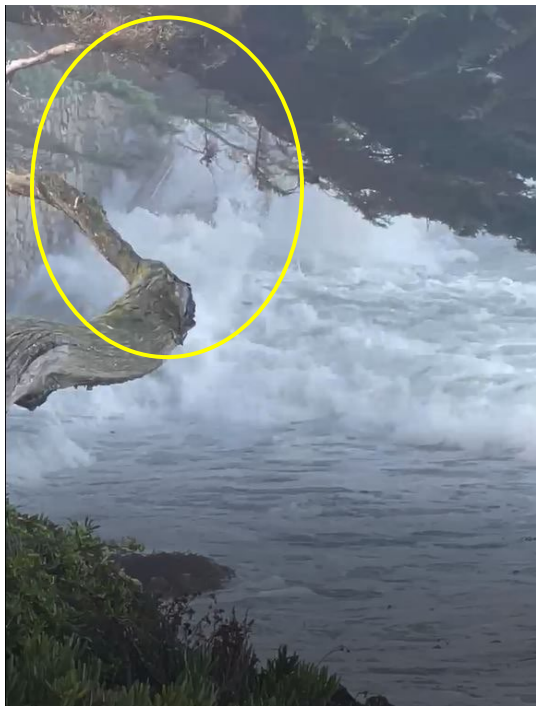
Figure 2. Martin Way Stairs (highlighted in yellow) during the El Niño winter of 2023–24.  
Source: City of Carmel, January 2024

Waves that reach the seawalls will reflect off the seawalls and travel seaward. At the seawall, the water particles under the reflected wave will move quickly, mobilize sand, and cause scour at the toe of the structure. The amount of scour is proportional to the height of the wave; the higher the wave, the greater the scour. In Figure 2, waves are crashing into the seawall near Martin Way.

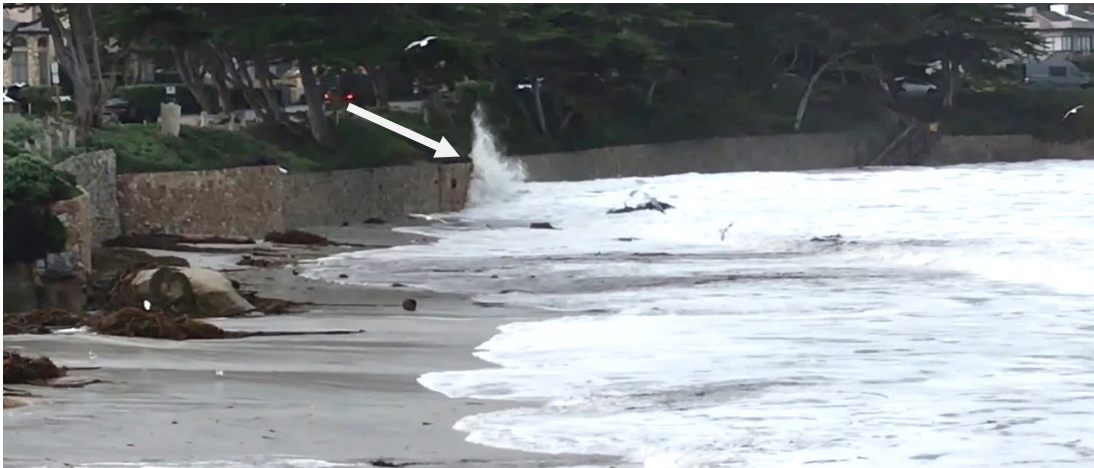
Figure 3. Wave overtopping on a Carmel seawall (see arrow). Note the directional wave and splash along the wall. Source: City of Carmel January 5, 2023

When wave run-up reaches coastal armoring structures, especially vertical seawalls, it can elevate water levels and create wave splash over the seawalls (Figure 3). This wave splash water, especially when driven by onshore winds, can saturate the bluff terraces behind the wall, contributing to bluff failure and erosion behind the seawalls. As sea levels rise, wave run up elevations reach a point where the water that is overtopping is not just a vertical splash but rather a wave (or “green water”), that has horizontal momentum and can further accelerate the erosion of the bluff above the coastal armoring structures.

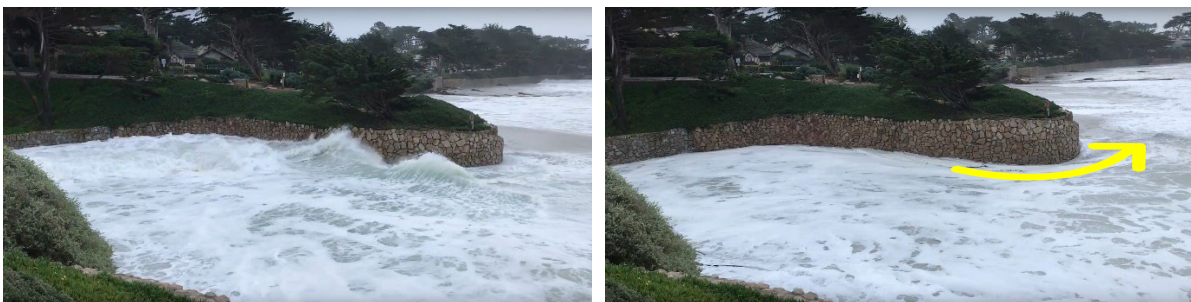
Figure 4. Rip currents moving away from the shore in the cove at 13th Avenue. Left, the cove fills with water from broken waves. Right, an alongshore current develops, channeling water out of the cove and along the seawall to the south. Source: City of Carmel, January 2023

The study by Rogers E. Johnson and Associates (Johnson 1983) detailed a swift inshore current that moves horizontally along the beach, typically heading southward where elevations are lower. Inshore and backshore currents have been observed in recent events, illustrated in Figure 4. In the initial panel, waves collide with the seawall, reflecting away from it. The water, attempting to escape, is directed around the seawall. These currents with high particle velocities can more effectively mobilize sand away from the beach.

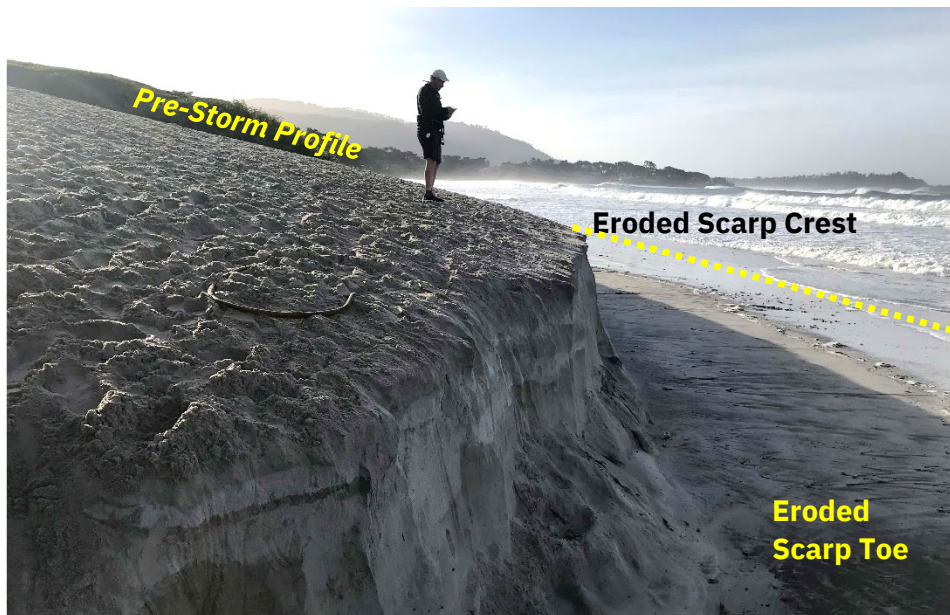
Figure 8. Dune scarp at Del Mar Sand Ramp. The yellow hatched line represents the previous summer's beach profile. Dune scarping can have a significant impact on beach access. Source: City of Carmel, January 2023

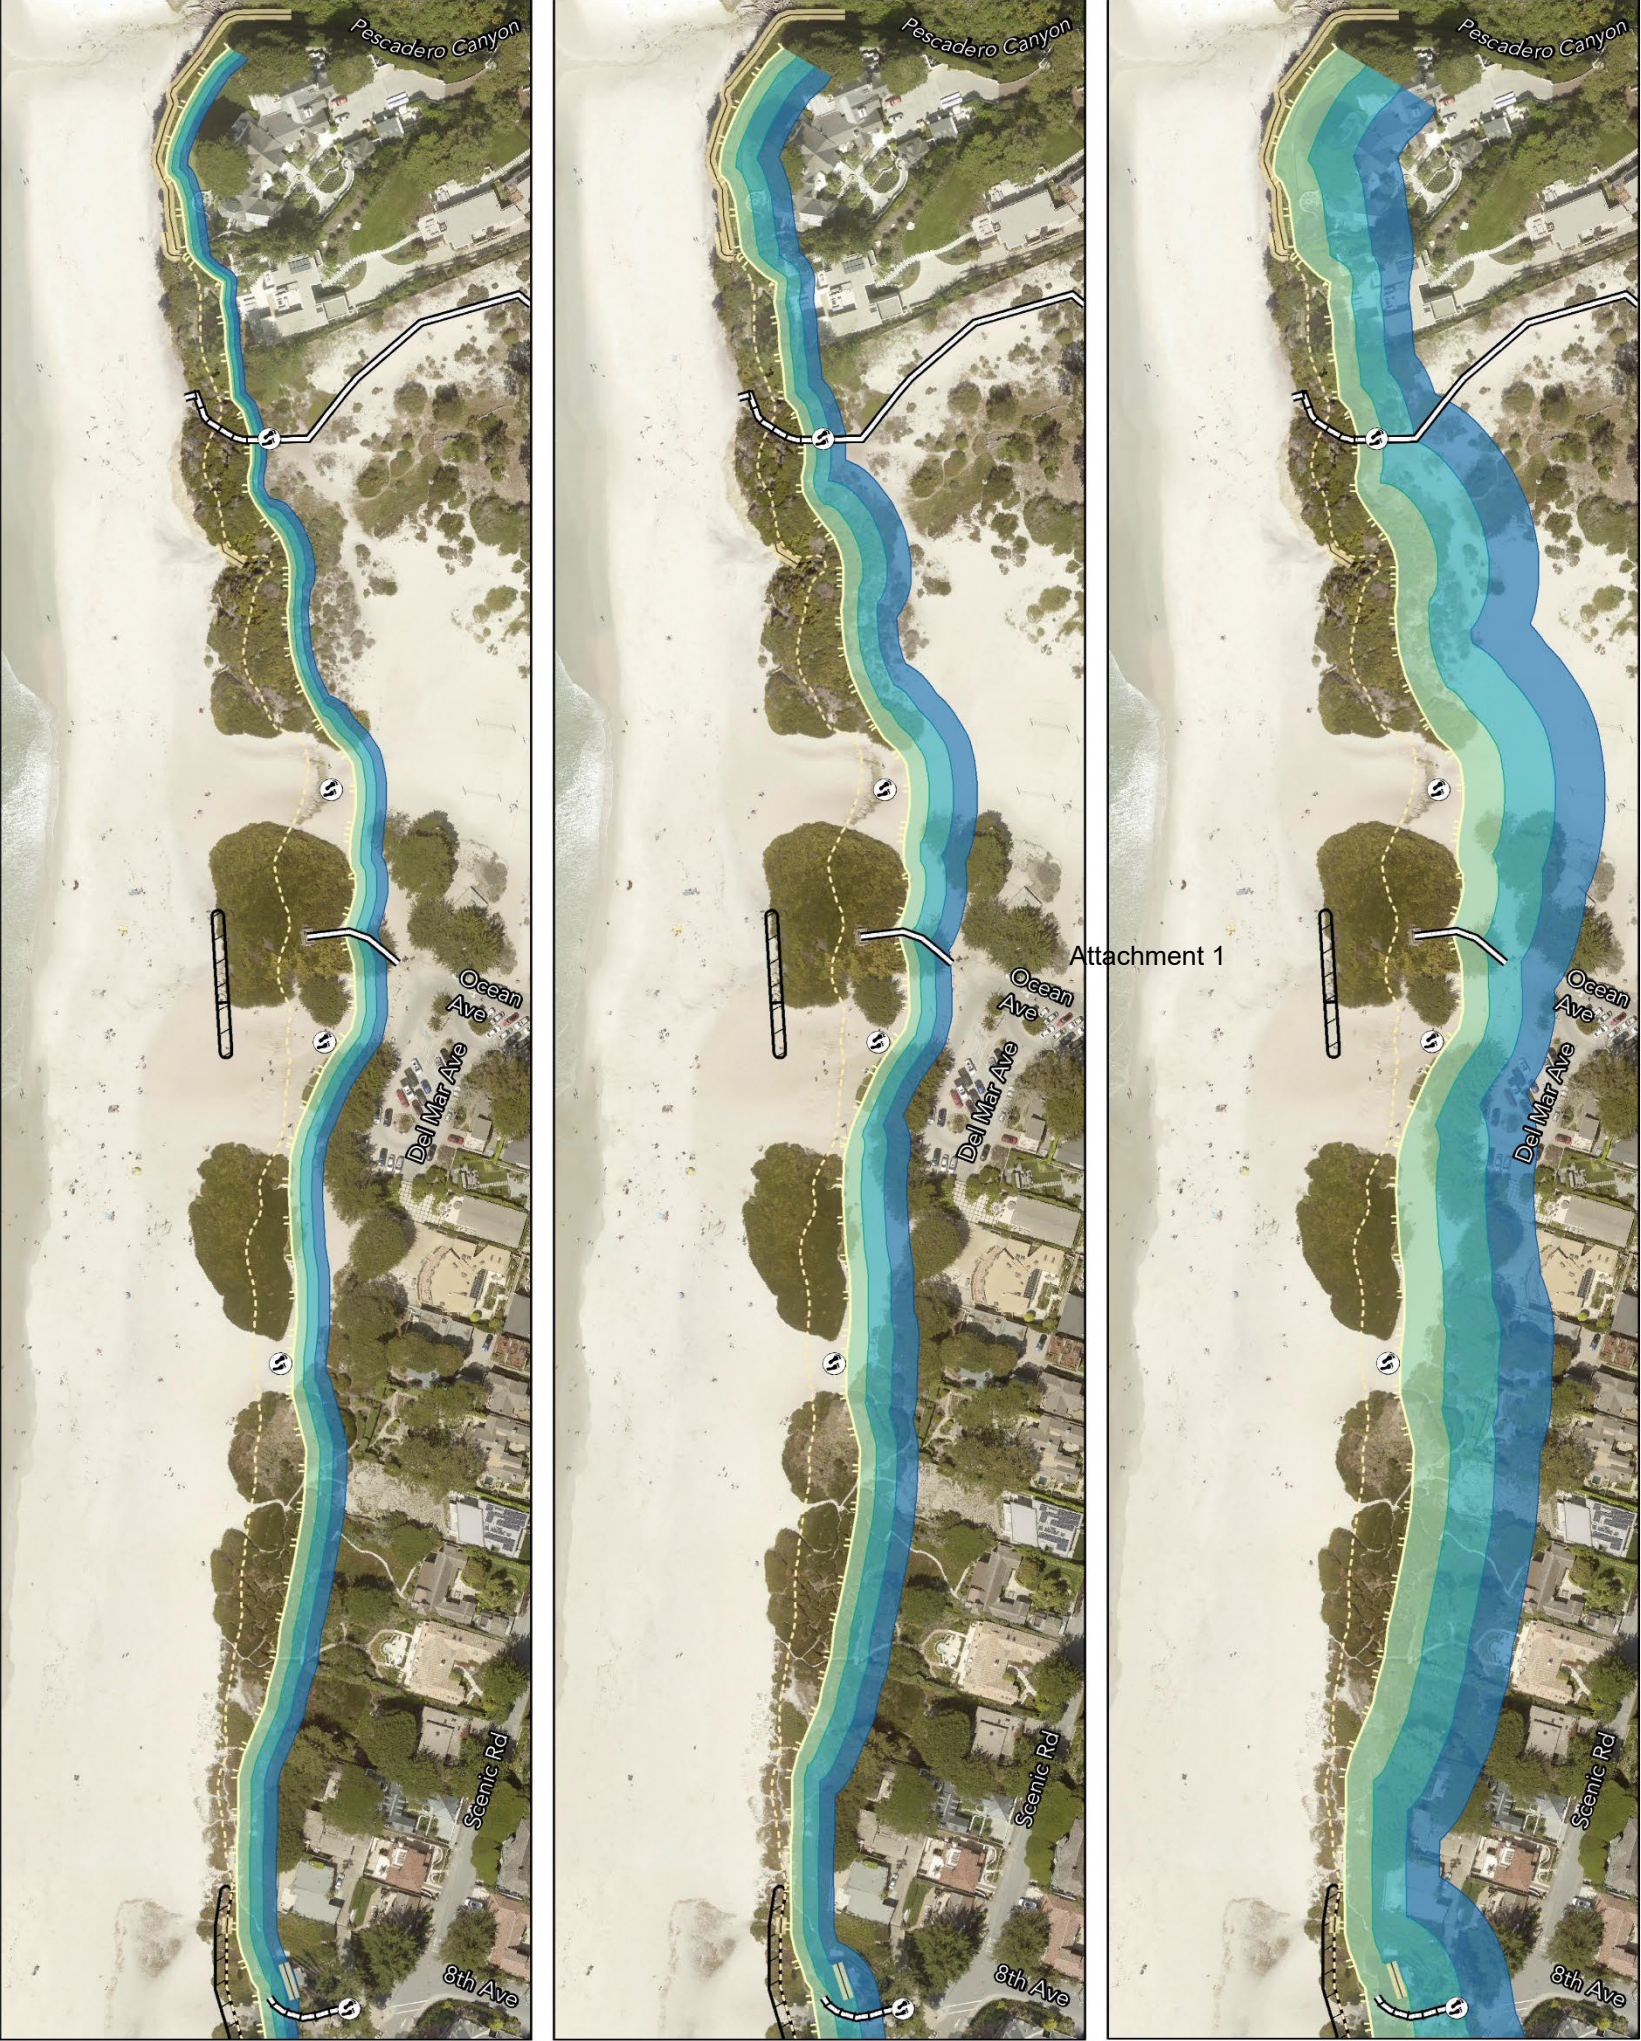
Figure 10. Map of dune and cliff erosion for the northern beach. Displays erosion hazards without armoring. Hazard zones represent three bands of certainty, most likely, based on the assumption of a low average erosion rate (0.2 ft/yr), best, based on the assumption of an average erosion rate (0.4 ft/yr), and worst case, based on the assumption of a high average erosion rate (0.7 ft/yr).

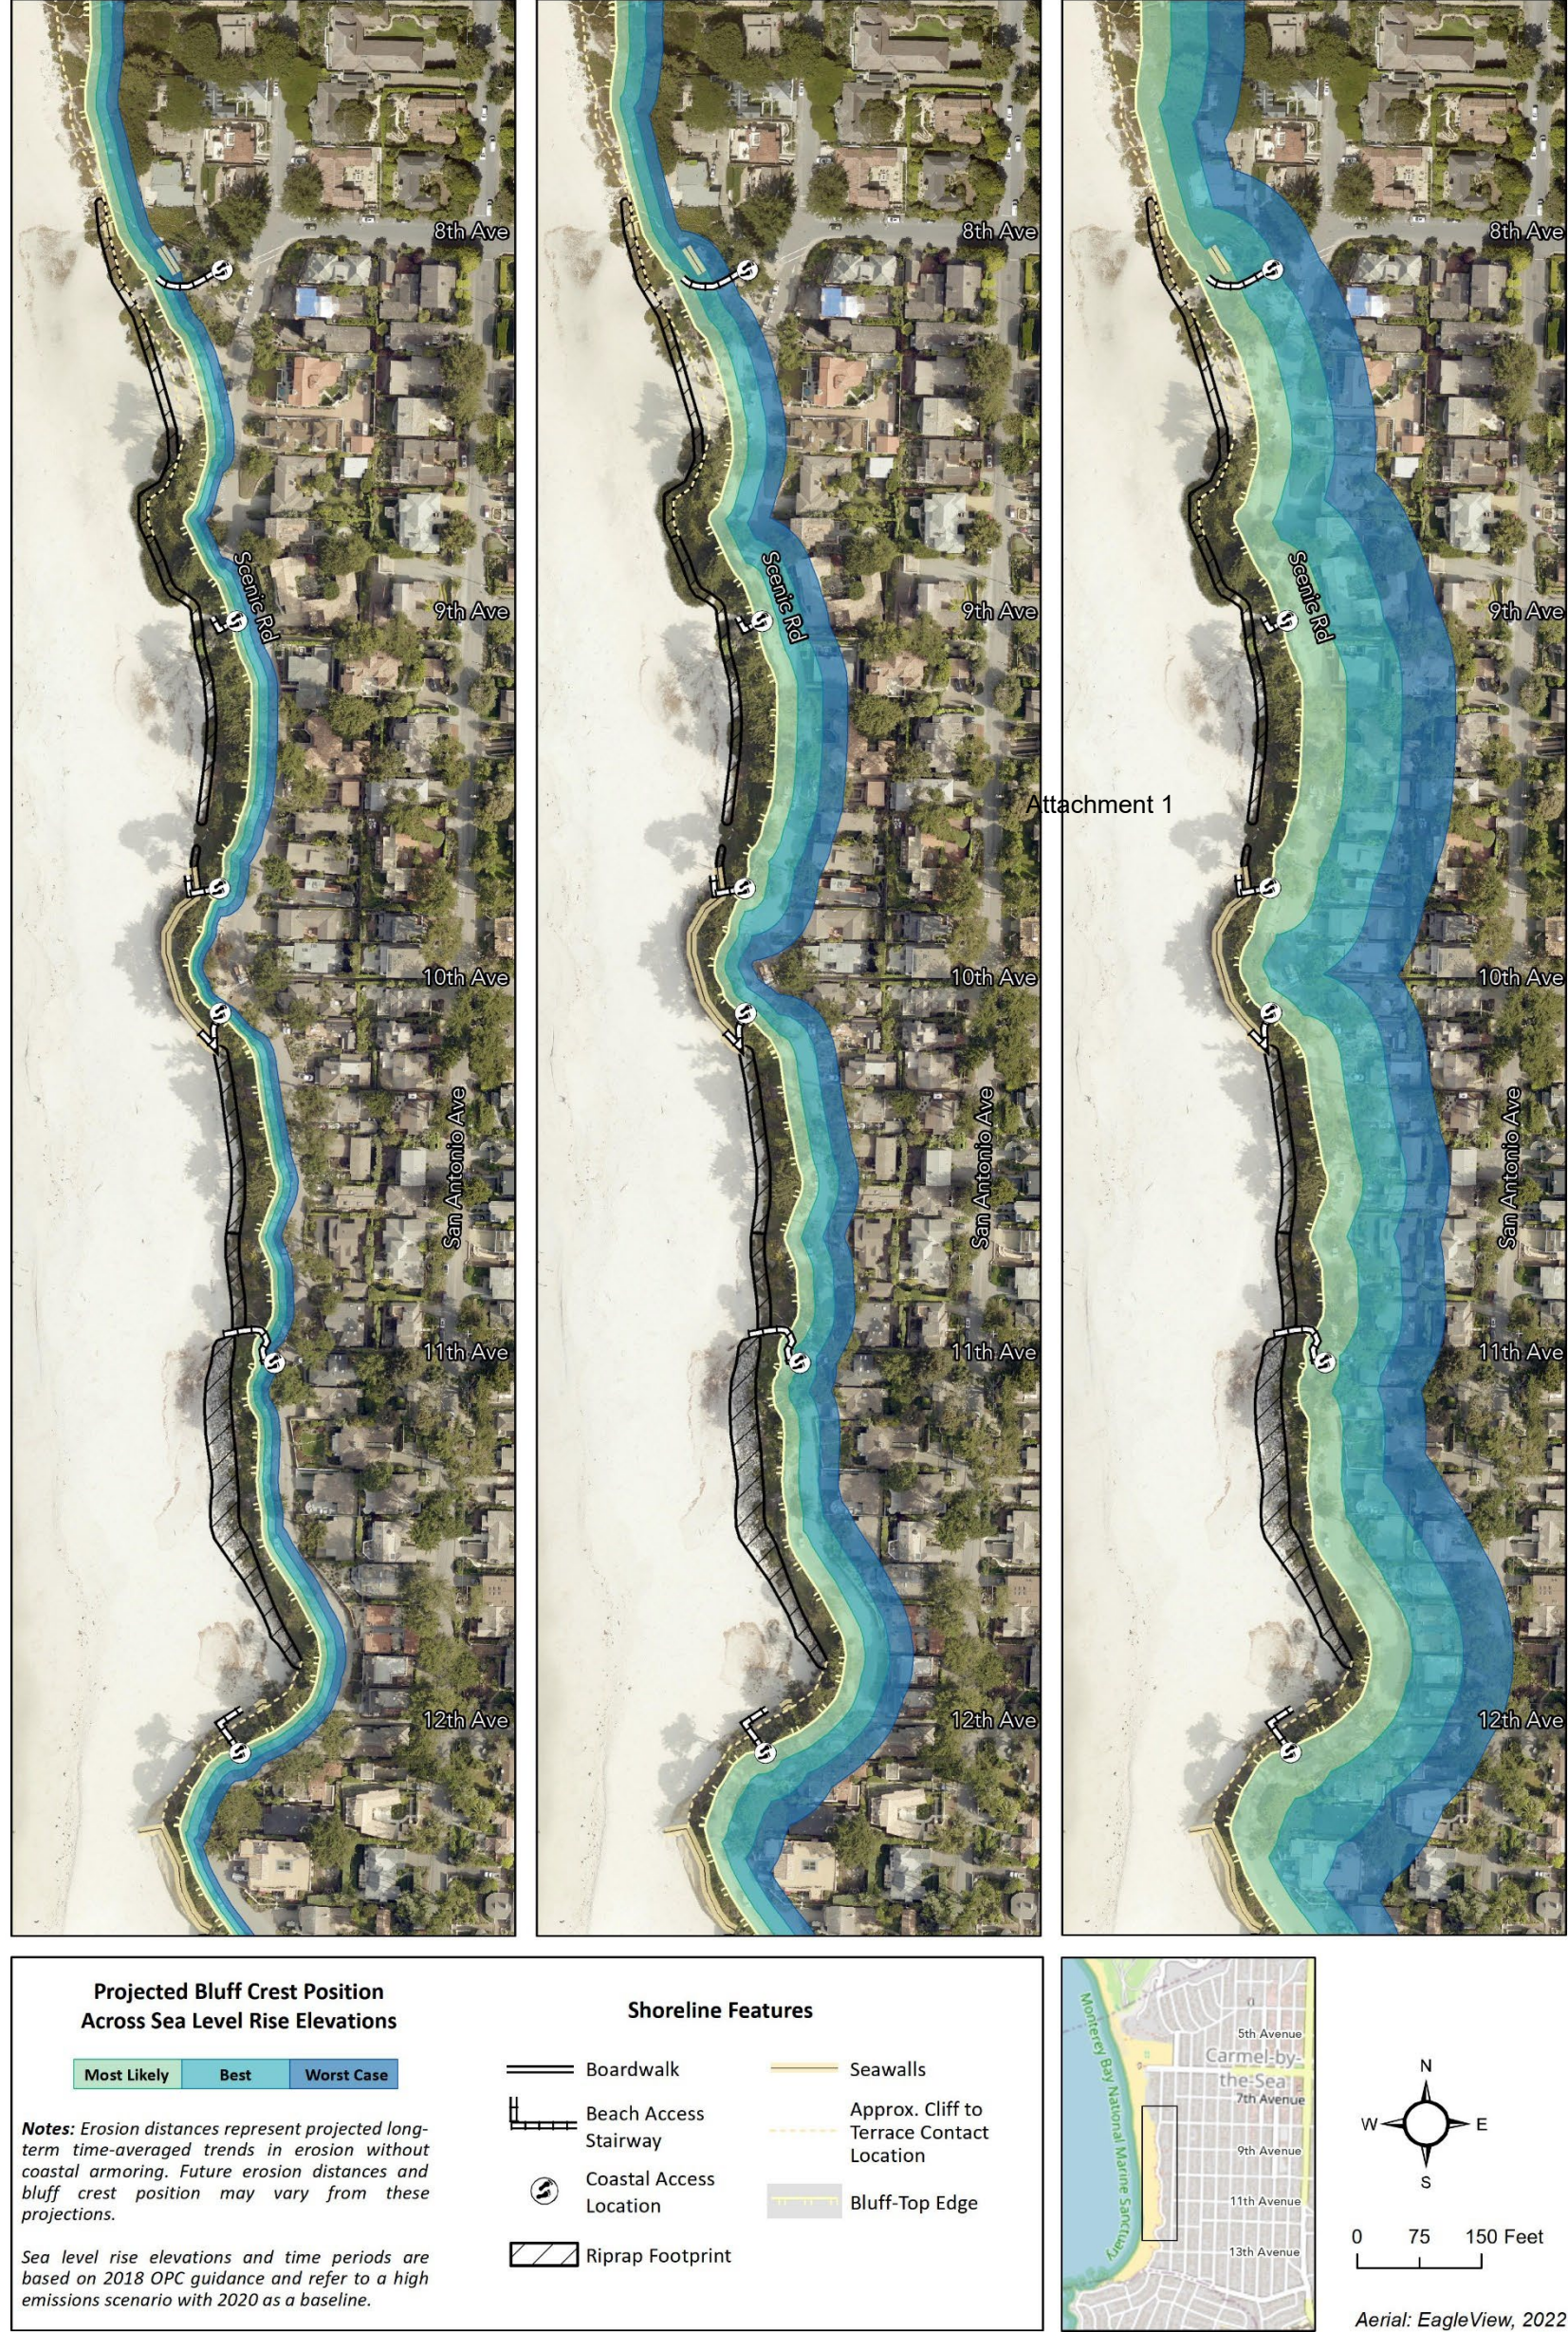
Figure 11. Map of dune and cliff erosion for the central beach. Displays erosion hazards without armoring. Hazard zones represent three bands of certainty, most likely, based on the assumption of a low average erosion rate (0.2 ft/yr), best, based on the assumption of an average erosion rate (0.4 ft/yr), and worst case, based on the assumption of a high average erosion rate (0.7 ft/yr).

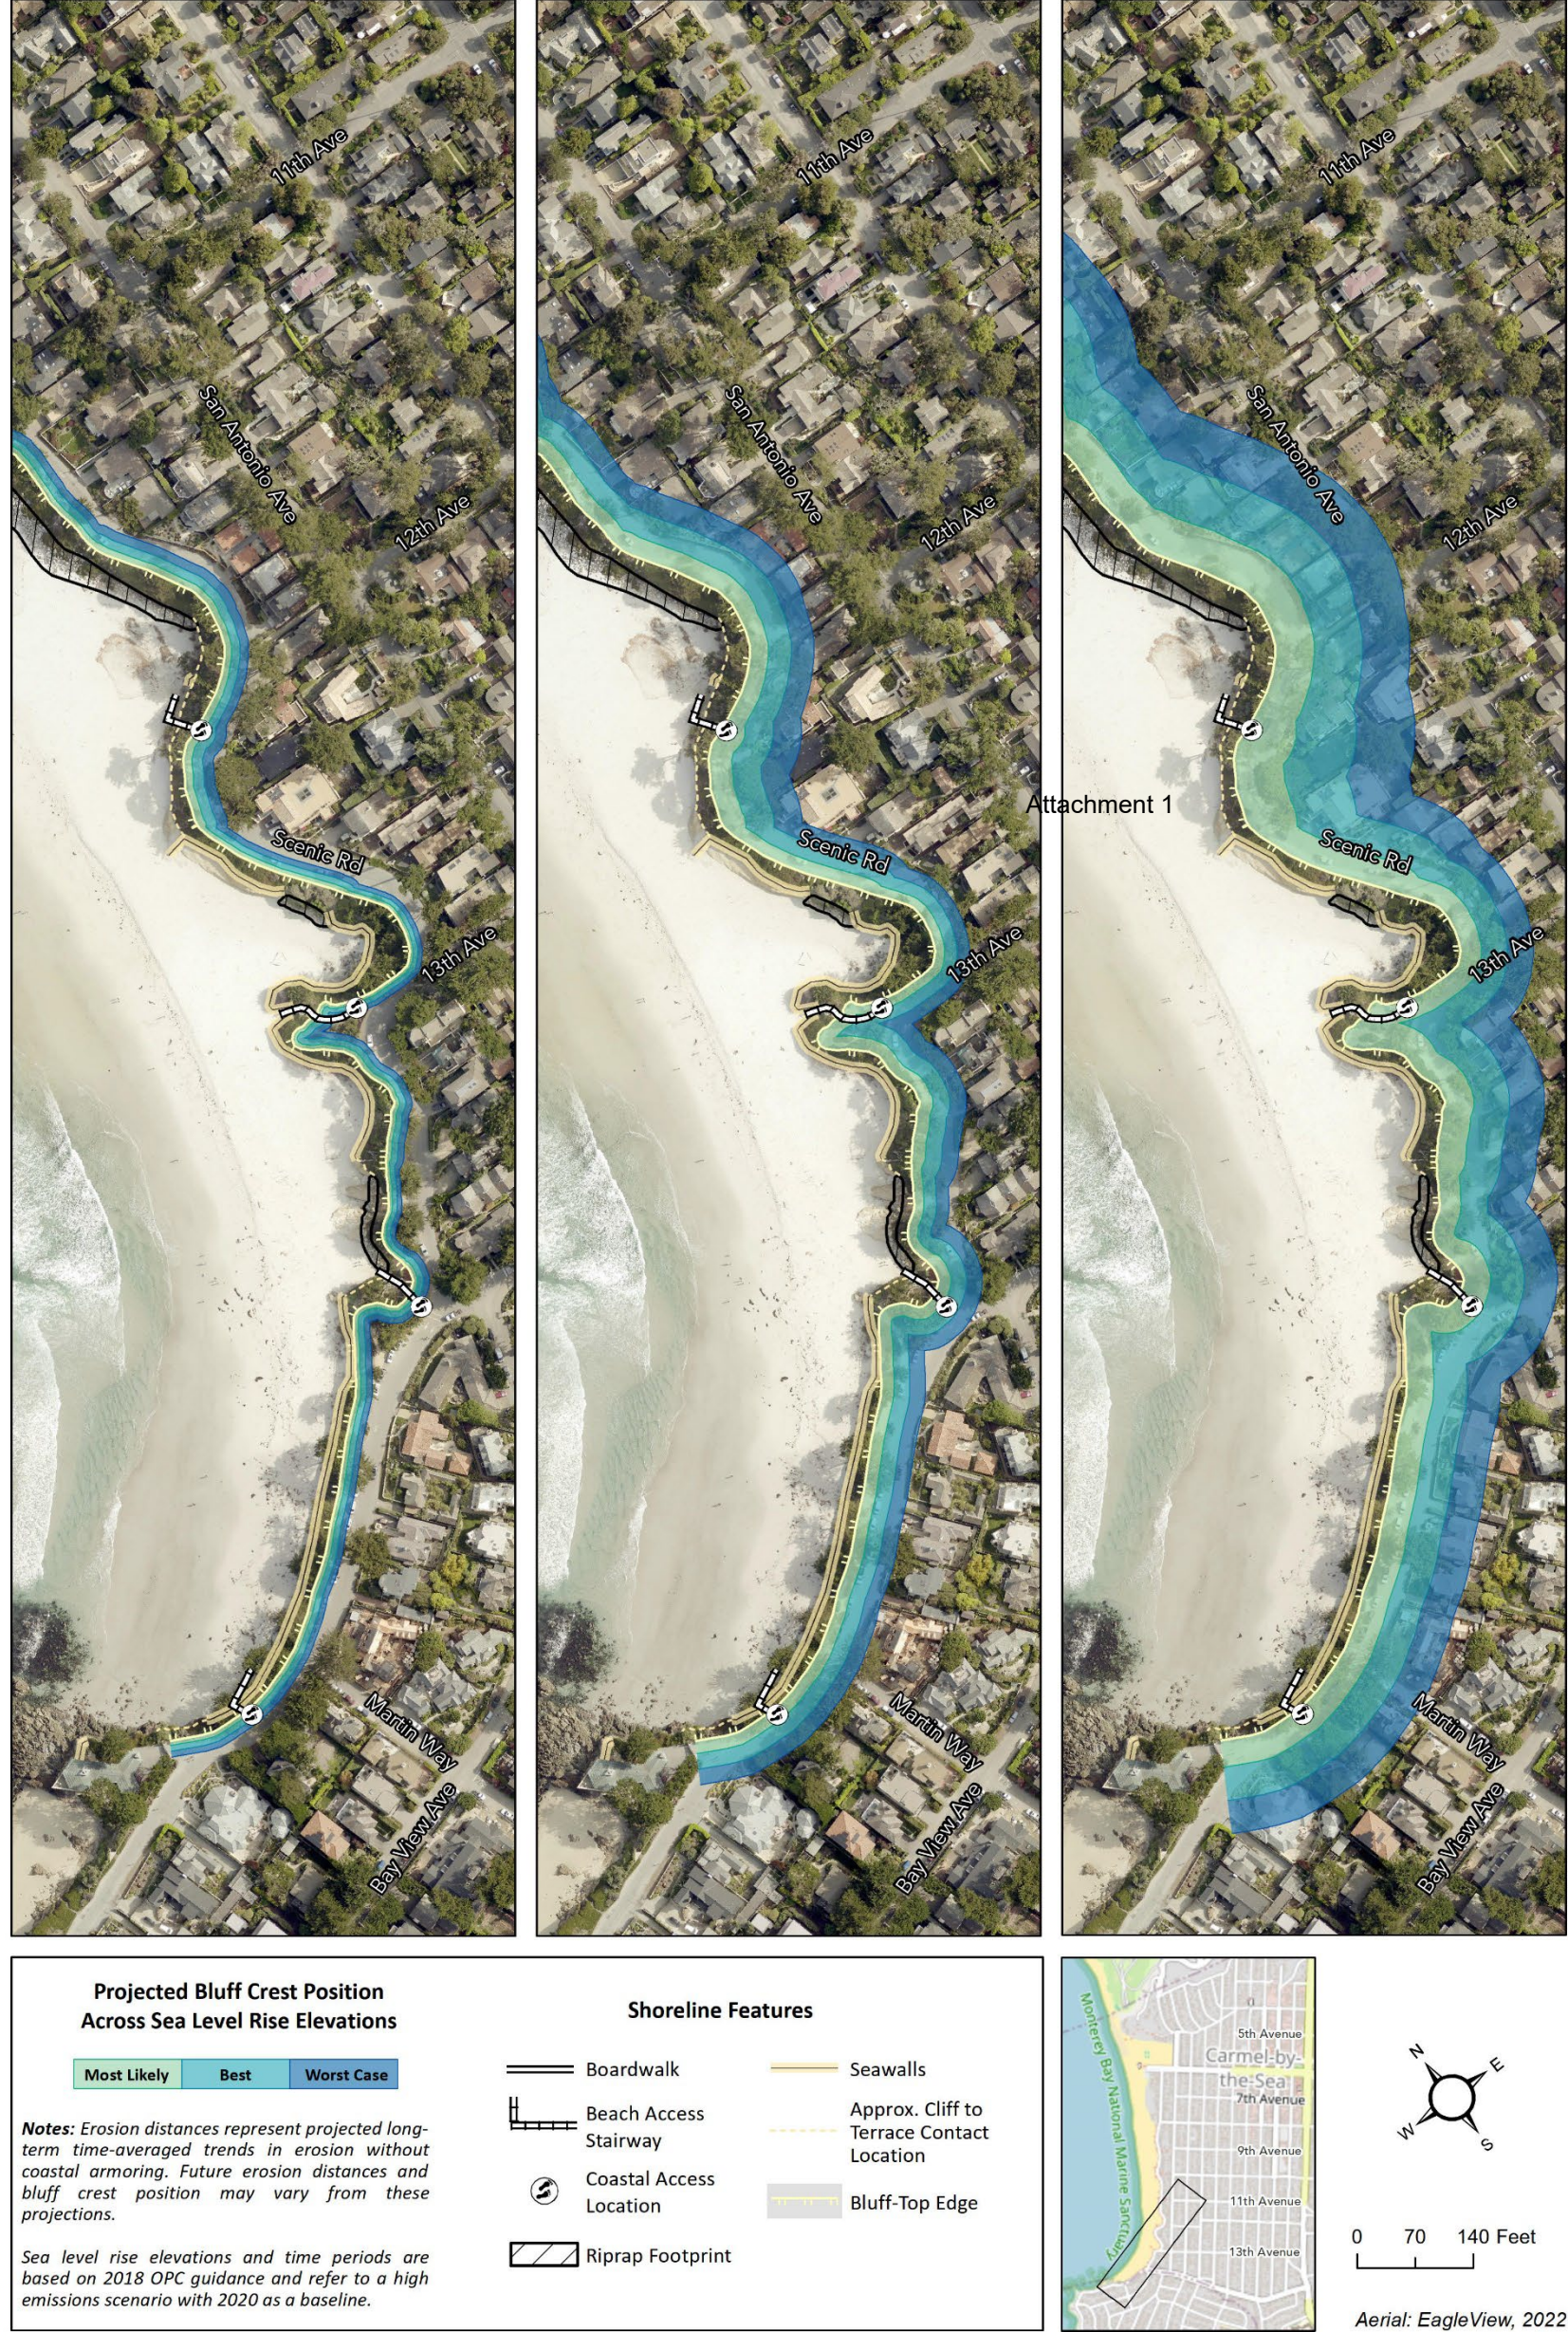
Figure 12. Map of dune and cliff erosion for the southern beach. Displays erosion hazards without armoring. Hazard zones represent three bands of certainty, most likely, based on the assumption of a low average erosion rate (0.2 ft/yr), best, based on the assumption of an average erosion rate (0.4 ft/yr), and worst case, based on the assumption of a high average erosion rate (0.7 ft/yr).

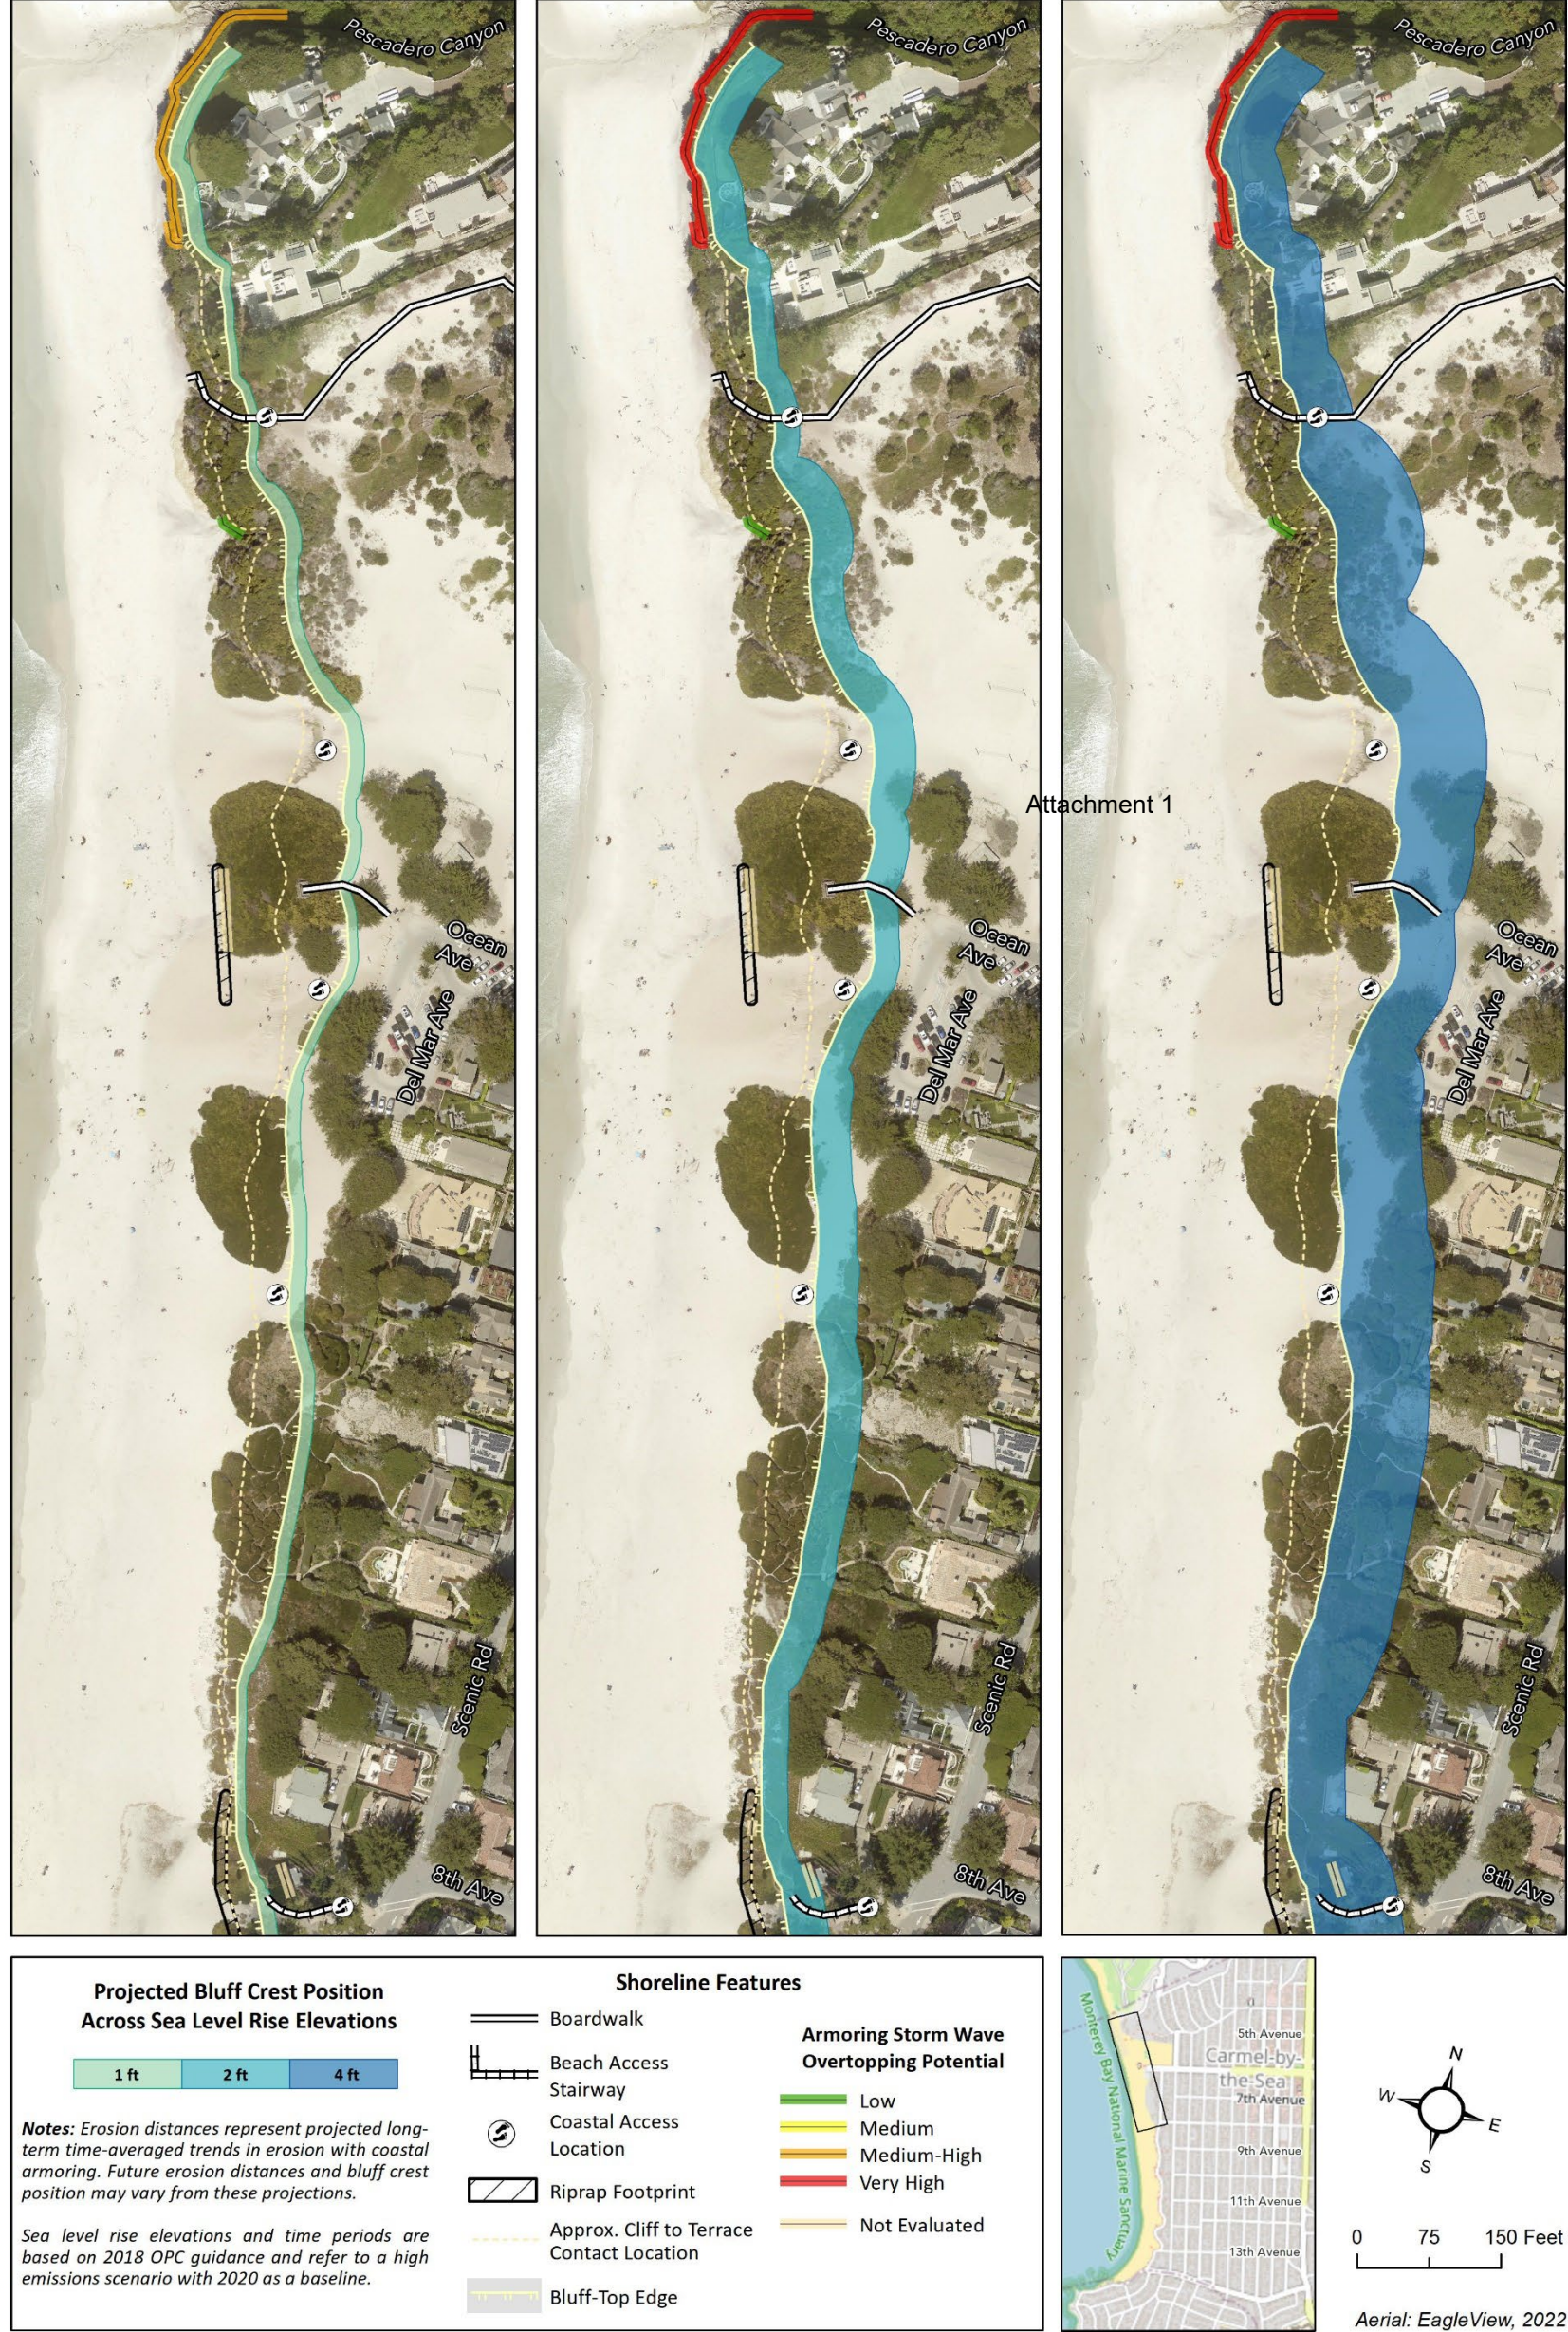
Coastal Cliff and Dune Erosion Projection With Armoring - North Carmel Beach  
1 ft of SLR (2045 - 2060)      2 ft of SLR (2060 - 2080)      4 ft of SLR (2080 - 2100+)

Figure 13. Map of dune and cliff erosion for the northern beach. Displays erosion hazards with armoring. Hazard zones in areas where armoring is not present rely on the ‘without armoring’ scenario using the assumption of an average erosion rate (0.4 ft/yr).

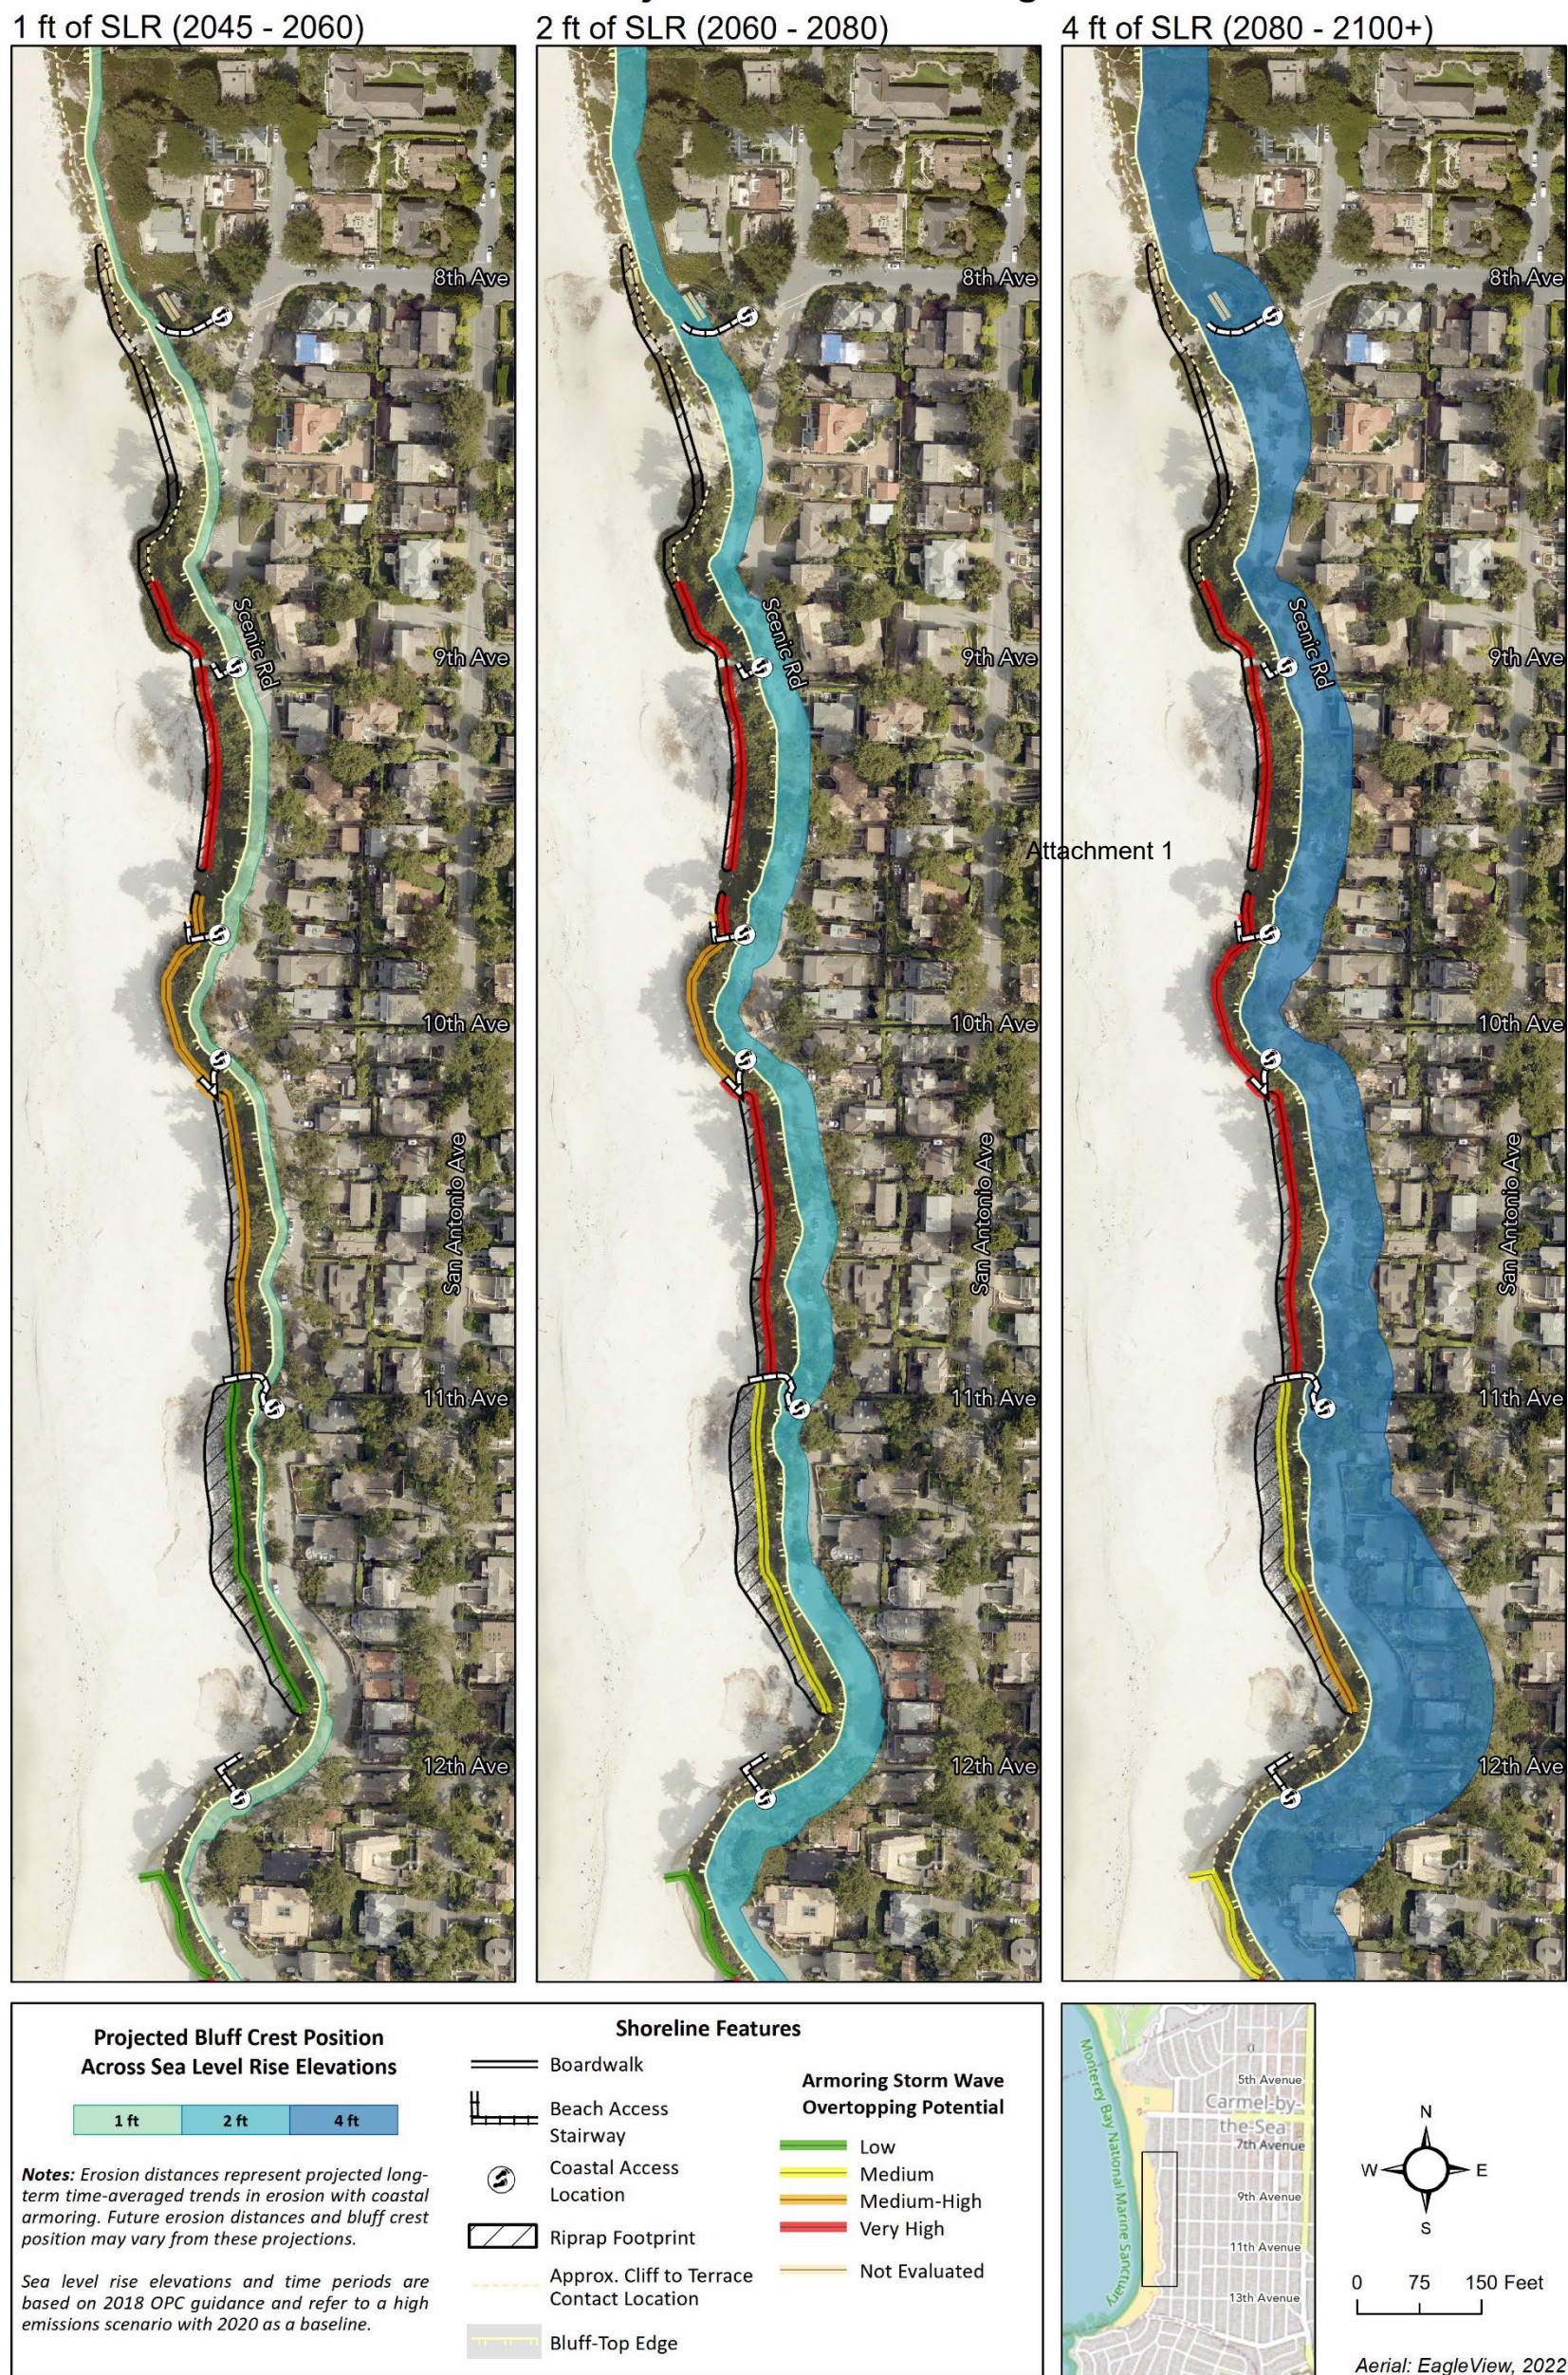
Coastal Cliff and Dune Erosion Projection With Armoring - Central Carmel Beach

Figure 14. Map of dune and cliff erosion for the central beach. Displays erosion hazards with armoring. Hazard zones in areas where armoring is not present rely on the ‘without armoring’ scenario using the assumption of an average erosion rate (0.4 ft/yr).
