## **CITY OF CARMEL-BY-THE-SEA FOREST AND BEACH COMMISSION**

### **REGULAR MEETING Thursday, March 14, 2024**

| <b>SUBJECT:</b> | Receive a presentation from Integral Corp./Haro Kasunich & Associates/EMC Planning Group providing the preliminary findings of the Shoreline and Beach Erosion Exposure Modeling, Task 3, and Coastal Hazard and Sea Level Rise Vulnerabilities, Task 4, which are part of the Coastal Engineering Study |

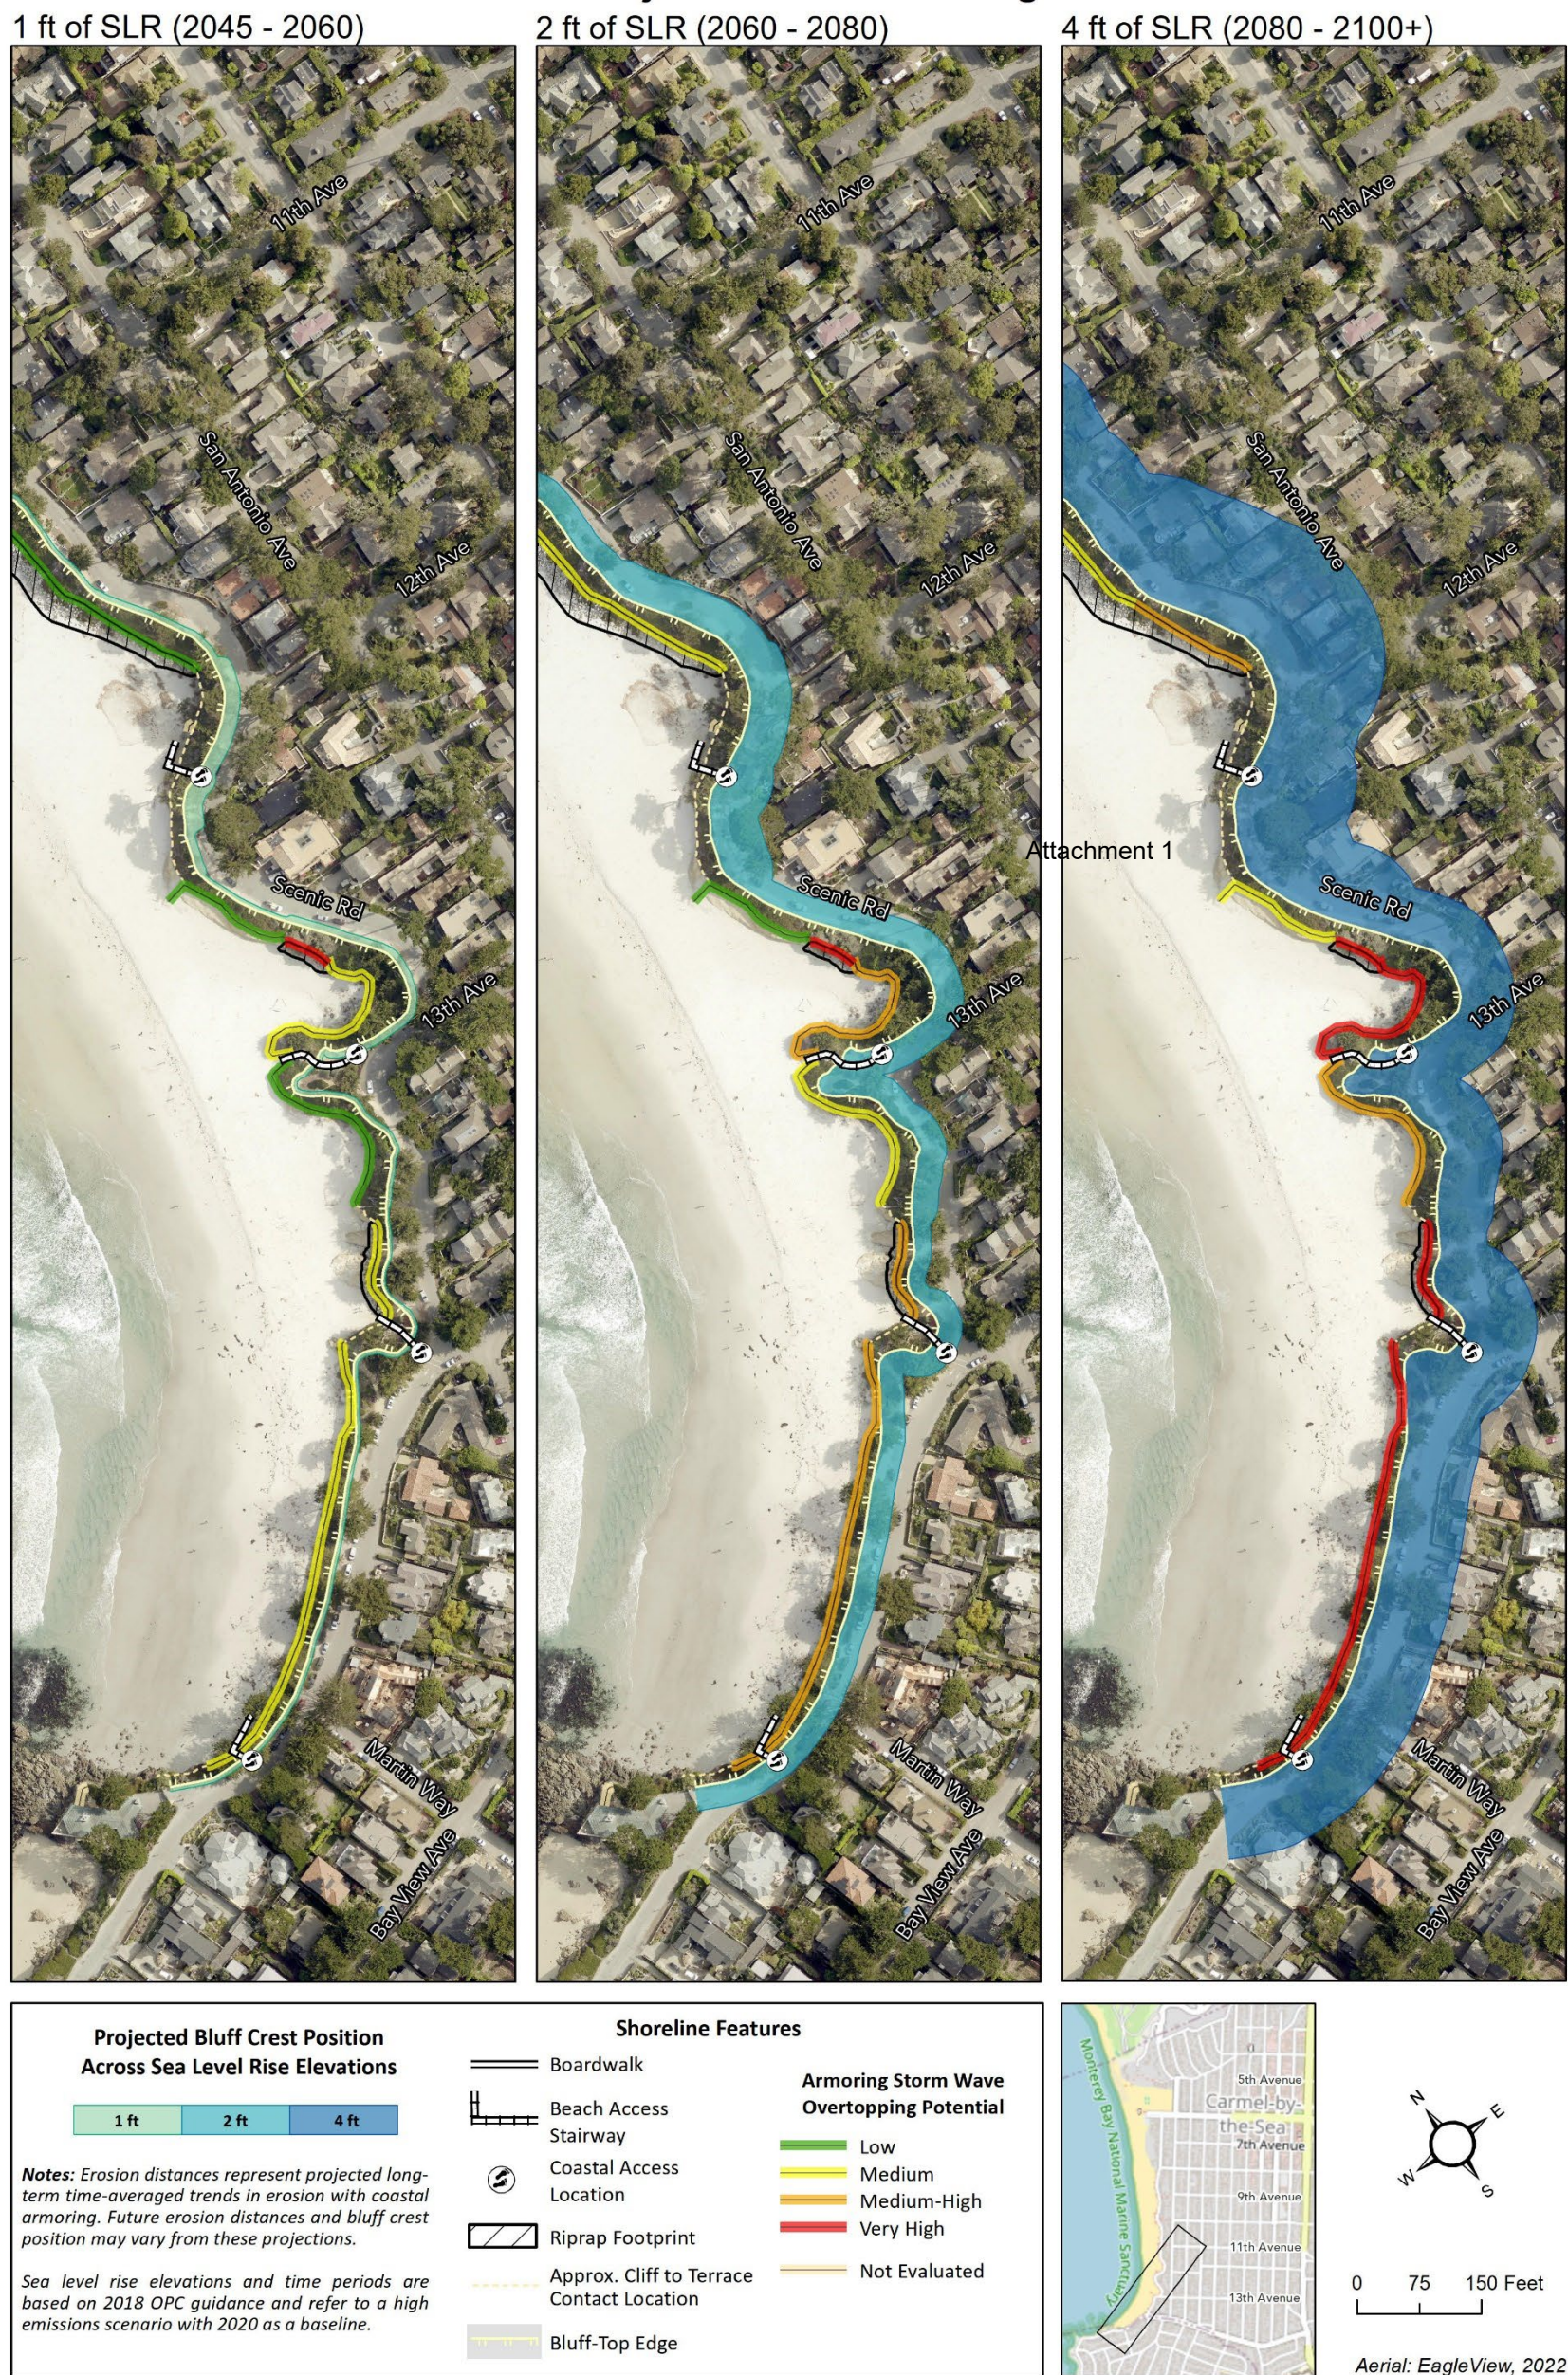
Coastal Cliff and Dune Erosion Projection With Armoring - South Carmel Beach

Figure 15. Map of dune and cliff erosion for the southern beach. Displays erosion hazards with armoring. Hazard zones in areas where armoring is not present rely on the 'without armoring' scenario using the assumption of an average erosion rate (0.4 ft/yr).

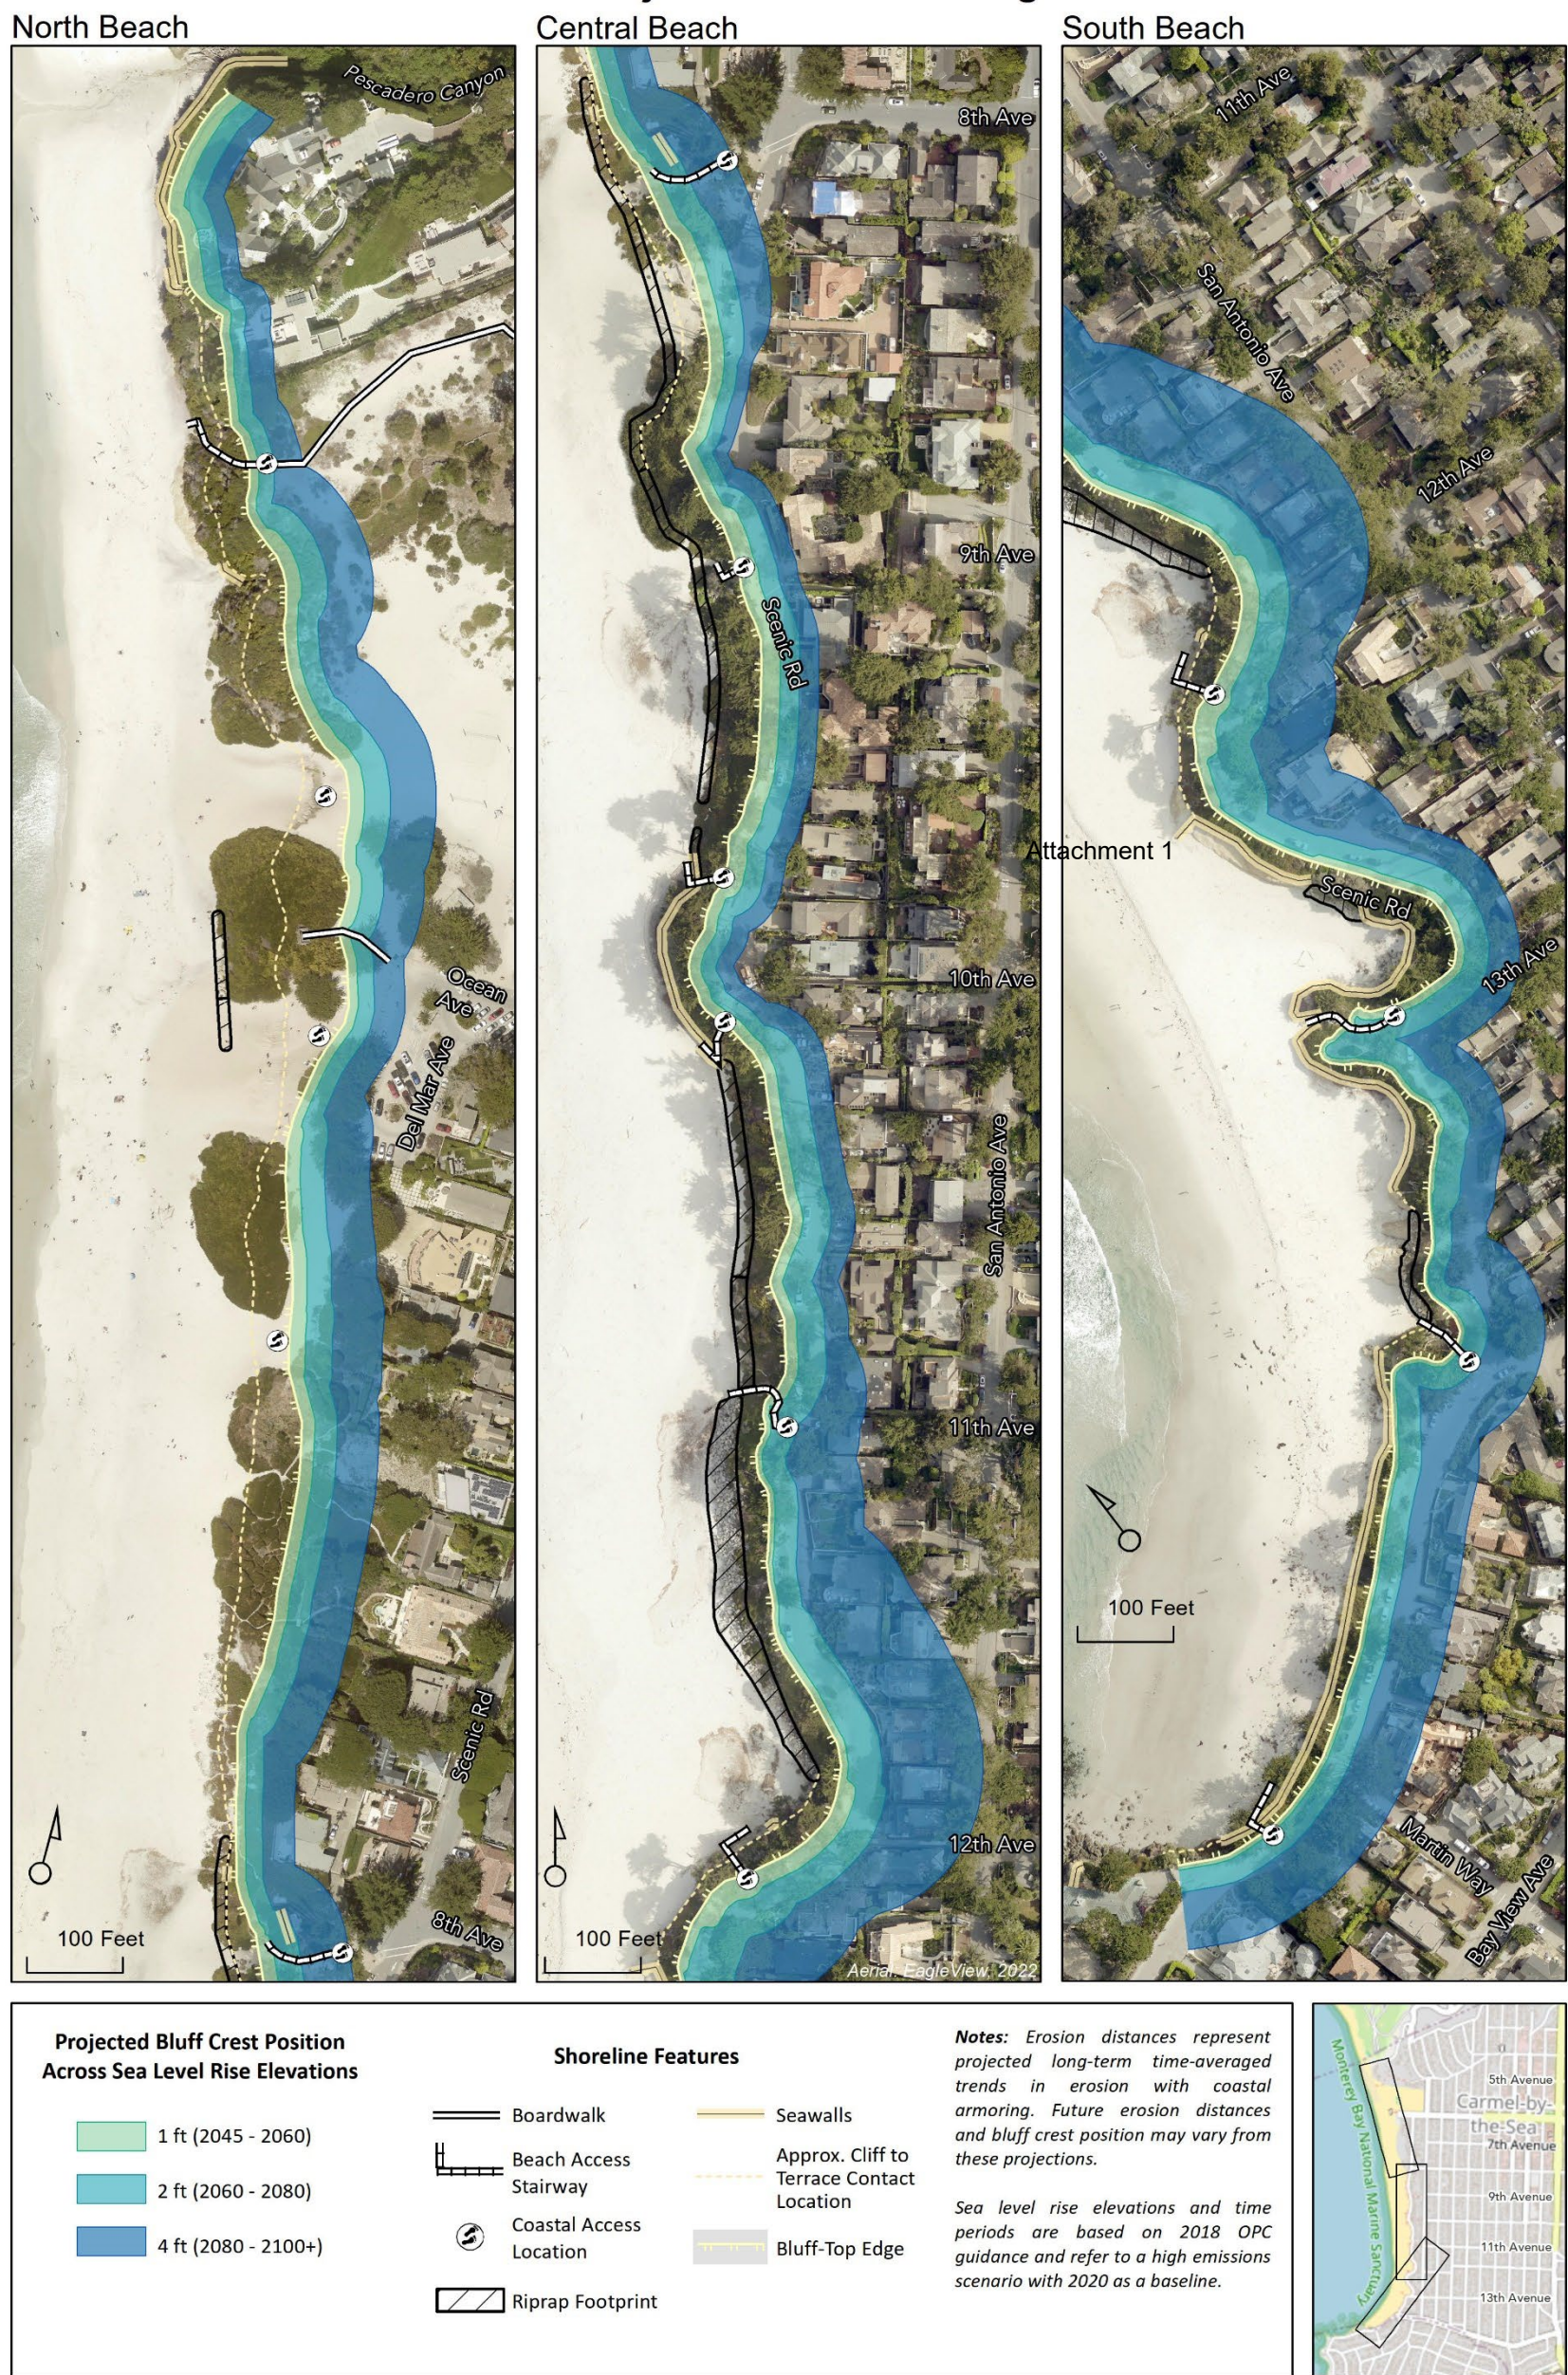
Coastal Cliff and Dune Erosion Projection With Armoring

Figure 16. Map of dune and cliff erosion for the entire beach. Displays erosion hazards with armoring. Hazard zones in areas where armoring is not present rely on the ‘without armoring’ scenario using the assumption of an average erosion rate (0.4 ft/yr).

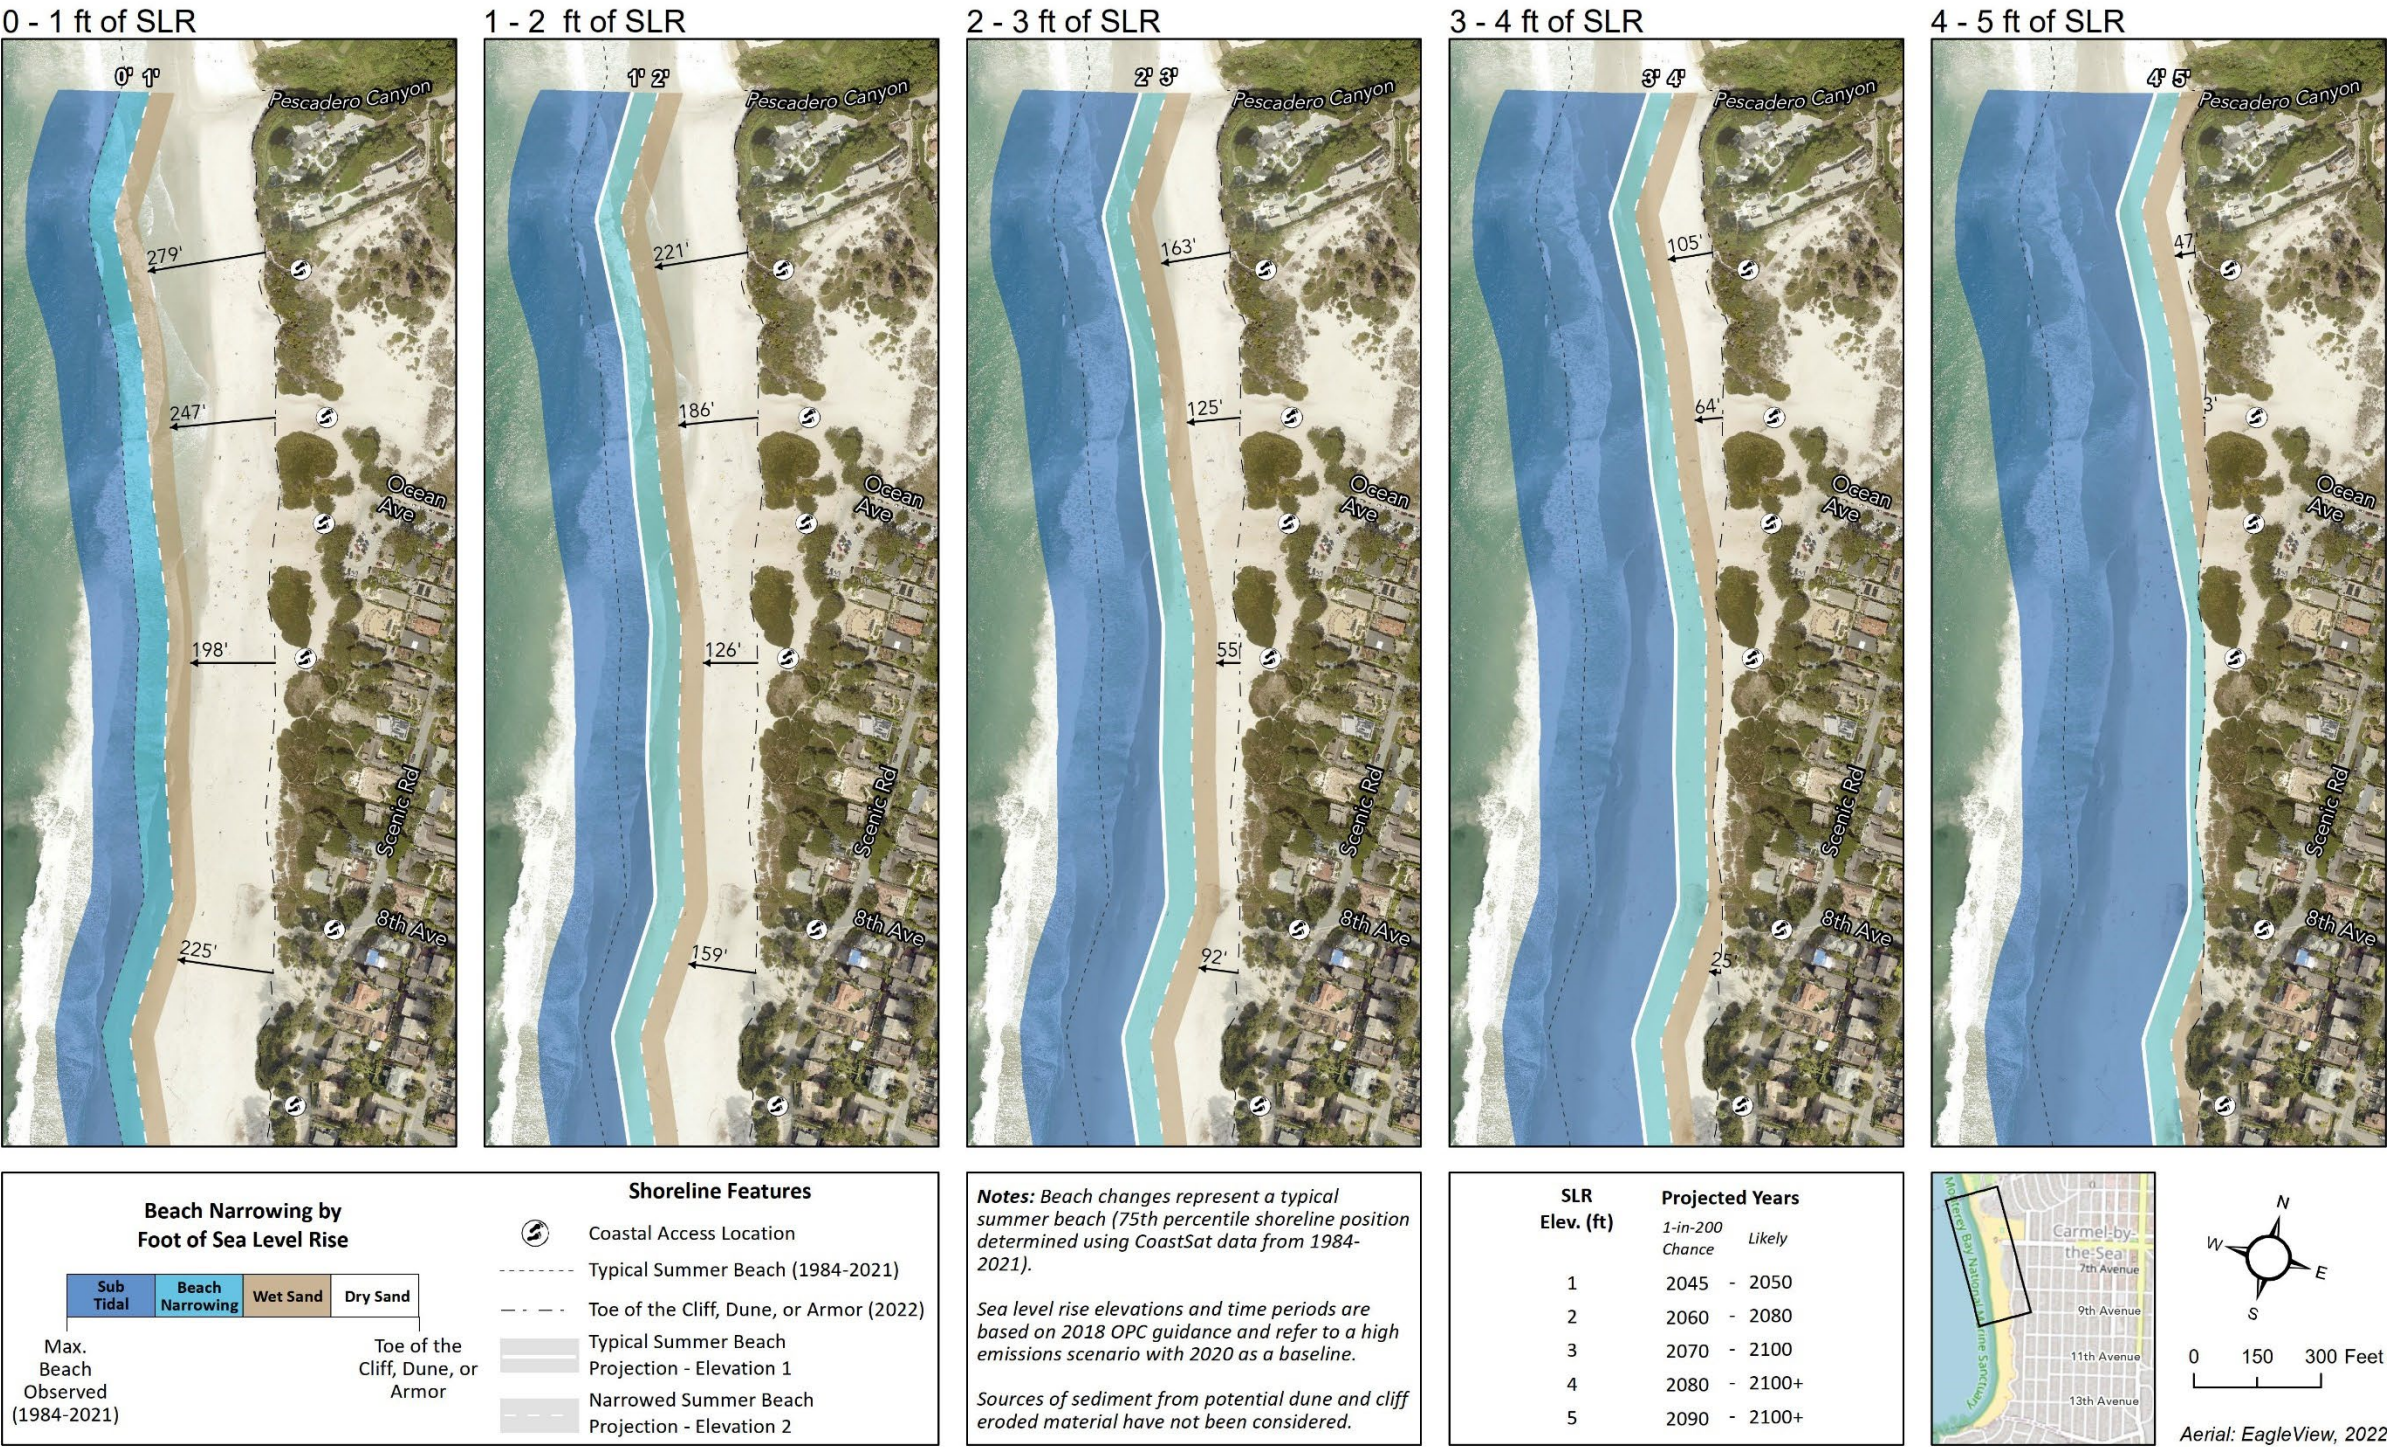
Summer Beach Width Change Projection - North Carmel Beach

The maps of beach narrowing with sea level rise represent a typical summer beach. Actual summer beach widths may vary. Beach widths are constrained by the current position of backshore toe and are reflective of a “hold the line” scenario.

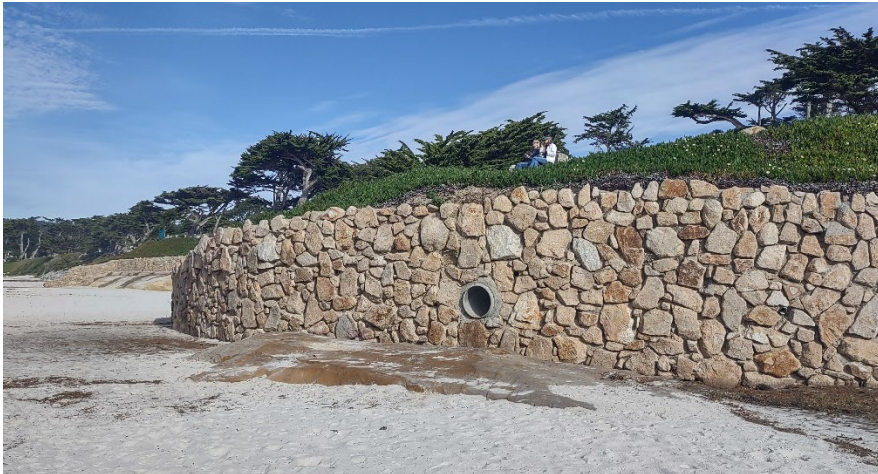
Figure 20. Stormwater drainage near 13th Avenue.

The stormwater drainage network, which is often buried beneath the bluff terrace and the cliff to drain stormwater to the beach, is likely to be exposed to storm wave flooding and erosion (Figure 20). Failure of a storm drain can also exacerbate erosion from terrestrial scouring during rain events.

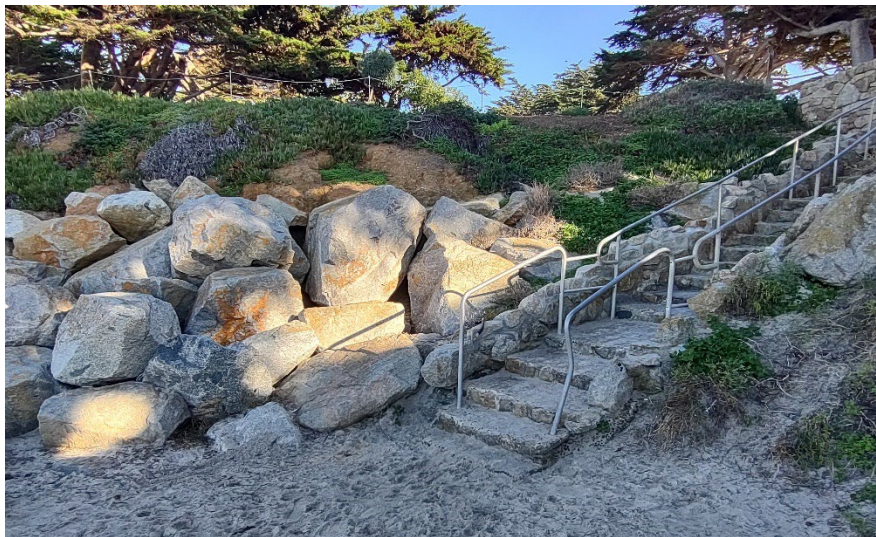
Figure 21. Stairway at Santa Lucia Avenue. Note damage to the railing from past storms.

There are ten beach access stairways that lead to the beach, and all of these stairways are vulnerable to wave attack, scouring and undercutting of their foundations, and coastal erosion. In addition, the failure of a stairway can exacerbate erosion of surrounding bluffs. Breakaway stair designs such as those just north of 10th Avenue can greatly reduce the potential for stairway failures to contribute to erosion.

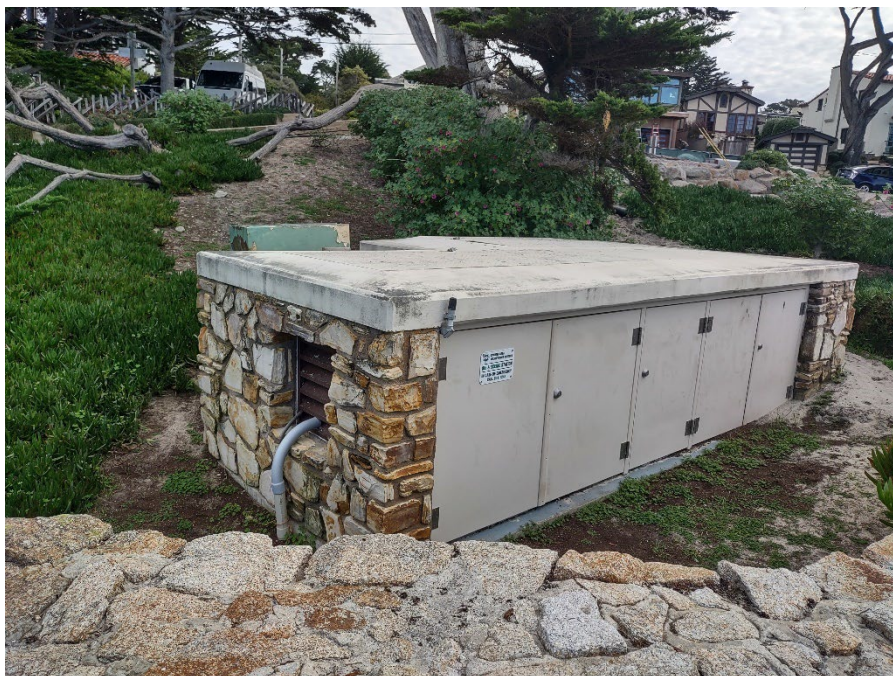
Figure 24. Wastewater lift station near 8<sup>th</sup> Avenue.

By 2 ft of sea level rise, and without any adaptation measures, the dune erosion process may shift toward cliff erosion processes as the foredune retreats inland and contact with the underlying cemented beach deposits and sandstone occurs. The threat of coastal storm waves overtopping the dunes and threatening the homes along the backdune remains unlikely. By 8th Avenue, a wastewater lift station located at ~24.5 ft may be exposed to storm wave flooding (Figure 24). A sewer main under the dunes between 7th Avenue and 8th Avenue could be exposed to dune erosion although the condition of the underlying revetment is not well understood presently.

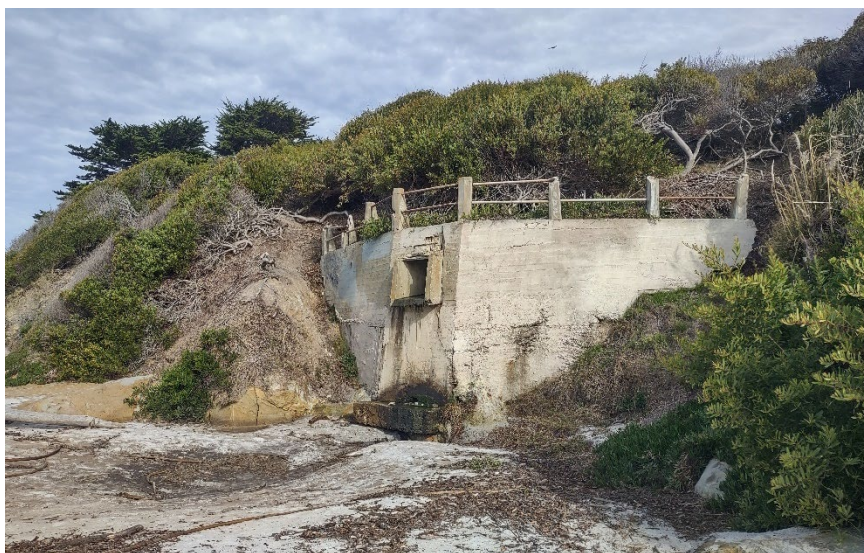
Figure 25. Seawall and outfall just south of the 4th Avenue Stairway.

The bluff-top viewing platform at Ocean Avenue is vulnerable to dune erosion, as is the coastal access stairway at 4th Avenue. A stormwater outfall and seawall just south of 4th Ave is likely exposed to erosion. The Task 1 Coastal Protection Assessment identified this seawall as being a high priority for repair.

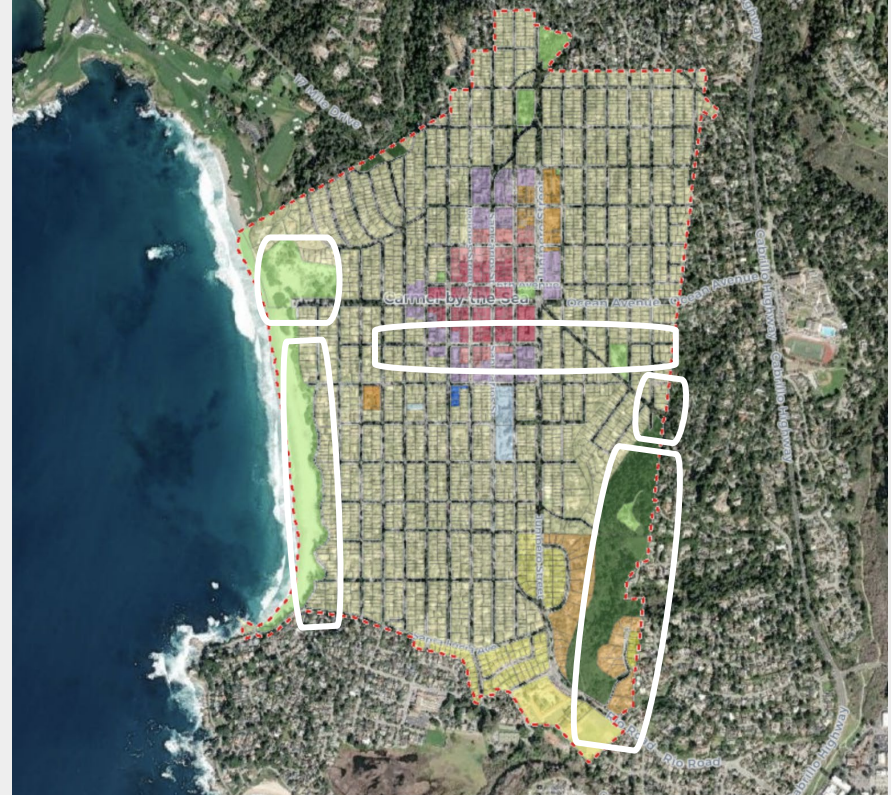
# Wildlife Corridor

- Provides transition zones from one wildlife habitat to another
- ❖ Wildlife corridors provide traveling avenues for wildlife species between two habitat areas.
- ❖ Ocean Avenue would connect the MTNP and Forest Theater to the North Dunes and Scenic Pathway.
- ❖ In the future, large medians and eastments, Forest Hill Park, and other areas could also be developed with native plants, increasing biodiversity throughout the city for humans and wildlife.

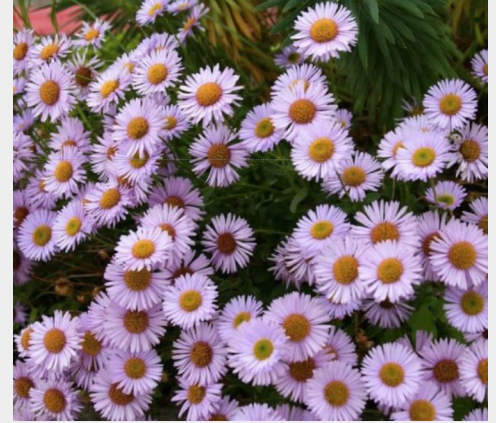
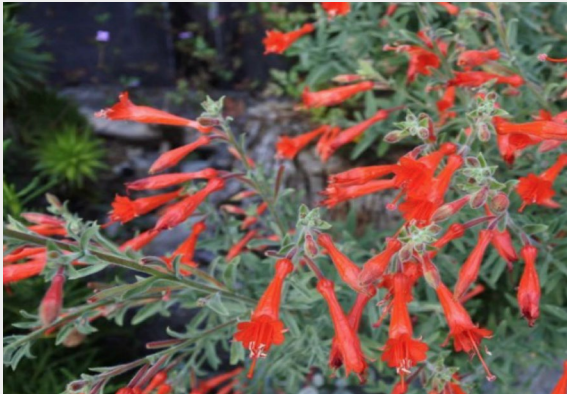
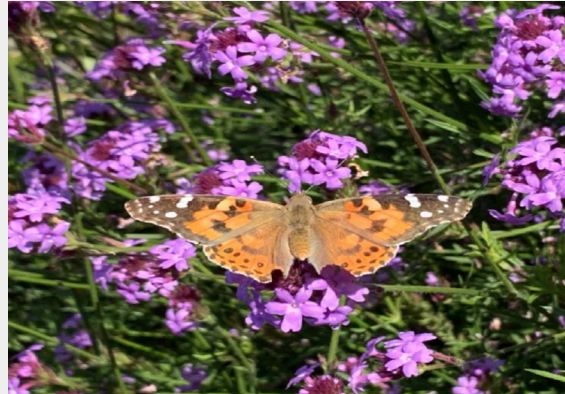
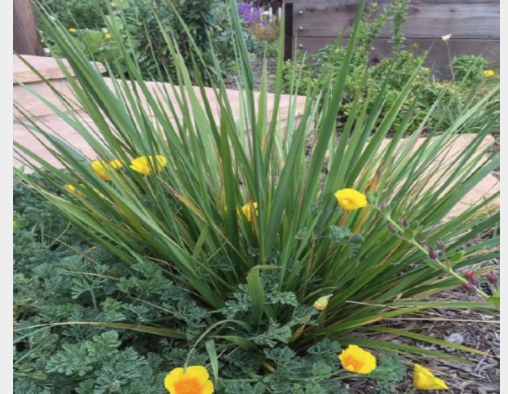
# Median Ends

- *Erigeron glaucus*, Seaside Daisy
- *Epilobium* 'Callistoga', California Fuchsia
- *Verbena* 'de la mina', Santa Cruz Island Verbena
- *Carex tumulicola*, Berkeley Sedge \*

**Median Ends**, low profile for visibility, long bloom period showing off at the ends.

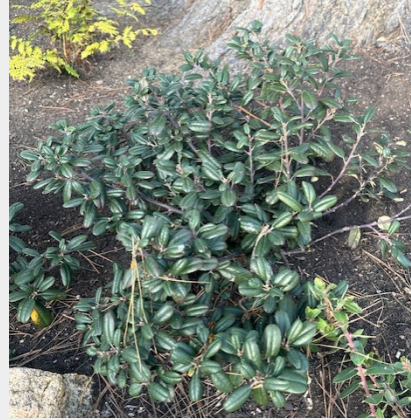
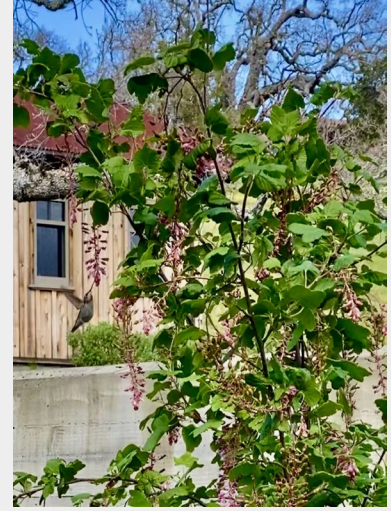
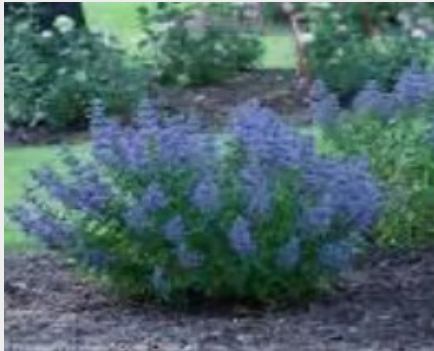
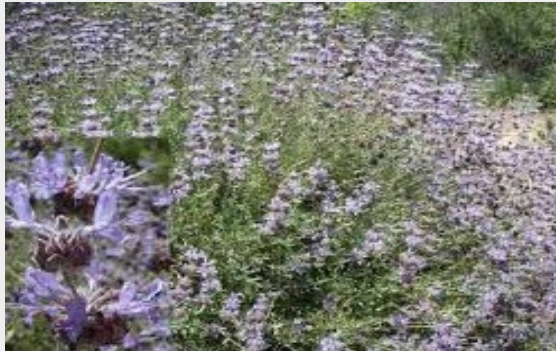
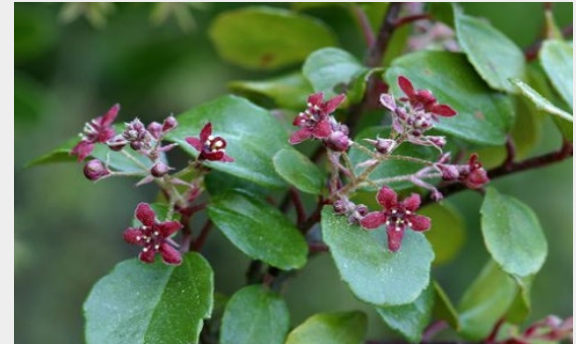
# Living Fence Mix

- *Frangula californica* 'Leather leaf', California coffeeberry
- *Ceanothus* 'Yankee Point'
- *Ribes viburnifolium*, Catalina Perfume
- *Ribes sanguineum*, Woodland currant
- *Salvia leucophylla*, Pt. Sal

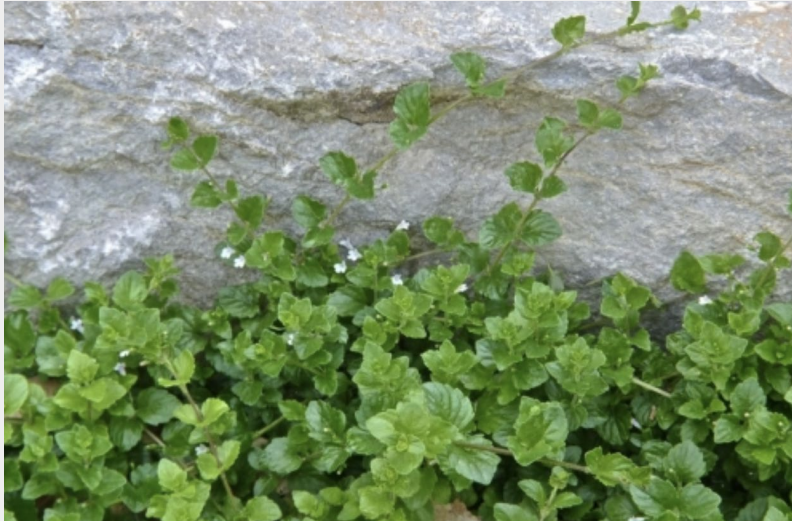
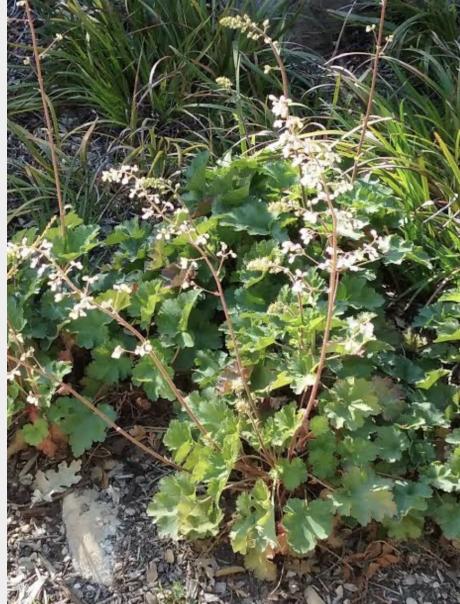
# Highlights - Spread over walls, boulder pockets

- *Clinopodium douglasiana*, Yerba Buena
- *Eschscholzia maritima*, California Beach Poppy
- *Huechera maxima*, Alum Root

**Highlights, spread in cool locations, boulder pockets, cascade over walls**

13. *Clinopodium douglasiana*, Yerba Buena
14. *Eschscholzia maritima*, California Beach Poppy
15. *Huechera* maxima, Alum Root

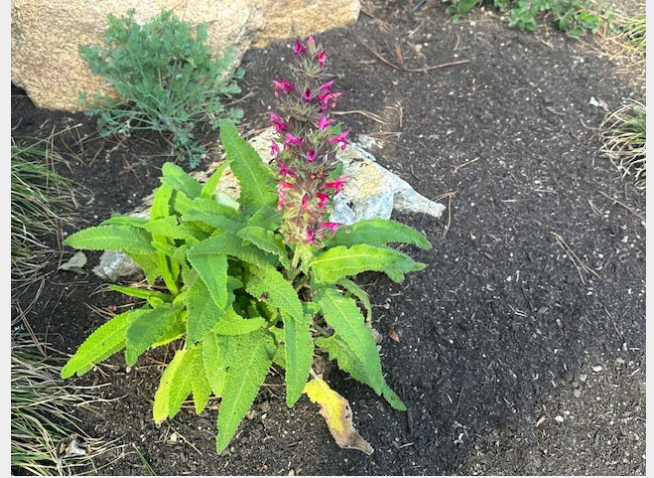
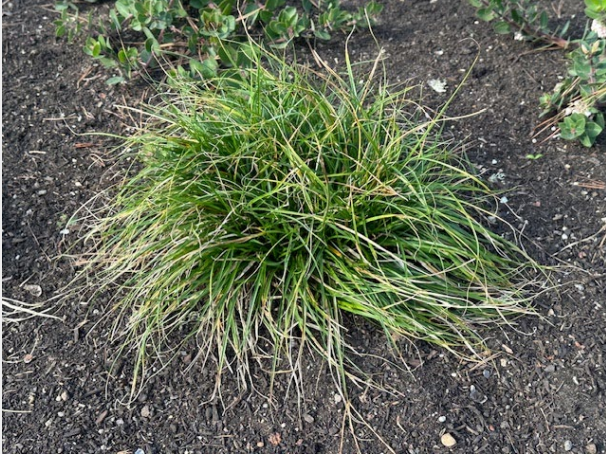
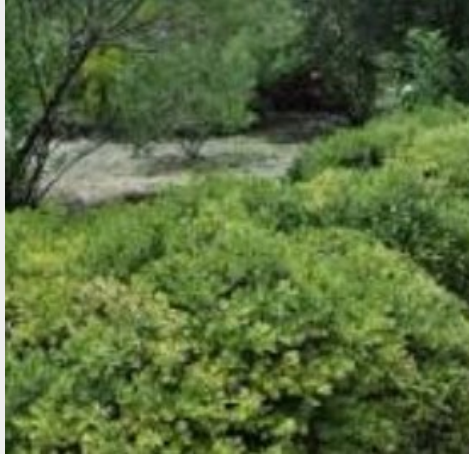
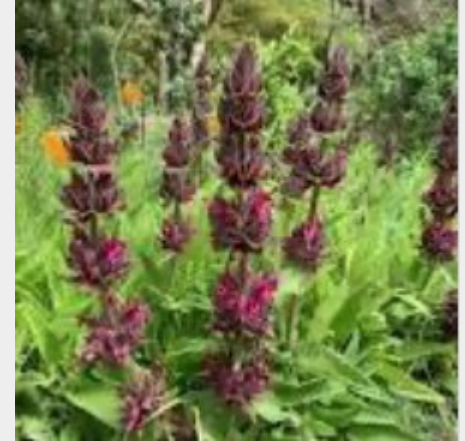
## Low Mix

- *Salvia spathacea*, Hummingbird sage
- *Carex tumicola*, Berkley sedge
- *Arctostaphylos* 'Emerald Carpet'
