# CITY OF CARMEL-BY-THE-SEA HISTORIC RESOURCES BOARD AGENDA

**Regular Meeting**  
**Monday, August 18, 2025**  
**4:00 PM**

- 2) DR 25181 (Carmel Mission Basilica):** Consideration of a Determination of Consistency with the Secretary of the Interior's Standards for accessibility upgrades at the historic "Mission San Carlos de Borromeo" located at 3080 Rio Road in the Single-Family Residential (R-1) District, Archaeological Significance Overlay, Park Overlay and Beach & Riparian Overlay districts. APN: 009-531-003-000.
- 3) DS 25197 (Graney):** Consideration of a Determination of Consistency with the Secretary of the Interior's Standards for the in-kind replacement of wood windows and wood shingle siding throughout, and in-kind

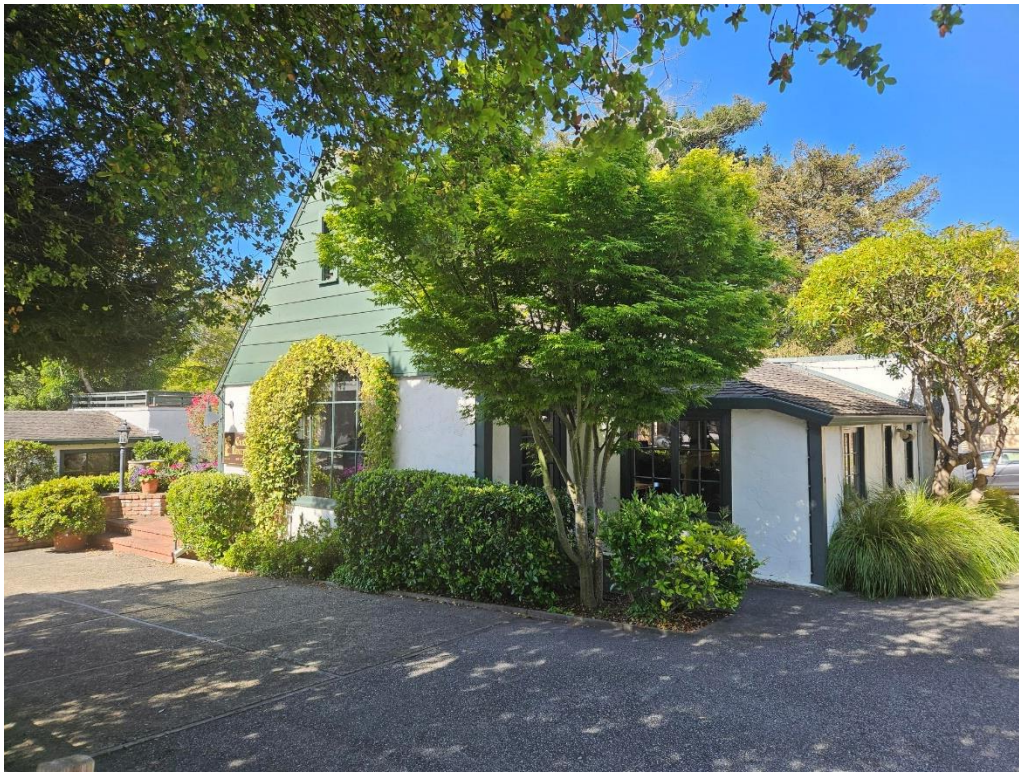
Figure 1: View of front elevation, 1926 building (former James & Irene Kitchen house).

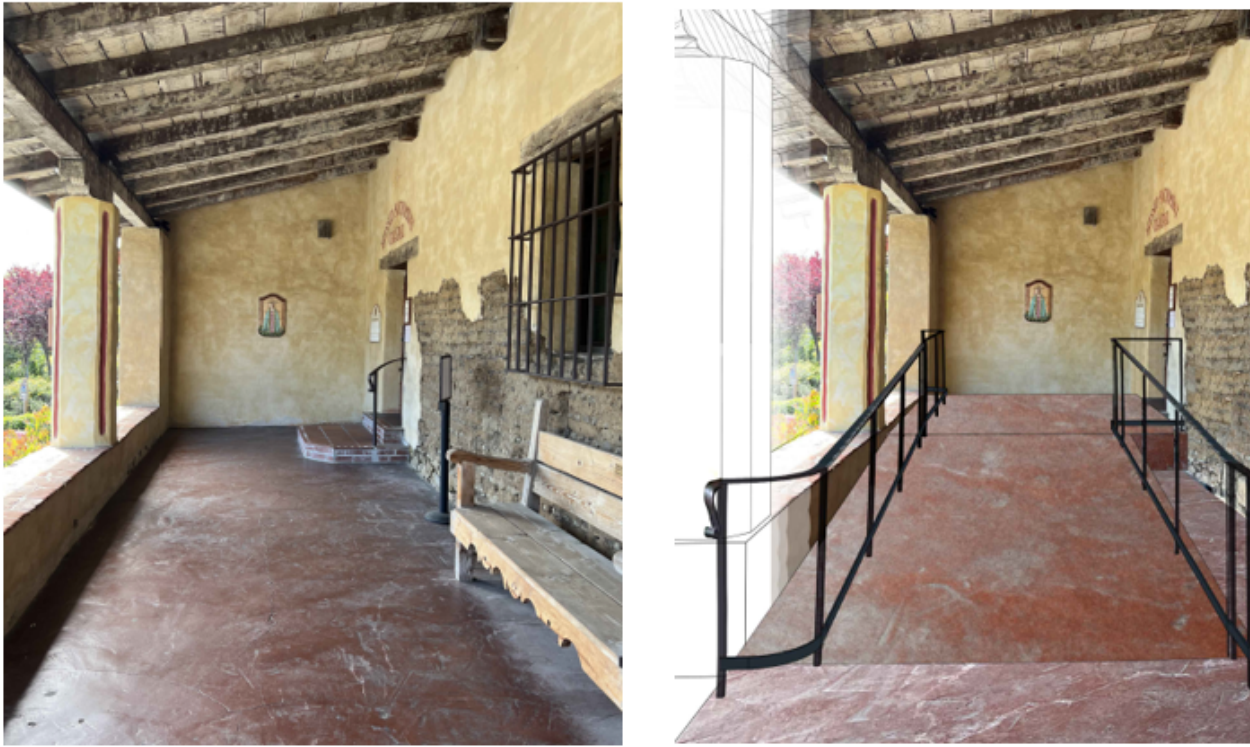
Figures 4 and 5: Existing Conditions (left) and proposed access ramp (right).

The proposed ADA access path removes the northwest section of the loggia crib wall to enable a direct ADA access path to/from the parking lot. The removal of this material is minimal and allows the remaining crib wall supporting the loggia columns to remain in place, which maintains sufficient historic material and detailing of the loggia crib wall. Material being removed at the Chapel entrance includes the upper masonry stair leading to the door threshold and the existing metal rail at the entrance. The lower masonry stair will remain in place, as recommended by TPSB 32. These impacts are to non-historic material, as the masonry stairs and rail were installed circa-2000 (per email correspondence from Justin J. Burke, Carmel Mission Basilica General Manager, to PAST, 7/28/2025. While drawings for the installation of the masonry stairs have not been located, Mr. Burke estimates the installation date as circa-2000). The location of the proposed ADA access ramp is within the north loggia, which is ideal for providing minimal visual impact to the north elevation of the Chapel. For the above reasons, the proposed design is supported by this *Standard*.

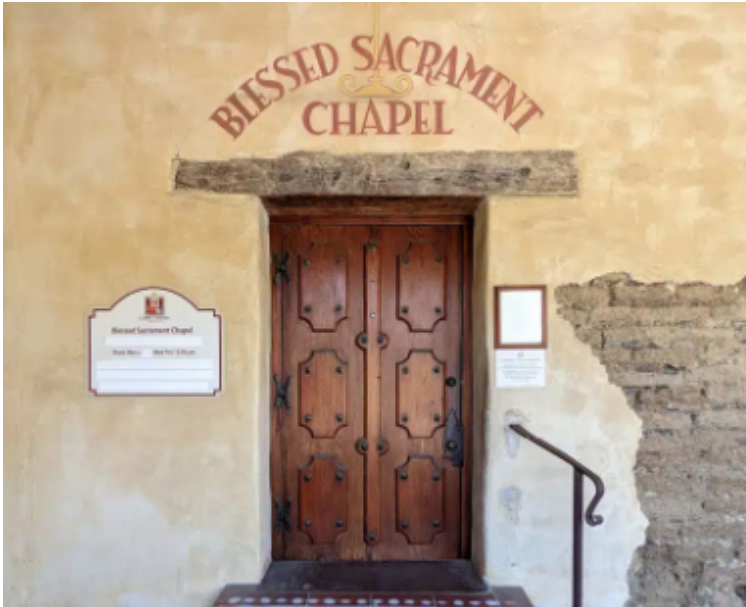
Figure 6: Blessed Sacrament Chapel door, to be moved forward towards the exterior loggia wall (no change to opening size).

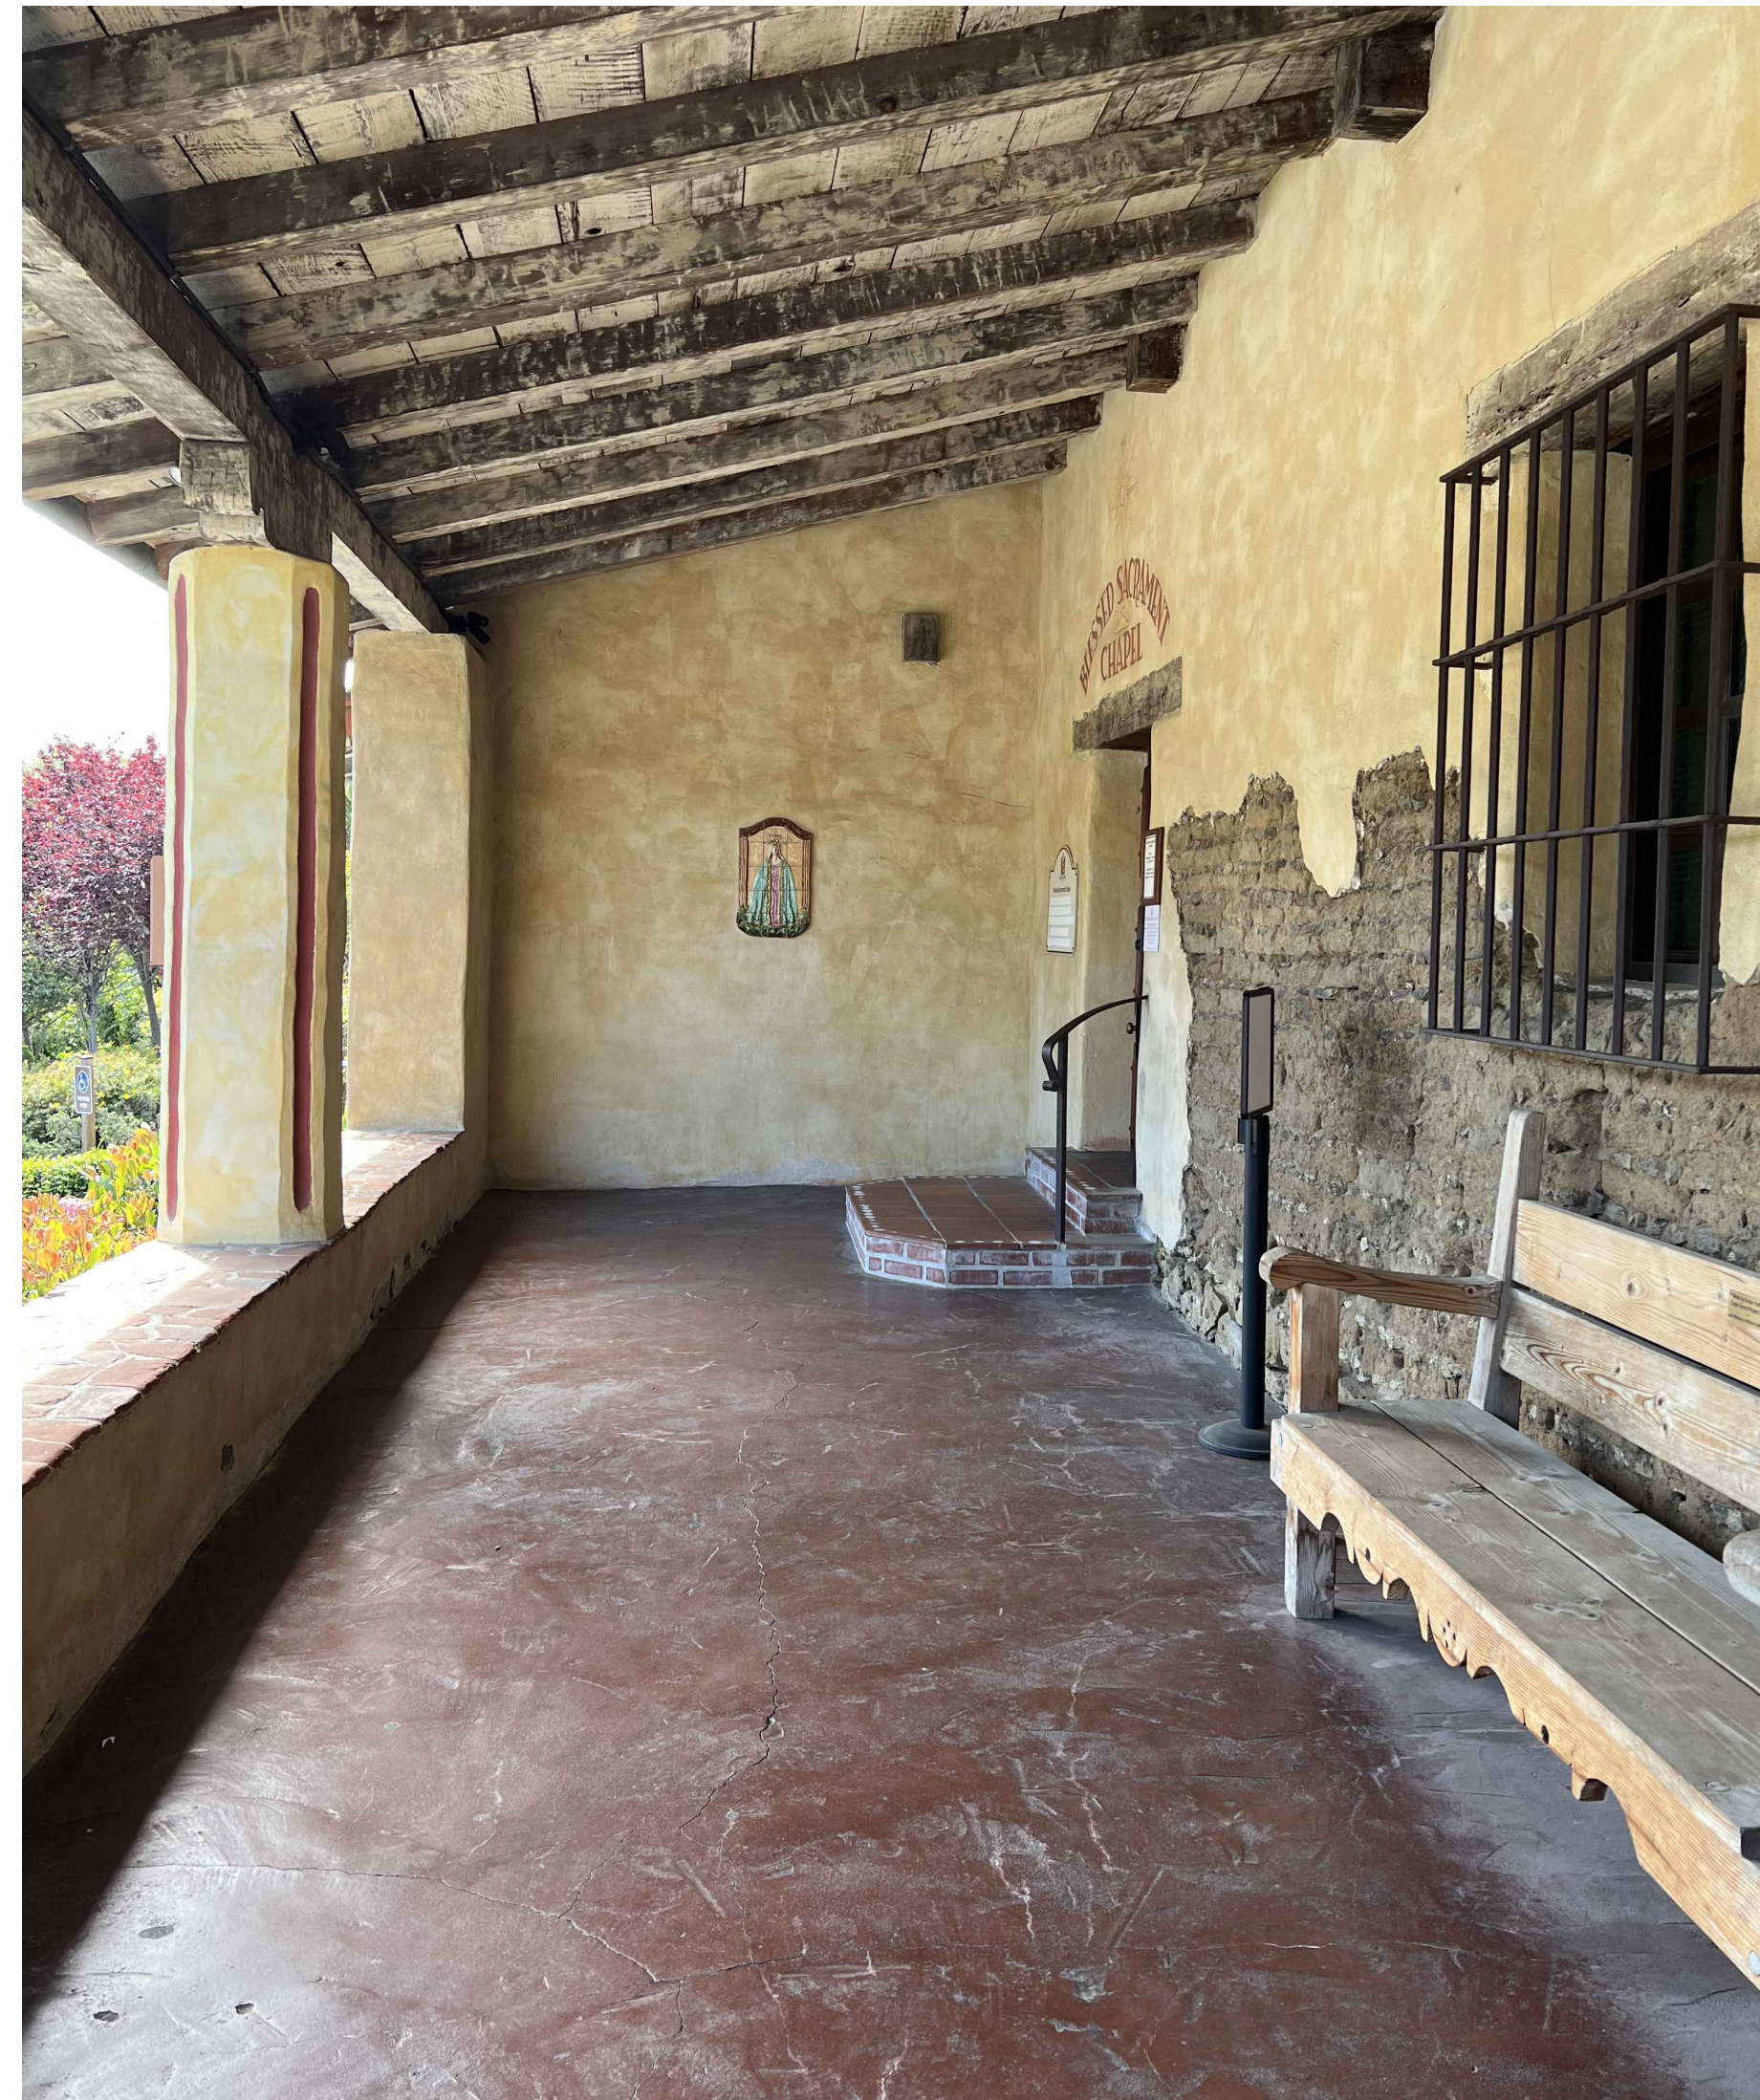
VIEW OF EXISTING CONDITIONS

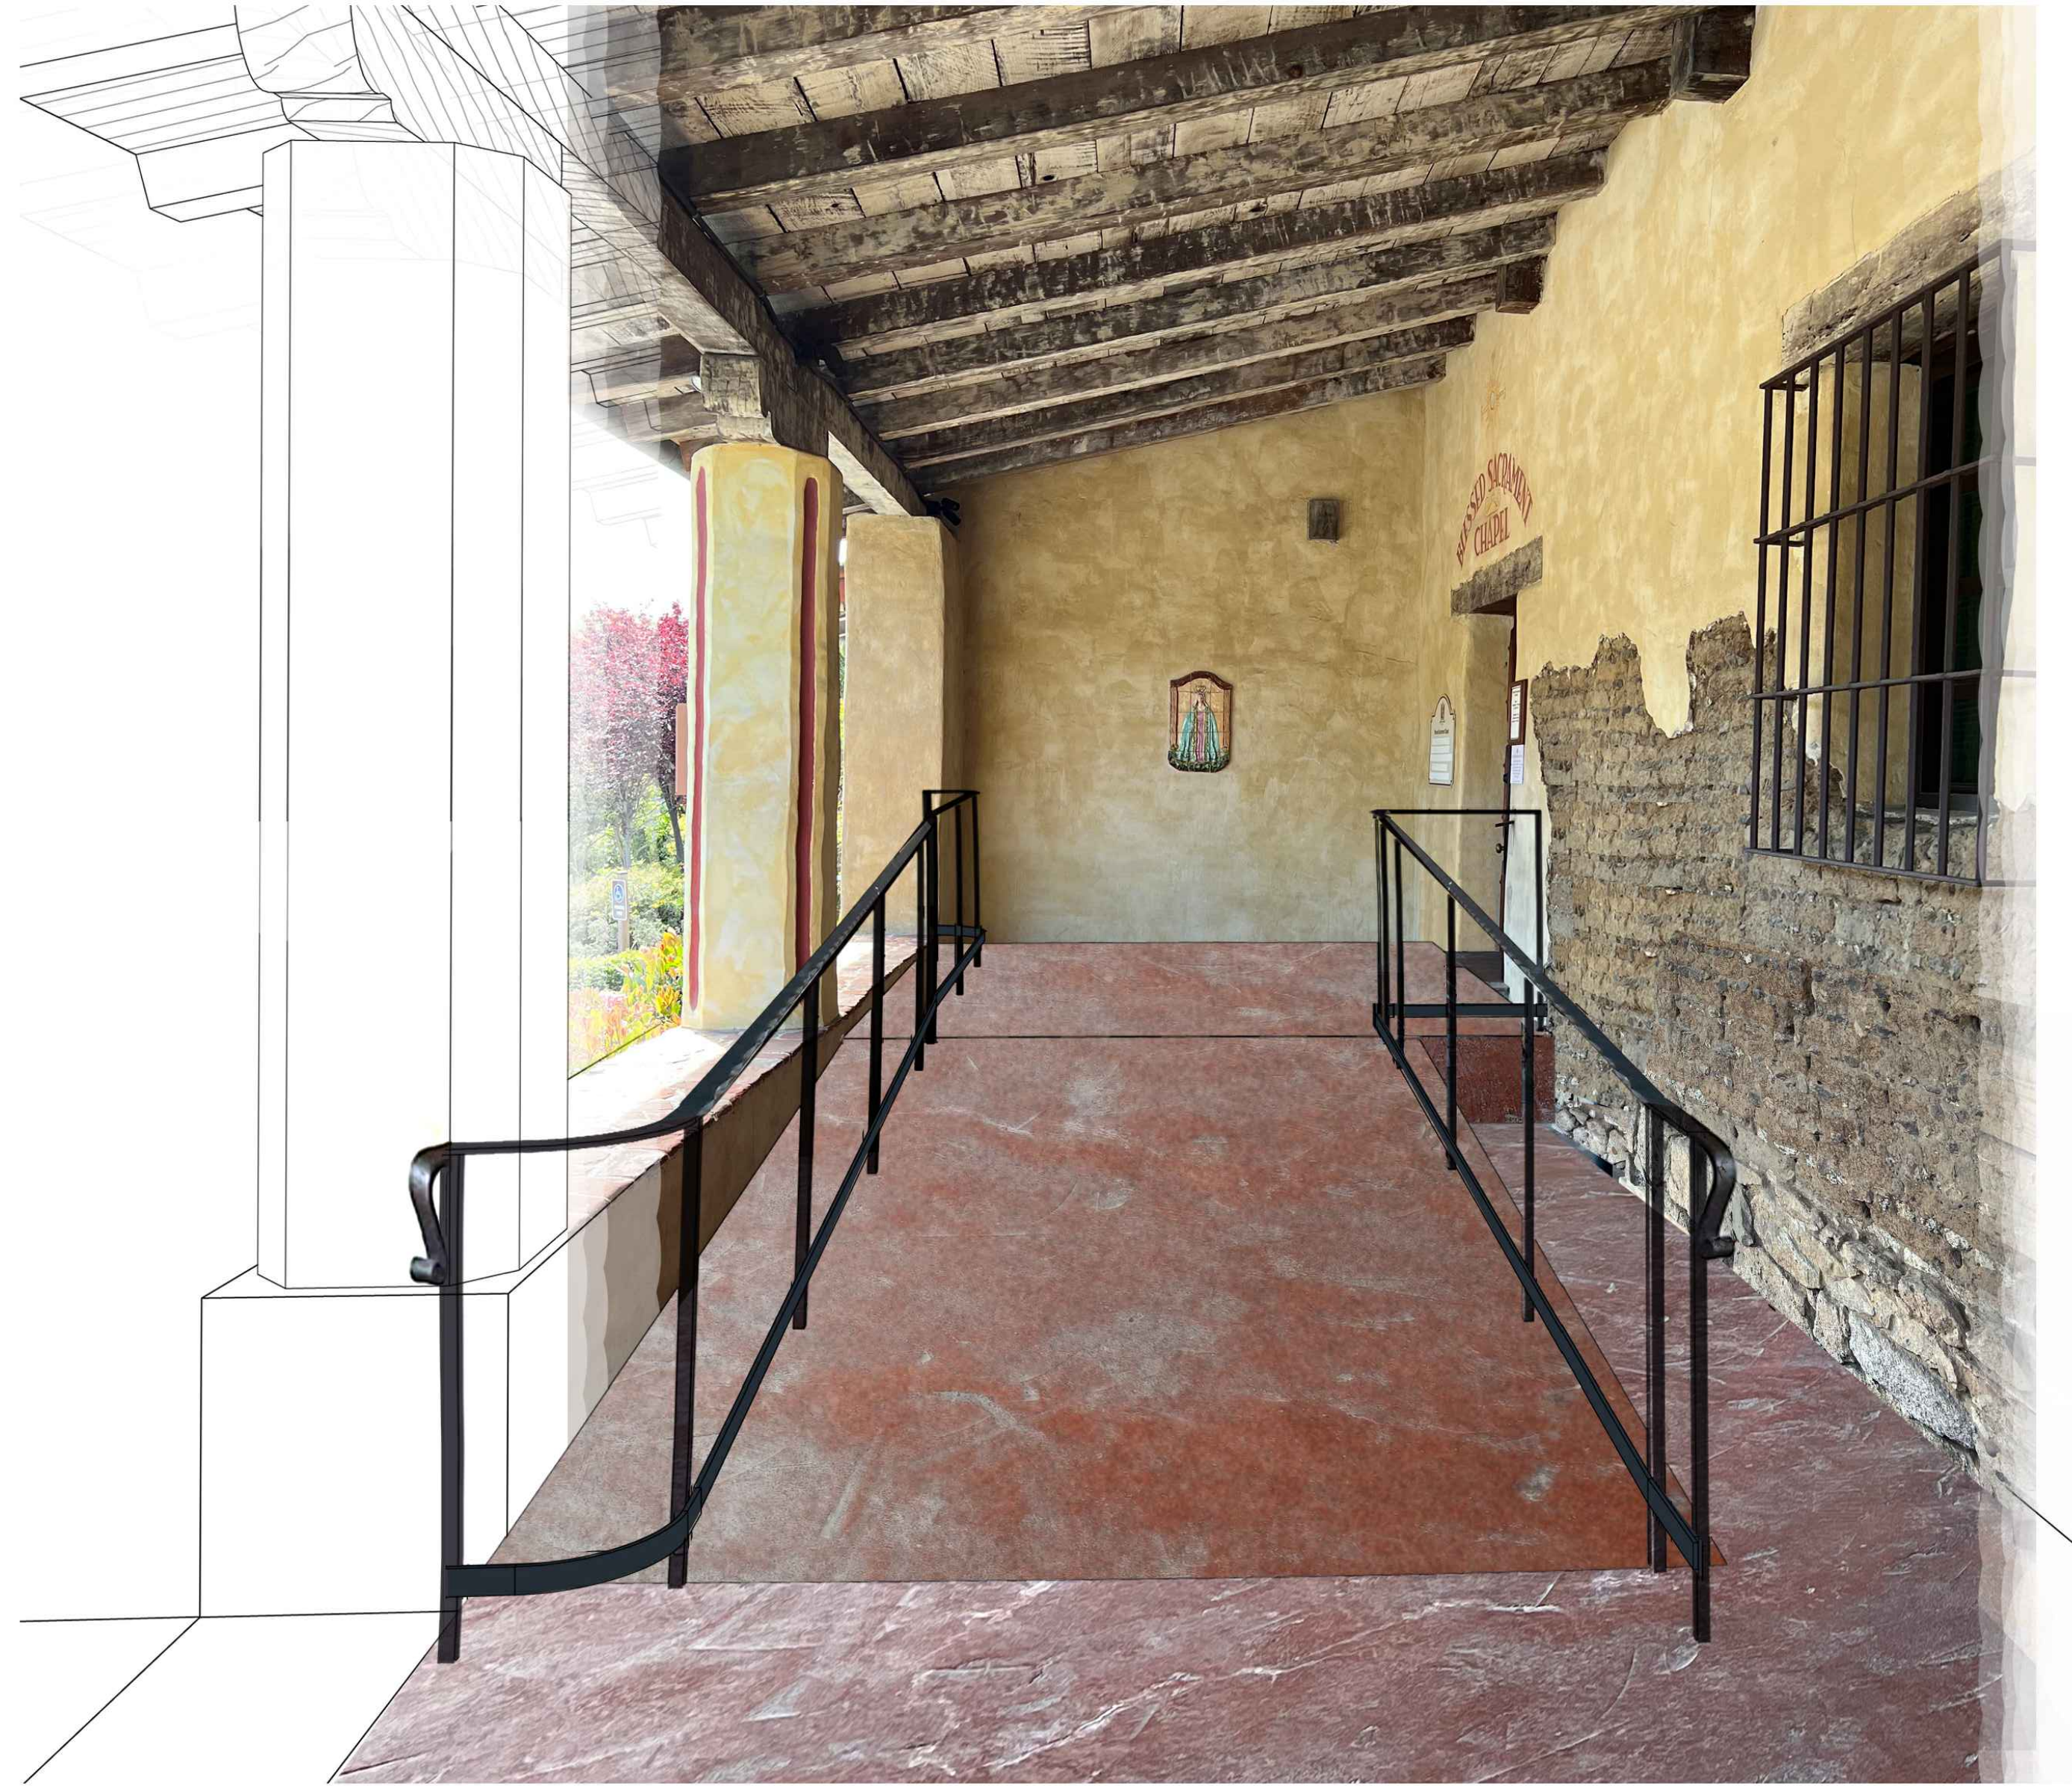
RENDERING VIEW OF PROPOSED RAMP

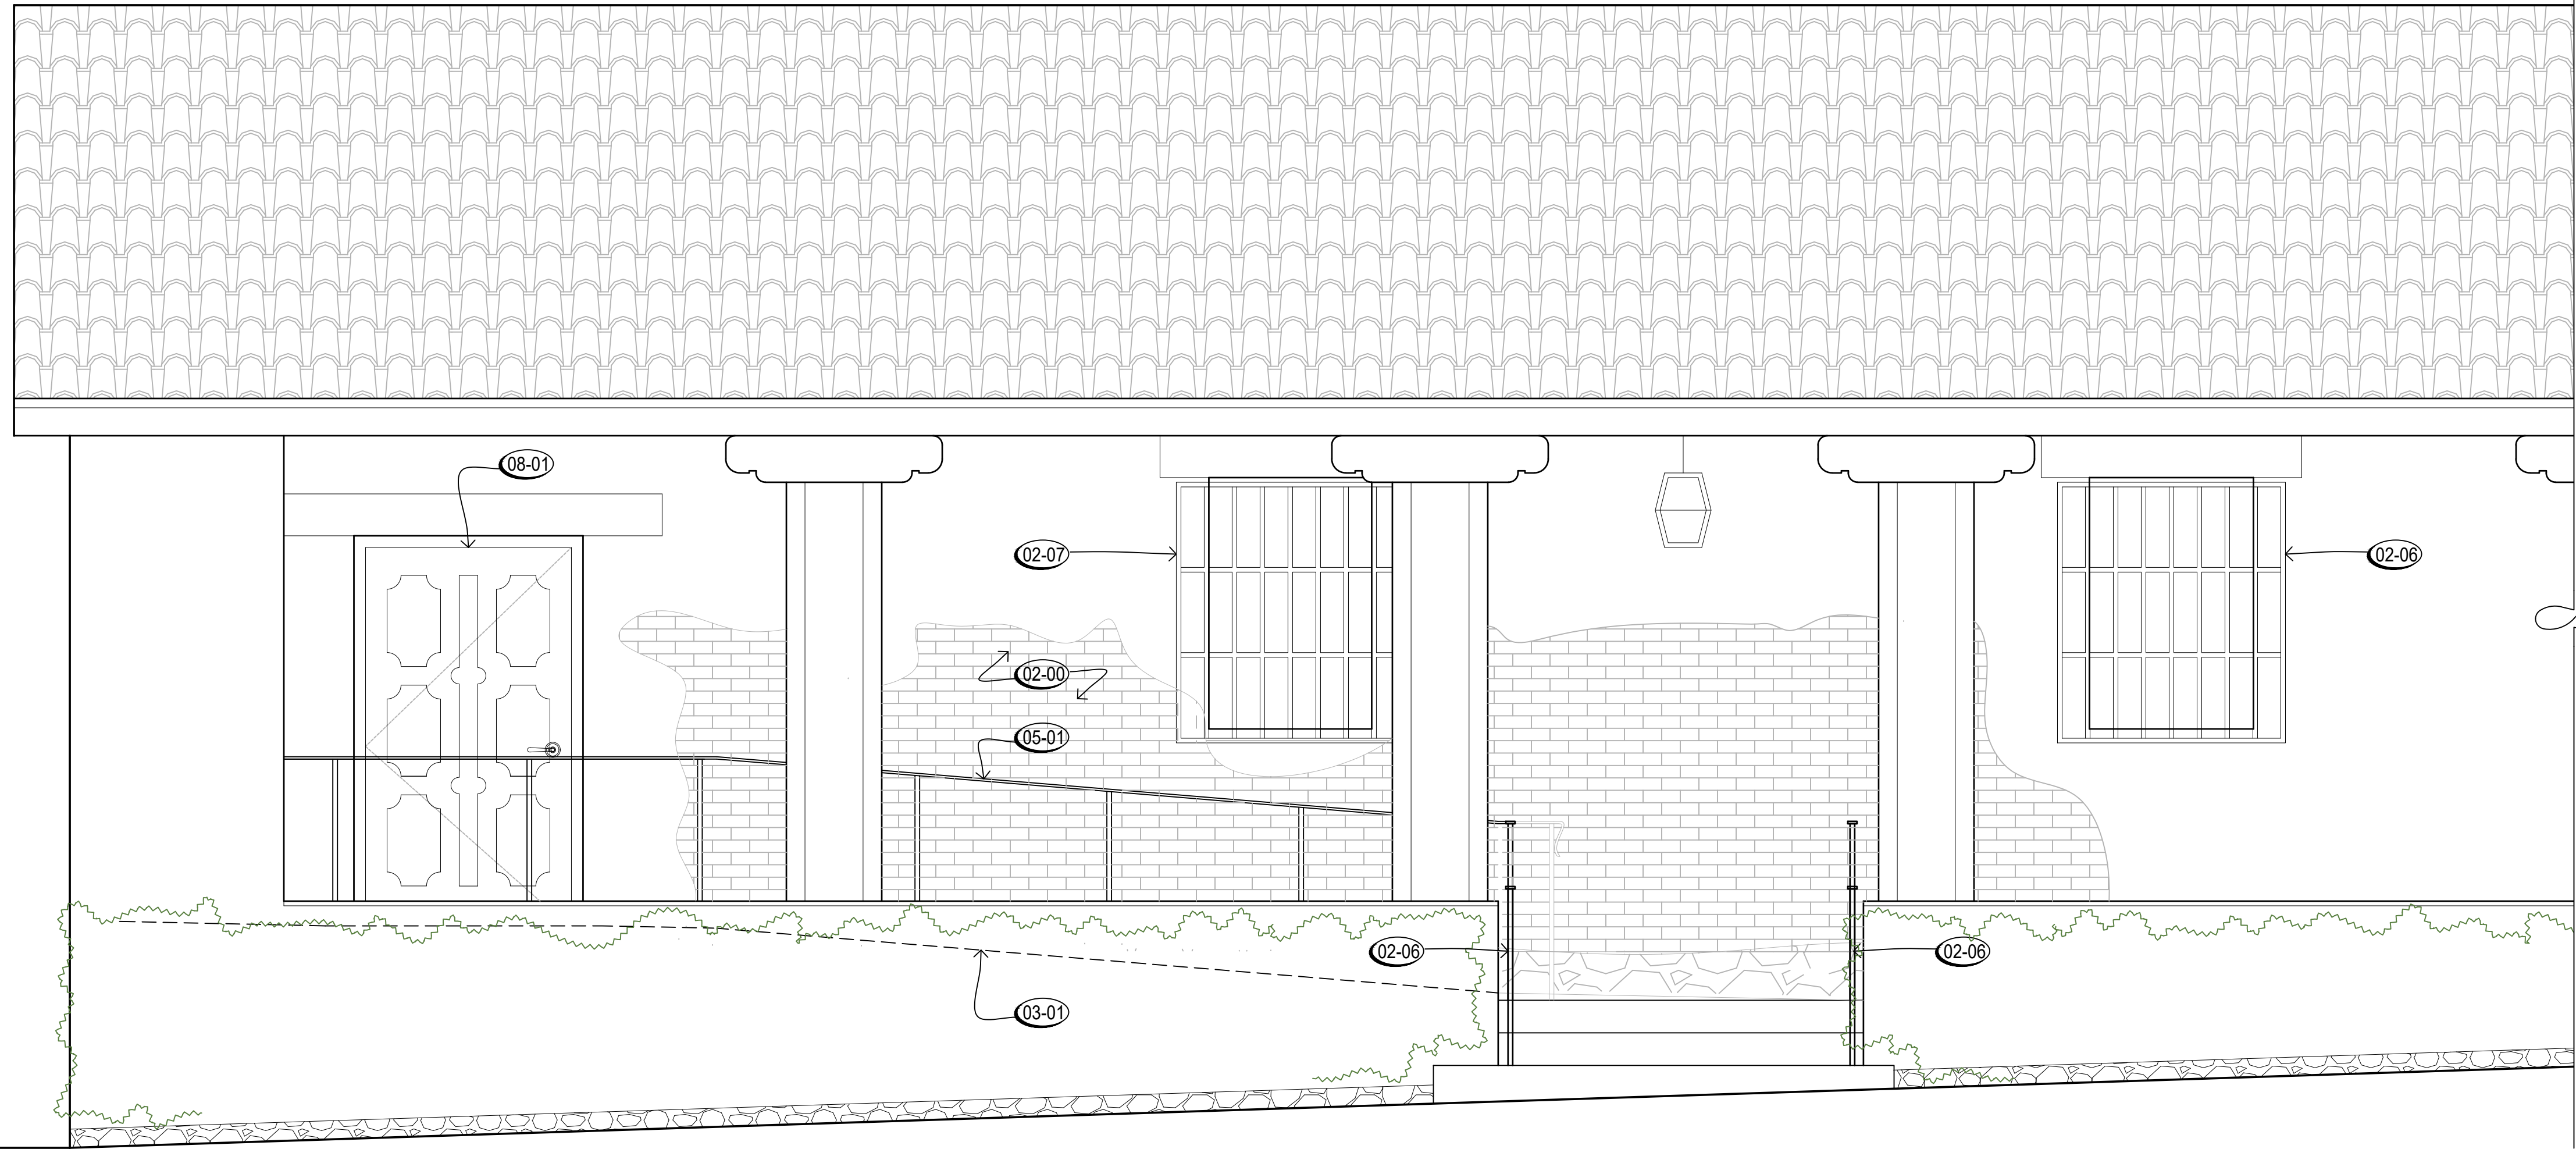
**1 EXTERIOR ELEVATION NORTH**  
 SCALE: 1/4" = 1'-0"

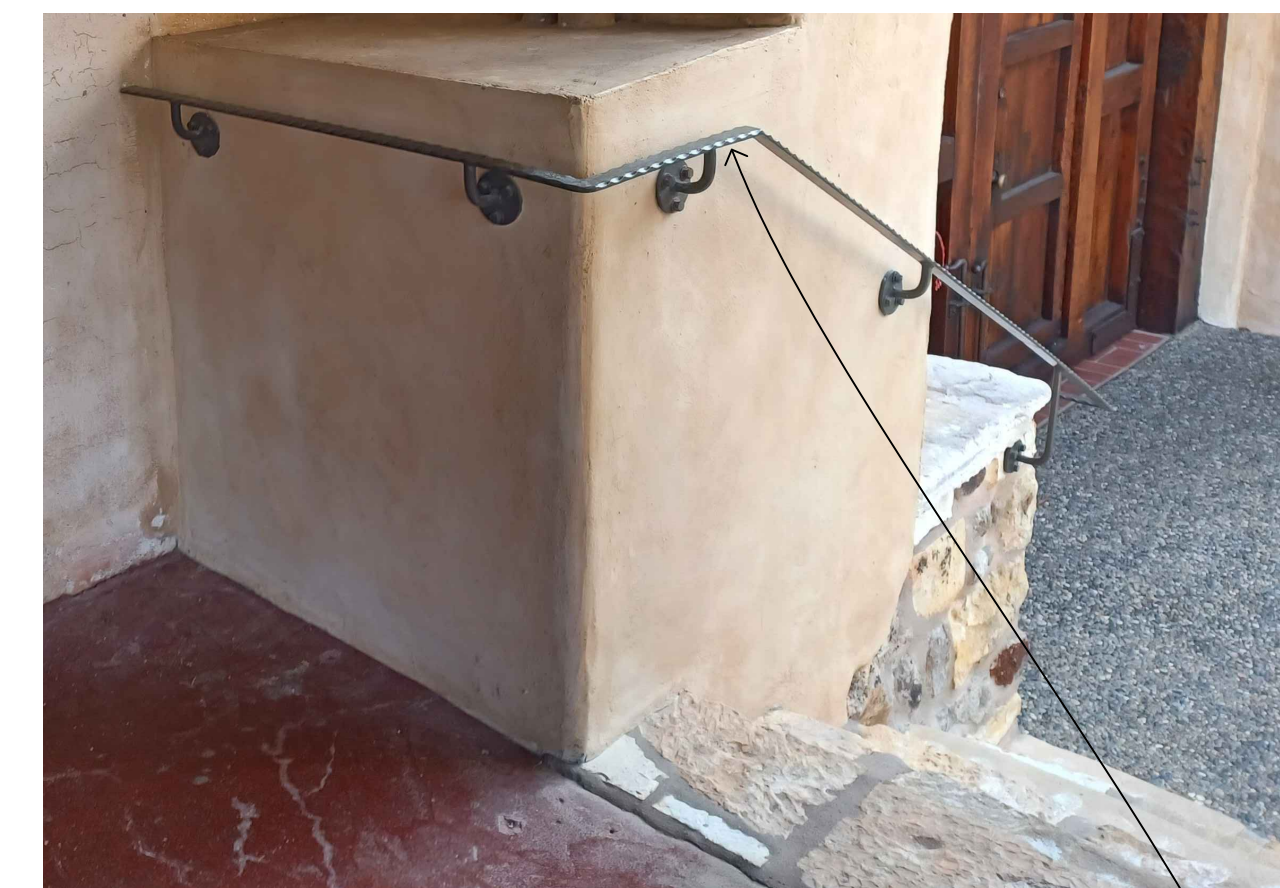
PHOTO OF EXISTING HANDRAIL WITH 'HAMMER FORGED' EDGE DETAIL, TO MATCH

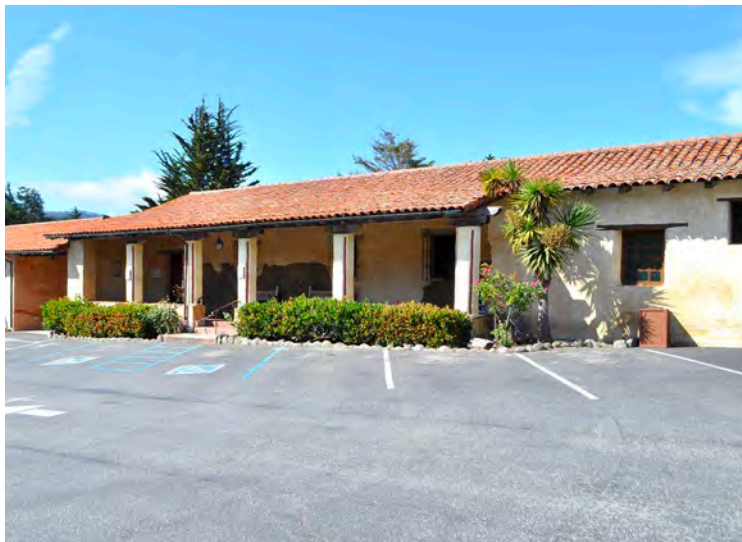
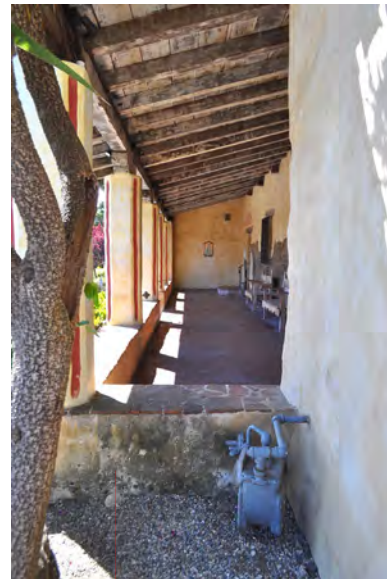
The location of the proposed work is at the north loggia of the Blessed Sacrament Chapel. The concrete ADA access ramp with steel rails will be placed along the north elevation and will remove the west end of the loggia crib wall (**Figures 1 and 2**).

**Figures 1 and 2.** Left image shows a view of the north elevation. Right image shows the location where the crib wall will be removed for the ADA access path.

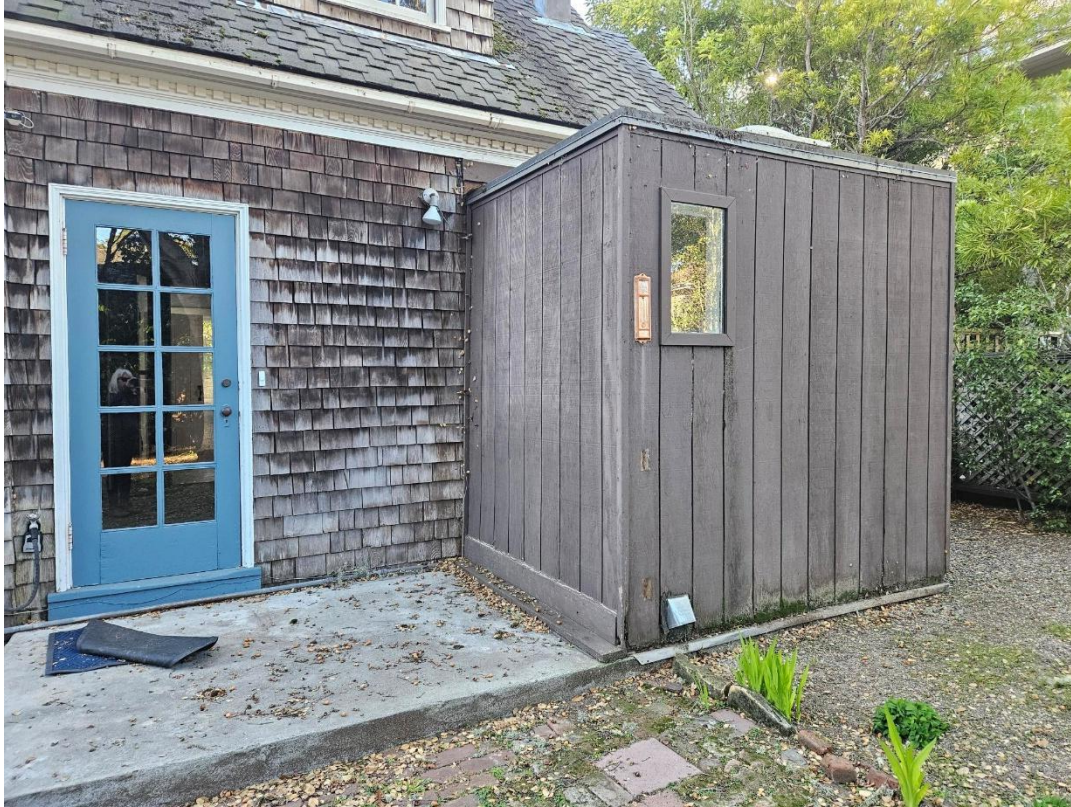
Figure 2: View of rear door to be replaced.

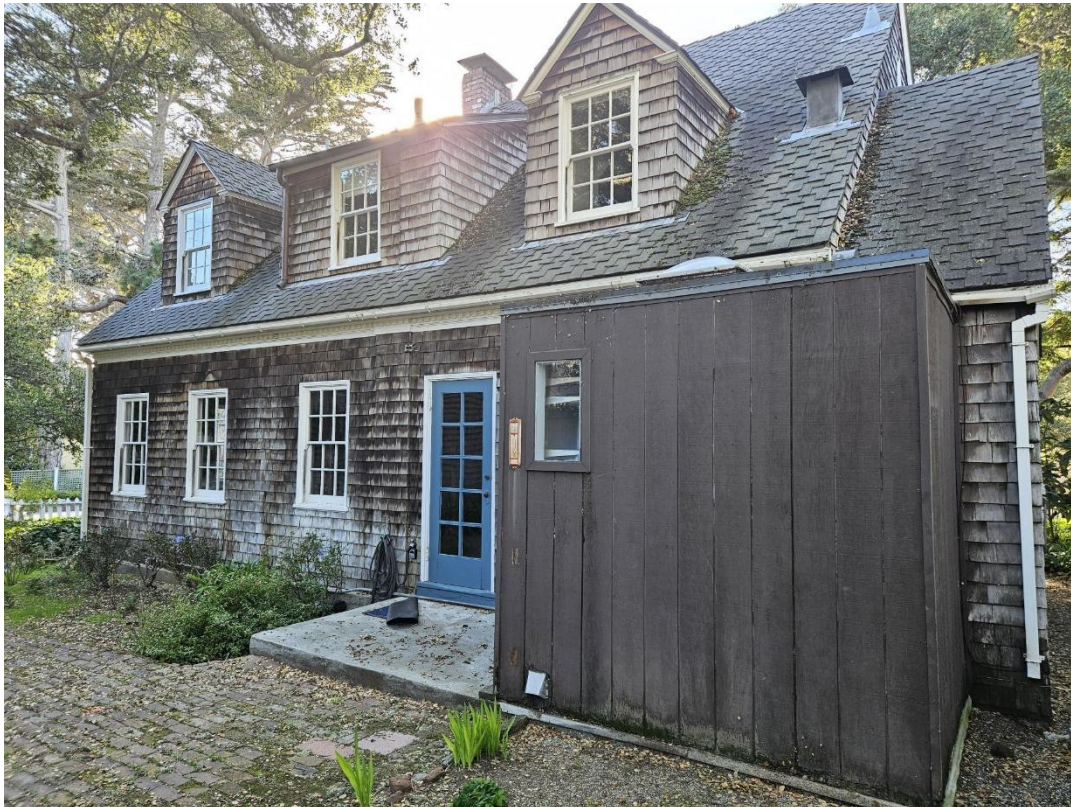
Figure 2: View of the rear elevation looking southwest.

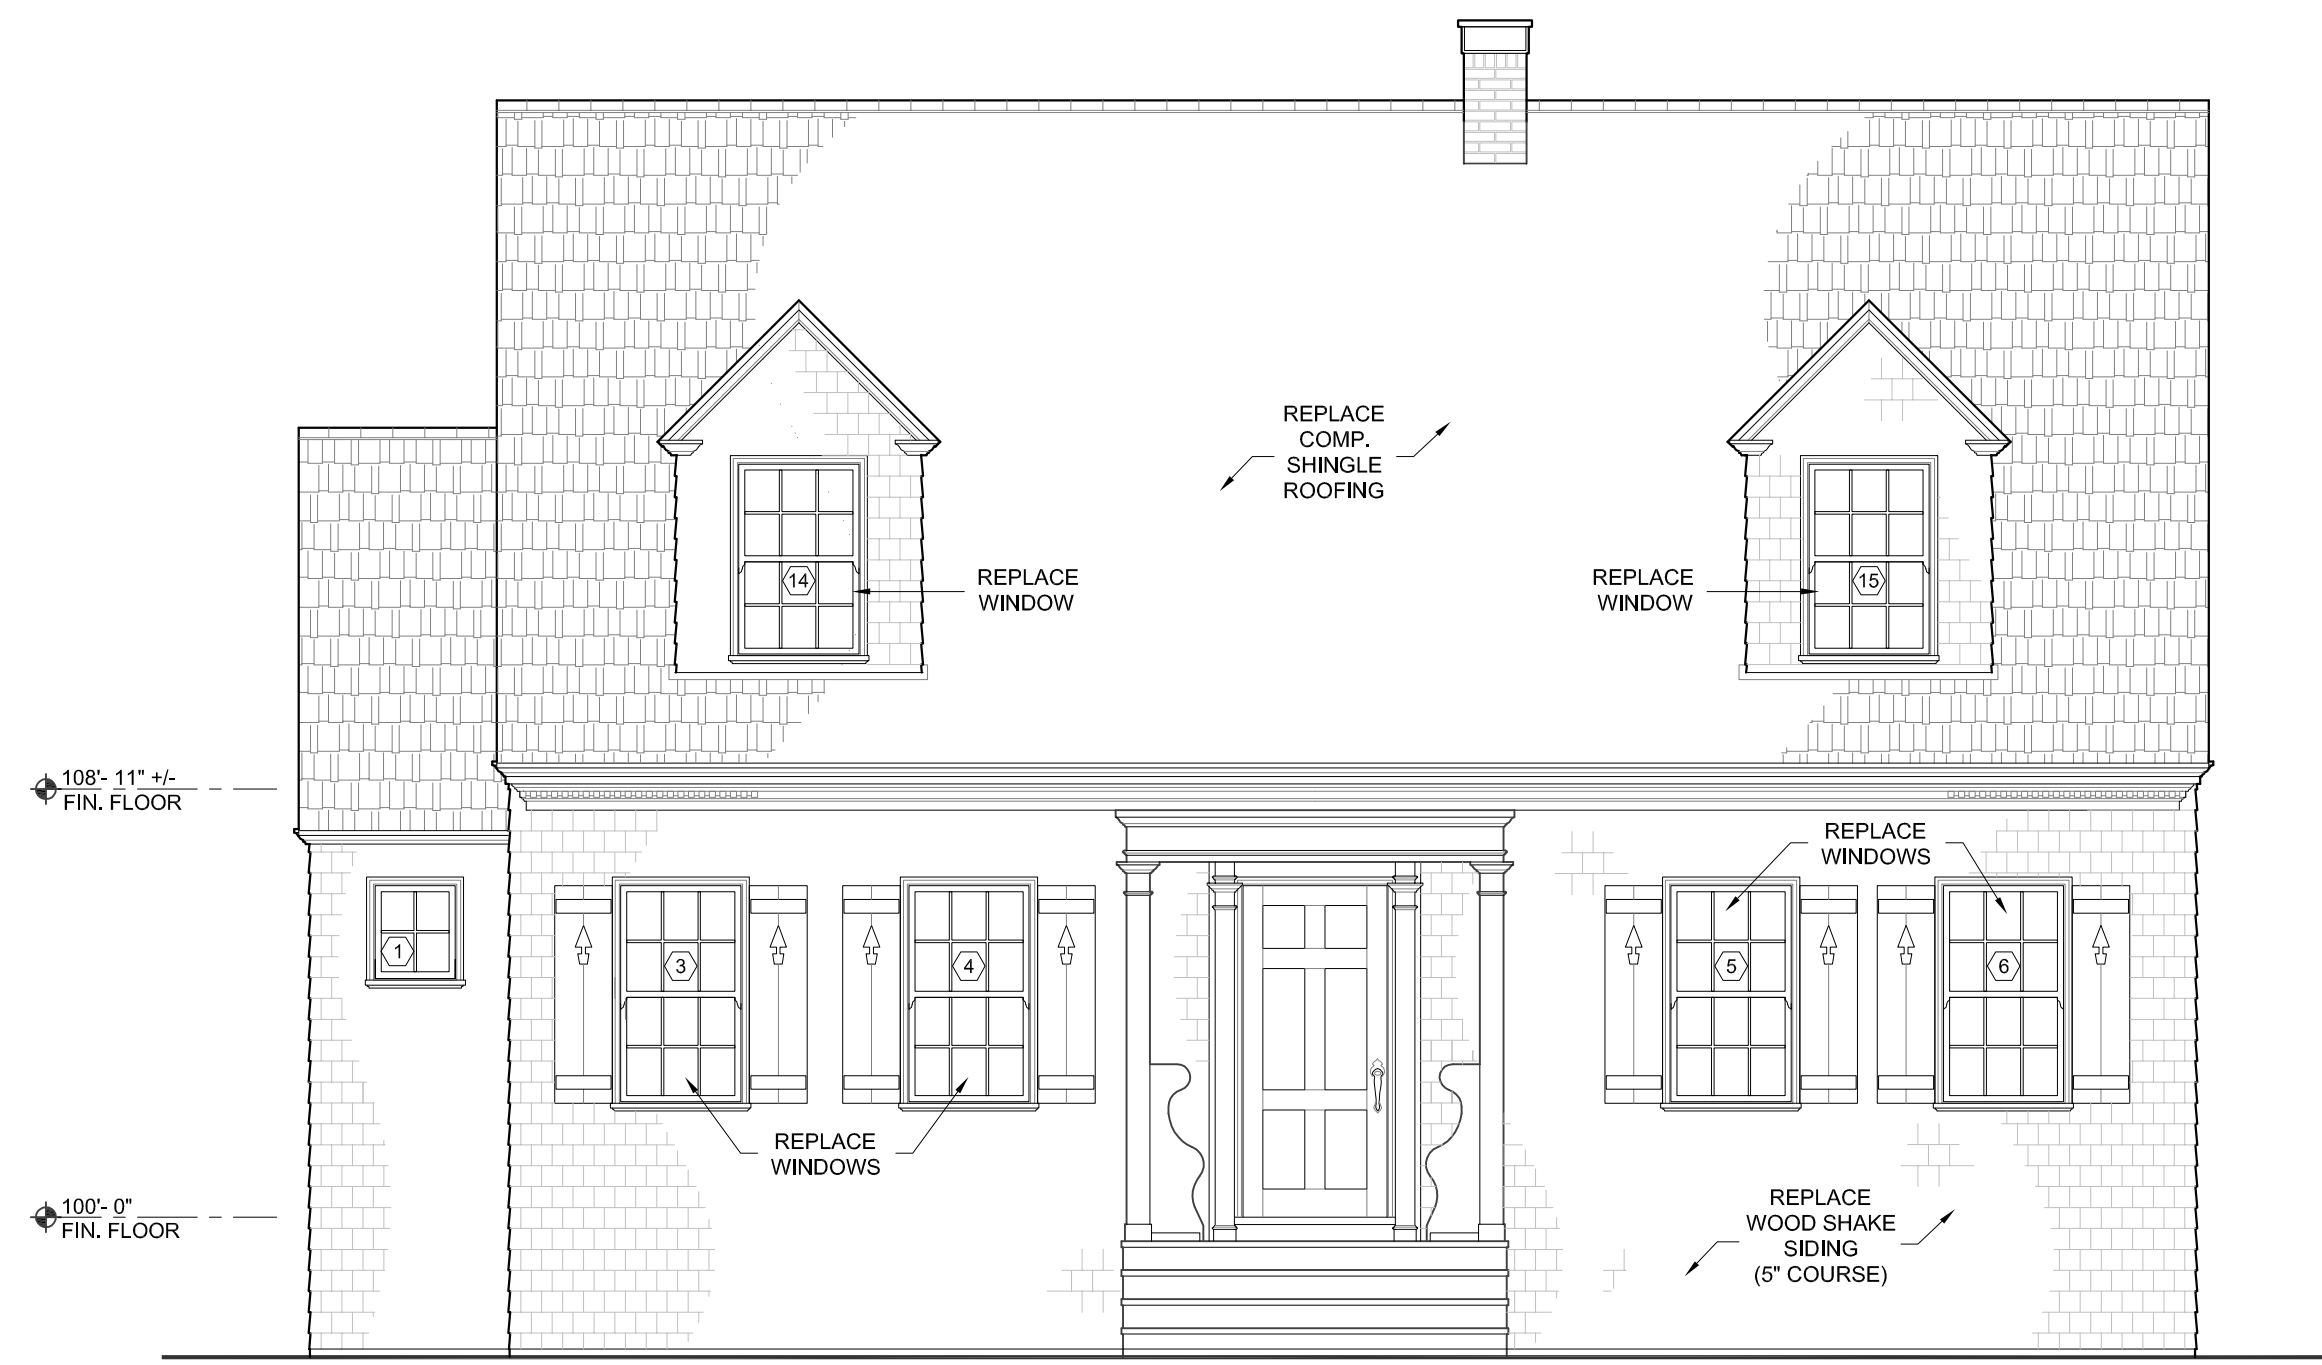
W WEST ELEVATION
