# CITY OF CARMEL-BY-THE-SEA HISTORIC RESOURCES BOARD AGENDA

**Regular Meeting**  
**Monday, August 18, 2025**  
**4:00 PM**

- 2) DR 25181 (Carmel Mission Basilica):** Consideration of a Determination of Consistency with the Secretary of the Interior's Standards for accessibility upgrades at the historic "Mission San Carlos de Borromeo" located at 3080 Rio Road in the Single-Family Residential (R-1) District, Archaeological Significance Overlay, Park Overlay and Beach & Riparian Overlay districts. APN: 009-531-003-000.
- 3) DS 25197 (Graney):** Consideration of a Determination of Consistency with the Secretary of the Interior's Standards for the in-kind replacement of wood windows and wood shingle siding throughout, and in-kind

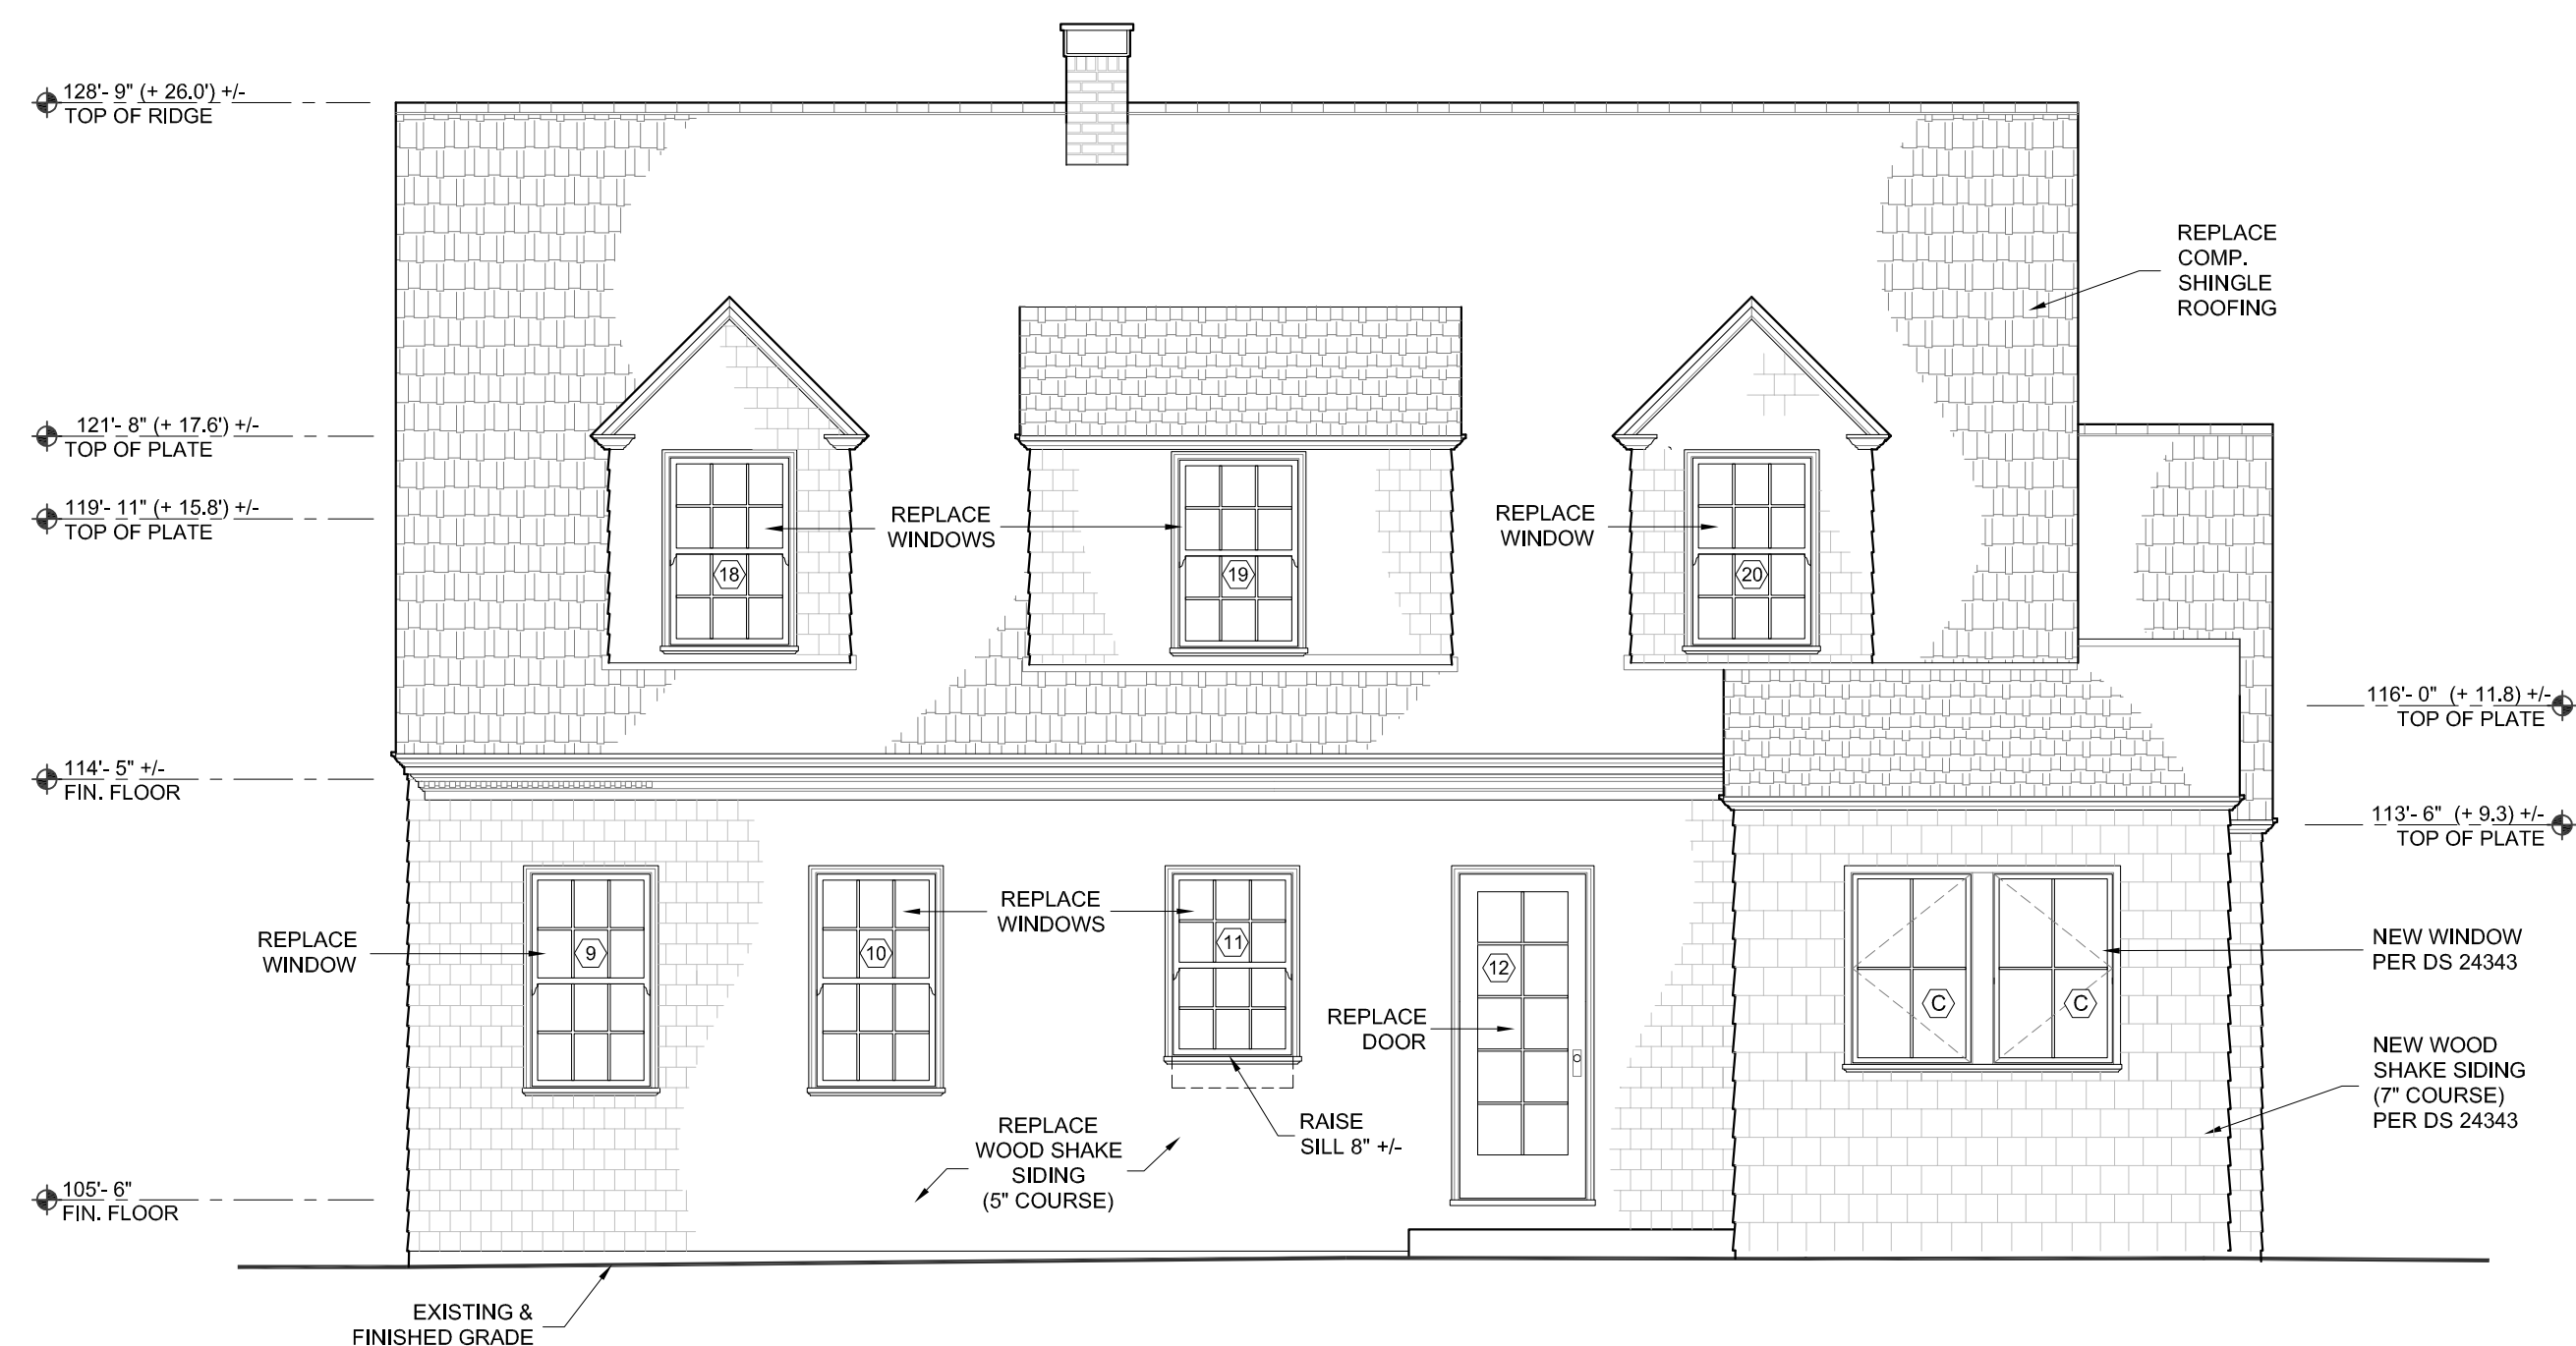
E EAST ELEVATION

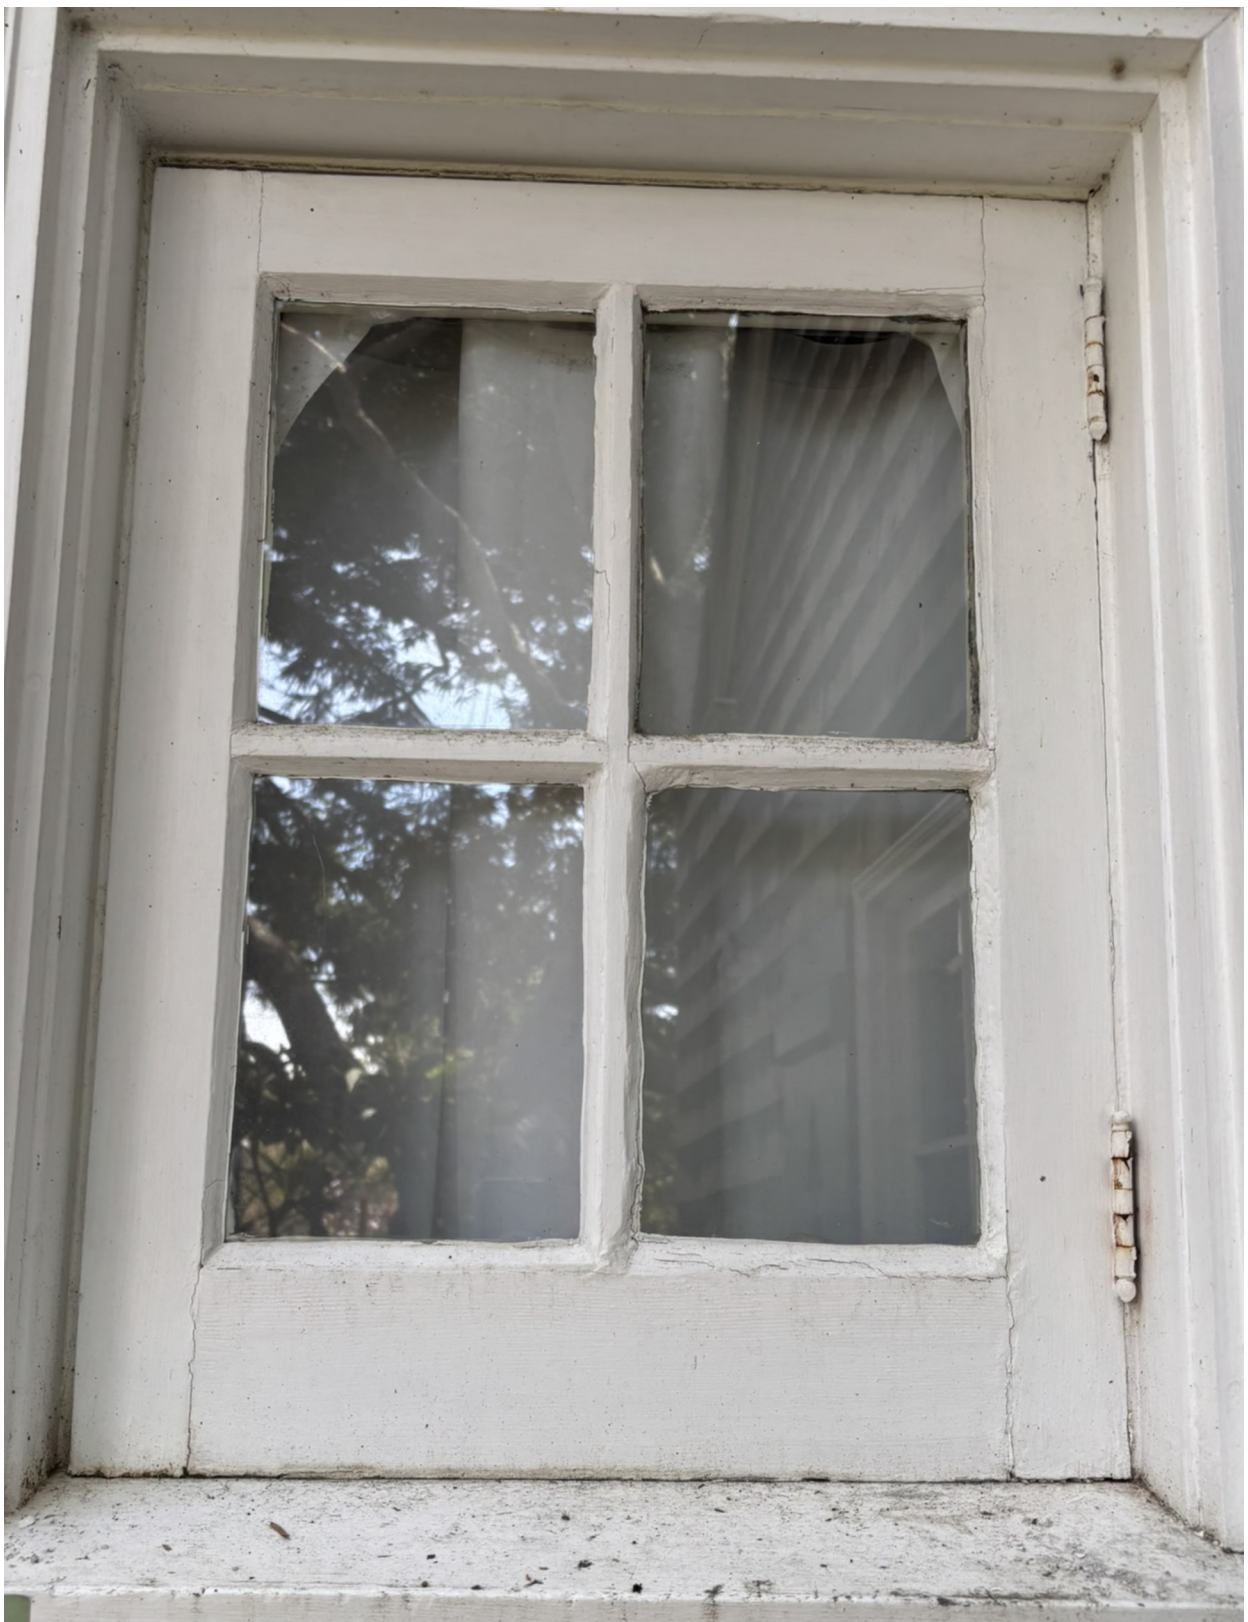
WINDOW # 1

Location : Main Level, West Elev.  
Paint / Finish : Poor  
Glazier's Putty : Poor  
Frame & Sill : Fair  
Sash : Poor (Joints Failing)

Overall Condition : Poor

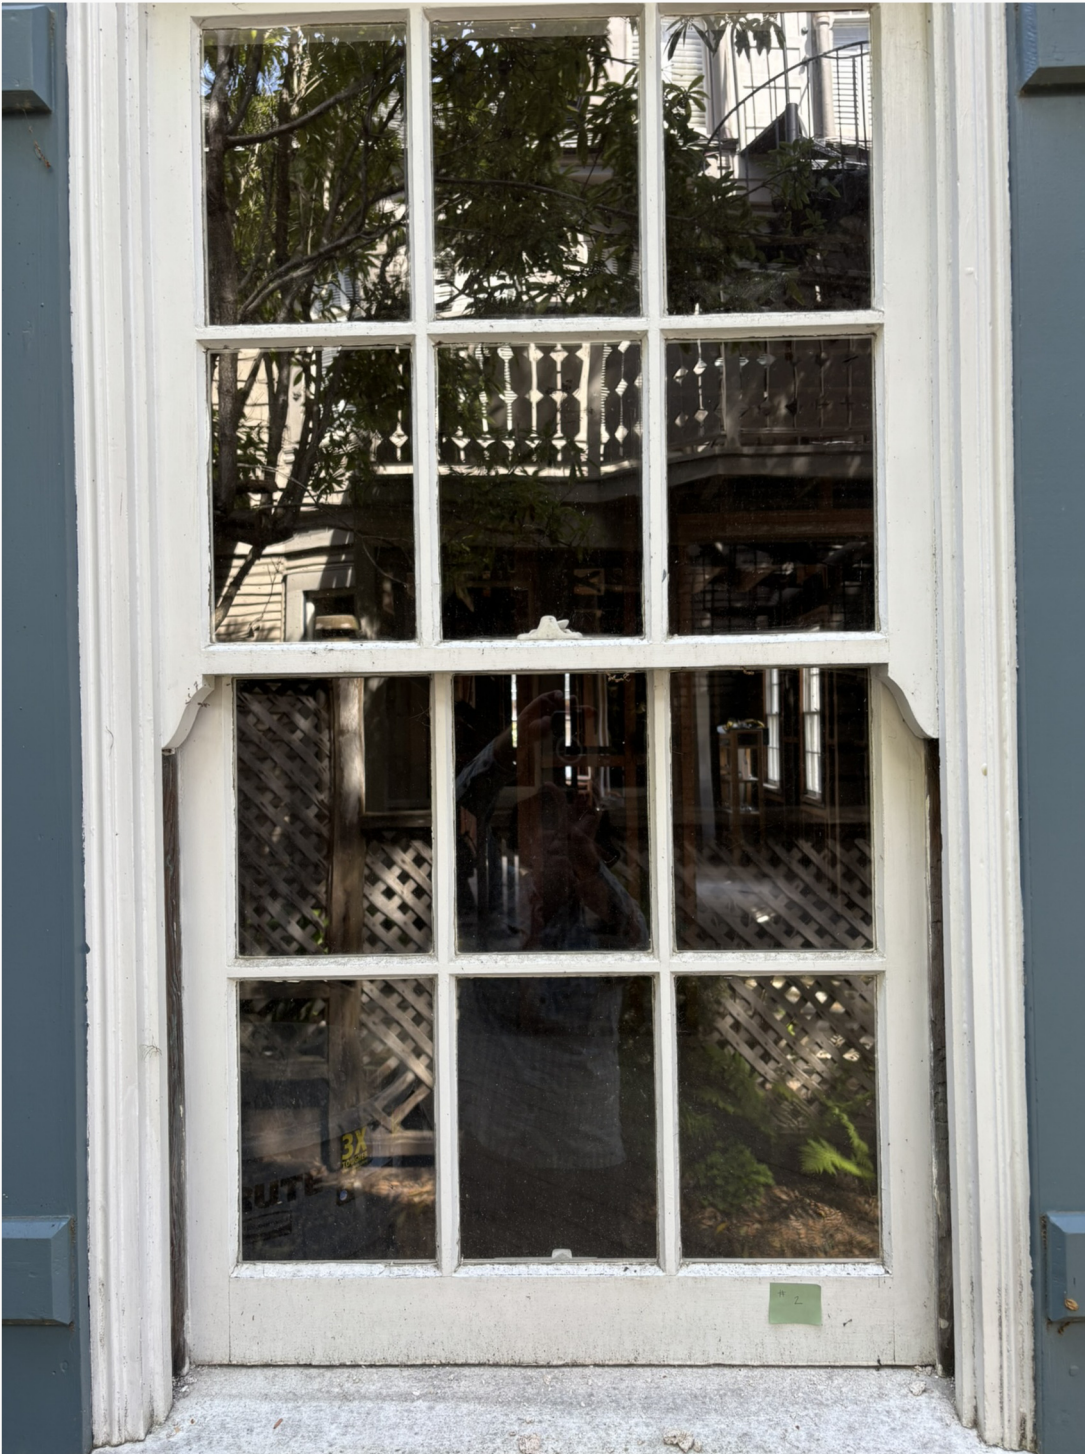
## WINDOW # 2

Location : Main Level, North Elev.  
Paint / Finish : Fair  
Glazier's Putty : Fair  
Frame & Sill : Fair  
Sash : Fair

Glazing : Fair, Single Pane, Scratches  
Hardware : (2) Hinges, Rusting  
Sash Chords : Broken & Missing  
Counterweights : (1) Missing  
Overall Condition : Fair

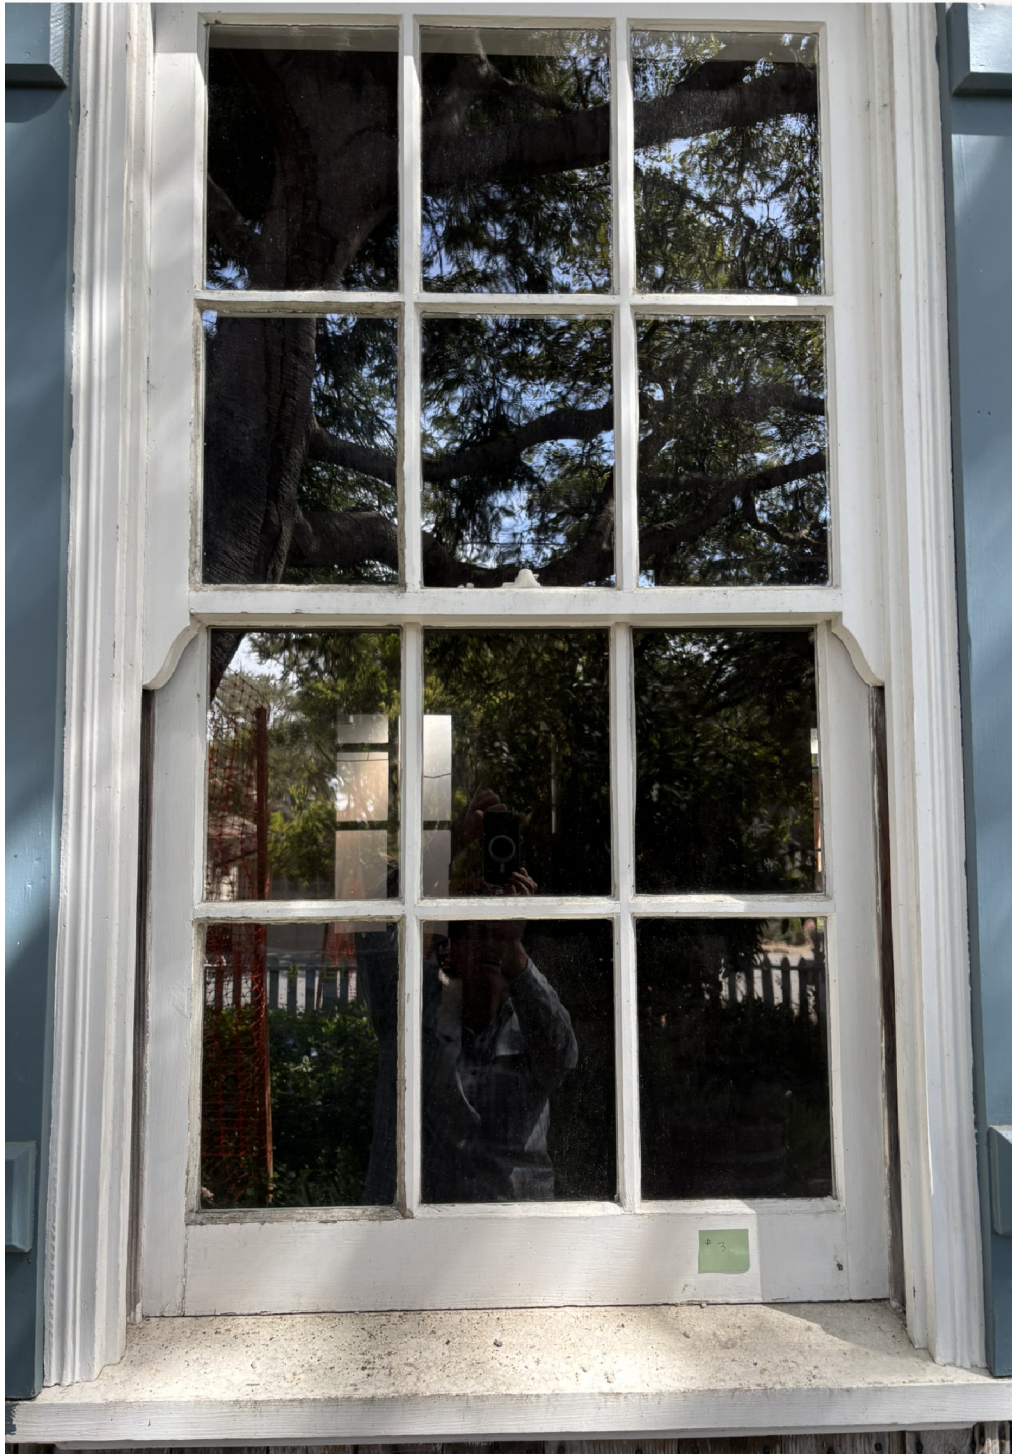
### WINDOW # 3

Location : Main Level, West Elev.  
Paint / Finish : Poor  
Glazier's Putty : Poor  
Frame & Sill : Fair  
Sash : Poor (Joints Separating)

Glazing : Fair, Single Pane, Scratches  
Hardware : (1) Latch, Good  
Sash Chords : Broken  
Counterweights : Good  
Overall Condition : Poor

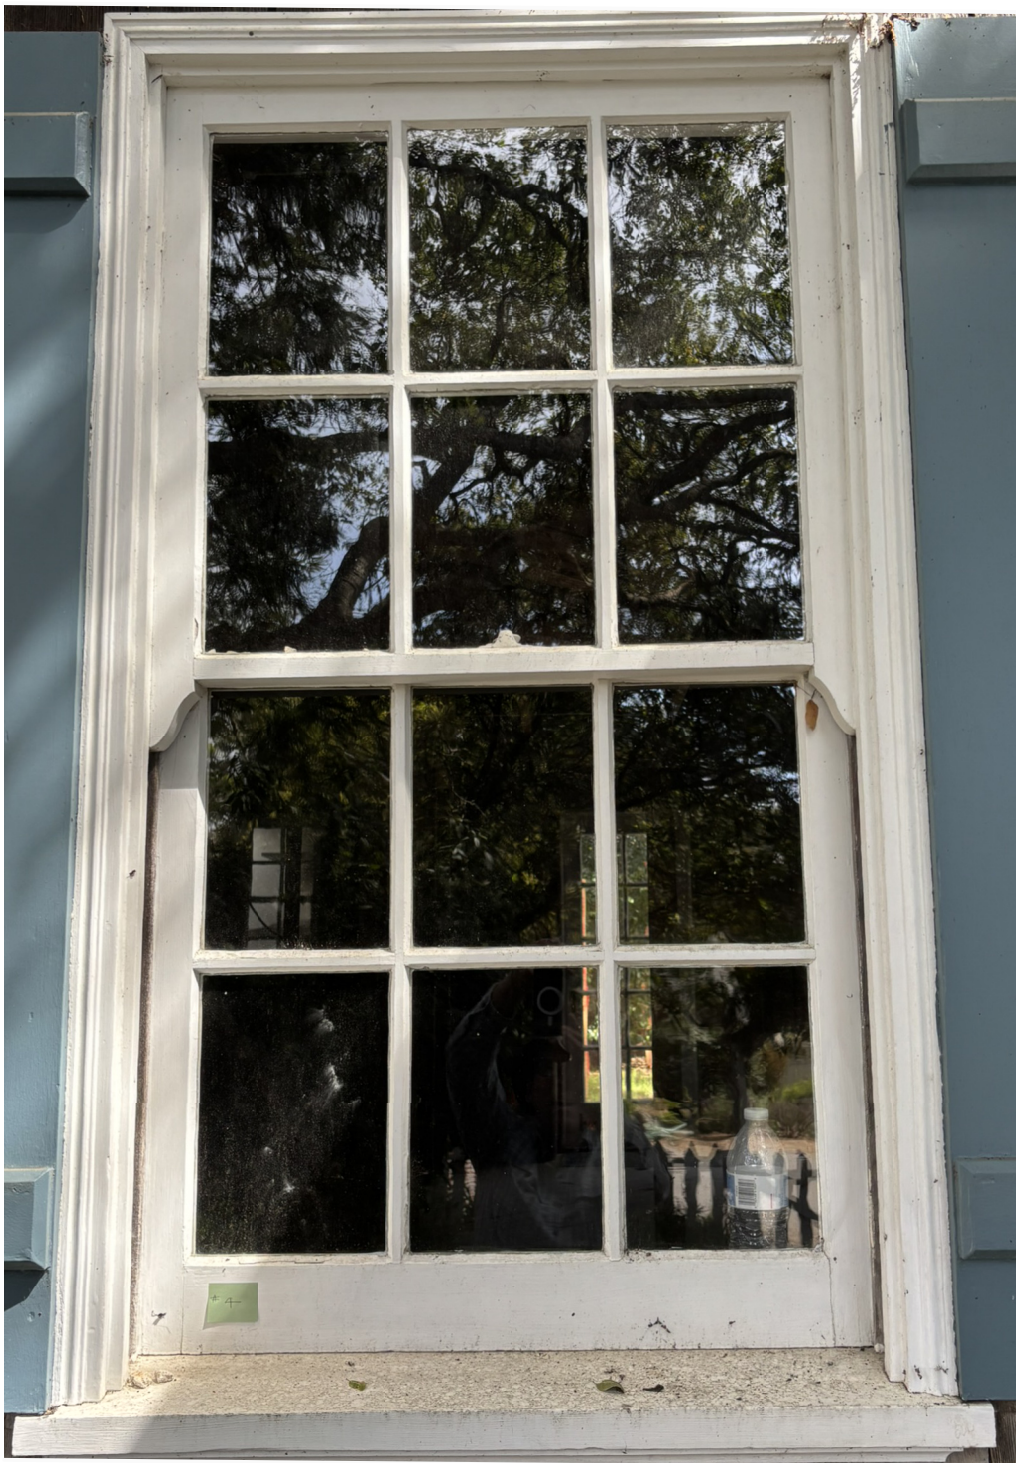
#### WINDOW # 4

Location : Main Level, West Elev.  
Paint / Finish : Poor  
Glazier's Putty : Poor  
Frame & Sill : Fair  
Sash : Poor (Joints Separating)

Glazing : Fair, Single Pane, Scratches  
Hardware : (1) Latch, Good  
Sash Chords : Broken  
Counterweights : Good  
Overall Condition : Poor

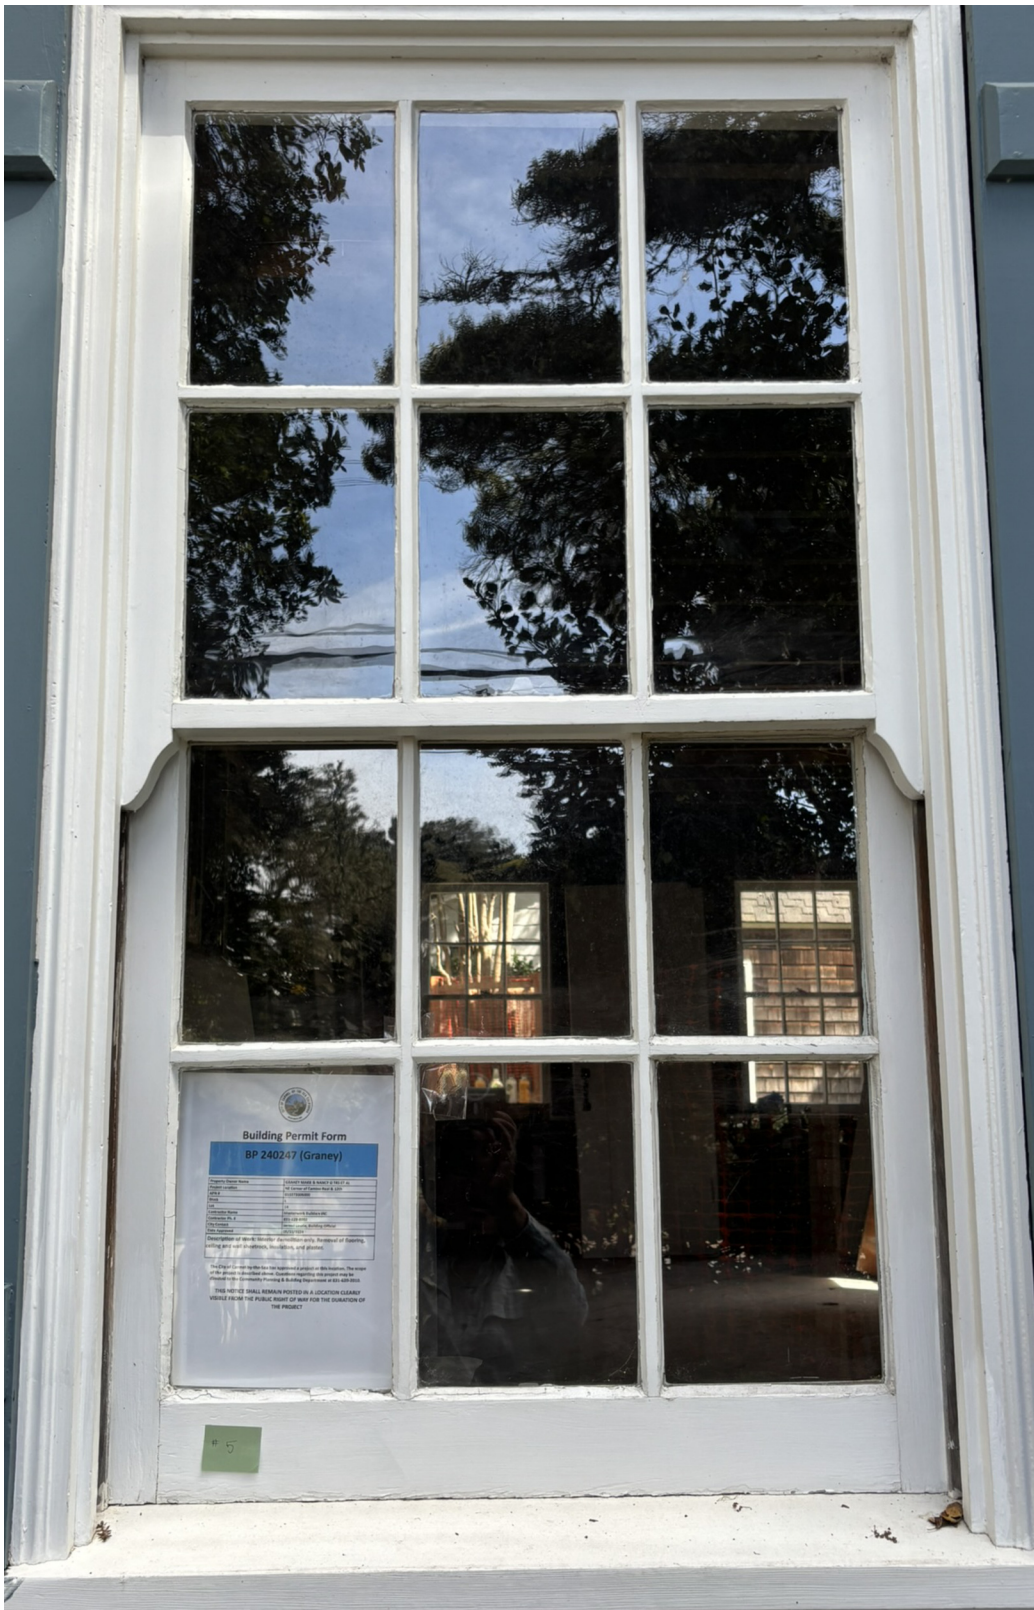
### WINDOW # 5

Location : Main Level, West Elev.  
Paint / Finish : Poor  
Glazier's Putty : Poor  
Frame & Sill : Fair  
Sash : Poor (Joints Separating)

Glazing : Fair, Single Pane, Scratches  
Hardware : (1) Latch, Good  
Sash Chords : Broken  
Counterweights : Good  
Overall Condition : Poor

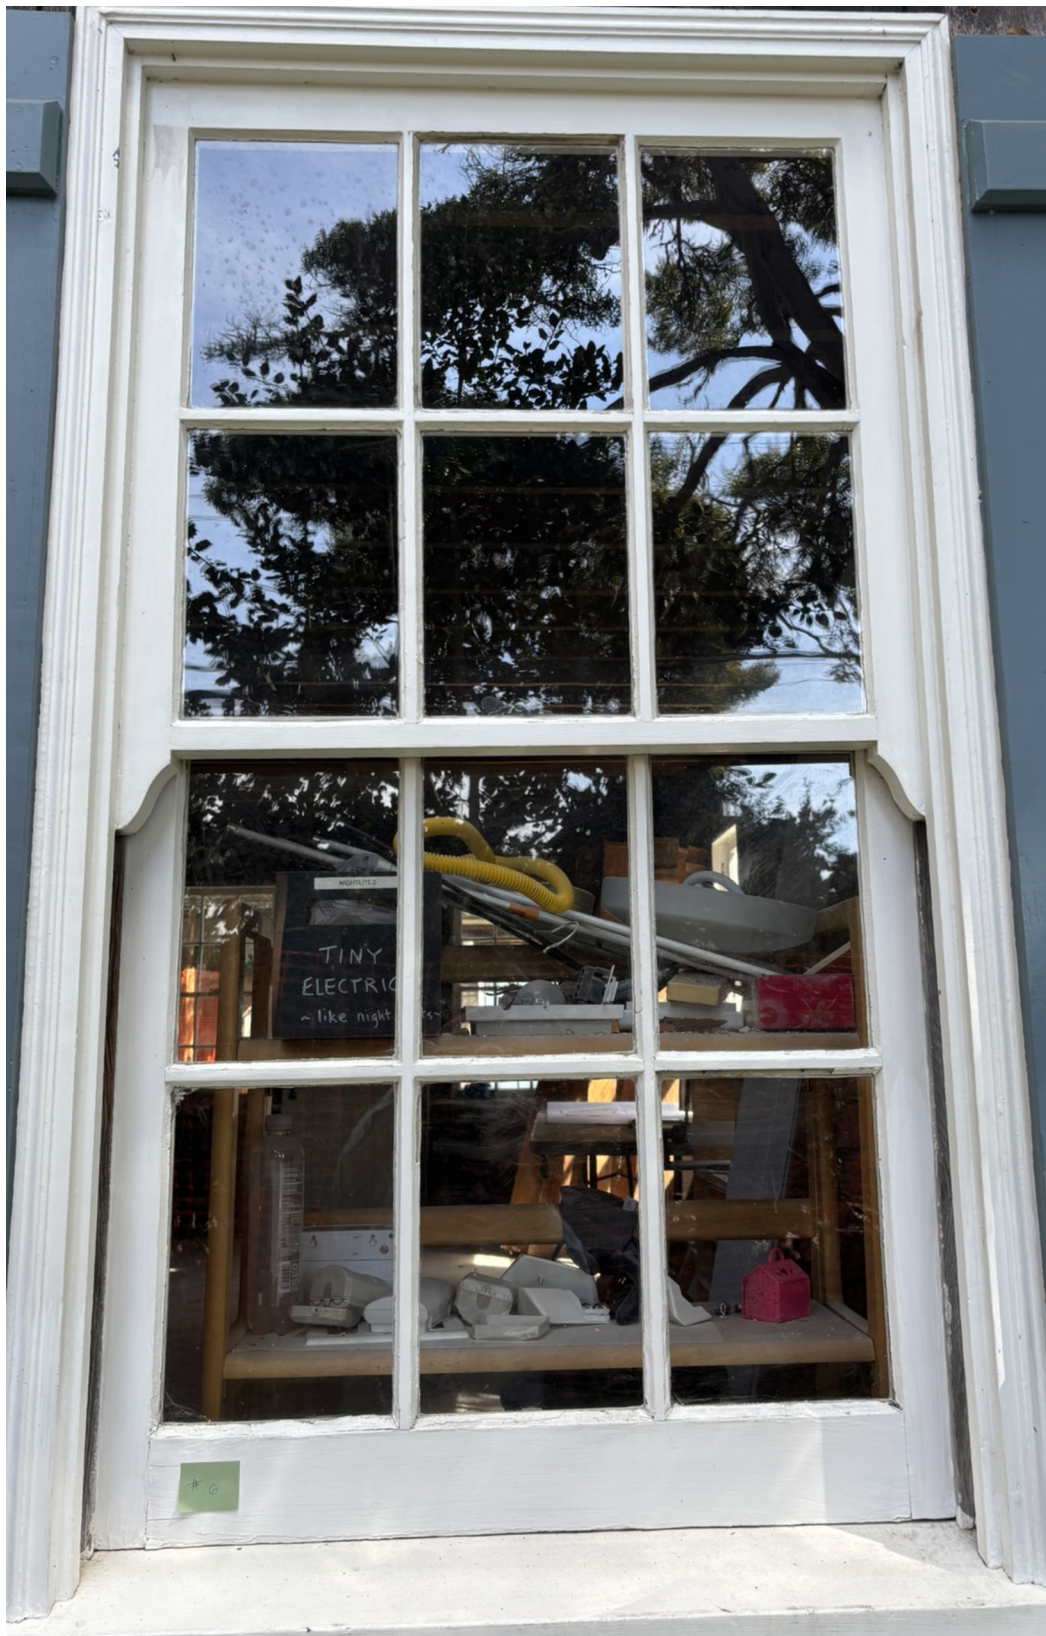
### WINDOW # 6

Location : Main Level, West Elev.  
Paint / Finish : Poor  
Glazier's Putty : Poor  
Frame & Sill : Fair  
Sash : Fair

Glazing : Fair, Single Pane, Scratches  
Hardware : (1) Latch, Good  
Sash Chords : Broken  
Counterweights : Missing  
Overall Condition : Poor

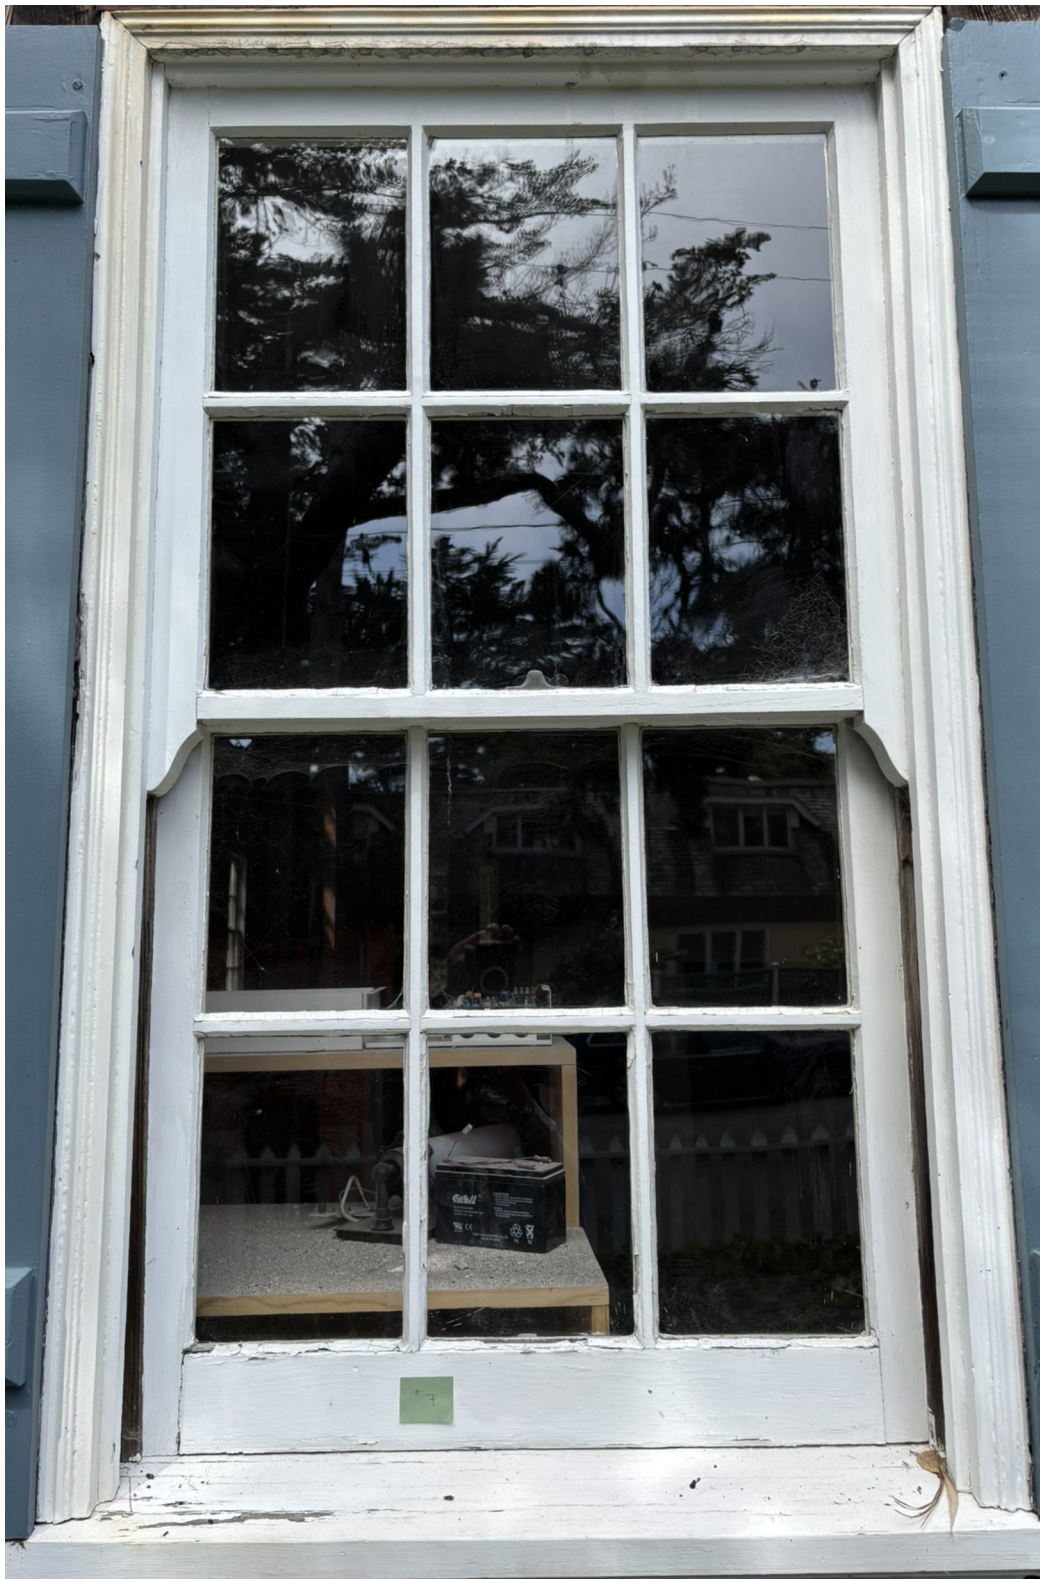
WINDOW # 7

Location : Main Level, South Elev.  
Paint / Finish : Poor  
Glazier's Putty : Poor  
Frame & Sill : Poor  
Sash : Poor (Joints Separating)

Glazing : Fair, Single Pane, Scratches  
Hardware : (1) Latch, Good  
Sash Chords : Broken  
Counterweights : Good  
Overall Condition : Poor

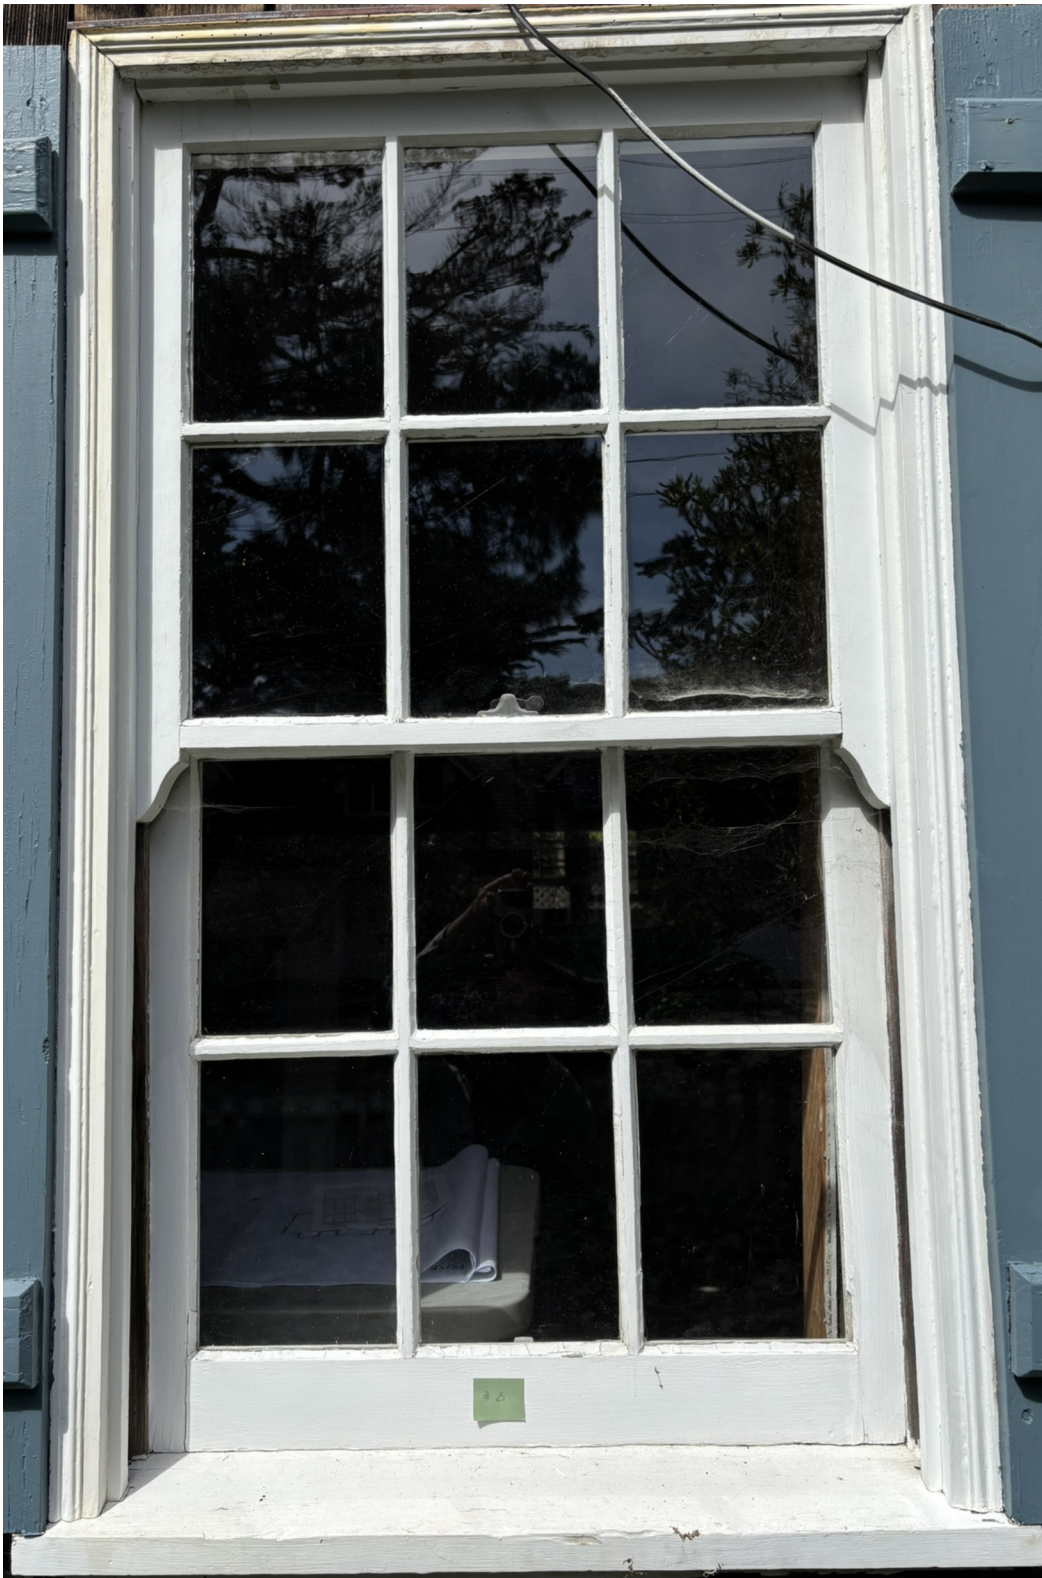
WINDOW # 8

Location : Main Level, South Elev.  
Paint / Finish : Poor  
Glazier's Putty : Poor  
Frame & Sill : Fair  
Sash : Poor (Joints Separating)

Glazing : Fair, Single Pane, Scratches  
Hardware : (1) Latch, Good  
Sash Chords : Broken  
Counterweights : Good  
Overall Condition : Poor

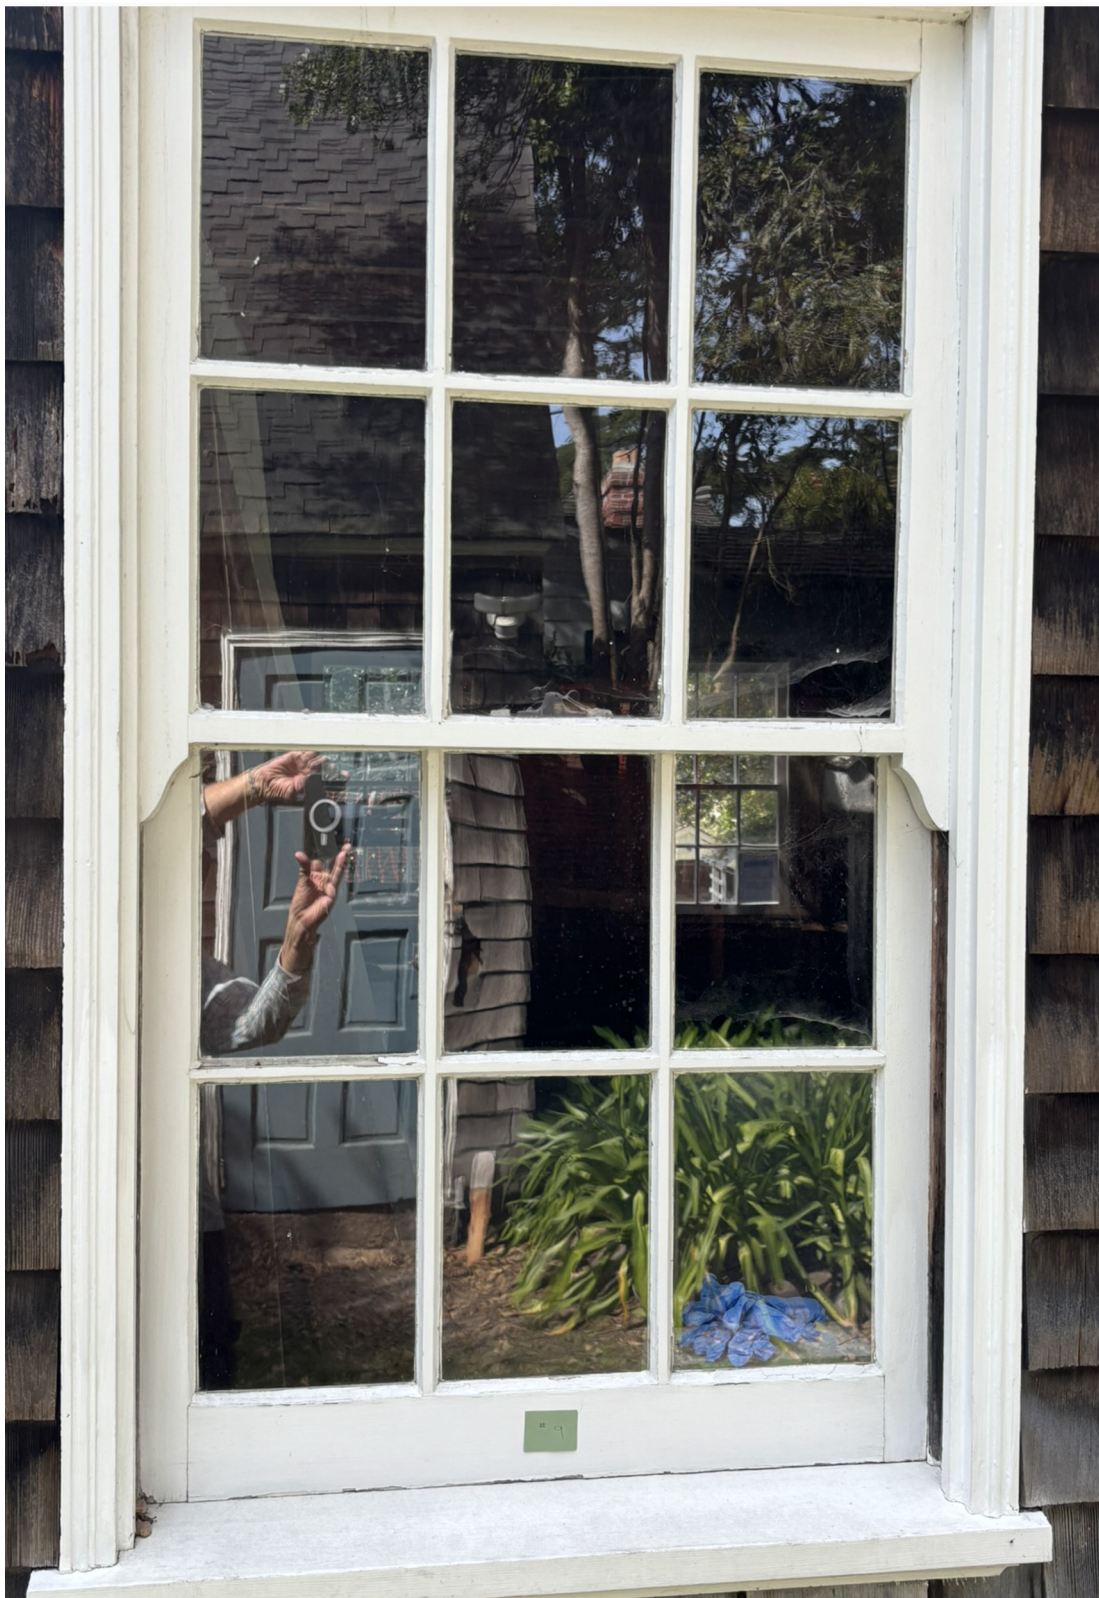
WINDOW # 9

Location : Main Level, East Elev.  
Paint / Finish : Poor  
Glazier's Putty : Poor  
Frame & Sill : Fair  
Sash : Poor (Joints Separating)

Glazing : Fair, Single Pane, Scratches  
Hardware : (1) Latch, Good  
Sash Chords : Broken  
Counterweights : Good  
Overall Condition : Poor

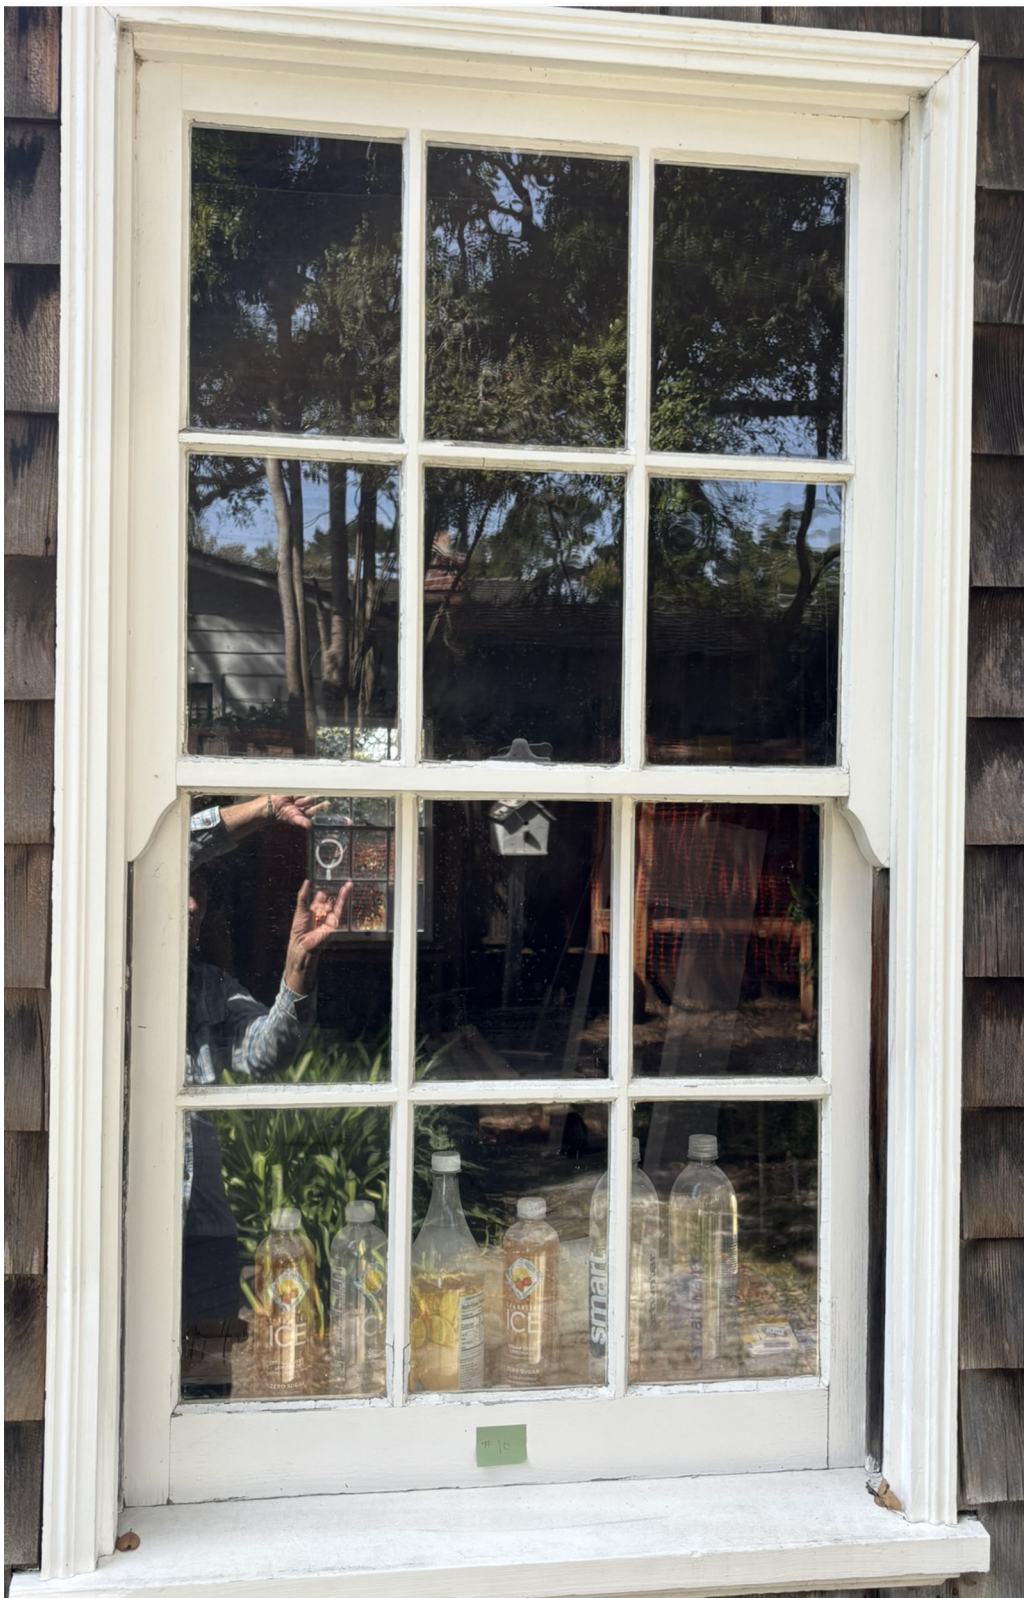
WINDOW # 10

Glazing : Fair, Single Pane, Scratches  
Hardware : (1) Latch, Good  
Sash Chords : Broken  
Counterweights : Good  
Overall Condition : Poor

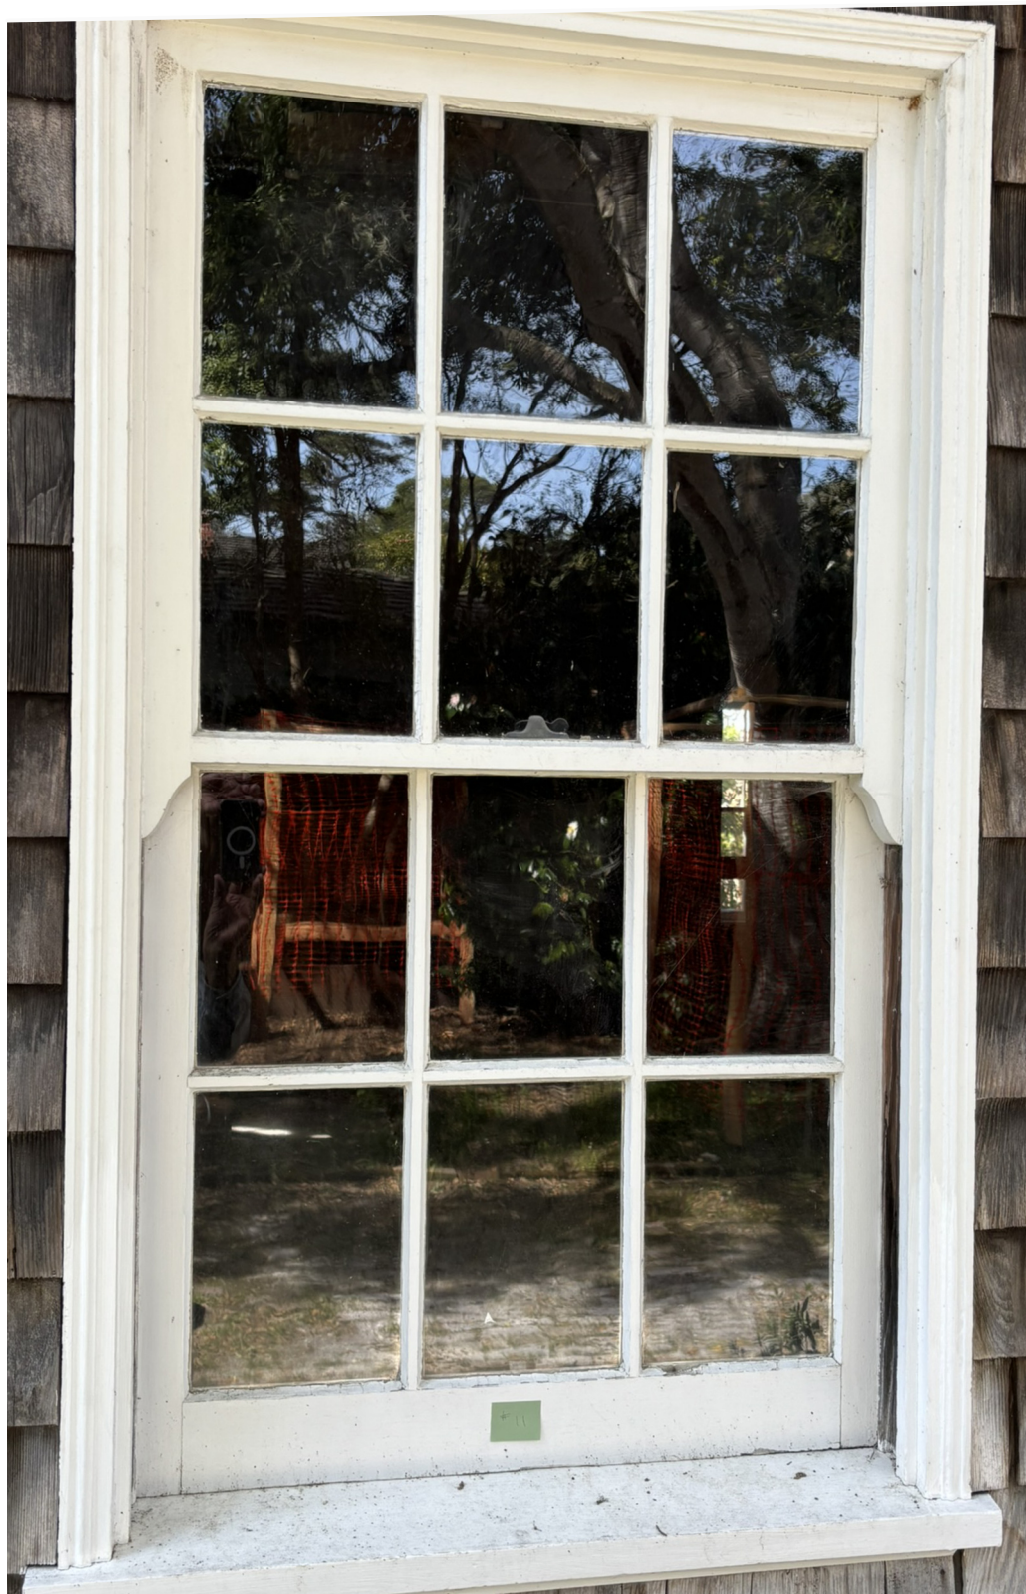
WINDOW # 11

Glazing : Fair, Single Pane, Scratches  
Hardware : (1) Latch, Good  
Sash Chords : Broken  
Counterweights : Good  
Overall Condition : Poor
