# CITY OF CARMEL-BY-THE-SEA HISTORIC RESOURCES BOARD AGENDA

**Regular Meeting**  
**Monday, August 18, 2025**  
**4:00 PM**

- 2) DR 25181 (Carmel Mission Basilica):** Consideration of a Determination of Consistency with the Secretary of the Interior's Standards for accessibility upgrades at the historic "Mission San Carlos de Borromeo" located at 3080 Rio Road in the Single-Family Residential (R-1) District, Archaeological Significance Overlay, Park Overlay and Beach & Riparian Overlay districts. APN: 009-531-003-000.
- 3) DS 25197 (Graney):** Consideration of a Determination of Consistency with the Secretary of the Interior's Standards for the in-kind replacement of wood windows and wood shingle siding throughout, and in-kind

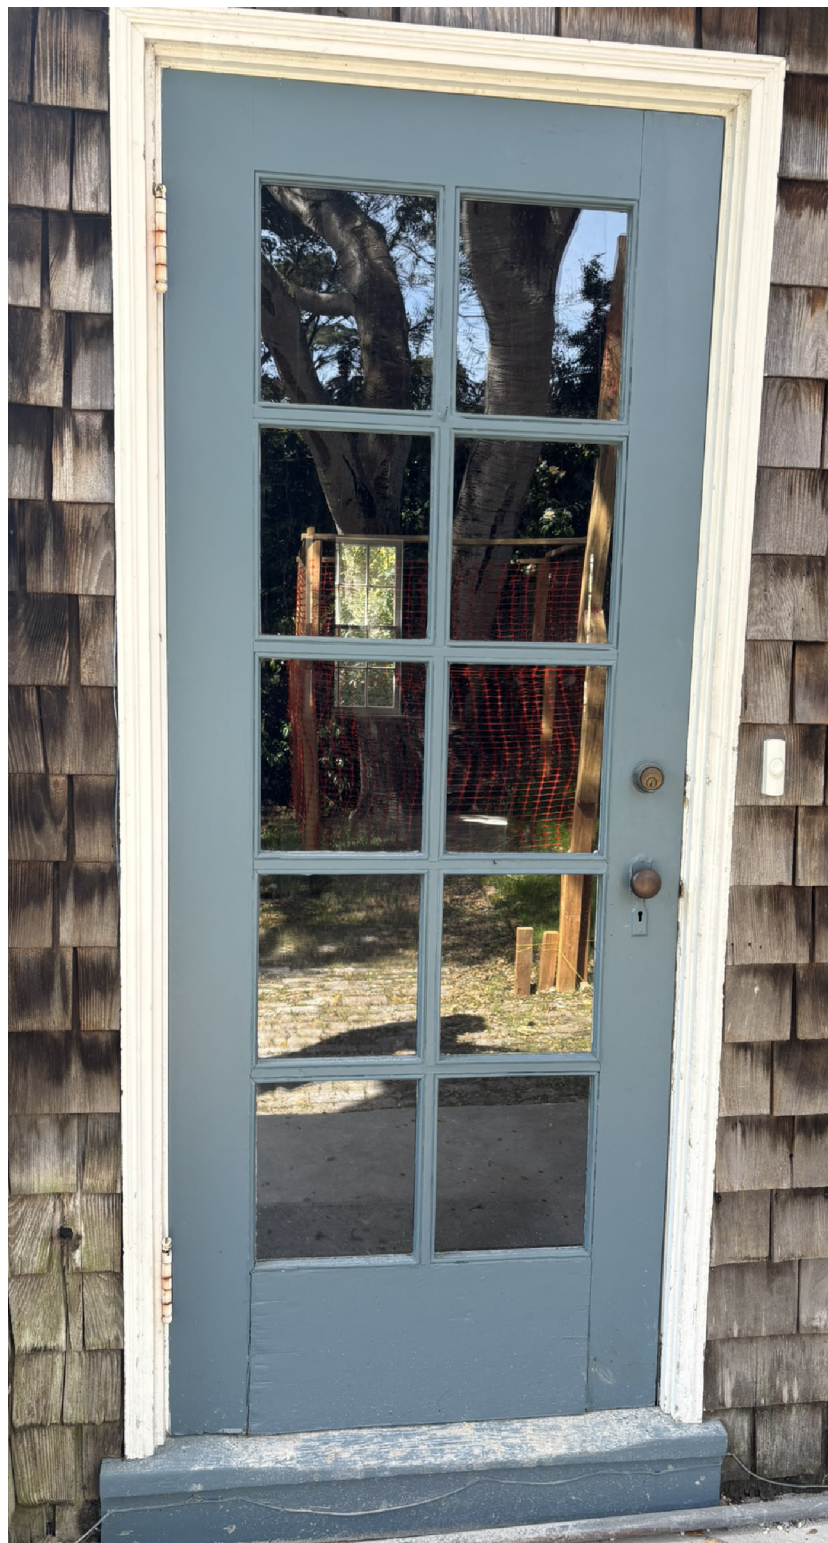
### DOOR # 12

Glazing : Fair, Single Pane, Scratches  
Hardware : (2) Hinges, Rusted  
(1) Lockset, Poor  
(1) Deadbolt, Fair  
Overall Condition : Poor

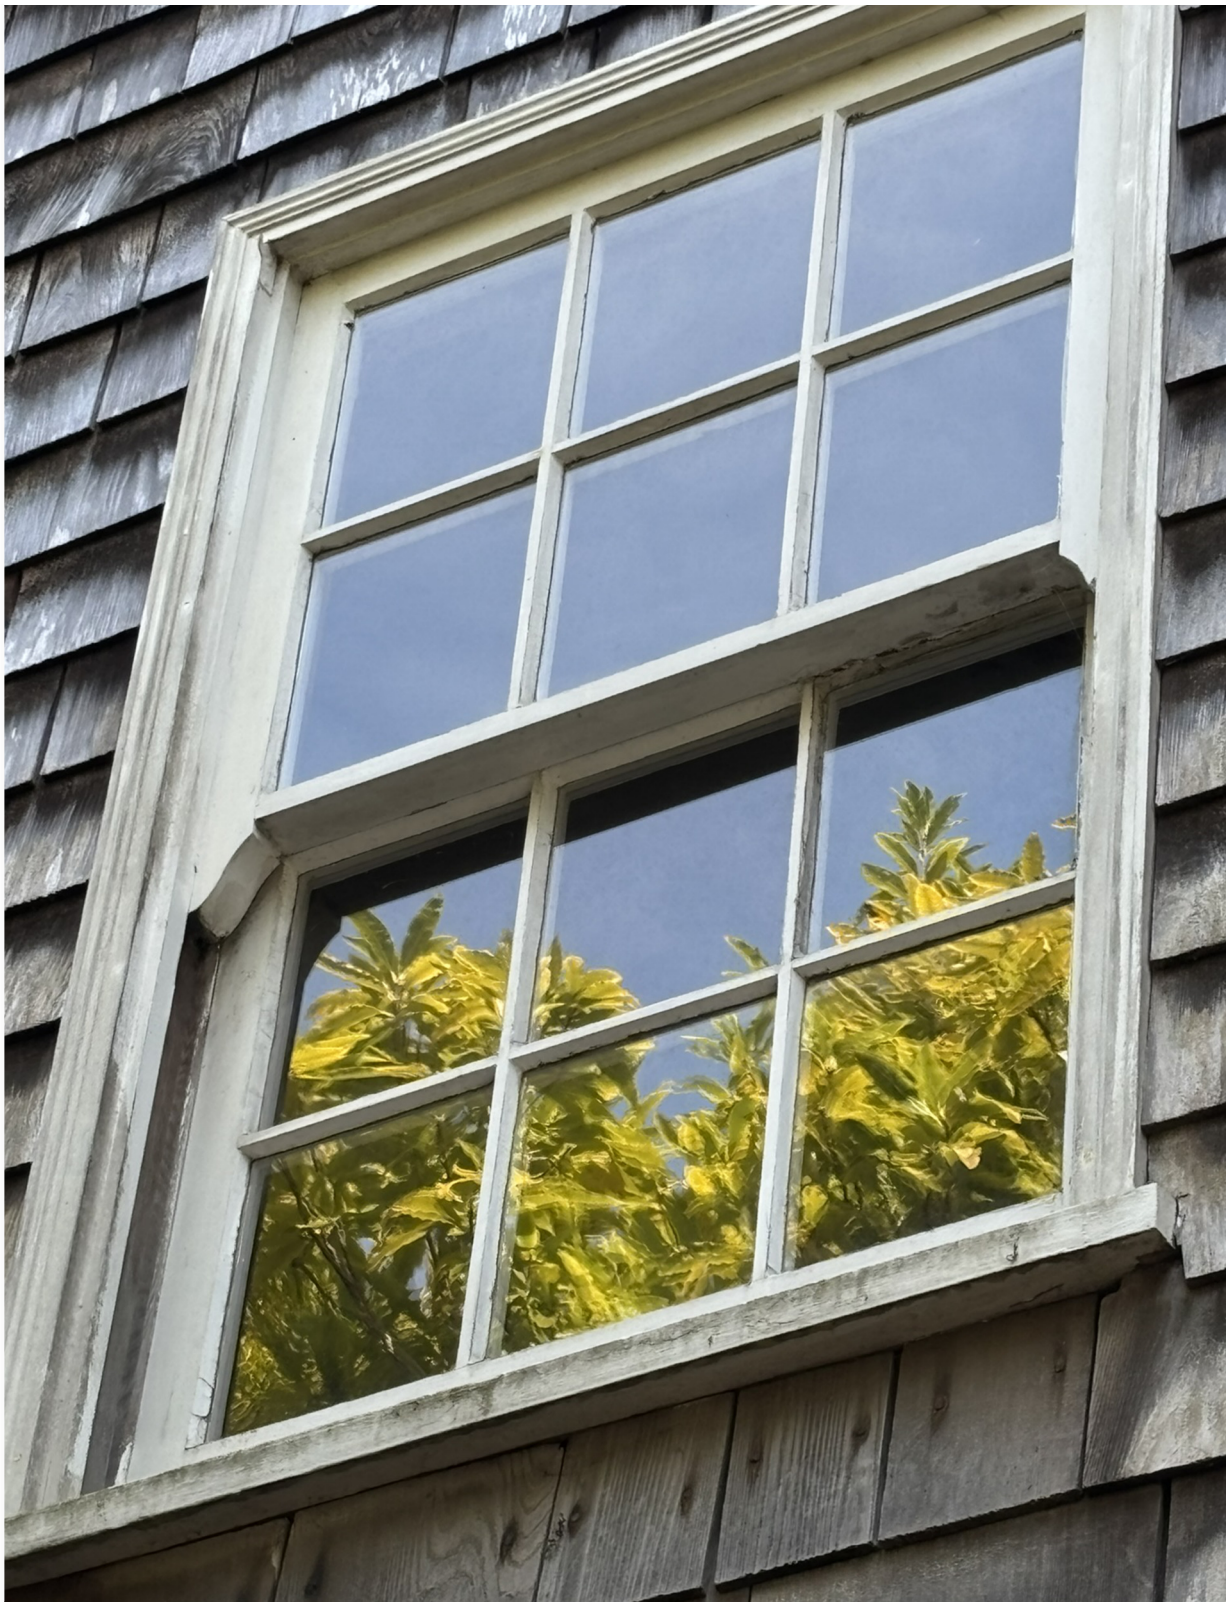
### WINDOW # 13

Glazing : Fair, Single Pane, Scratches  
Hardware : (1) Latch, Good  
Sash Chords : Broken  
Counterweights : Good  
Overall Condition : Poor

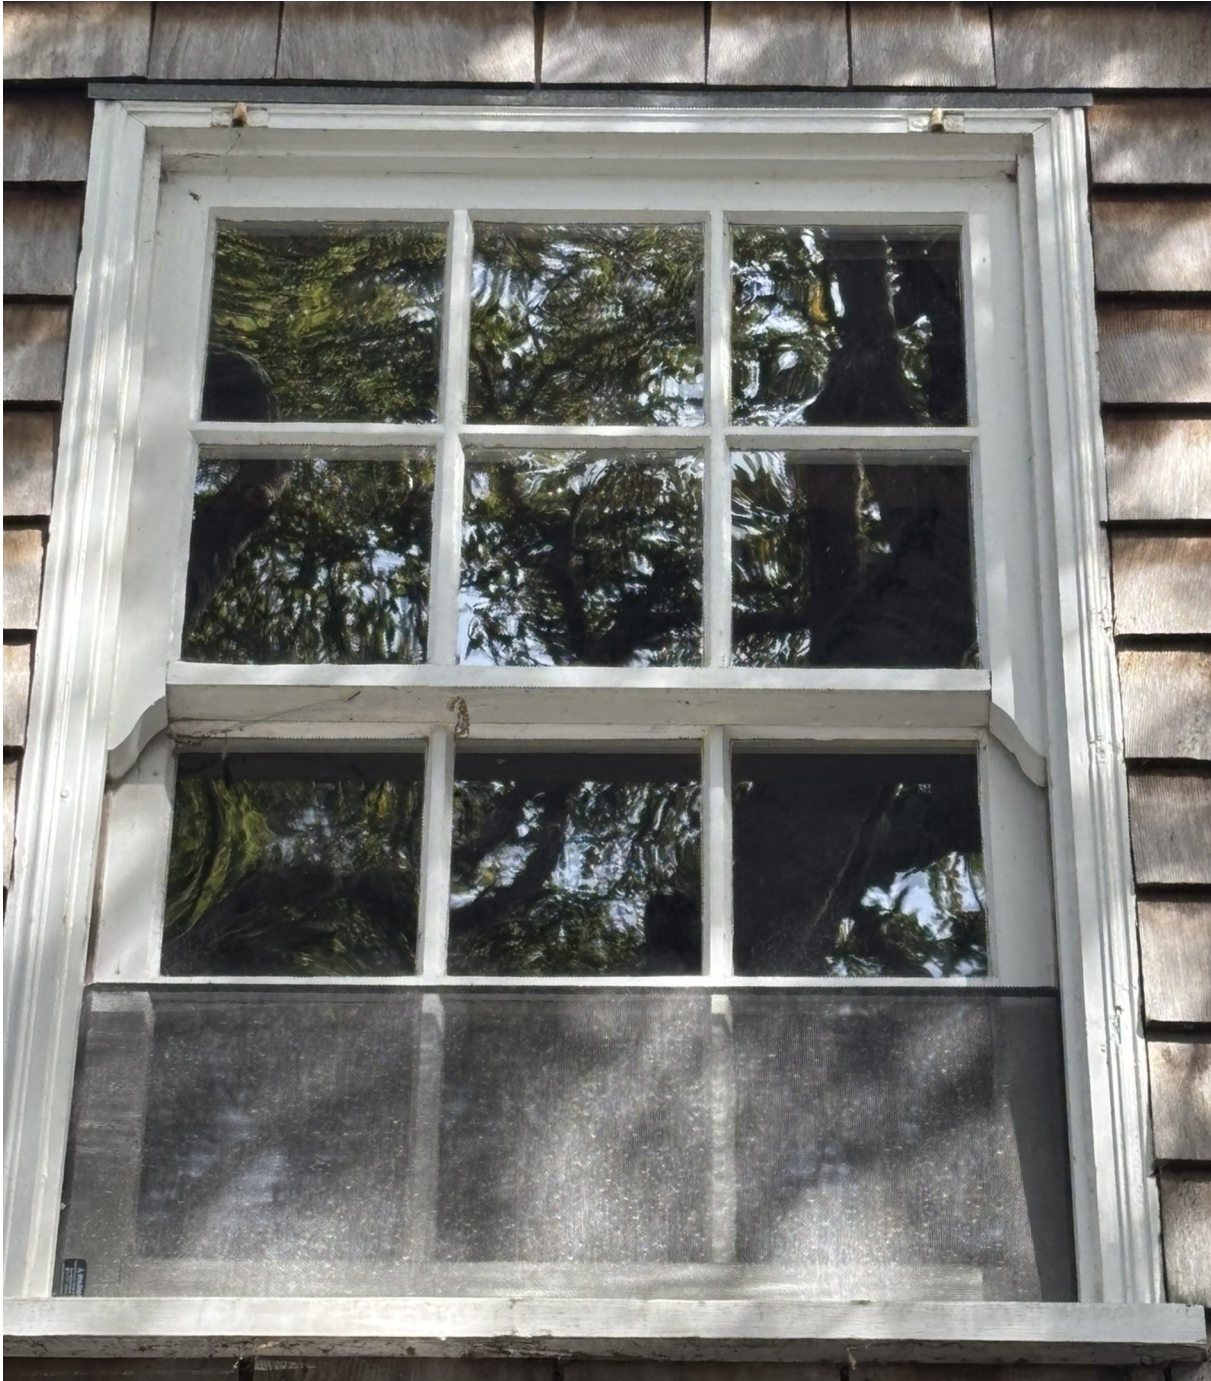
### WINDOW # 14

Glazing : Fair, Single Pane, Scratches  
Hardware : (1) Latch, Good  
Sash Chords : Broken  
Counterweights : Good  
Overall Condition : Poor

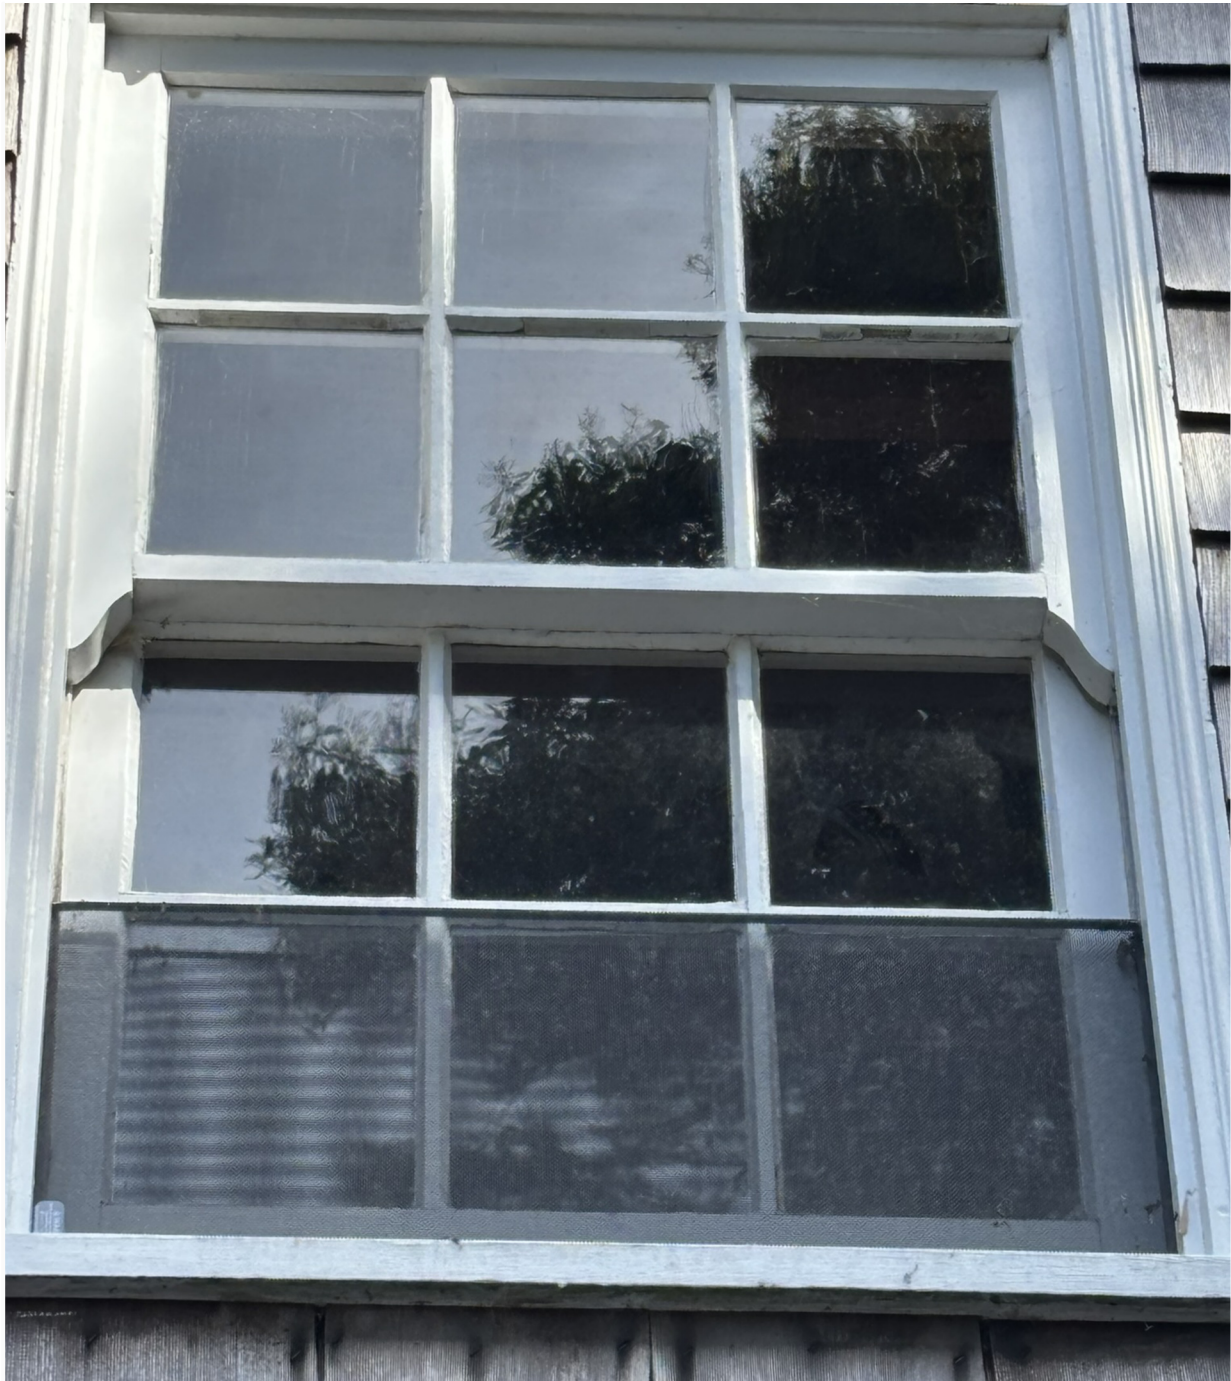
### WINDOW # 15

Glazing : Fair, Single Pane, Scratches  
Hardware : (1) Latch, Good  
Sash Chords : Broken  
Counterweights : Good  
Overall Condition : Poor

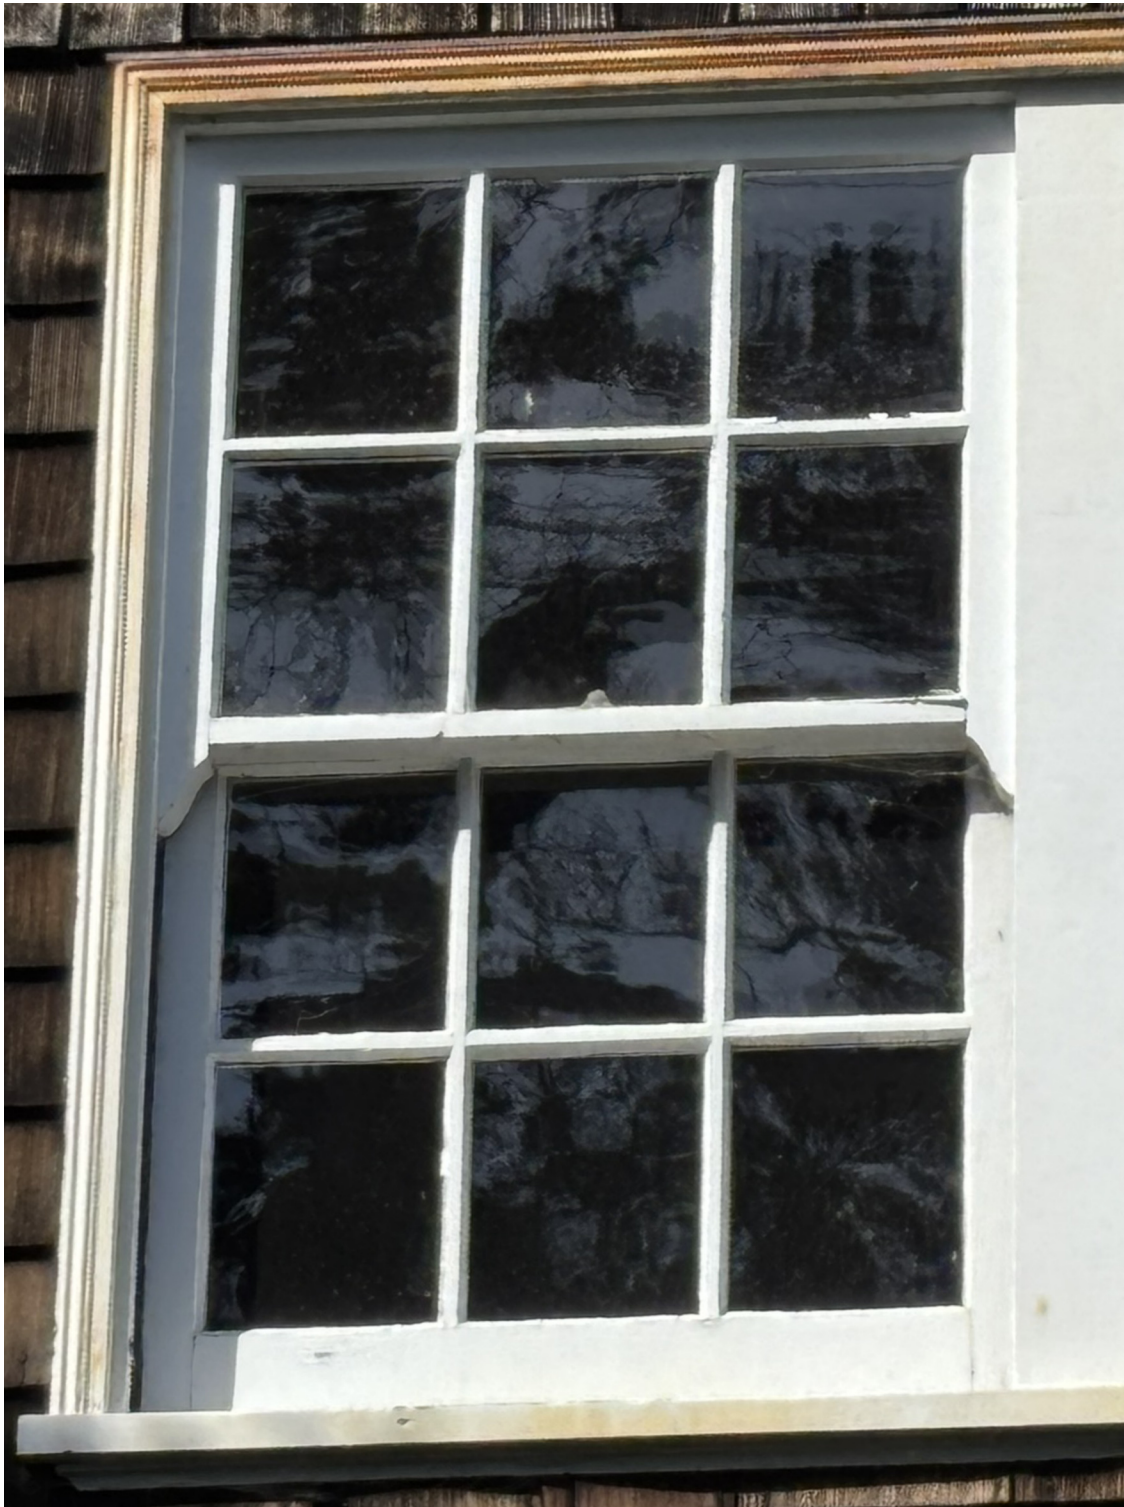
WINDOW # 16

Glazing : Fair, Single Pane, Scratches  
Hardware : (1) Latch, Good  
Sash Chords : Broken  
Counterweights : Good  
Overall Condition : Poor

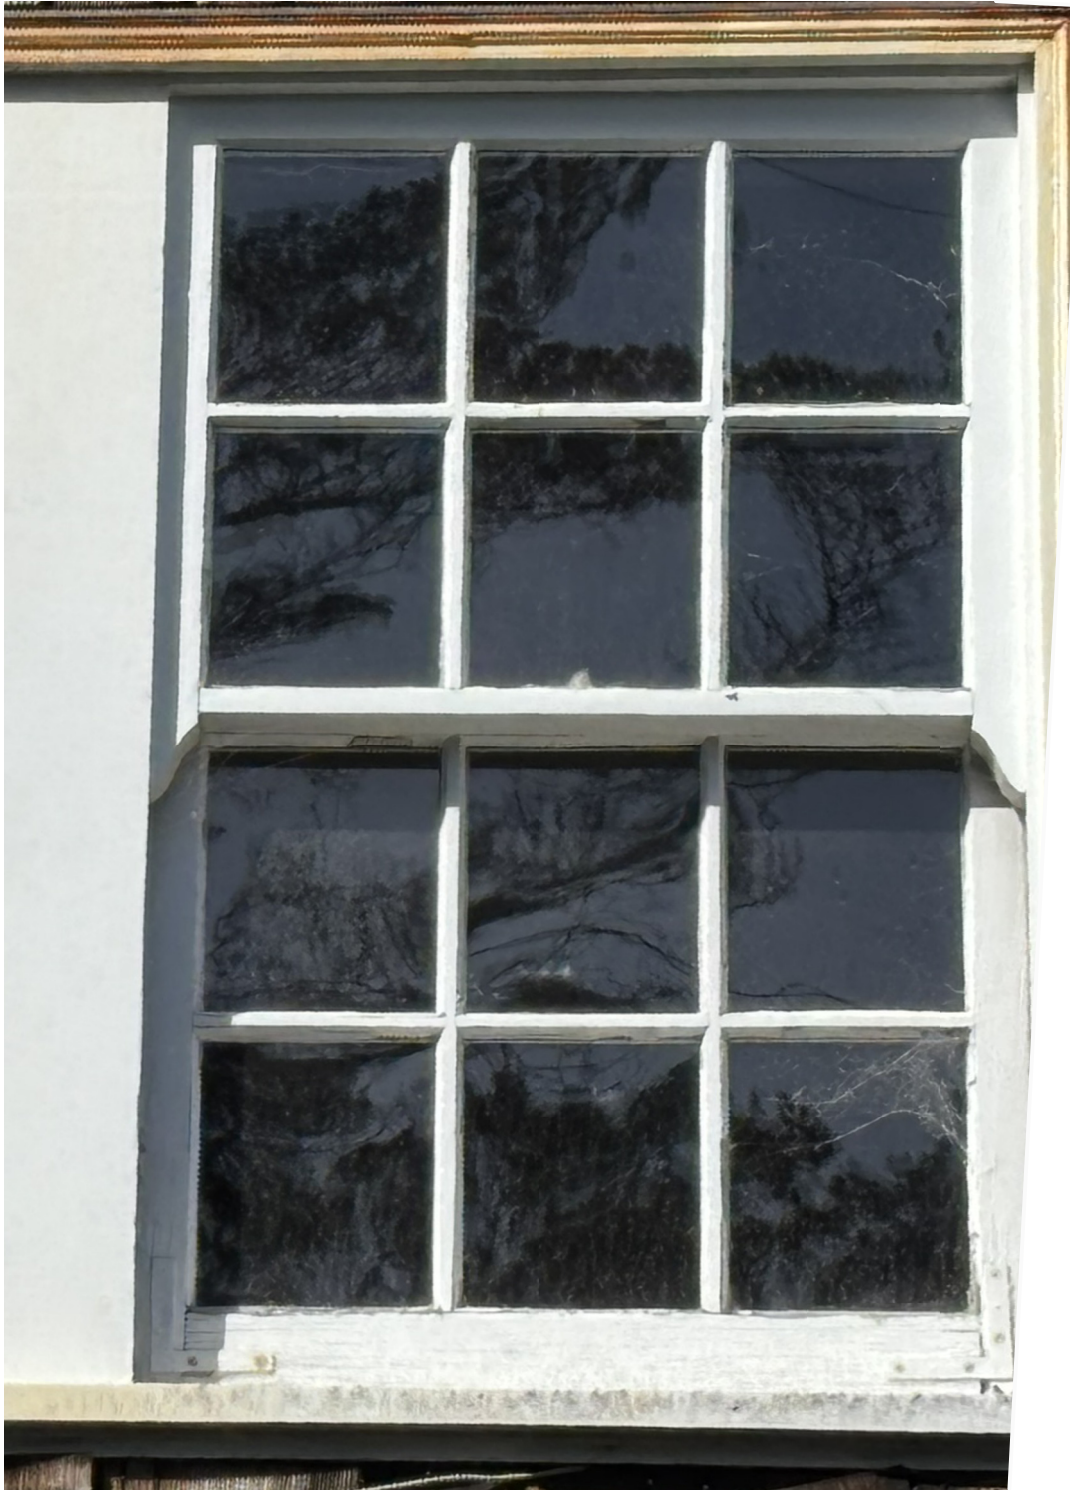
WINDOW # 17

Glazing : Fair, Single Pane, Scratches  
Hardware : (1) Latch, Good  
Sash Chords : Broken  
Counterweights : Missing  
Overall Condition : Poor

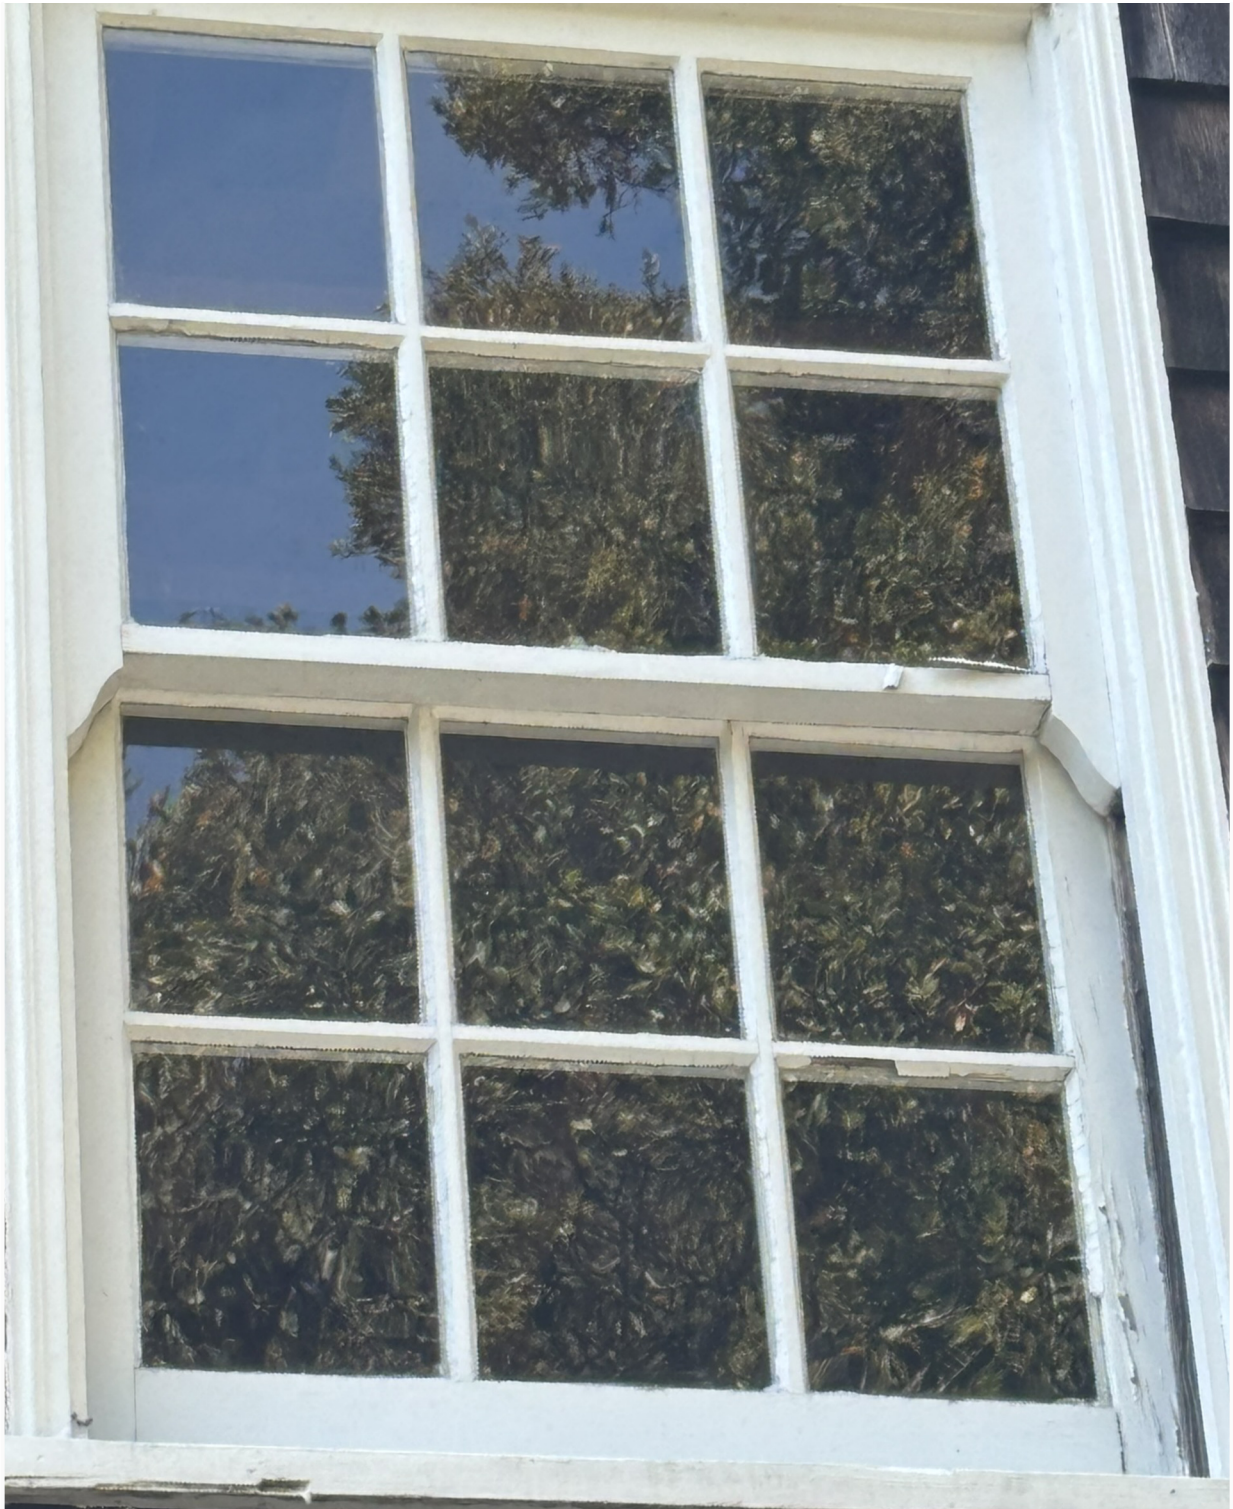
WINDOW # 18

Glazing : Fair, Single Pane, Scratches  
Hardware : (1) Latch, Good  
Sash Chords : Broken  
Counterweights : Good  
Overall Condition : Poor

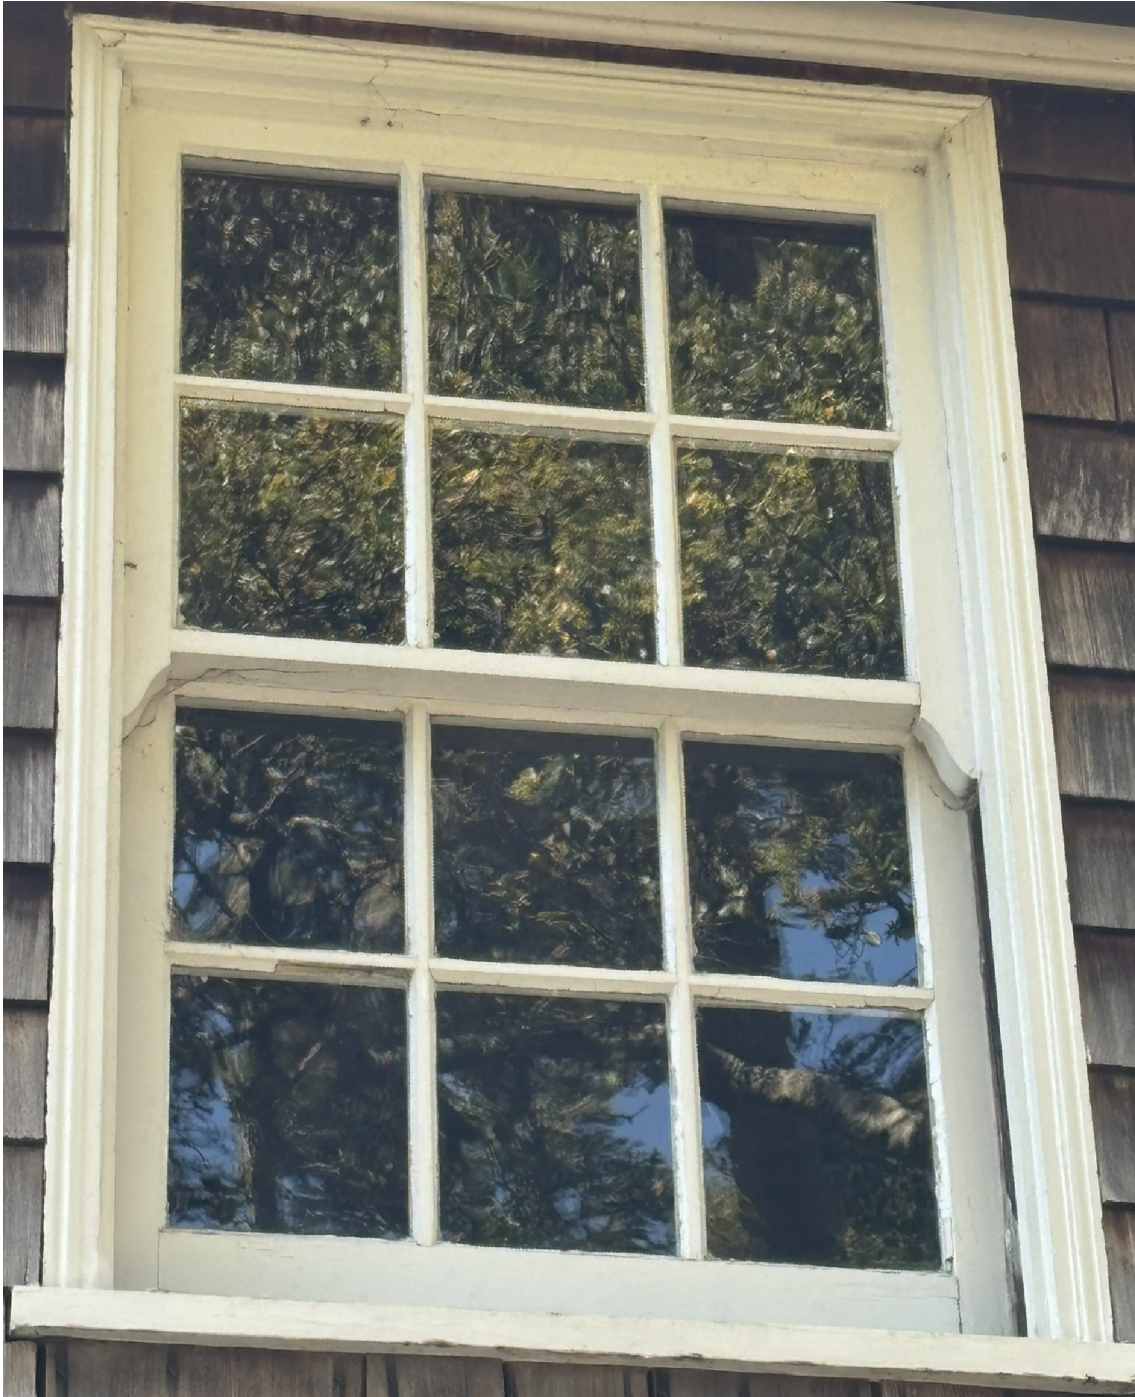
### WINDOW # 19

Glazing : Fair, Single Pane, Scratches  
Hardware : (1) Latch, Good  
Sash Chords : Broken  
Counterweights : Good  
Overall Condition : Poor
