CITY OF CARMEL-BY-THE-SEA HISTORIC RESOURCES BOARD AGENDA

Regular Meeting Monday, November 17, 2025

TO: Historic Resources Board Members
SUBMITTED Jacob Olander, Assistant Planner
BY:
SUBJECT: **DS 25240 (Ramos):** Consideration of a Determination of Consistency with the Secretary of the Interior's Standards for Design Study application, DS 25240 (Ramos), for after-the-fact revisions to a previous approval (DS 23396) including the removal of horizontal wood siding, wood shingle siding, wood windows, and a Carmel stone chimney, replaced with new, and associated site and landscaping improvements at the historic "Rockwell House" located on the northeast corner of San Antonio and 12th Avenues in the Single-Family Residential (R-1) District and the Beach and Riparian Overlay District. APN 010-279-008-000

The applicant is requesting the issuance of a determination of consistency with the Secretary of the Interior's Standards for the Treatment of Historic Properties for after-the-fact revisions to a previous approval (DS 23396), including the removal of roof shingles, horizontal wood siding, wood shingle siding, wood windows and French doors, and a Carmel stone chimney, replaced with n

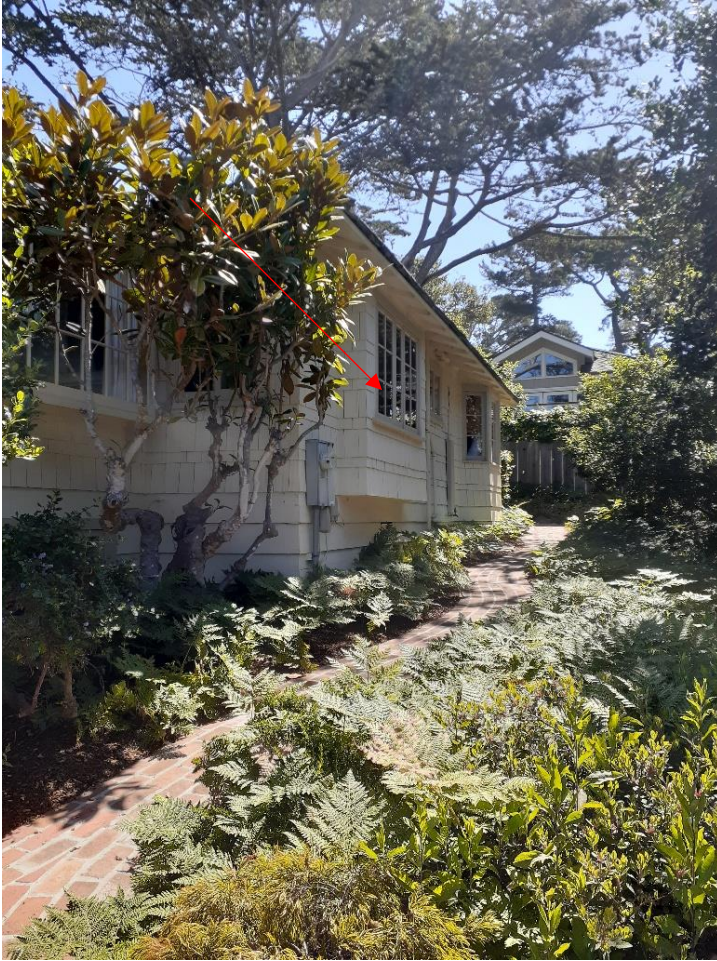
Figure 3: Arrow indicates location of new entrance.

A new entrance will be constructed on the south elevation which will remove one of the square bay windows. Although not ideal, the loss of a single window will not affect the building's integrity as a whole. The non-original canted bay window will be removed and replaced with a relocated window. The bathroom window opening will be filled in. A new window opening will be created next to the entry porch. The removal of the canted bay window and bathroom window does not affect the integrity of the house since they are not original. The proposed work is consistent with Standard Two.

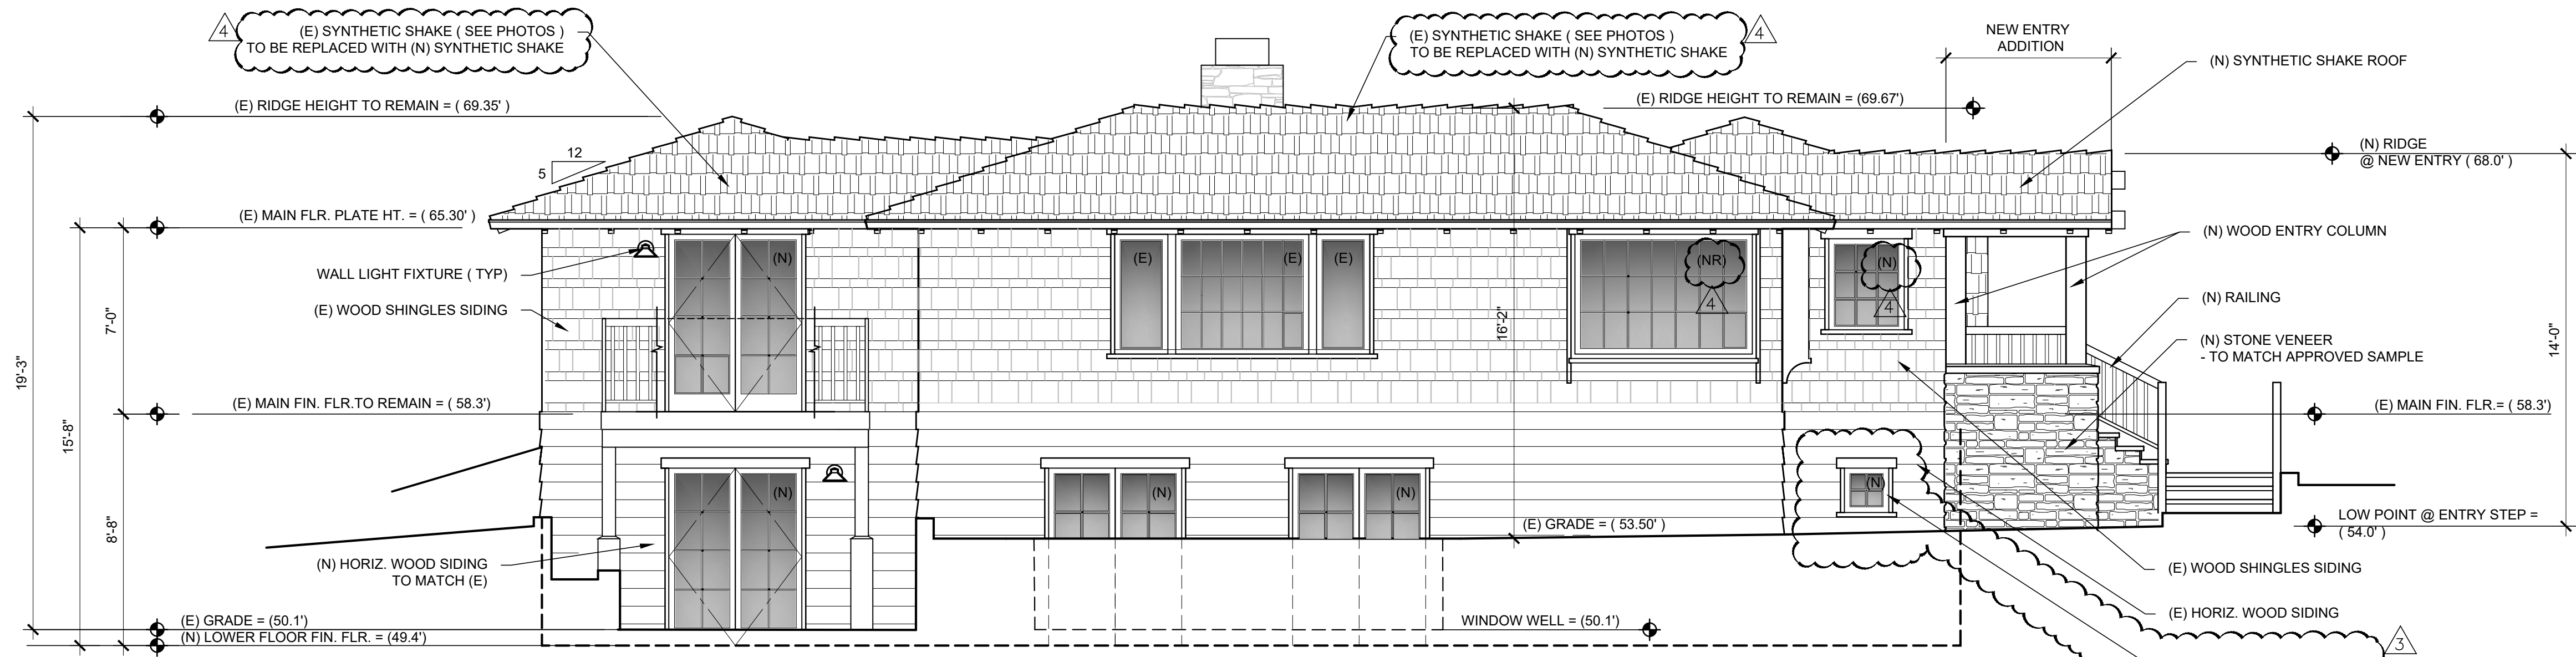
WEST ELEVATION

NOTE:
RELOCATED OR EXISTING WINDOWS (NR)
AS ORIGINALLY INDICATED, REPLACED
WITH "LIKE-TO-LIKE".

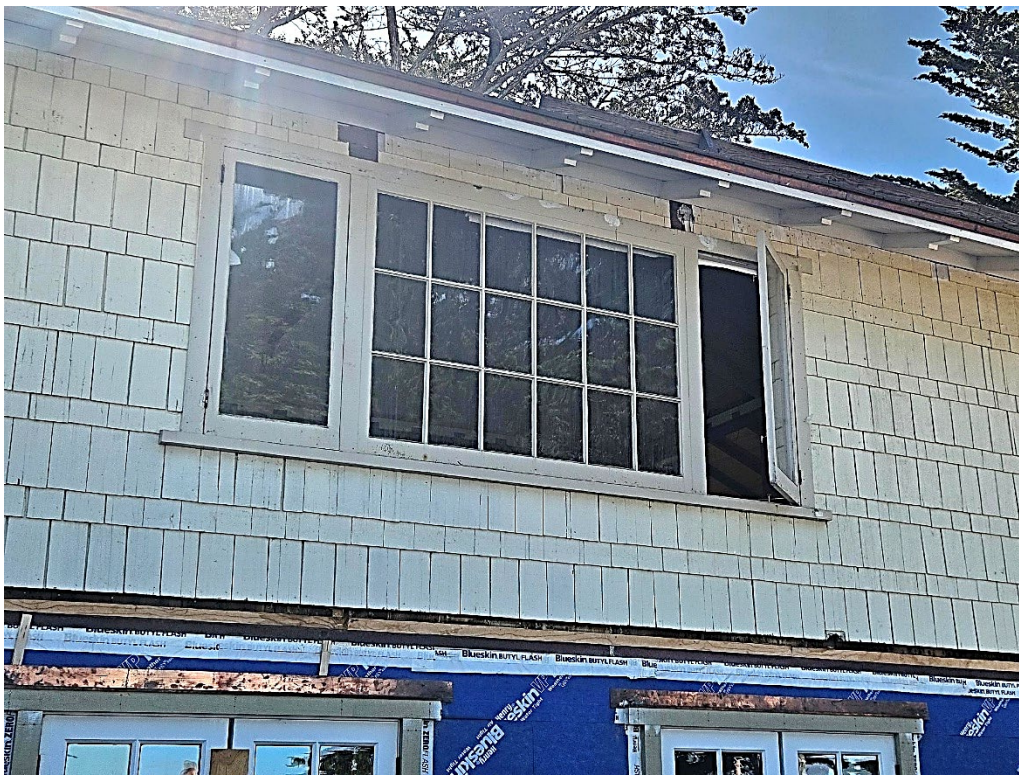
Figure 3: Detail of the one remaining original window on the front elevation.

Documentation of the deterioration is required prior to replacing windows to ascertain whether the windows can be repaired, which is the preferred rehabilitation treatment. The National Park Service recommends, “Determination as to when deterioration is sufficiently severe to justify replacement must be based on documentation of the condition of the windows. What constitutes effective documentation may vary with the circumstances of the project, but at a minimum must include enough good quality photos to clearly depict the full range of conditions.” The project architect submitted photographs to staff that document the deterioration of the original windows. Although these photos should have been submitted prior to any window replacements, it appears that the replaced windows were rotted to the point where repair was not feasible. Additionally, French doors opening to the patio (flanking the chimney) were slated to be retained but were replaced in kind. The existing French doors were found to have post-dated the period of significance (1923) as they were installed in 1950. The completed after-the-fact work on the doors and windows are consistent with applicable Standards.

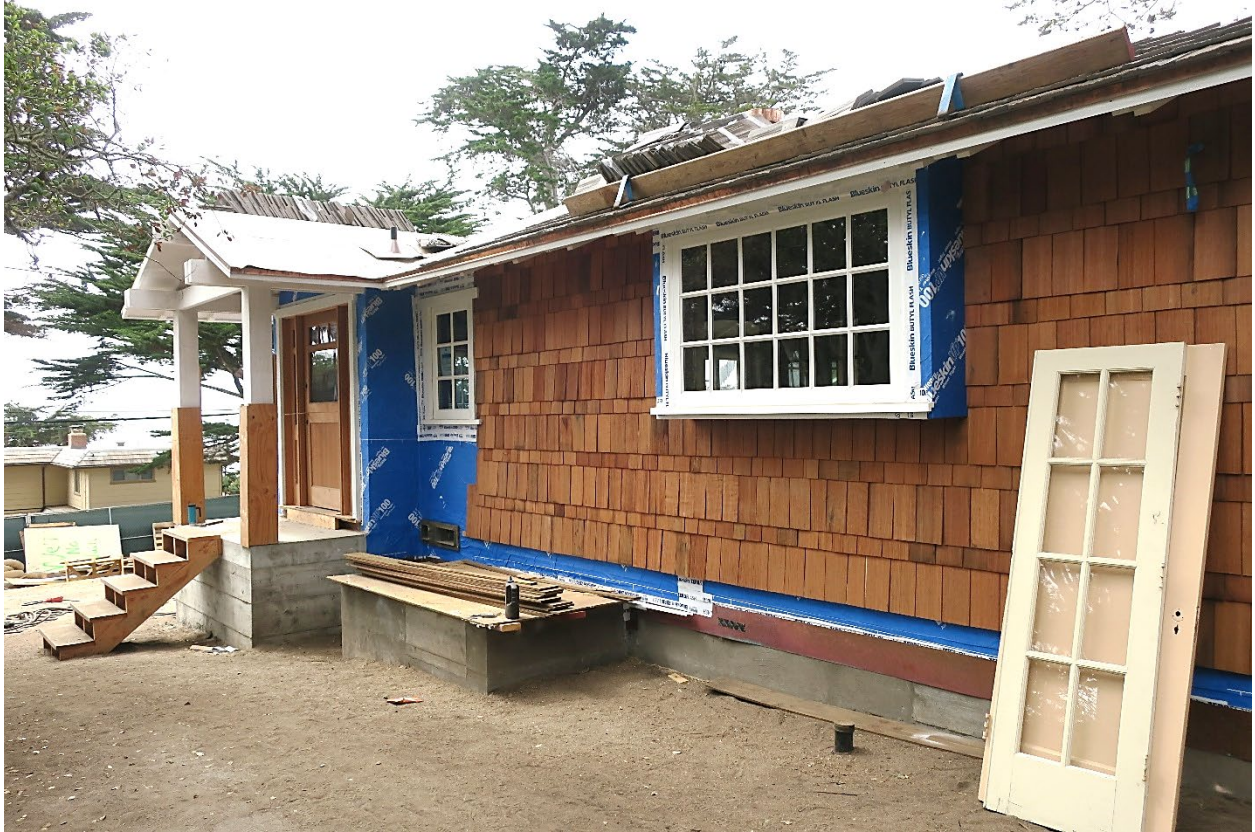
Figure 8: View of new shingles, south elevation.

Standards Two and Six recommend the retention and repair of character-defining features, however both the shingles and horizontal siding were replaced rather than repaired. The architect explained that two different types of shingles were found on the house and submitted photos to staff of the older redwood shingles that were cracked and brittle and cedar shingles that were in better shape. Preservation Brief 47 (*Maintaining the Exteriors of Small and Medium Sized Historic Buildings*. National Park Service, June 2007) states that, “One of the advantages of wood shingles as a wall covering is that individual shingles that are damaged can easily be replaced.” According to Standard Six, documented deteriorated features can be replaced in-kind. As such, the replacement of the redwood shingles is consistent with the Standards due to the documented deteriorated condition. The cedar shingles were replaced as well; however, because they were not original and were installed outside the period of significance (1923) the completed work is consistent with Standards Two and Six.

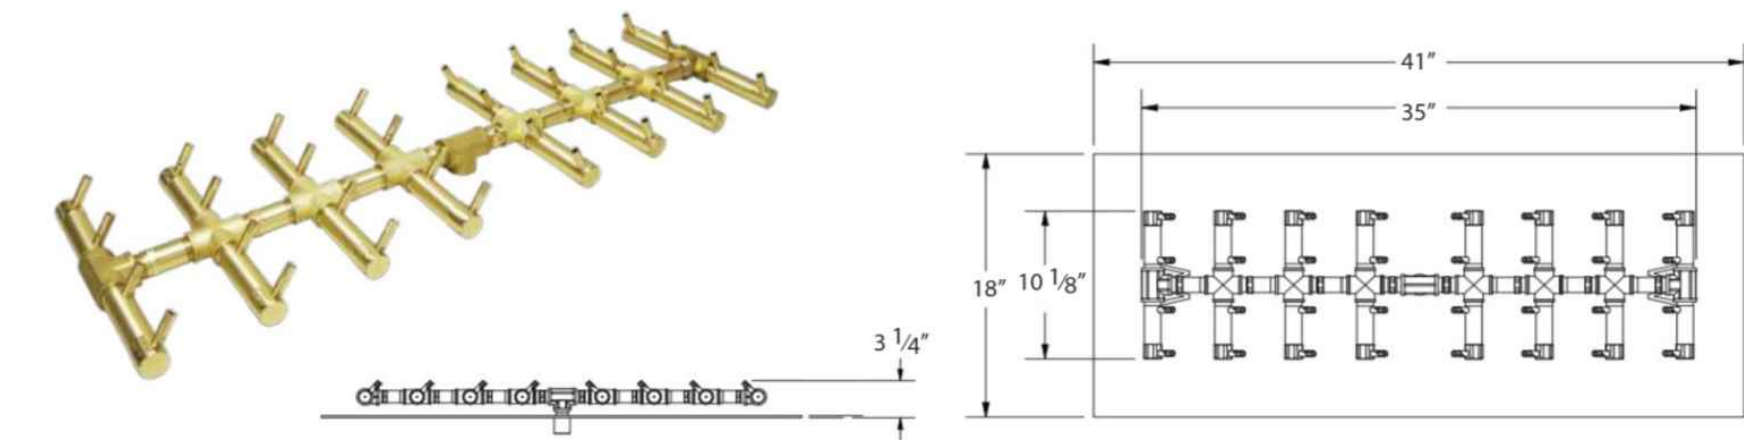
DOUBLE TREE-STYLE CFBDT320 - For 41" x 18" opening or larger

SKU (NG OR LP)	DESCRIPTION	SHIP WEIGHT	SHIP METHOD
CFBDT320NG CFBDT320LP	320K BTU Double-Tree-Style Brass Burner	18 lbs	SHIPS PARCEL
Recommended parts - Plate: ALPL4118 • FK2 • Optional 6x Support Collars			
CFBDT320NGALPL4118 CFBDT320LPALPL4118	with 41" x 18" Rectangular Plate		SHIPS FREIGHT
CFBDT320NGALPL4118FK2 CFBDT320LPALPL4118FK2	with 41" x 18" Plate + FK2		SHIPS FREIGHT

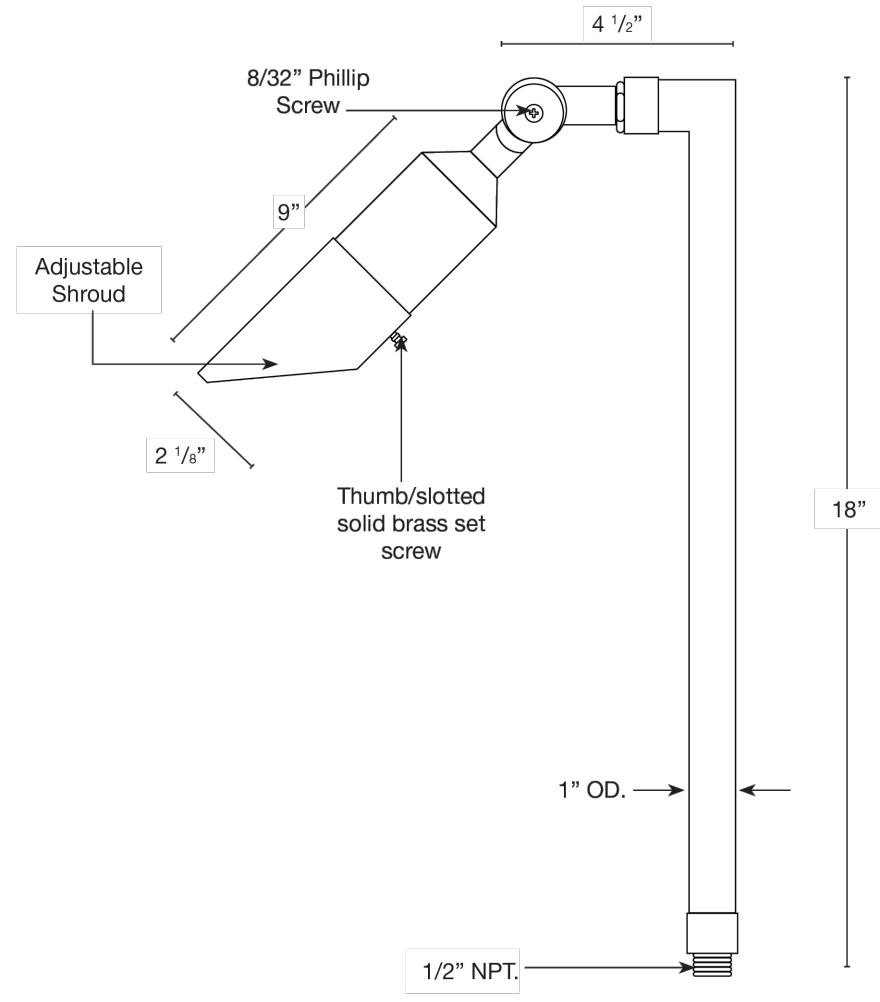
SPJ LIGHTING Inc. <small>ARCHITECTURAL LANDSCAPE & OUTDOOR LIGHTING</small>		SPECIFICATION SHEET	Contemporary Path Lights SPJ18-16

MODEL: SPJ18-16 MATERIAL: Solid Brass FINISH: Matte Bronze ELECTRICAL: 8-15V ENGINE: FB-3W-CYL-TA16 LUMENS: 200 COLOR TEMP: 2700K MOUNTING: 1/2" NPT, Dual Fin Spike Included Niche LED:

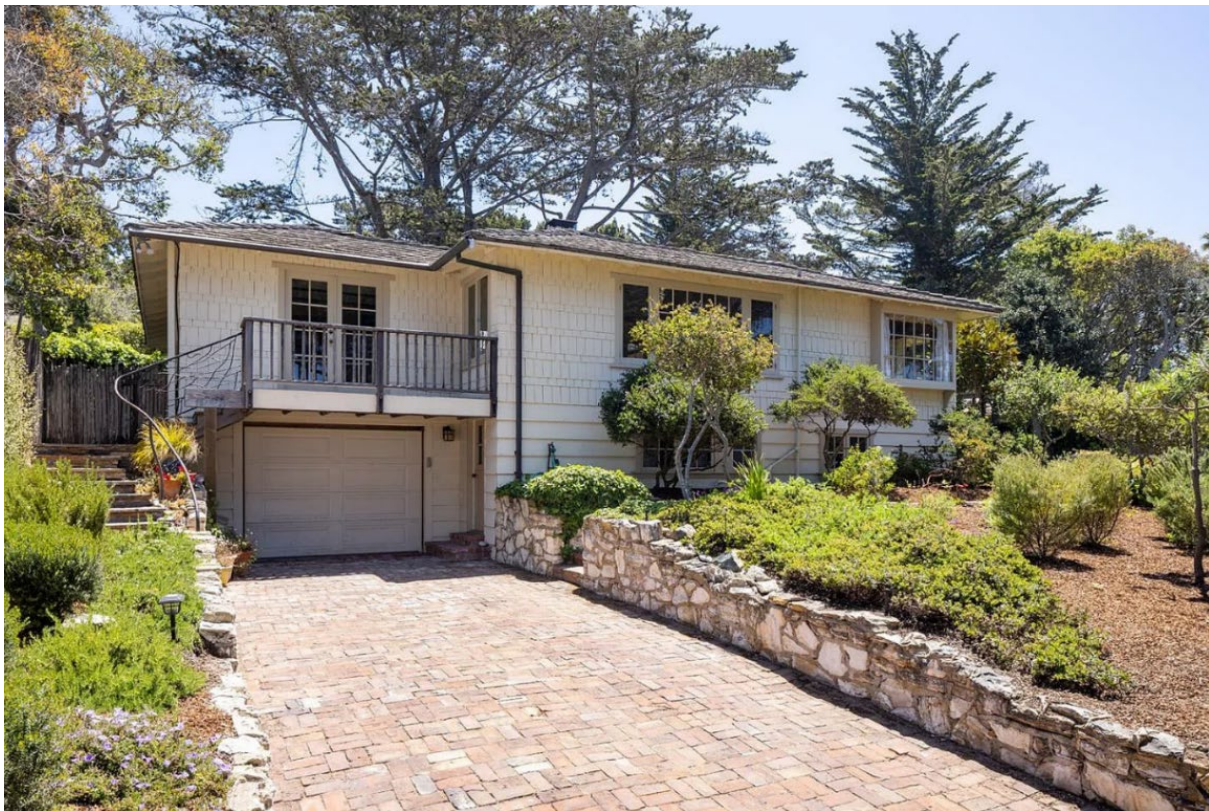
Figure 1: View of the brick driveway, retaining walls, and staircase in 2022.

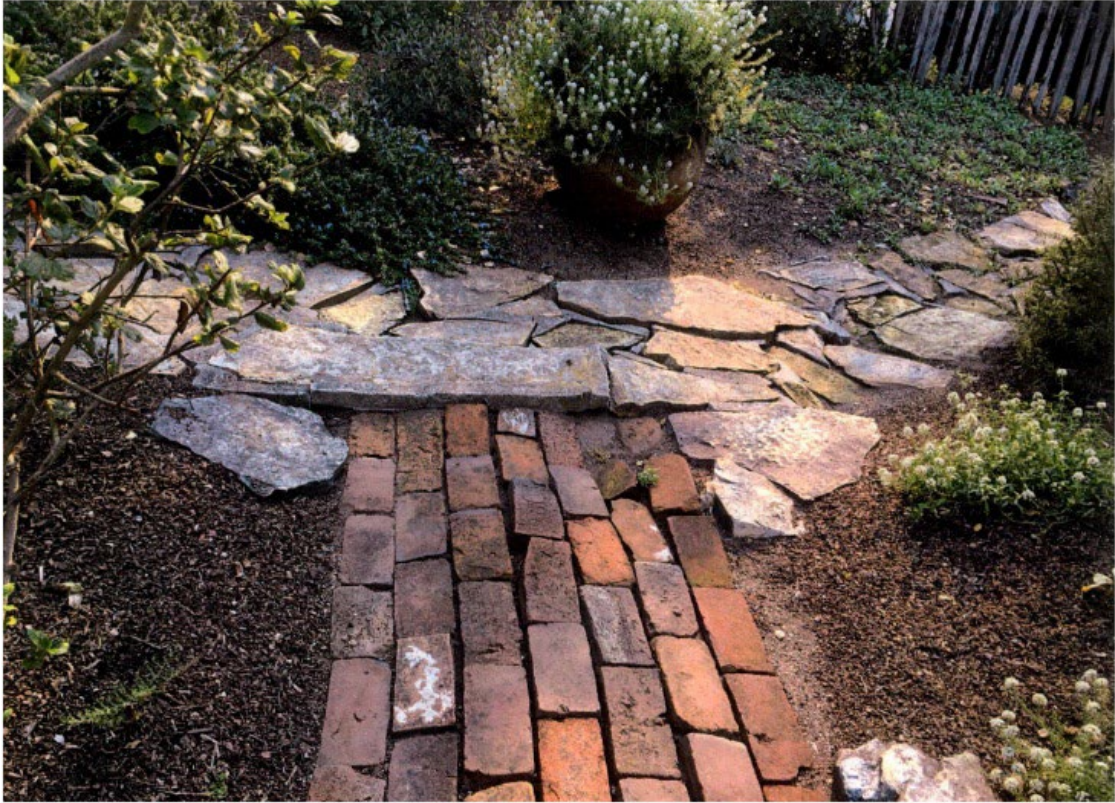
Figure 1: Detail of pre-replacement walkway materials, 2018.

- 3. The current pathways will be removed and reconfigured. The non-historic pathway materials that date to 2018 will be replaced with mulch.*
- 4. Several retaining walls will be added to the property. Some will be faced with a Carmel stone veneer while others will be finished with stucco painted with an integral color.*

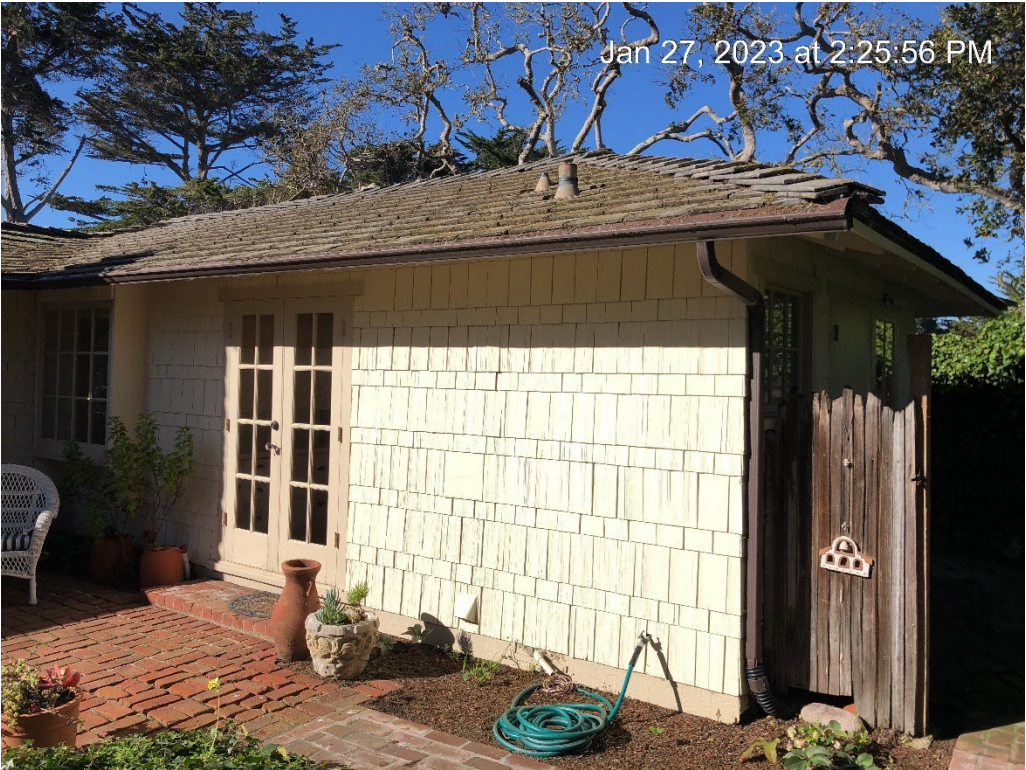
Figure 2: View of original rear patio.

Phase II Addendum. The non-historic patio brick was removed and will be replaced by permeable brick pavers. The original patio was a free-form space edged by a few planters, as depicted in the topographical survey dated September 2022. The current plans proposed a rectangular space bordered by a brick soldier course. It is recommended that a less formal configuration be designed for the rear back patio and omit the soldier course. This will be more consistent with the more informal aesthetic of the Craftsman style.

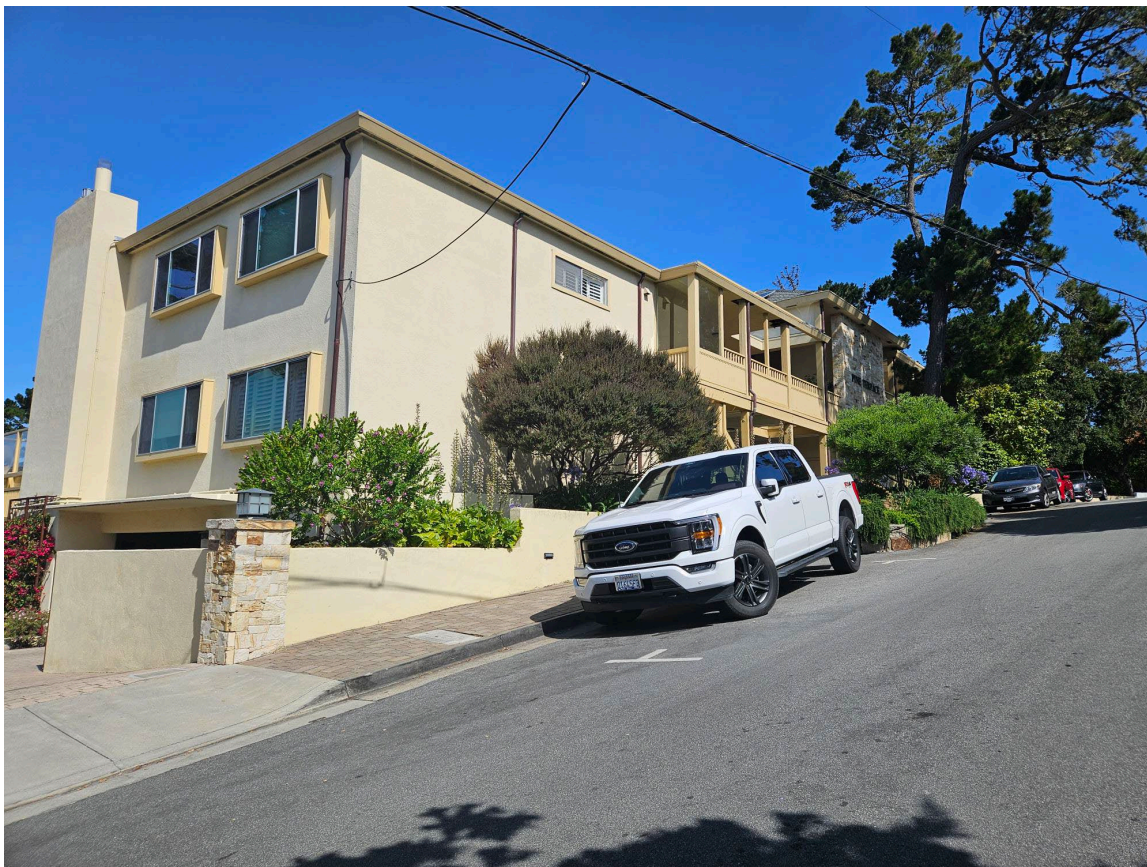
The veneer of Carmel stone was installed in 2006 and covered the original wall of vertical redwood boards. A covered walkway supported by plain square posts runs the length of the second floor. The porch railing has two parts. The lower section has closely set vertical slats. The slats are topped by a narrow strip of vertical wood trim. Exterior stairs from the street level to the second story are located at the southeast corner. Two roof cut-outs along the walkway are covered with bubble skylights. There are two access points to the basement garage – one on the south elevation and one on the north elevation.

Figure 1: Building A looking northwest with view of “boxed” windows.

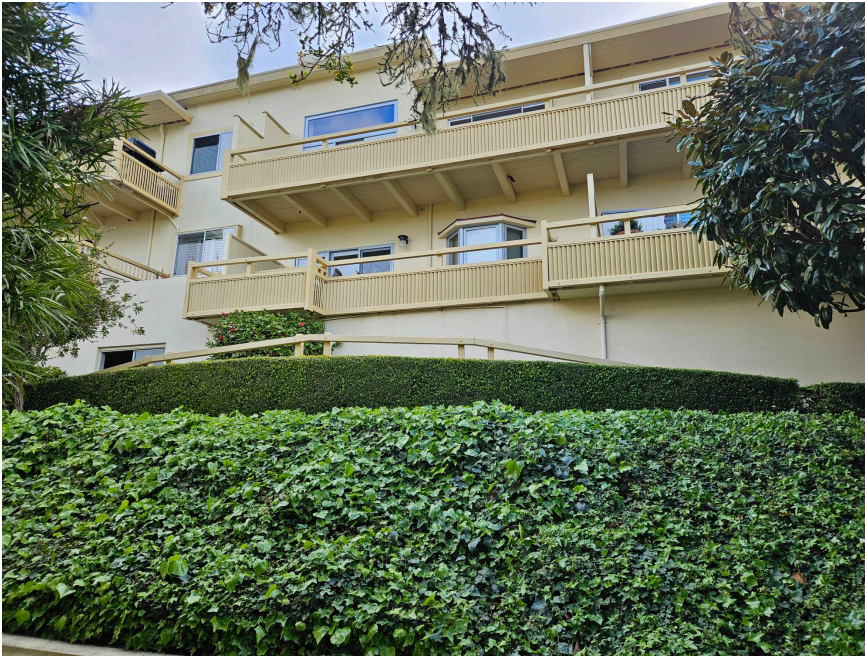
The balconies on the west elevation are accessed by sliding glass doors. Wood partitions divide the balconies between units. The tripartite casement “boxed” windows on the south elevation project from the wall plane. This type of “boxed” window is found throughout the complex. One window on the west elevation (unit A3) was converted into a bay window in 2016.

Figure 2: West elevation of Building A.

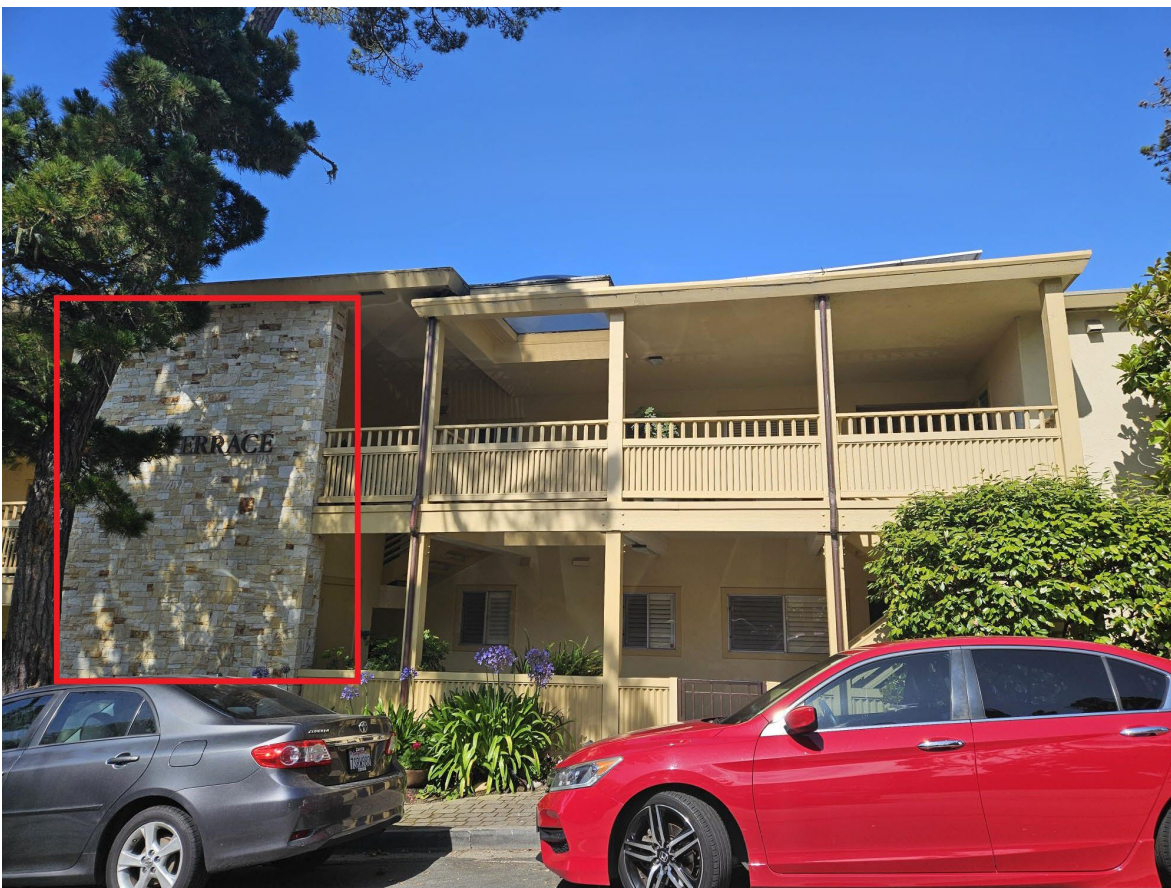
Figure 10: View of altered wall, east elevation Building A.
