# CITY OF CARMEL-BY-THE-SEA FOREST AND BEACH COMMISSION AGENDA

**CITY OF CARMEL-BY-THE-SEA**  
**Forest and Beach Commission**  
**Staff Report**

Staff recommends that the Forest and Beach Commission deny the appeal to remove the 'Significant' Monterey Pine tree at Junipero Street, 6 NE 8<sup>th</sup> Avenue (TR 25-332)

Albert Weisfuss  
ISA Certified Arborist #WE-1388A  
ISA Tree Risk Assessment Qualified  
(831) 869-2767  
[albertweisfuss@gmail.com](mailto:albertweisfuss@gmail.com)  
[montereybaytreeworks.com](http://montereybaytreeworks.com)

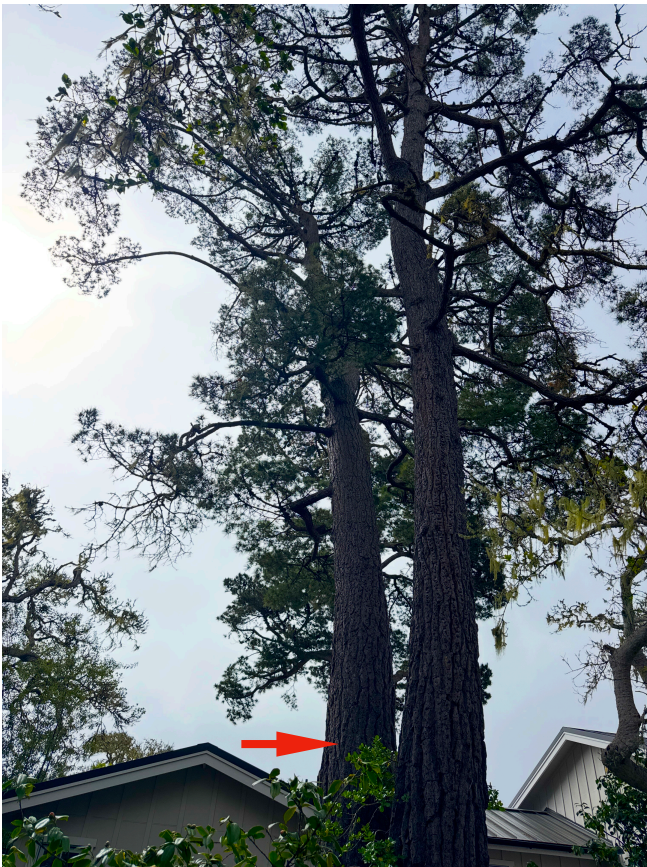
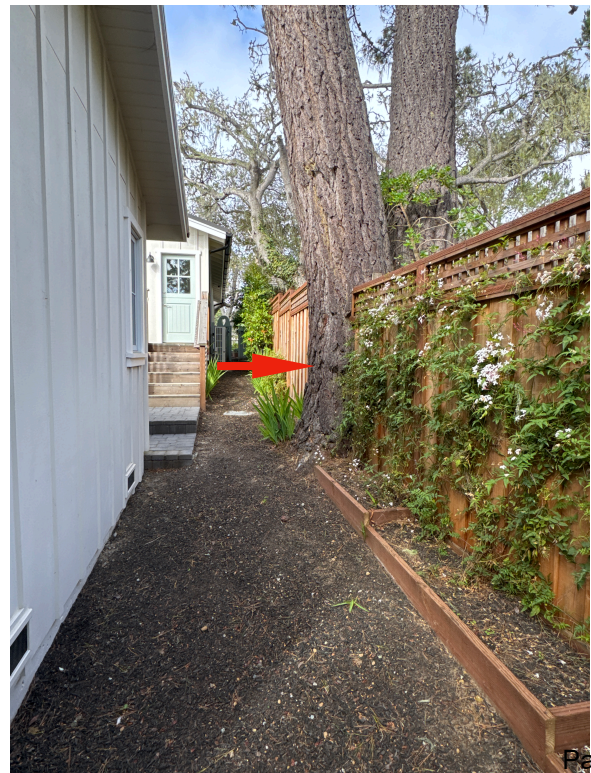
*The subject tree develops on the north property line approximately 10 feet north of the residence.*

*Two trunks are visible from Junipero Avenue, with both canopies extending above surrounding trees. Upon entering the property the subject tree was observed developing directly on the north property line, while a second trunk was located behind a fence running east to west*

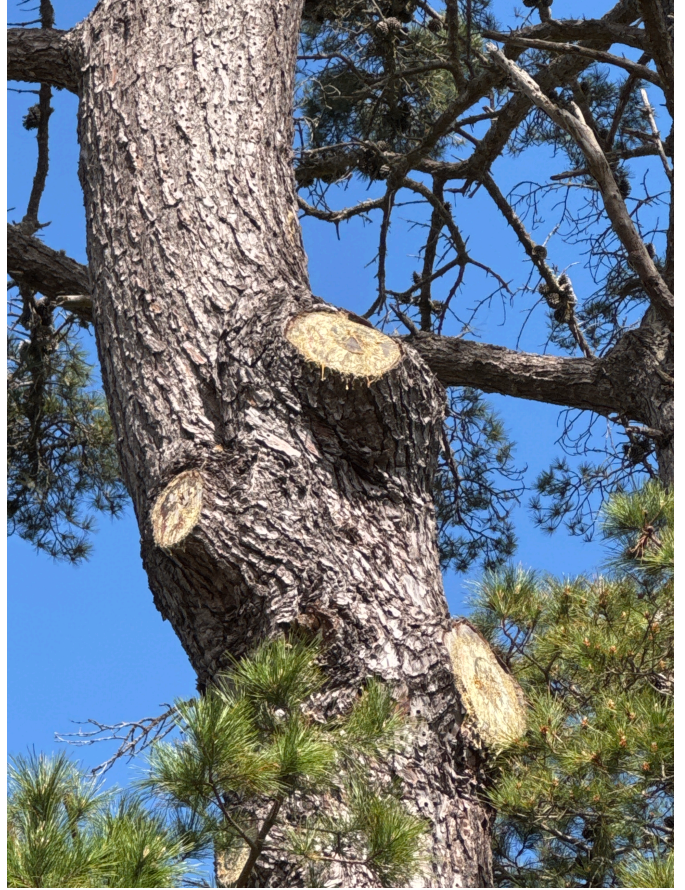
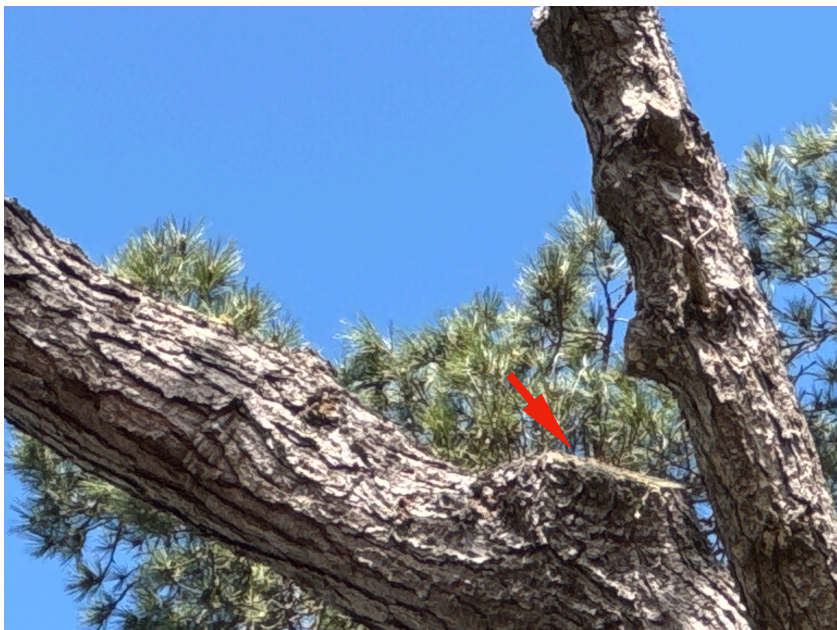
*Poorly compartmentalized pruning wounds in pine species often serve as entry points for decay fungi, weakening structural wood over time*

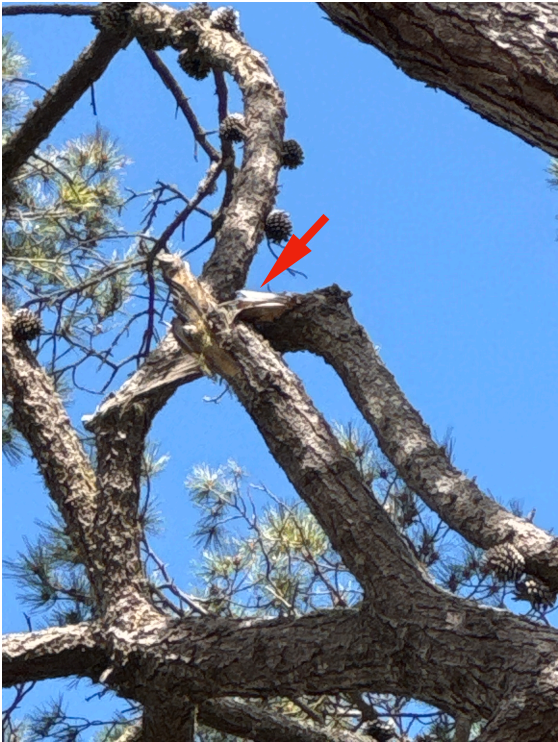
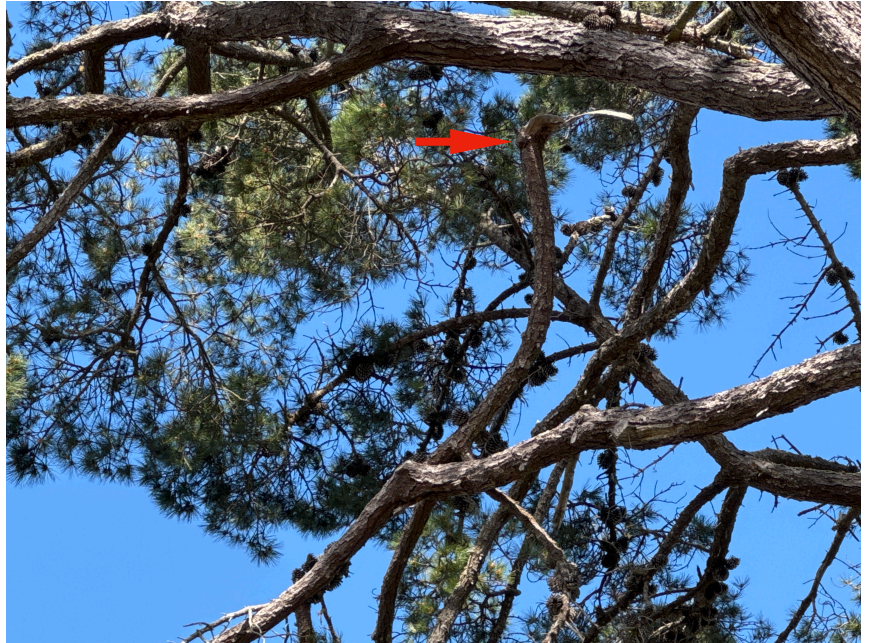
*Evidence of current and historical storm damage was present throughout the canopy.*

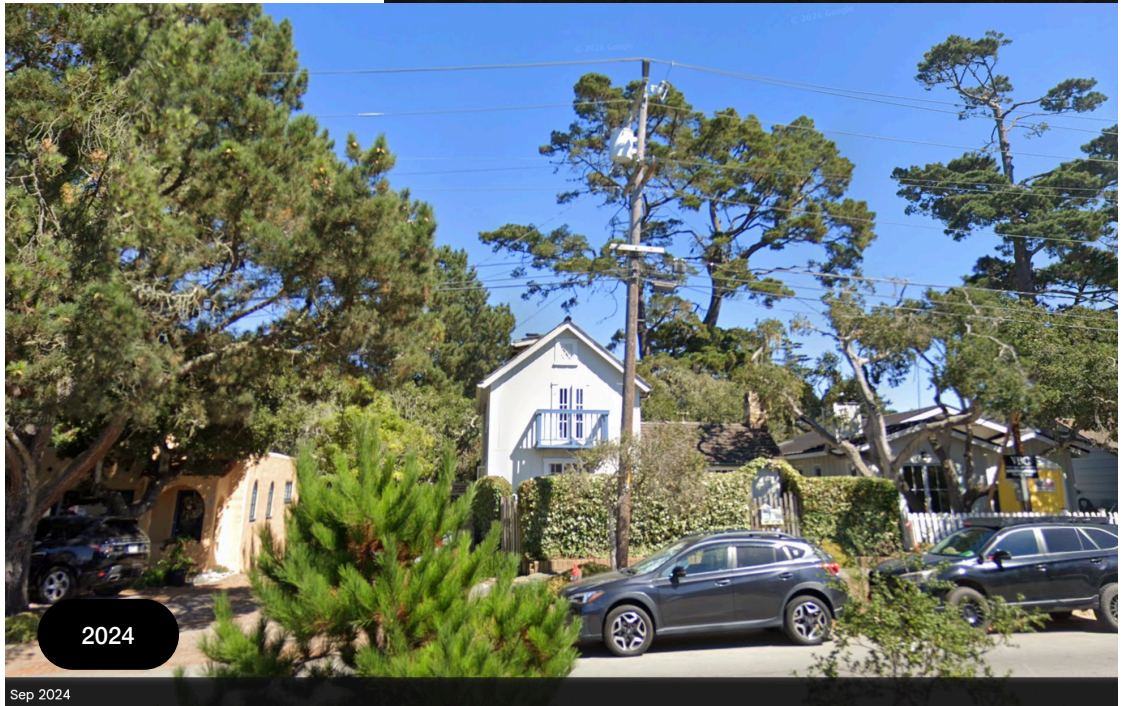
2024

*Loss of surrounding canopy coupled with existing structural defects has likely accelerated the current decline and structural vulnerability observed today.*
