## **CITY OF CARMEL-BY-THE-SEA CITY COUNCIL AGENDA**

## CITY OF CARMEL-BY-THE-SEA CITY COUNCIL Staff Report

# CARMEL-BY-THE-SEA POLICE DEPARTMENT ASSESSMENT REPORT

Prepared by: Indigo | Hammond + Playle Architects, LLP.

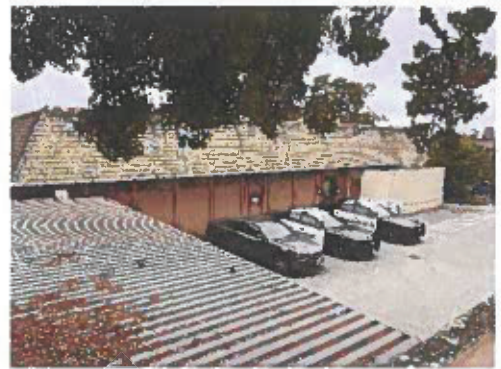
*Figure 2 – View into Existing Non-Secure Patrol Parking Lot from 4<sup>th</sup> Avenue*

- ◆ No immediate short-term site security repairs or replacements are identified, as perimeter fencing would require gates, which would require renovations to provide site circulation space.

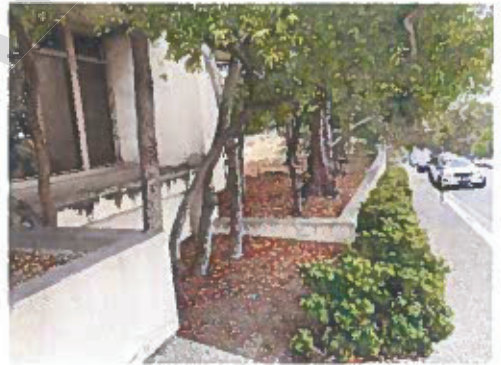
*Figure 3 – Existing Front Landscaping*

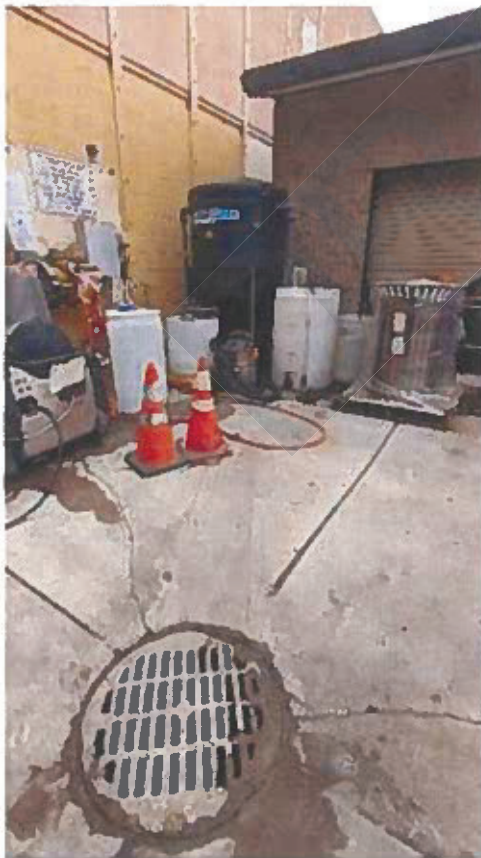
*The storm drainage system serving the courtyard and roof of the Public Works Service Garage needs inspection to determine the source of water leaks into the garage below (Figs. 2-3).*

Figure 12 – Existing storm drain

*The city should have the garage roof and courtyard drainage system inspected to see if it can be determined how water may be entering the garage below and make necessary repairs.*

- ◆ Inspect the DPW Service Garage roof and courtyard drainage system to see if it can be determined how water may be entering the garage below and make necessary repairs.

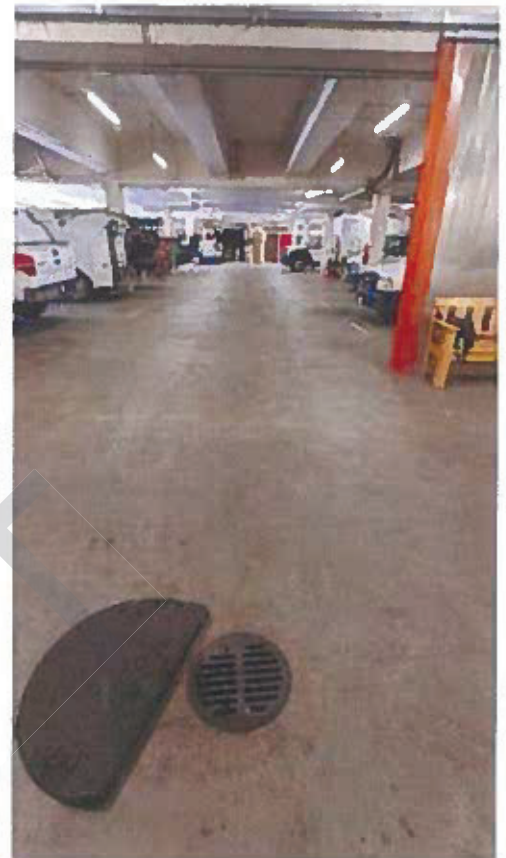
Run a color dye test of the garage floor drains (Fig. 7) to confirm that they discharge to the sewer system and not routed to the onsite storm drain recycled water system (Fig. 8) as such a connection would be a violation of public health code.

Figure 11 – Existing garage floor drains

- ◆ Run a color dye test of the garage floor drains to confirm that they discharge to the sewer system and not the onsite storm drain recycled water system as such a connection would be a violation of public health code.

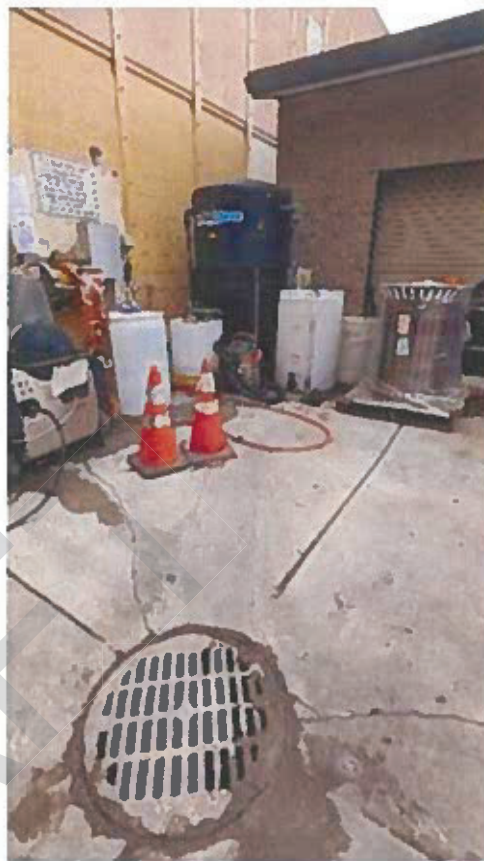
Figure 16 - Existing onsite storm drain recycled water system

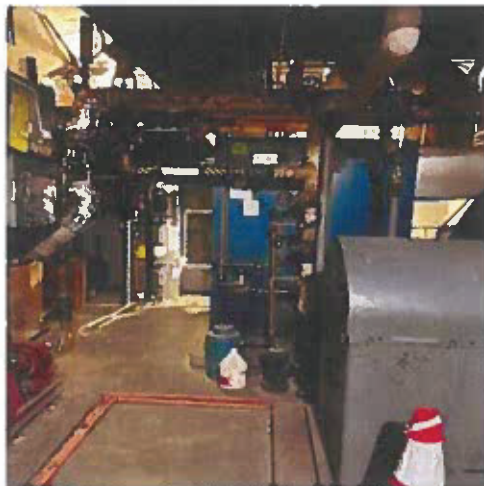
Figure 17 - Existing Hot Water Boiler (Mechanical Room)

*Provide a new, high efficiency heating boiler.*

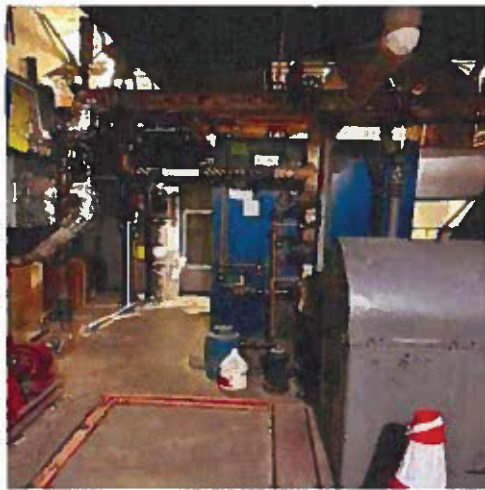
*Figure 18 – Existing Hot Water Boiler (Mechanical Room)*

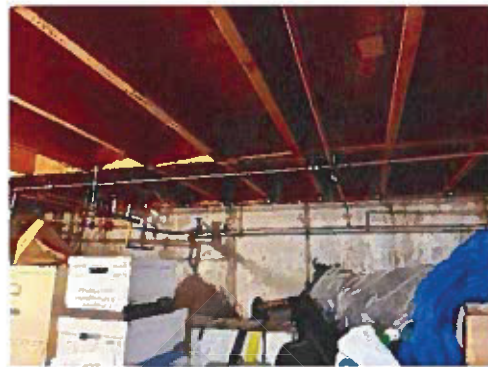
*Figure 19 – Garage Storage - Existing Uninsulated Hydronic Piping*

*Heating hot water piping not insulated. To provide improved, more energy efficient heating for the building the hot water piping for hydronic heating needs to be insulated as soon as possible.*

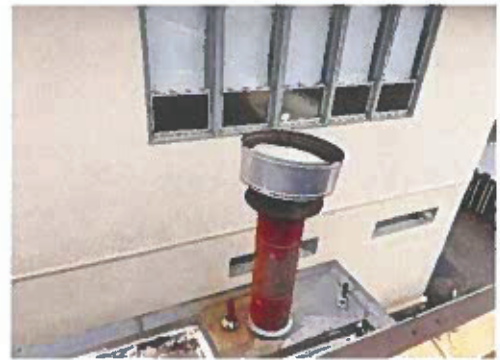
*The boiler flue pipe location does not meet code and needs to be extended to the proper height and location.*

Figure 22 – Existing Hot Water Boiler Flue

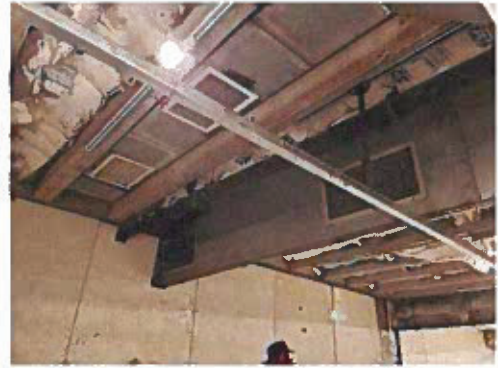
Figure 26 – Existing Shooting Range Exhaust Ventilation

- ◆ The new system should include exhaust ventilation in all necessary areas.
- ◆ The new system shall provide non-cooled airflow during the summer months.
- ◆ This will improve the working conditions for personnel and ensure that the building is properly ventilated.
- ◆ Replace the hot water distribution pumps, piping, ductwork, diffusers control valves, controls and piping.

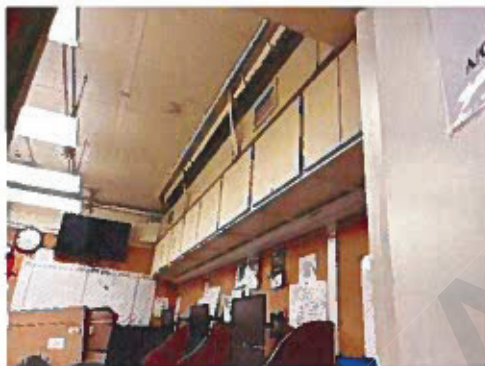
Figure 28 – Existing Shooting Range Supply Ventilation

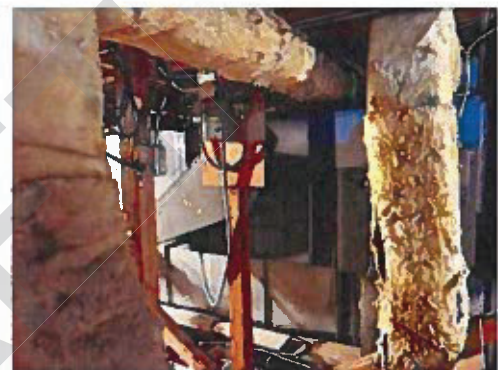
Figure 27 – Existing Air Handler in Attic

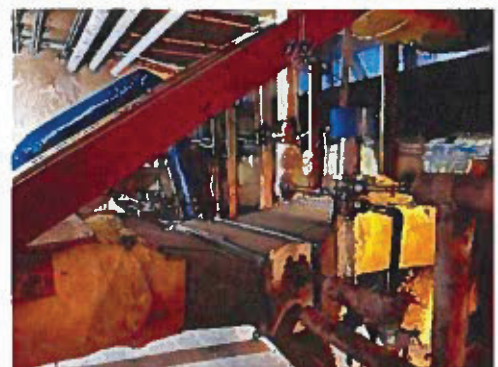
Figure 29 – Existing Hot Water Heating Coil Temperature Control Valve (TCV) in Attic

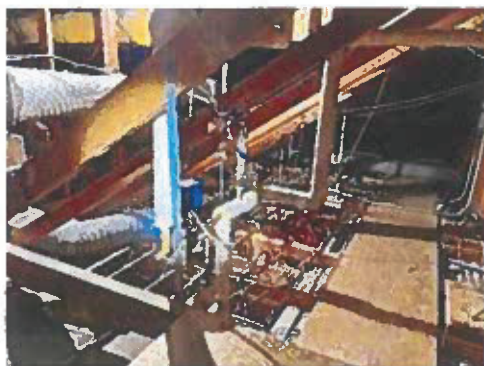
*There are existing non-code compliant and exposed wire splices in the attic.*

Figure 32 – Electrical splices not in electrical box.

*All electrical boxes are required to have covers and wire splices need to be remade and located in electrical boxes as required.*

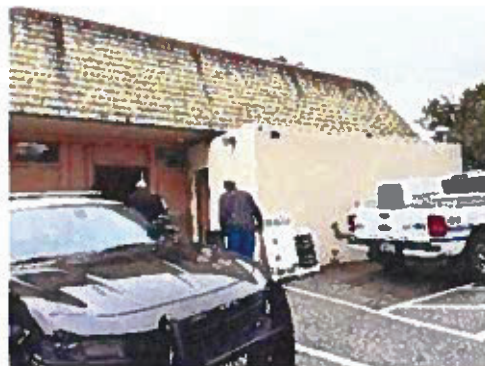
*Figure 35 – Existing parking area light fixture*

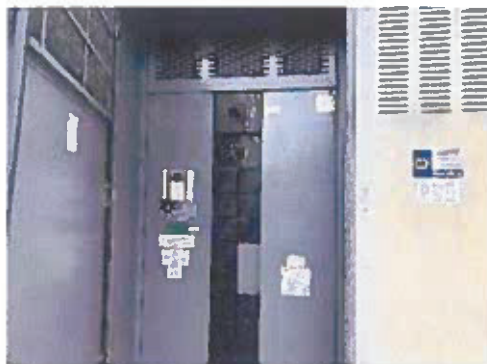
The breakers in the emergency power distribution switchboard are not labeled for the loads supported as required by the electrical code.

Figure 38 - Existing power distribution switchboard

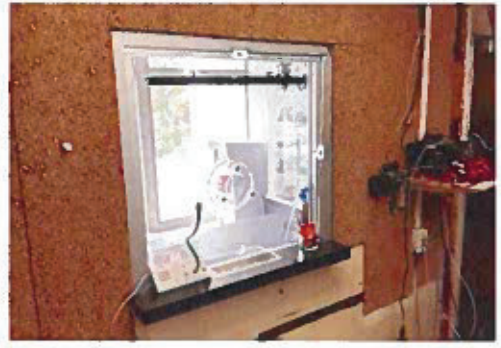
*Figure 46 - Existing Reception Window*

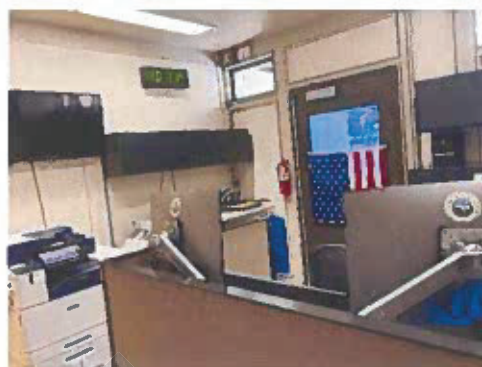
Figure 47 – Existing Staff Entry & Dispatch Workstations & Copy Area

*Some walls and doors have failing paint. Where some walls have been modified, there are no finishes and bare gypsum and wood are exposed. Some ceiling tiles are damaged. Flooring is worn and near the end of its useful life. Fixtures, receptacles, switches, and low-voltage wiring are loose and exposed in many locations throughout the building.*

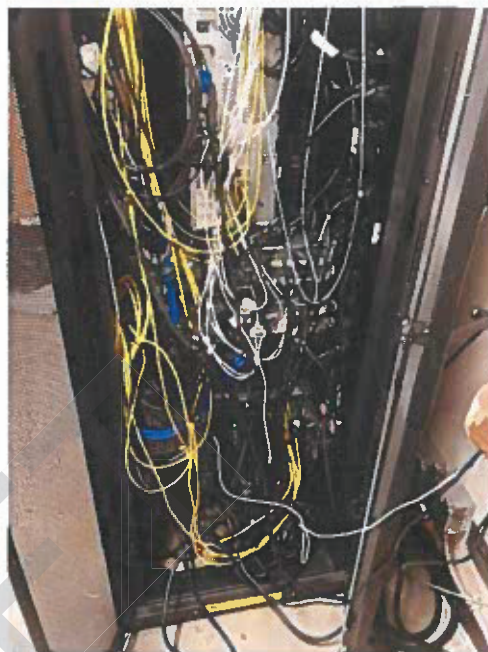
Figure 50 - Existing floor mounted security cabinet

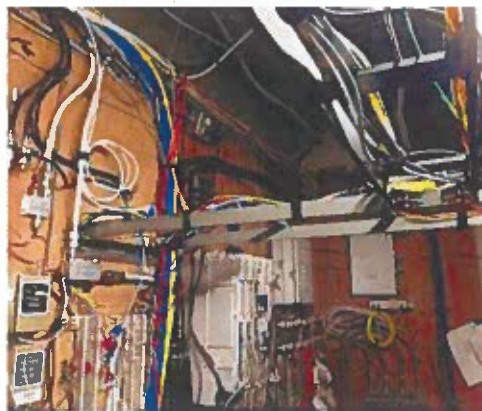
Telecommunications system revolves around the intermediate level MPOE/MDF room 207. All service providers copper, fiber, and coaxial lines feed into this room. Many legacy items such as the existing Avaya PBX, abandoned / unused cables, 66-blocks, and equipment can be removed, consolidated, and cleaned up. However, it will be extremely difficult to try to change this room as the service provider point of demarcation and it is recommended that it is kept as such. A floor mounted cabinet within this room houses existing security head end equipment.

Figure 51 - Incoming copper RJ21X, AT&T fiber optic lines, Avaya PBX, and coaxial antenna connections

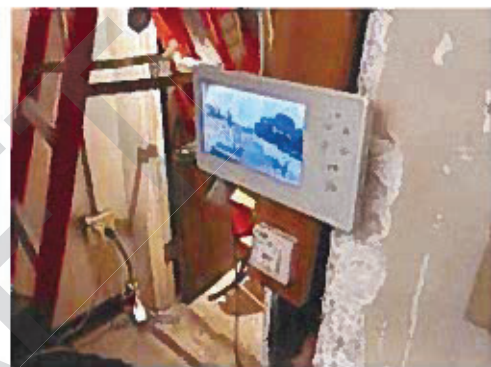
Figure 53 - Aiphone Video Intercom Detail

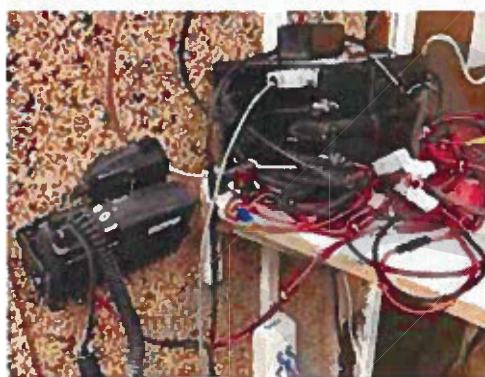
Figure 54 - Motorola Radius SM50 mobile radio head end detail

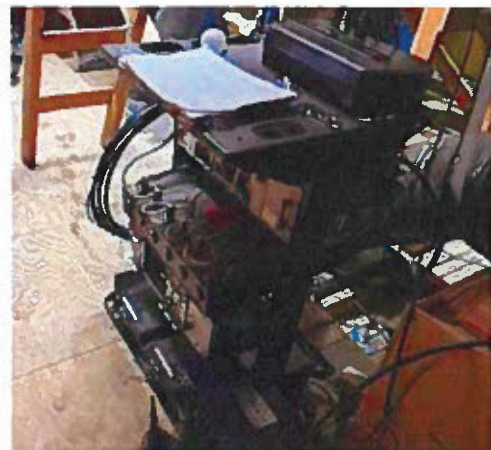
Figure 55 - Existing Motorola amplifiers and distribution

- ◆ *An intermediate station cabling distribution frame (IDF) and Motorola antenna amplifiers and antenna distribution exists in the attic space above the upper level accessible via drop down stairwell in the upper-level corridor. This location can be re-used for new cabling and patch panels, but it is highly recommended that additional plywood flooring be placed for easier / safer access.*
- ◆ *The Motorola Radius SM50 mobile radio head end and power supply, Aiphone JO-1MD Video Intercom, and Intrado 911 cable and equipment reside in the current dispatch area on the upper level and will require special attention to relocate. Each will require secure mounting within floor/wall mounted racks.*

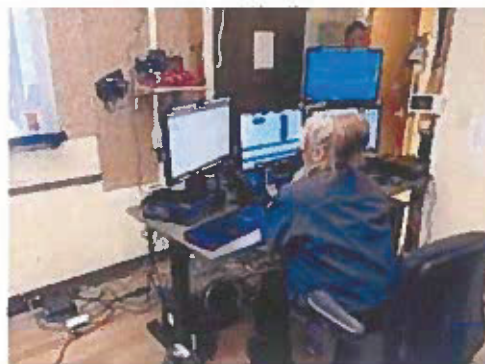
*Figure 56 - Motorola Radius SM50 mobile radio head end and Aiphone Video Intercom*

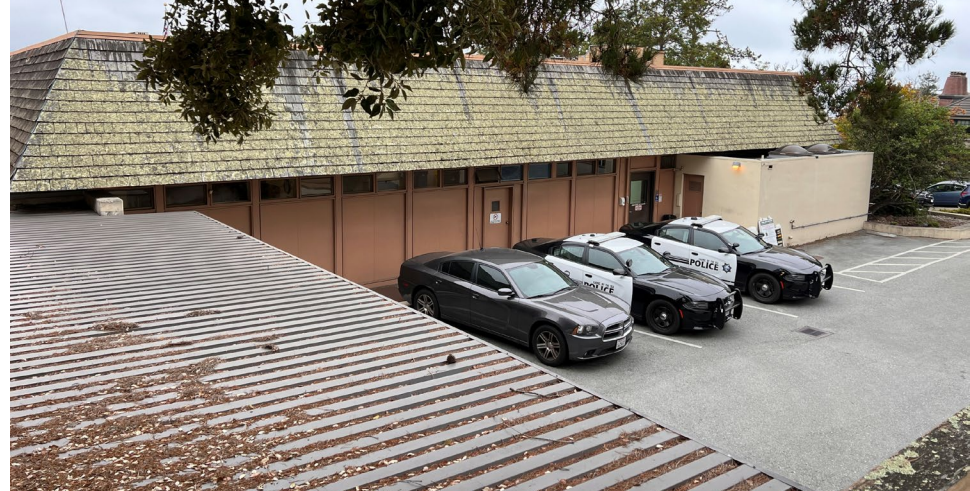
The Police Building site is open to unrestricted access along Junipero Street and 4<sup>th</sup> Avenue, including parking lot. This makes it easy for criminals to target police vehicles and officers, and it also potentially makes it difficult for police officers to respond to calls quickly.

Potential shooters view from 4<sup>th</sup> Ave.

- Provide security fencing / wall at the perimeter.
- Provide police parking sheltered from view.
- Provide motorized vehicular gate.
- Provide new site lighting.
- Provide new site security system.
- Maintain the cloud-based camera system at this facility.

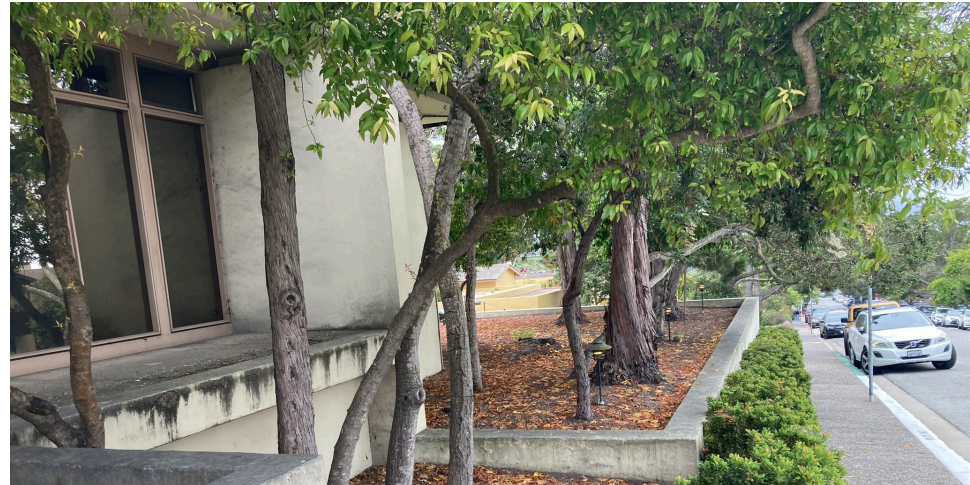
Unimpeded access to Police Building Windows from Junipero Street

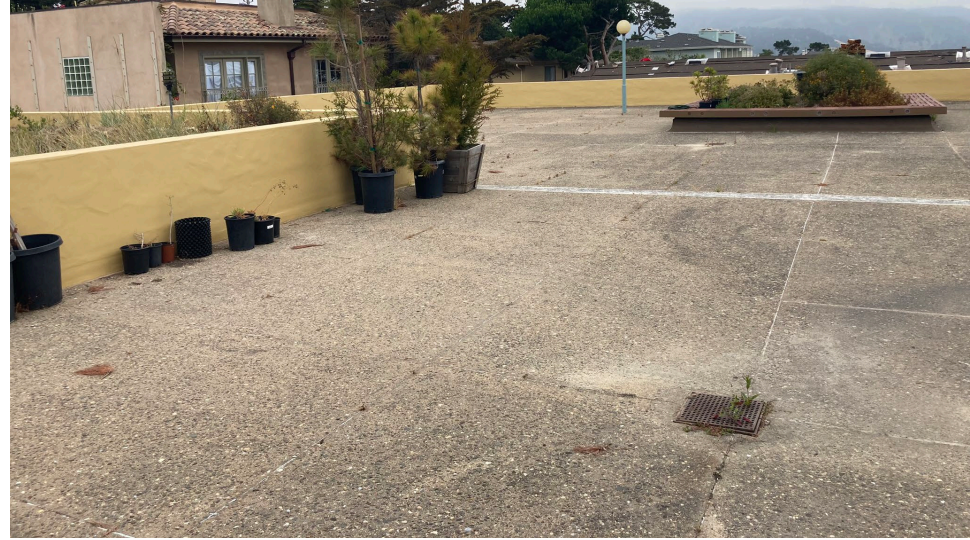
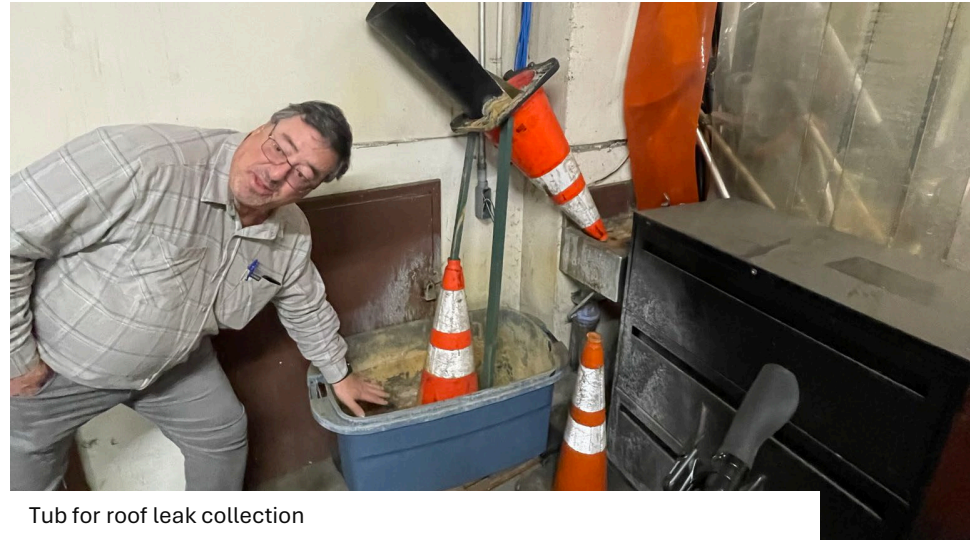
- There is adequate domestic water service; however, no provisions for fire water for fire sprinkler system.
- Plaza Deck drainage system needs inspection to determine source of water leaks into garage.
- Garage below plaza suffers from extensive leakage.
- Garage floor drains may discharge into storm drain system.

Tub for roof leak collection

- Remove all plaza surfaces to allow garage roof repairs.
- Run a color dye test of the garage floor drains to confirm discharge to sewer system.
- Sprinkle both wings of the combined structure for life safety.
- Provide new fire water service.

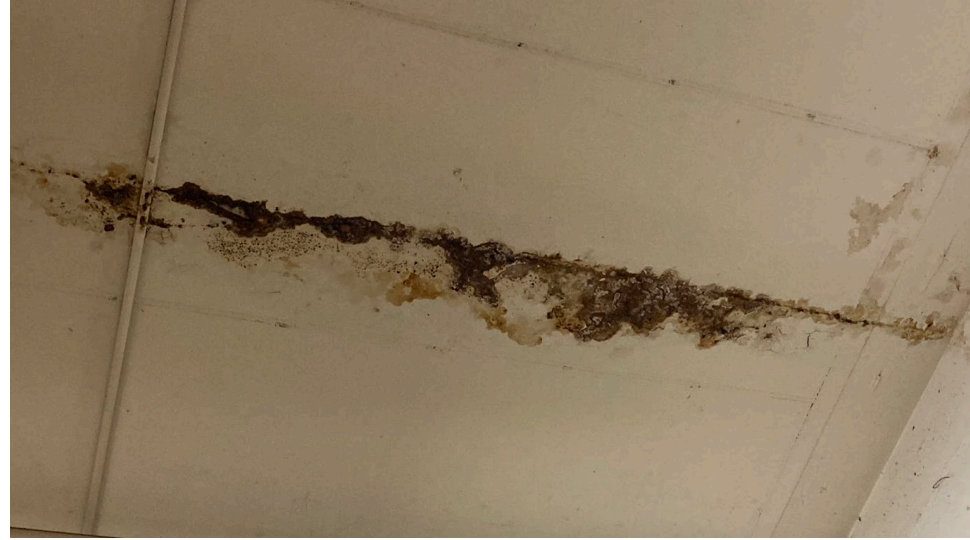
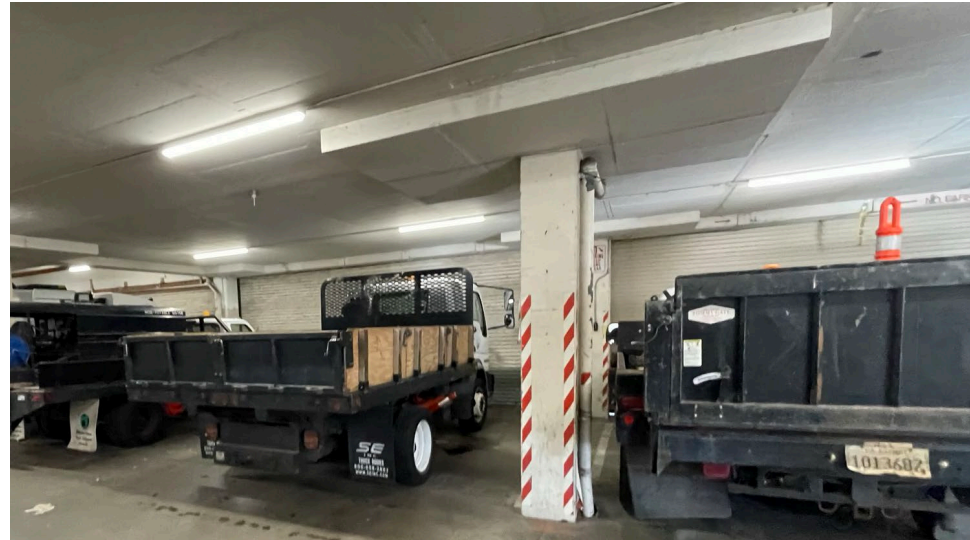
- Police building wood roof is in good condition with no evidence of structural deterioration or damage.
- Concrete walls and floor slabs at Police building appear to be in good condition.
- At the Police building, the attachments of the wood framed roof to the concrete shear walls are inadequate.
- At the Police building, the wood framed roof diaphragm is inadequate.
- Moisture stains through cracks in existing concrete slab, caused by roof leak in garage roof.

- Conduct additional testing to determine the extent of damage to the garage roof structure and the north concrete retaining wall.
- Repair the cracks in the north concrete retaining wall.
- Strengthen attachment of the wood framed roof to the concrete shear walls.
- Introduce additional concrete shear walls and beams at the Police building and garage.
- Strengthen existing concrete columns and beams at garage with FRP wrap.

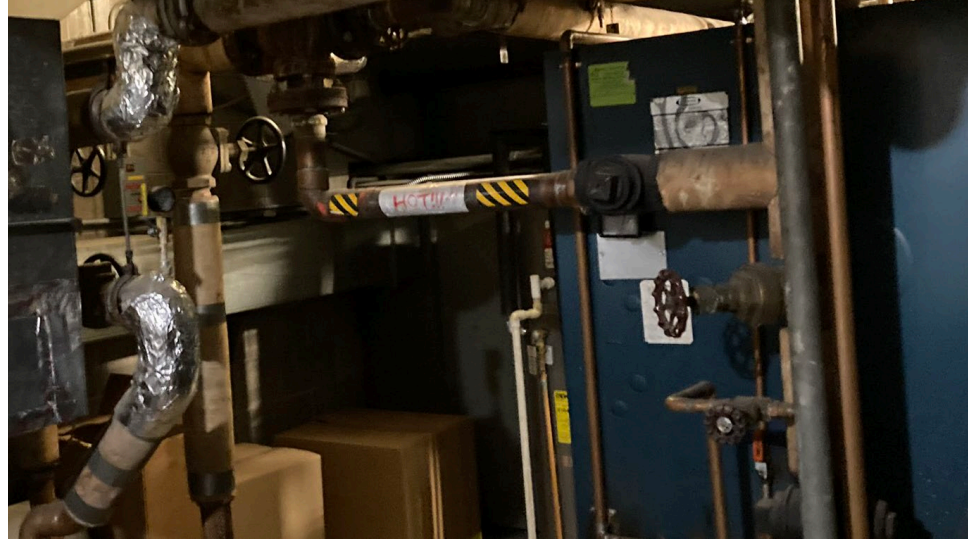
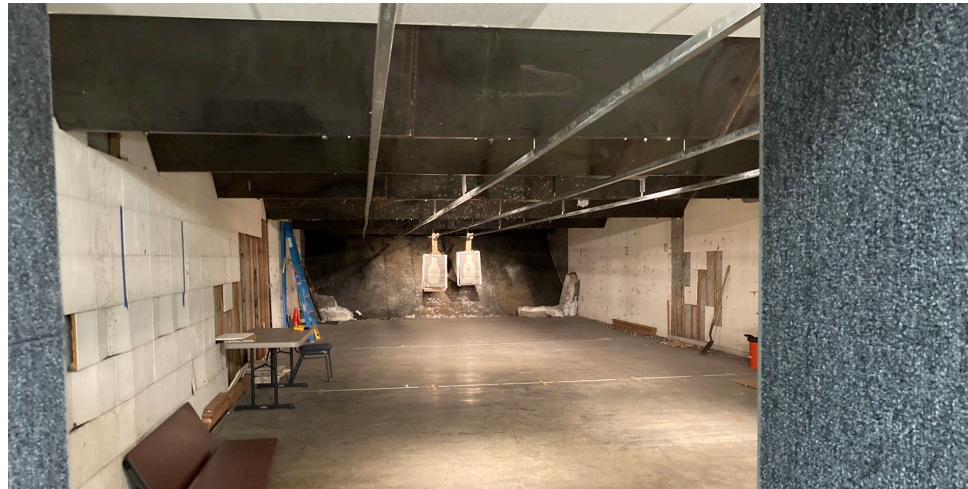
- The existing HVAC systems are old and beyond their useful life.
- Personnel have complained about the lack of exhaust ventilation.
- The evidence room does not have acceptable exhaust. Dangerous materials may be recirculating back into the HVAC system.
- The locker areas are under ventilated.
- Shooting range exhaust system is obsolete and inadequately filtered.
- The boiler flue pipe location does not meet code.
- Heating hot water pipes in the Garage are located almost directly above electrical panels and generator ATS.

Shooting Range

- Provide a new, high efficiency heating boiler.
- Relocate pipes for life safety and code compliance.
- Evidence room needs to be negative and 100% exhausted at no lower than 12 air changes per hour.
- The indoor shooting range ventilation exhaust and filtration system needs to be replaced to meet OSHA requirements for air quality.
- Provide non-cooled airflow during the summer months.
- Replace entire HVAC system.

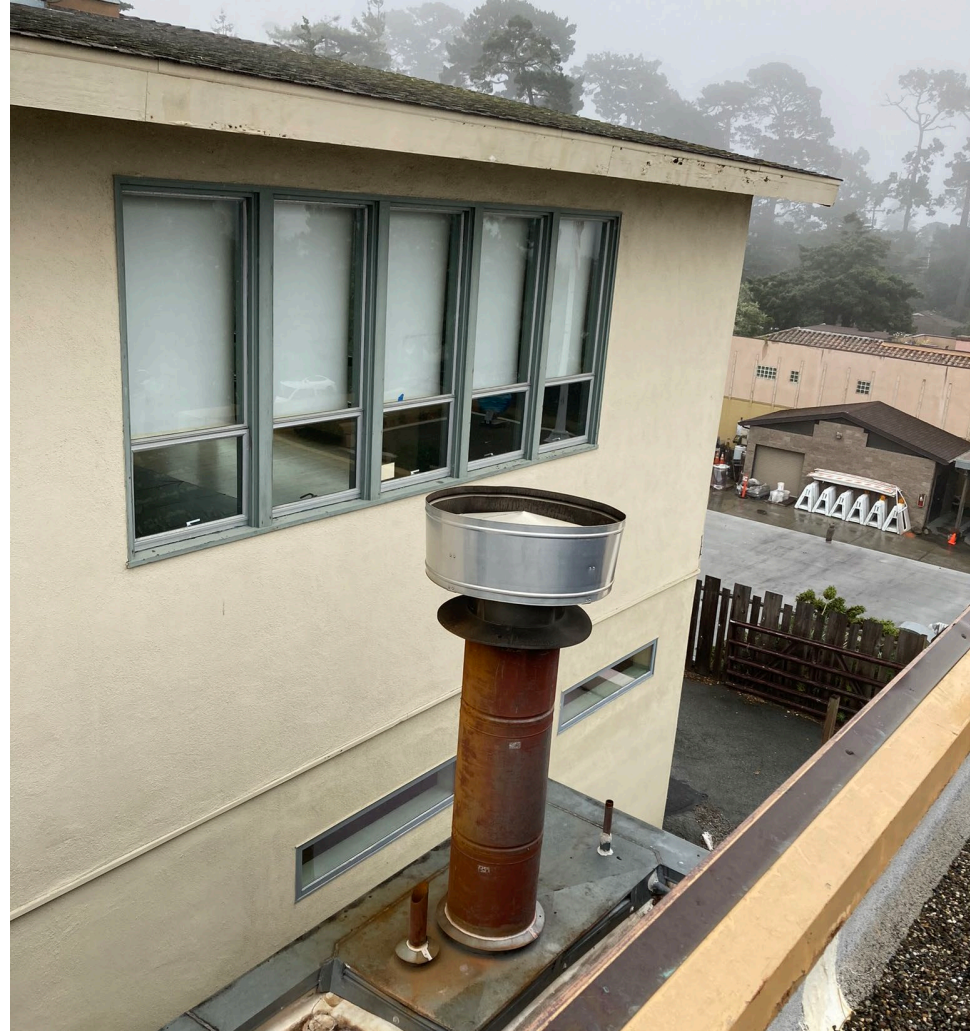
Non-Compliant boiler exhaust

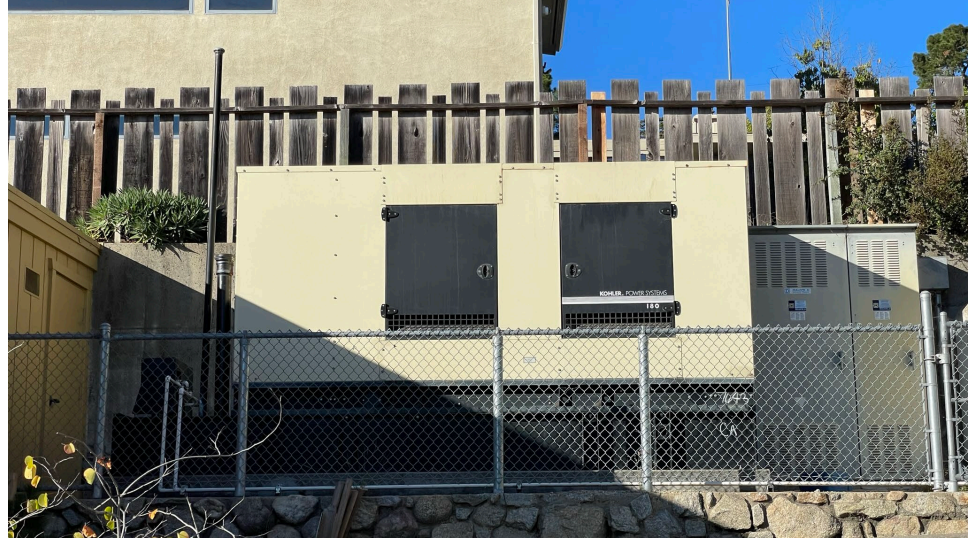
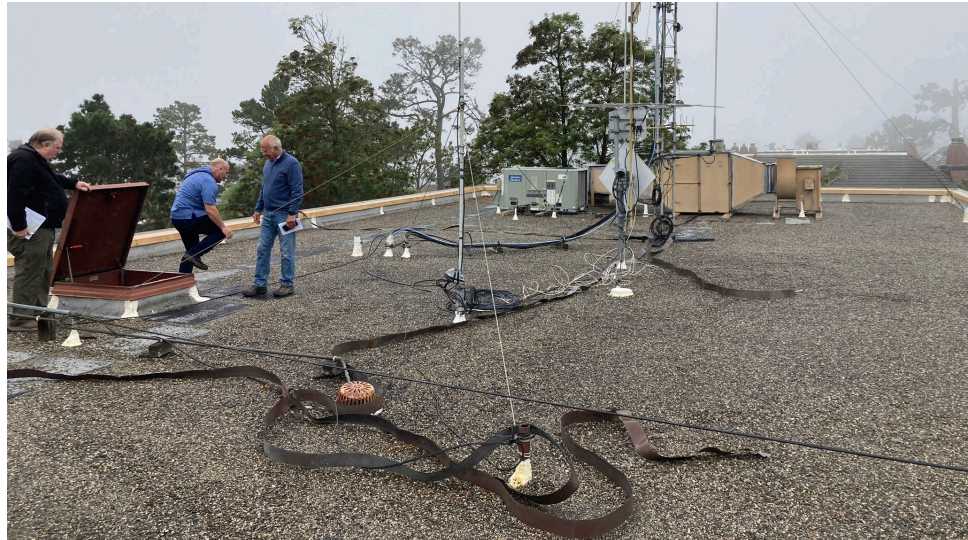
- Power utility service transformer is not compliant with current PG&E standards.
- The roof top lightning protection system has failed. The installation is antiquated and no longer complies with NFPA 780.
- The lighting in the Police parking area is insufficient and is a safety risk.
- The building is supported by an emergency power system that is fairly new.
- The generator's waterproof enclosure tends to leak moisture when it rains.
- The raised platform for the generator has insufficient working clearances.
- The breakers in the emergency power distribution switchboard are not labeled for the loads supported as required by the electrical code.

- Replace all electrical panels.
- Replace all wiring.
- Replace all fire alarm system.
- Replace all interior lighting.
- Replace all exterior lighting.
- Extend generator platform to meet working space requirements per manufacturer and OSHA.

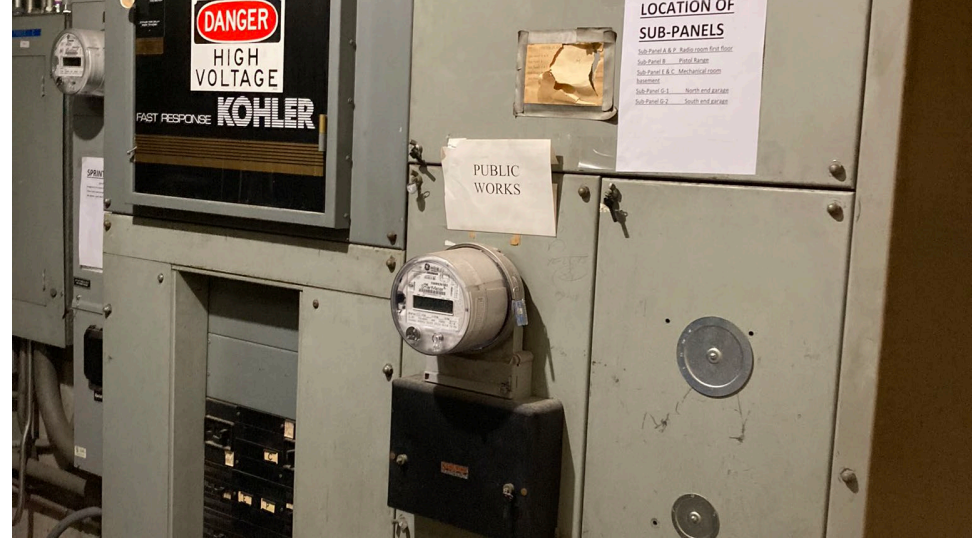
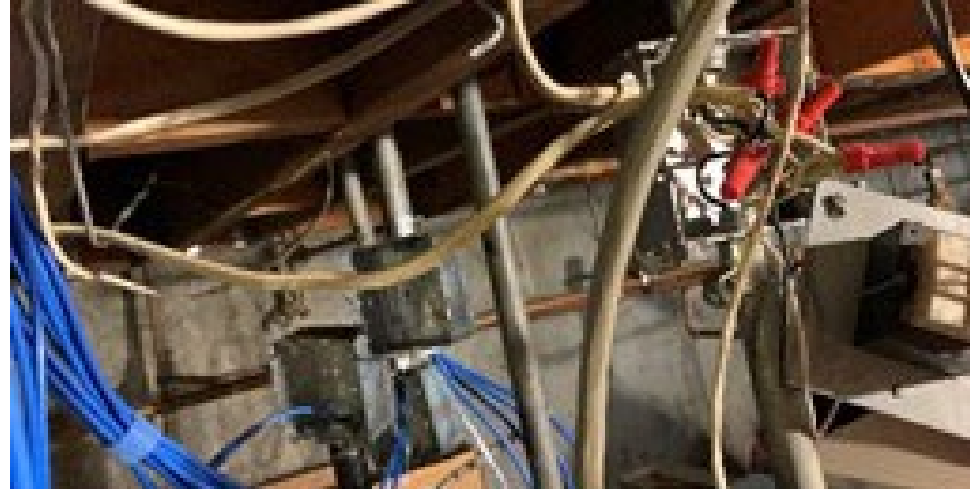
- The existing 400-amp main switchboard and sub panels installed in 1966, at end of useful life.
- No spaces for future breakers, typical.
- No evidence of maintenance testing as recommended by NETA and ANSI.
- Panel nameplates have amperage ratings greater than feeder size, no labels to indicate limited feeder rating.
- Existing non-code compliant and exposed wire splices in attic.
- Electrical boxes missing covers.
- Mounting heights of existing fire alarm control panel and manual pull station do not meet code.
- No remote annunciator located in the lobby.

Electrical box missing cover

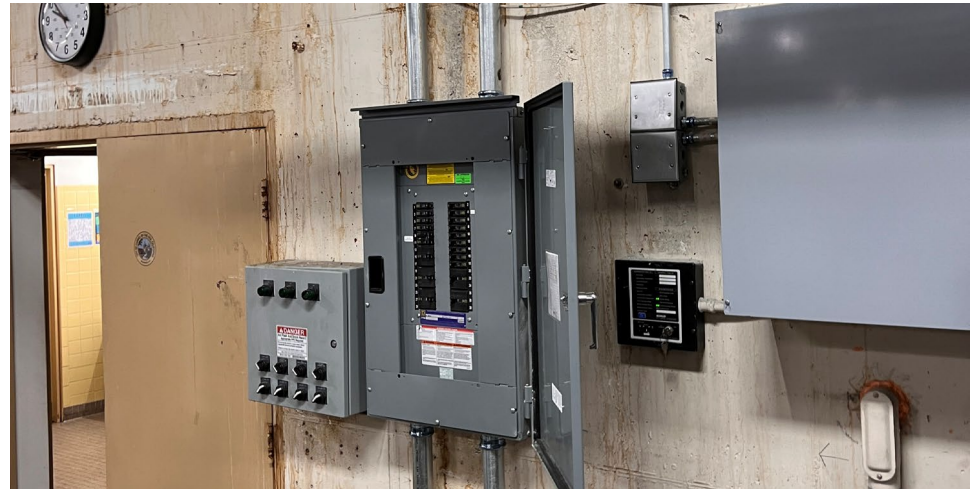
Water intrusion at electrical equipment

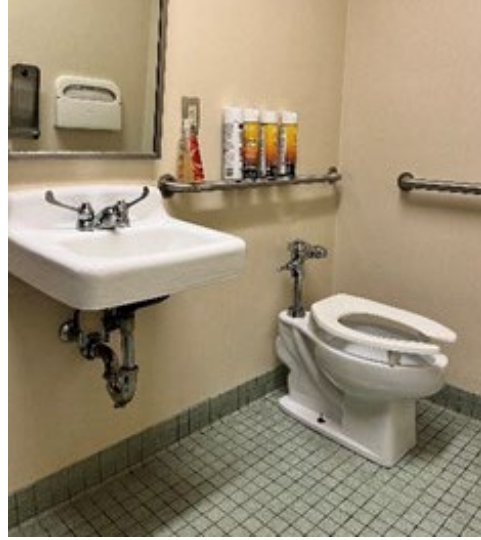
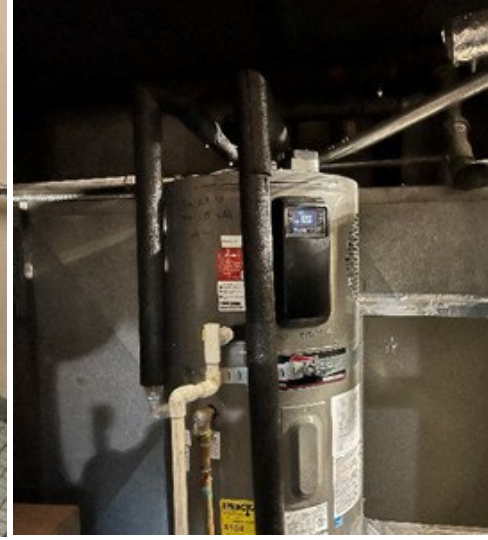
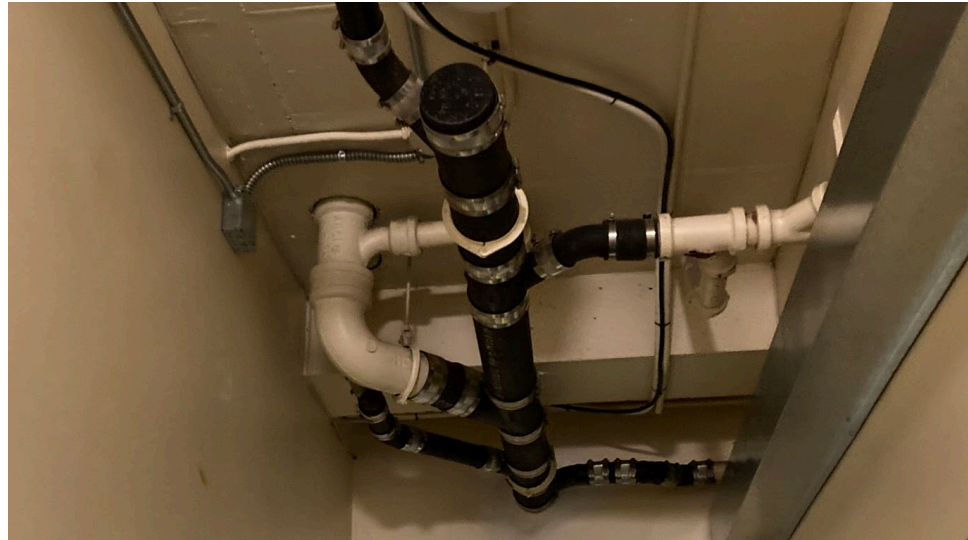
- Existing corroded pipes are likely to leak.
- Clogged sewer lines can cause backups and flooding.
- Restricted water lines can cause low water pressure.
- Buildup of minerals and bacteria in the pipes create unsanitary conditions.
- The water heater recently preplaced, however has no code required expansion tank installed.
- Restroom plumbing fixtures outdated.
- Additional restroom facilities are needed per code.

- Only recommended if entire plumbing system is replaced.
- Install water softeners to remove minerals and calcium buildup from the water.
- Replace all plumbing systems.
- Provide additional restroom facilities.

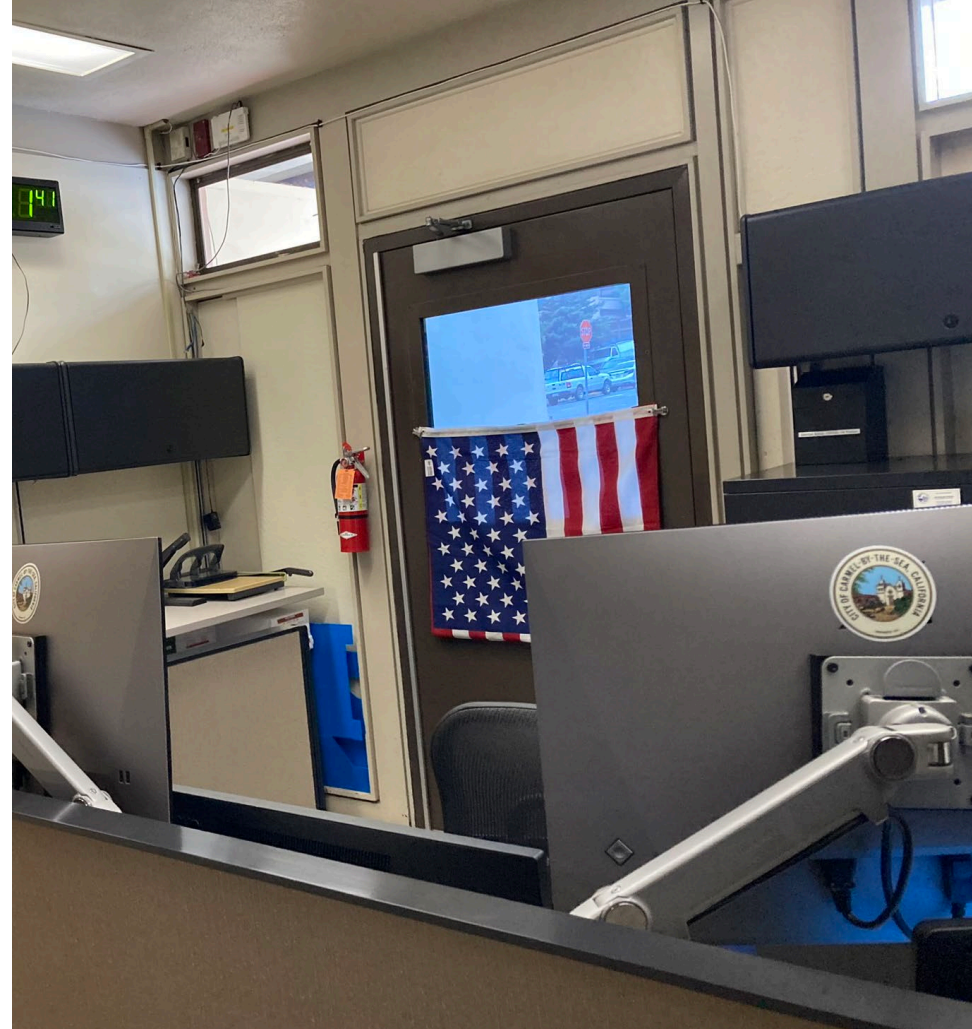
- The Program Assessment has determined that the Police have less than half the space they need to meet minimum standards.
- Exterior walls are uninsulated.
- Single-paned glazing fails to meet current energy code and has poor acoustic properties.
- Numerous leaks through out building.
- Original mansard shingles are failing.
- Hazardous materials like lead and asbestos are present in the building.
- Water intrusion is causing damage to equipment and creating environmental hazards.

Non secure door at dispatch leading to unsecured parking area

- Expand building to provide adequate space for police operations.
- Replace worn architectural systems to meet current code standards.

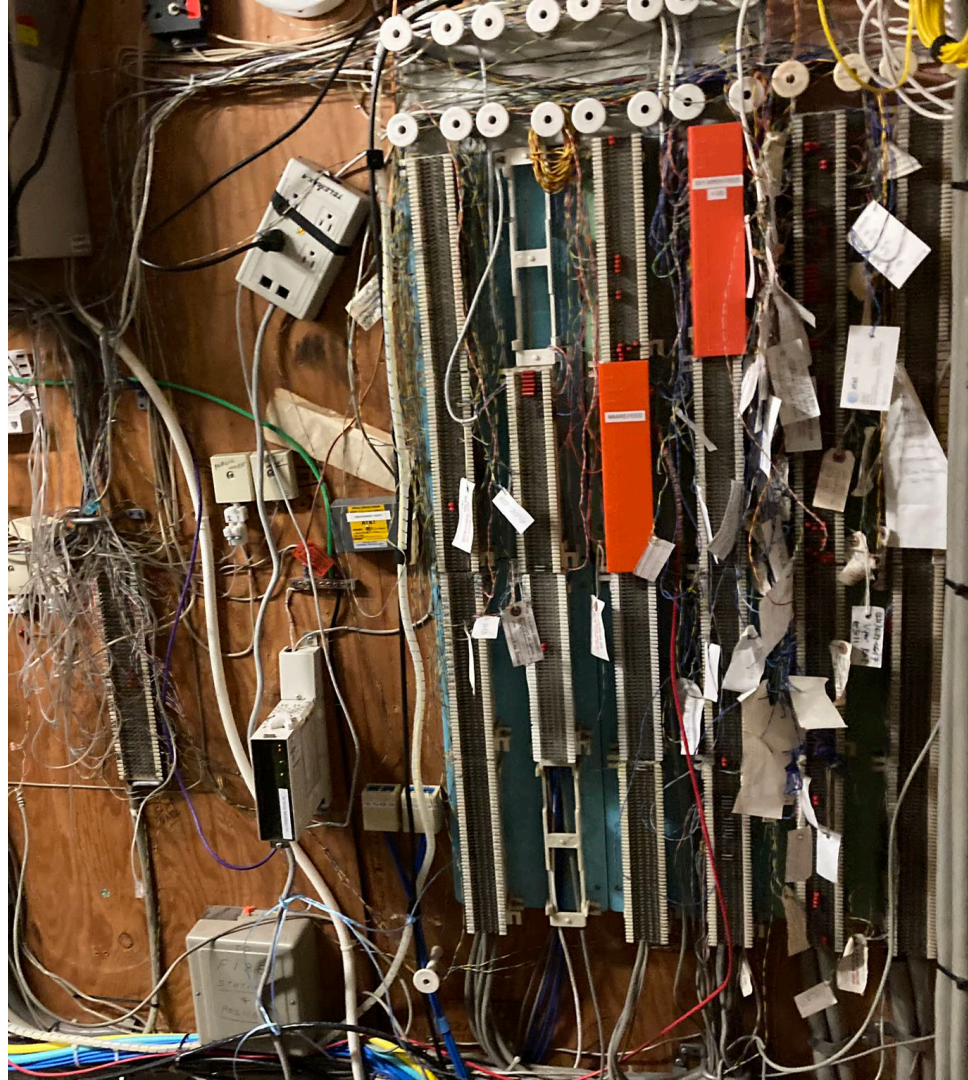
- Many existing legacy equipment unused.
- Floor mounted cabinet houses existing security head end equipment.
- An intermediate station cabling distribution frame (IDF), Motorola antenna amplifiers and antenna distribution exists in the attic. Access cramped and unsafe.
- Radio equipment in current dispatch area should be relocated.

- Remove and consolidate legacy equipment.
- Relocate radio equipment in dispatch area.
- Provide safe access to IDF.
