CITY OF CARMEL-BY-THE-SEA CLIMATE COMMITTEE

1. Receive a presentation from Integral Corp./Haro Kasunich & Associates/EMC Planning Group regarding the results of the Coastal Engineering Condition Evaluation, Task 1, and Shoreline and Beach Change Analysis, Task 2, which is part of the Coastal Engineering Study
2. Review list of Adaptation Strategies for Climate Action and Adaptation Plans and Provide Feedback for Monitoring the Implementation of the Plans

TO:	Climate Committee Members
SUBMITTED BY:	Mary Bilse, Environmental Programs Manager
SUBJECT:	Receive a presentation from Integral Corp./Haro Kasunich & Associates/EMC Planning Group regarding the results of the Coastal Engineering Condition Evaluation, Task 1, and Shoreline and Beach Change Analysis, Task 2, which is part of the Coastal Engineering Study

27 April 2023
Coastal Protection Evaluation 22 December 2022 thru 30 January 2023
Carmel Adaptation Plan - Carmel Beach All Areas
Project No. 12176
Page 19

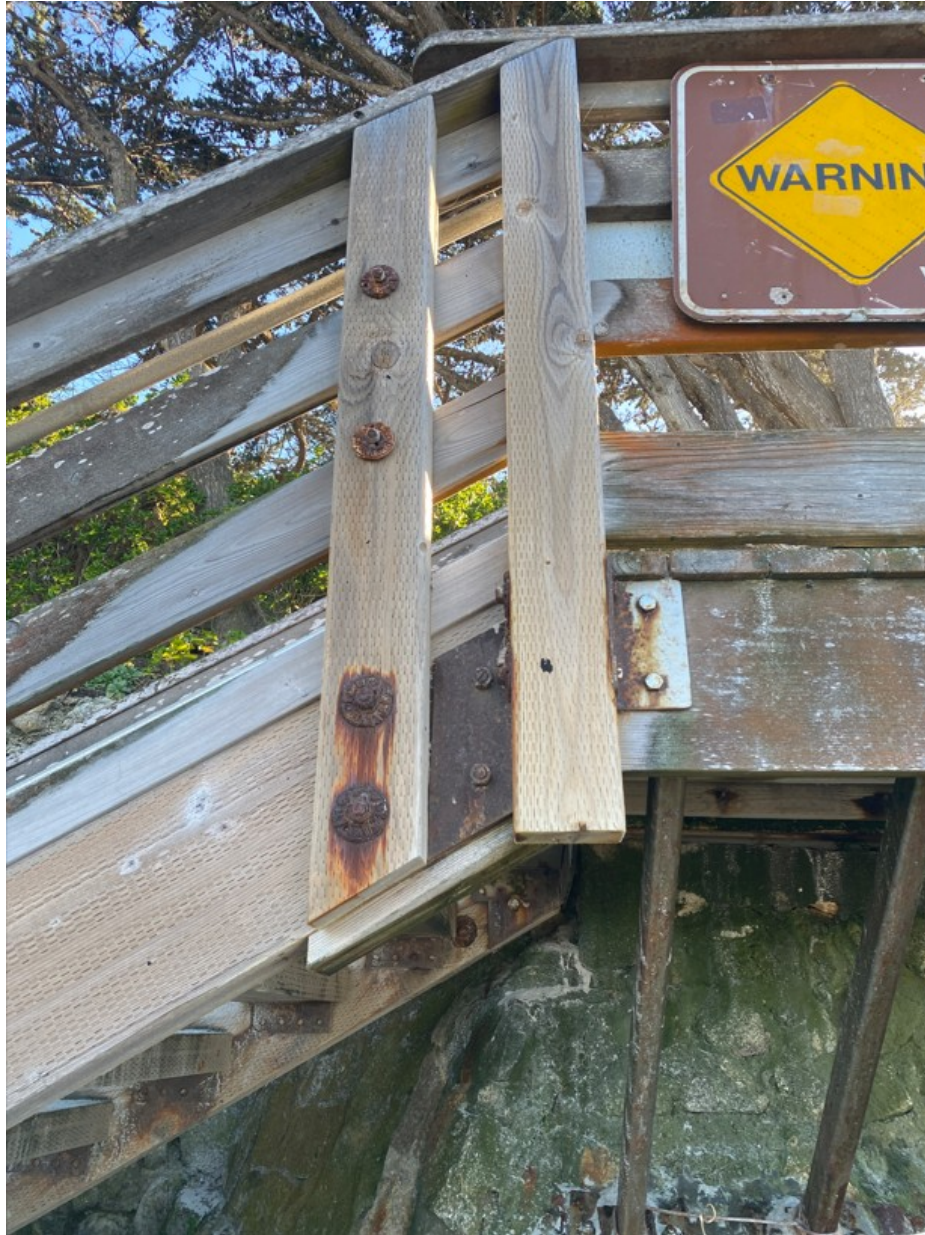
Photograph 5: Public Access Stairway ST1 on December 22, 2022

Photograph 5 shows Public Access Stairway ST1 on December 22, 2022. Corrodible fasteners and brackets were used on this stairway and those are deteriorating. At some point it will need maintenance and/or repair. Visually it appears satisfactory to us at this time. Further evaluation of the structure by an independent licensed structural engineer (and if need be a licensed corrosion engineer) should be scheduled to verify the structure is safe for public use, and recommend any needed repairs.

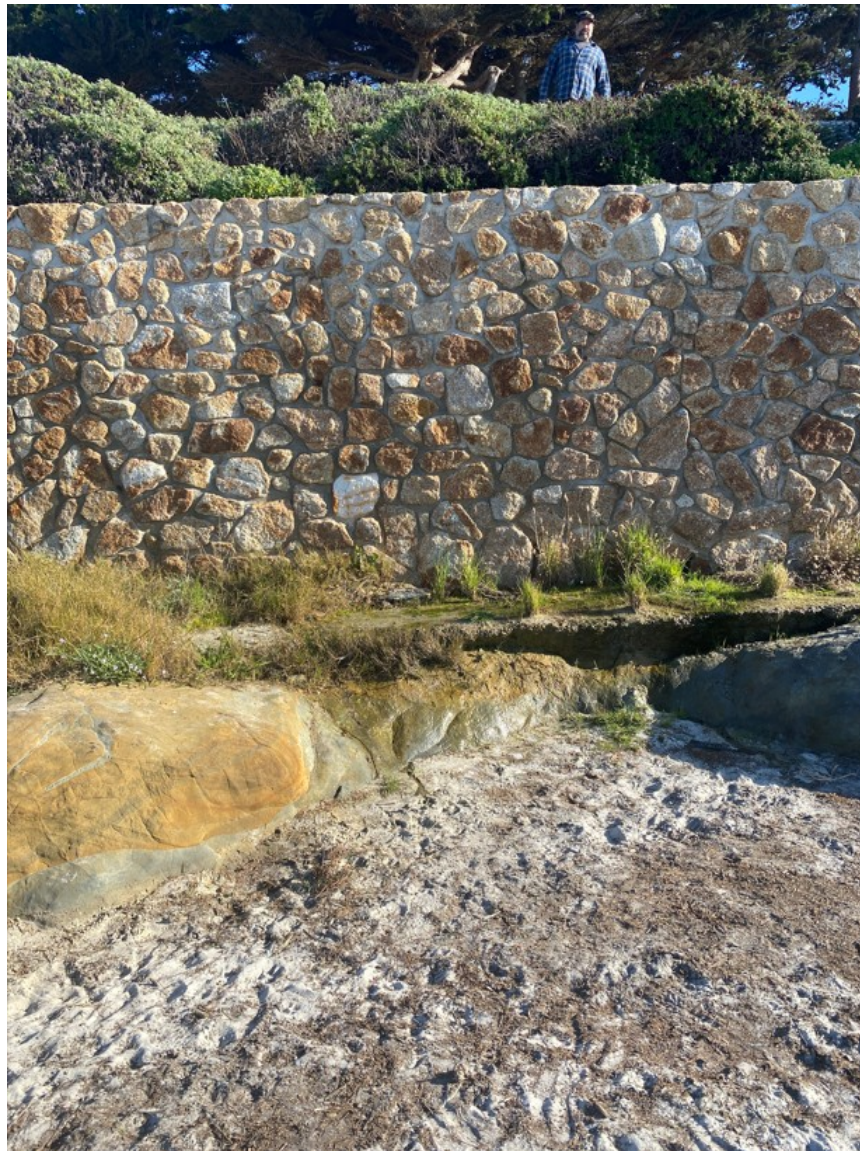
Photograph 11: North End of Seawall S2 on December 22, 2022

Photograph 11 shows an area at the northern end of Seawall S2 on December 22, 2022, where the edge of the seawall footing is exposed and it has been slightly undermined. Easton Geology inspected this location as well. Photograph 12 (below) is an Easton Geology photograph of the north end of Seawall S2 showing it was undermined in 2016. Comparison of that photo with the 2022 photo (above) shows there has been very little change in the conditions; there has been no continued undermining during that 7 year period. It is likely that this area was buried in beach sand during most of those 7 years; when the bedrock supporting the footing is buried, wave action does not contact the bedrock and no erosion or bedrock retreat occurs under the footing.

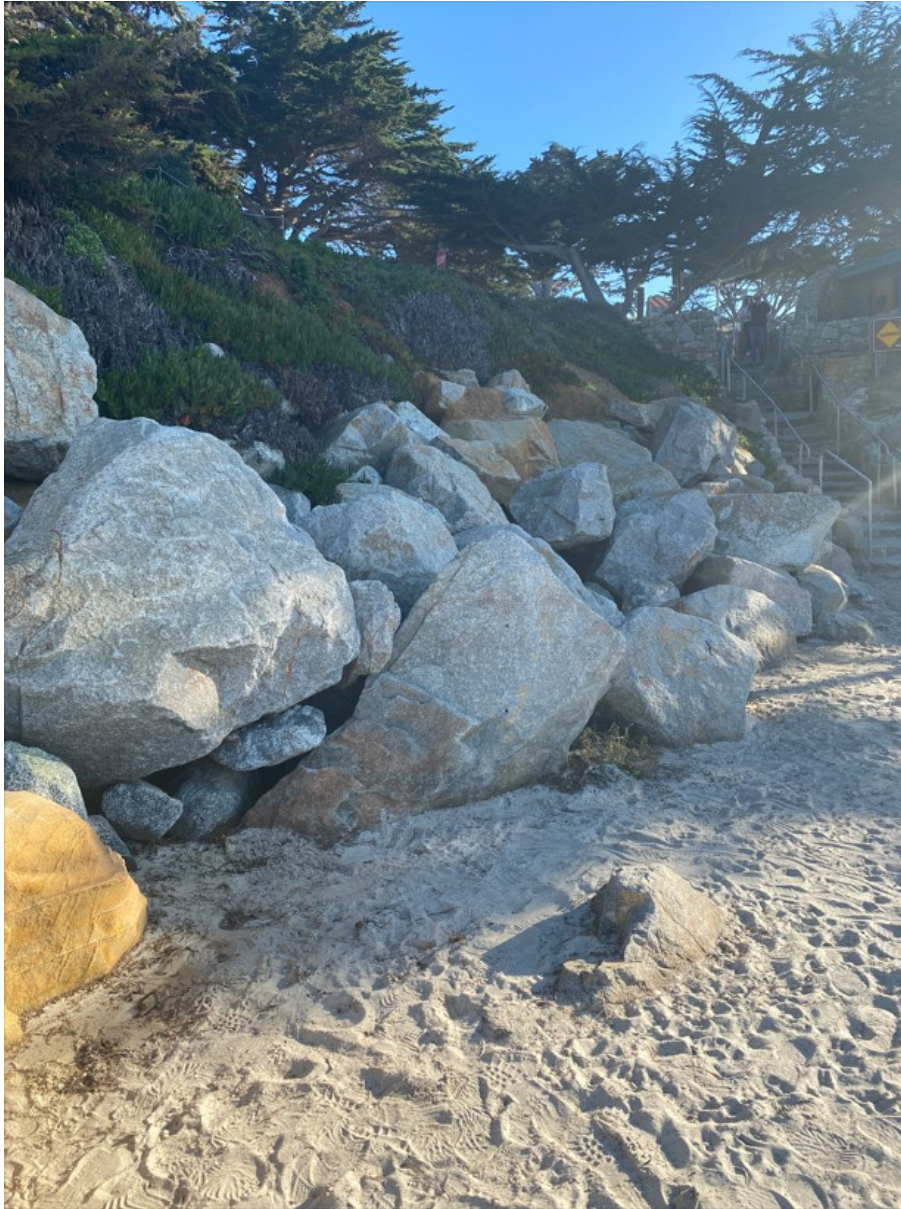
Photograph 17: Revetment R1 on December 22, 2022

Photograph 17 shows the southern end of Revetment R1 on December 22, 2022, which consists of oversteep riprap, making it relatively unstable. One displaced boulder (a "fugitive" rock) can be seen poking out of the beach sand seaward of the revetment. Historic instability and the use of undersized boulders to construct this revetment have caused cavities to develop in the revetment and have diminished the erosion protection it provides. We recommend the holes in the revetment structure be filled and the 1 to 4 ton rocks be restacked. It is presently unsafe.

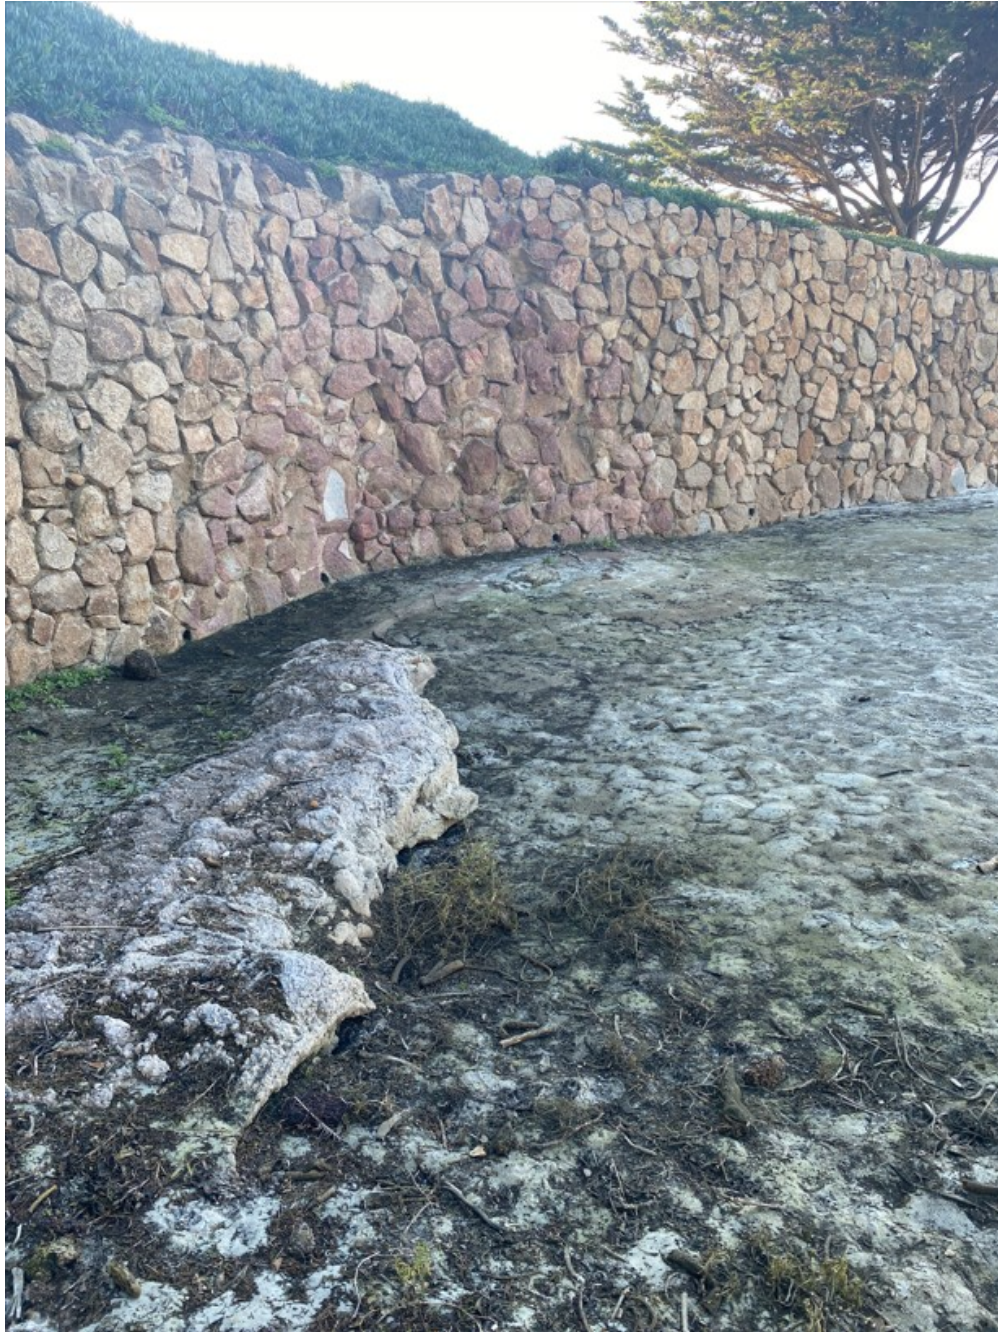
Photograph 23: Concrete Debris on Beach at Base of Seawall S3 on December 22, 2022

Photograph 23 shows Seawall S3 on December 22, 2022 which has pumped concrete debris located on the beach at base of the seawall. Easton Geology inspected Seawall S3 in February 2016 and again in June 2016 for the City. Photograph 24 from Easton Geology shows that the beach was more scoured then than during our 2022 and 2023 inspections.

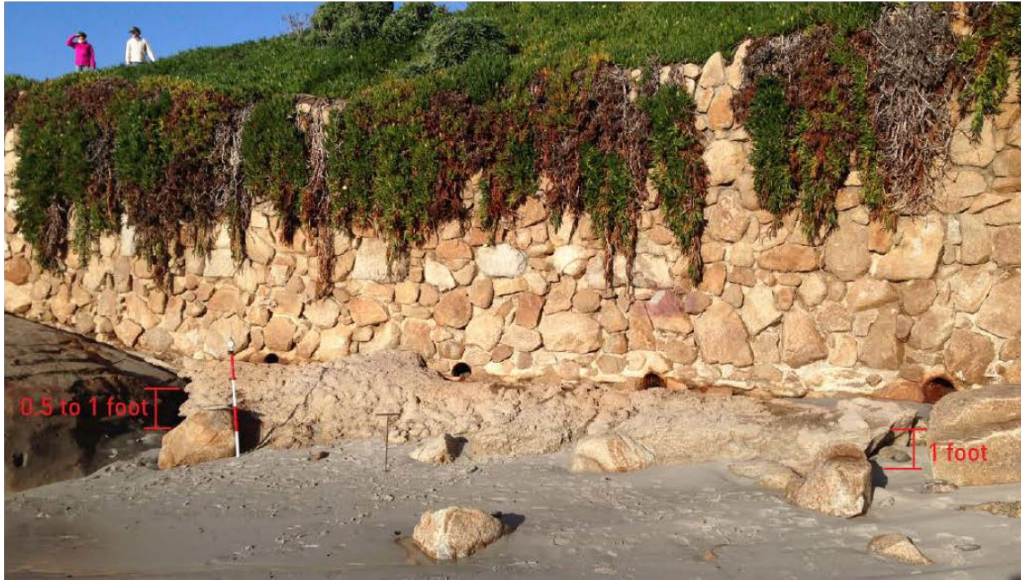
Photograph 24: Southern End of Seawall S3 in February 2016 Photographed by Easton Geology Showing Pumped Concrete Repair of Undermining of Seawall S3

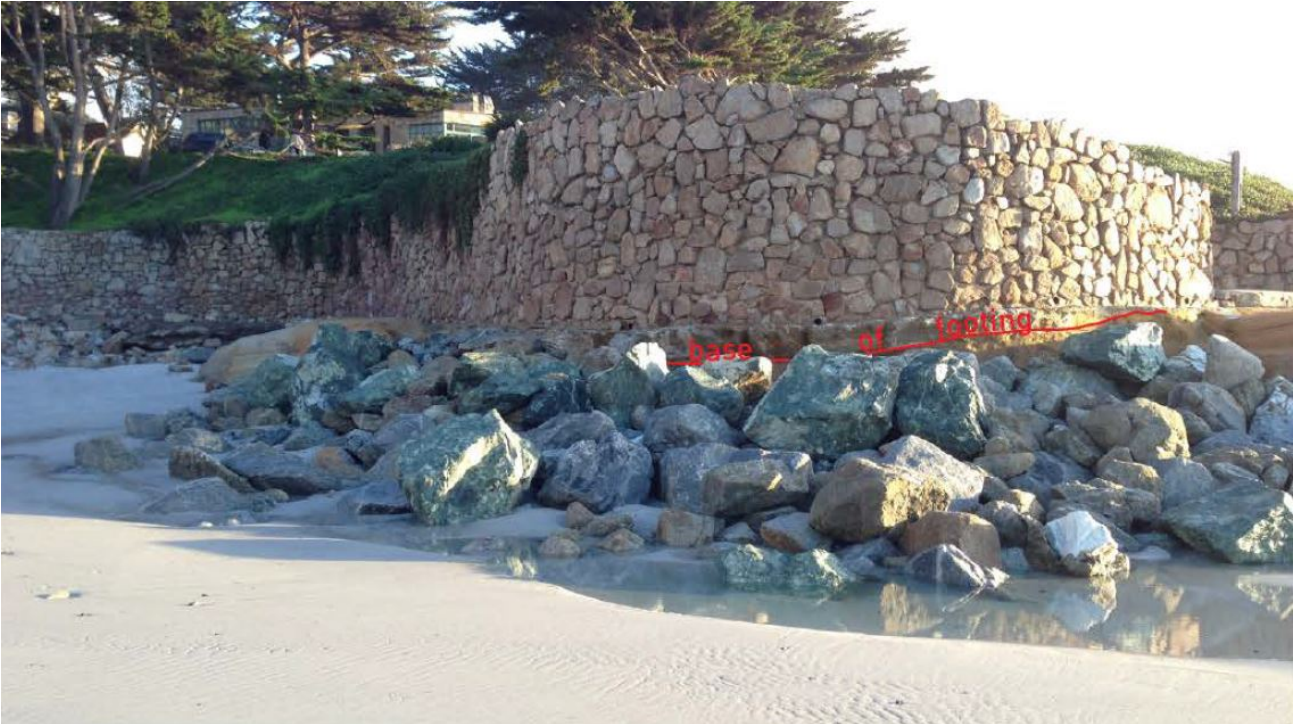
North of Public Beach Access Stairway ST3, Seawall S3 had an exposed foundation in February 2016. Easton's June 2016 letter states "exposed undercuts (*identified and documented in February 2016*) between the wall footing and the underlying bedrock within the 13th Avenue Cove (*referred to as S3 in this document*) were filled with concrete" (*between February and June 2016*) (*italicized portions added by HKA for clarity*). Photographs 29 and 30 from Easton Geology illustrate the condition of S3 in 2016.

Photograph 29: Seawall S3 Just North of ST4 in February 2016 (Easton Geology)

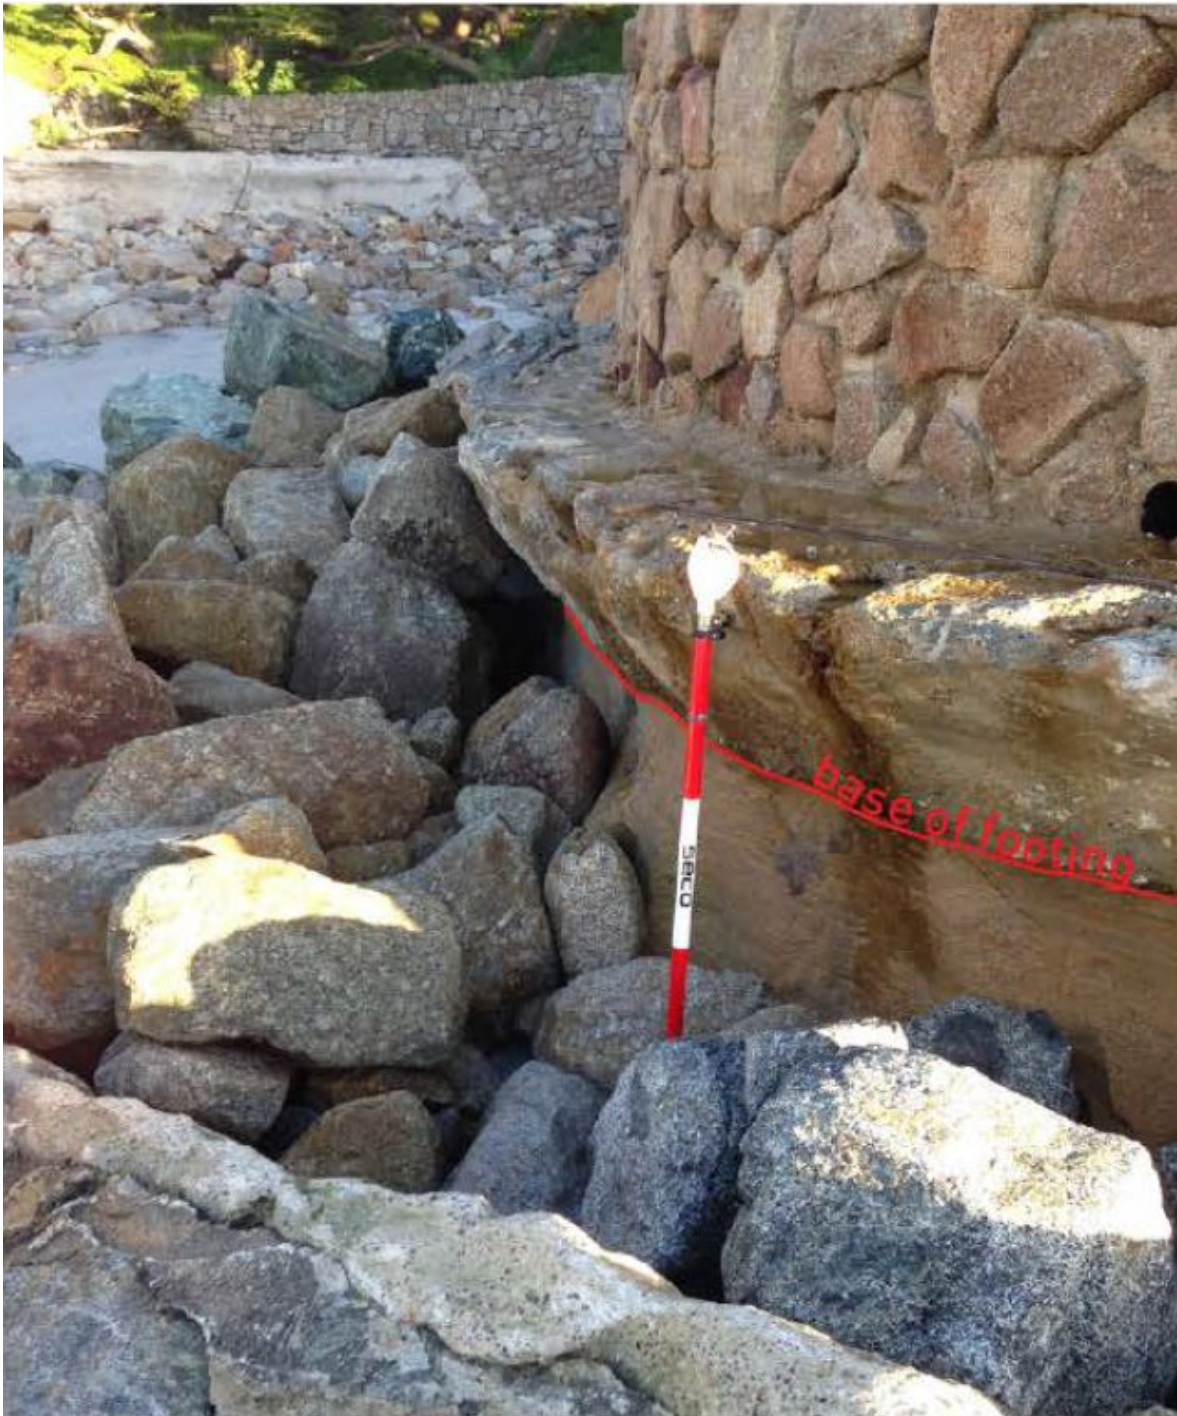
Photograph 30: Seawall S3 Just North from ST4 in February 2016 (Easton Geology)

Photograph 30 shows that the footing of Seawall was bearing on bedrock and slightly undermined in 2016.

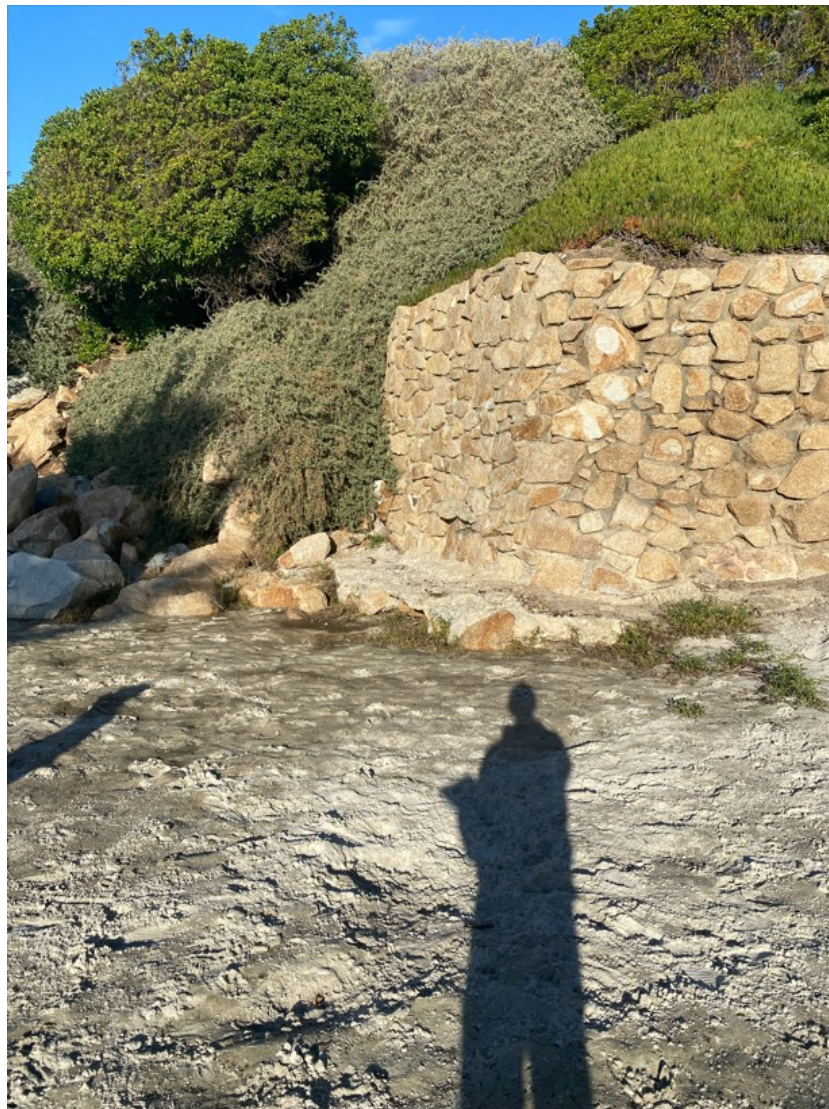
Photograph 32: North End of Seawall S3 on December 22, 2022

Photograph 32 shows the north end of Seawall S3 where it adjoins Revetment R2 on December 22, 2022. The north end of Seawall S3 was historically slightly undermined, and the resultant cavities have been repaired with concrete patchwork, and or grouted riprap. The north end of Seawall S3 appears to be stable.

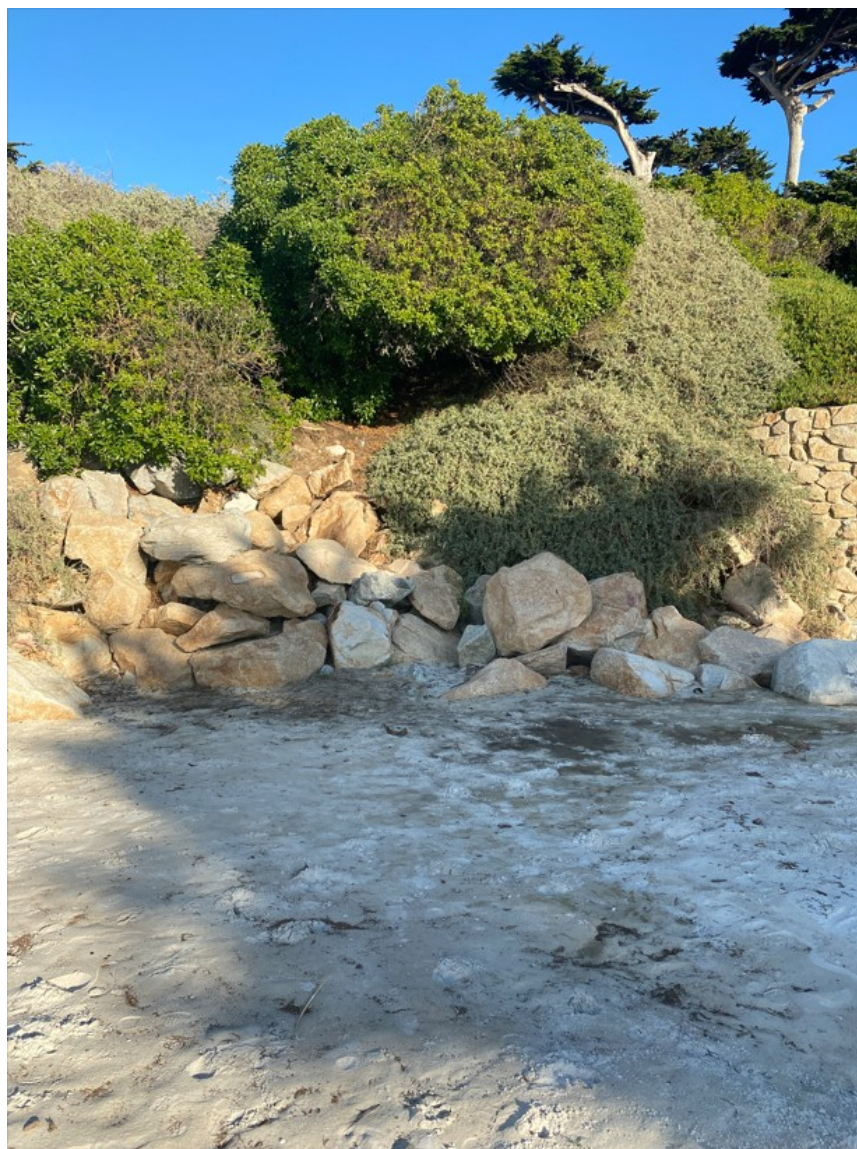
Photograph 33: Showing South End of Revetment R2 on December 22, 2022

Photograph 33 shows the south end of Revetment R2 on December 22, 2022, which has some displaced fugitive riprap. The revetment surface gradient is not uniform and the coastal erosion protection this revetment provides could be improved from restacking the riprap boulders. Revetment R2 includes a large volume of undersized riprap, which is vulnerable to plucking from wave attack. Revetment R2 poses risks to beach users, and we recommend it as a high priority for repair. The base of the revetment was buried by beach sand during our inspections and so its condition is unknown. Whenever it is next exposed by natural beach sand scour processes, it should be inspected. That may not be for a decade but could be possible any winter.

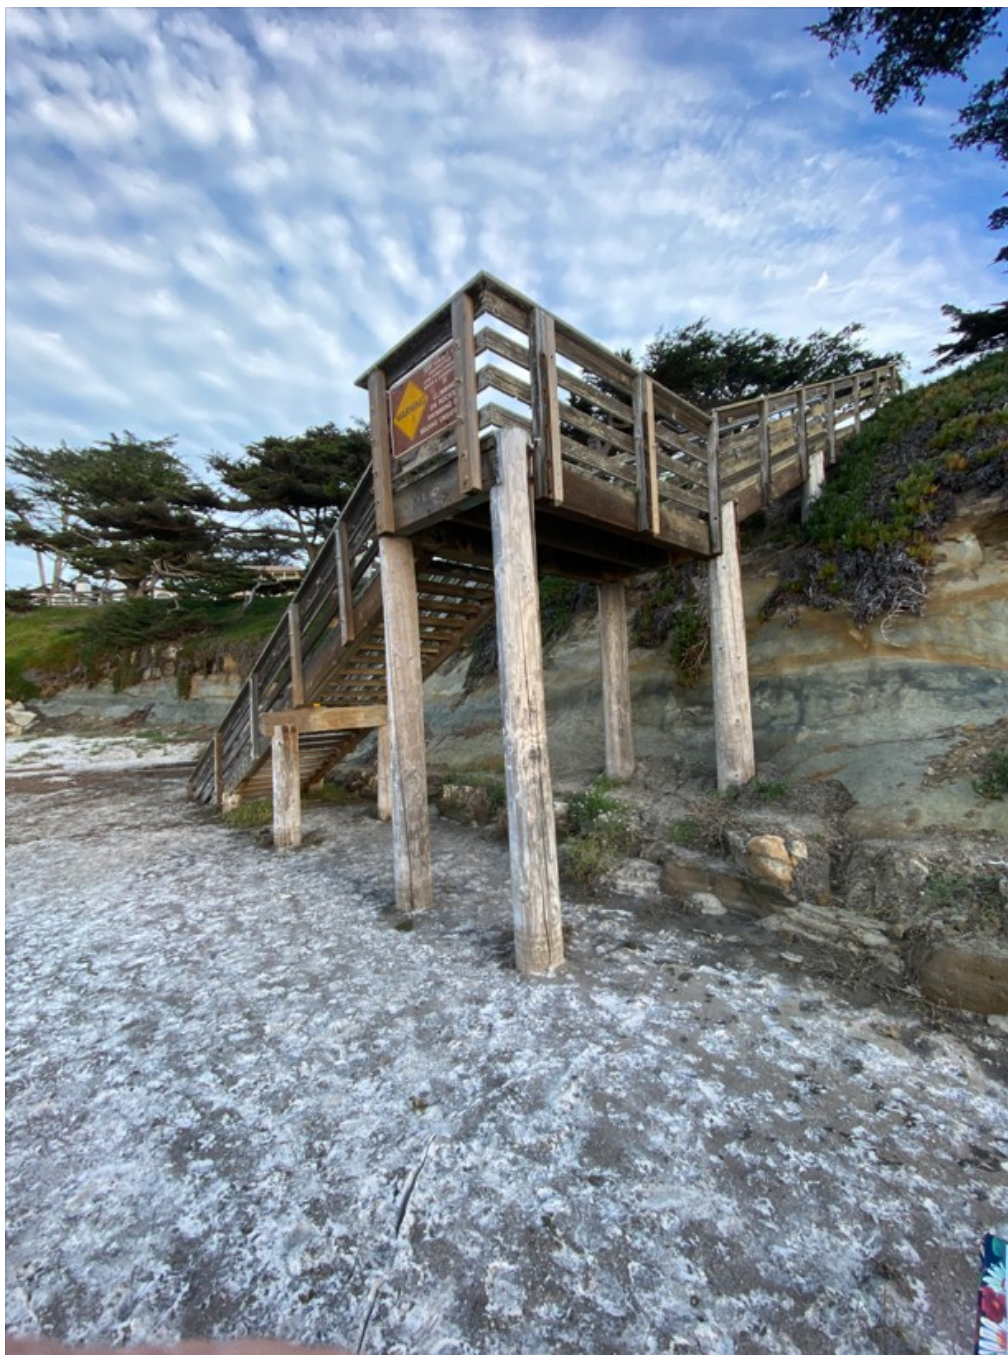
Photograph 38: Showing Public Access Stairway ST4 on December 22, 2022

Photograph 38 Shows Public Access Stairway ST4, located at 12th Avenue, on December 22, 2022. This stairway was undermined as shown in Photograph 39 (below) contained in a letter from Easton Geology dated February 8, 2016

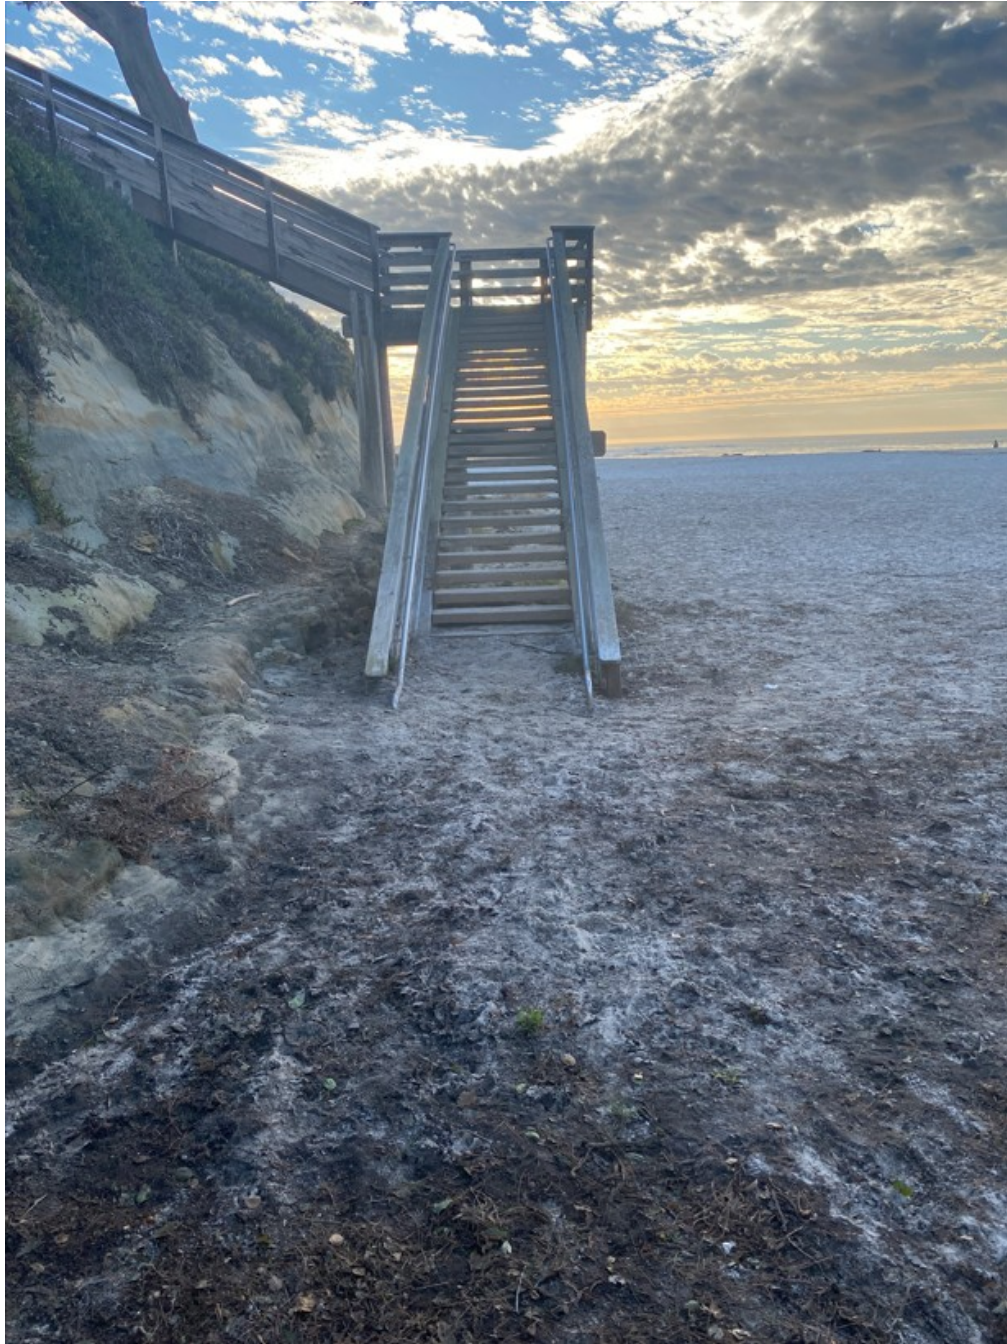
As shown in Photograph 40 (below) the foundation of Public Access Stairway ST4 was not exposed during either our December 2022 inspection or our January 2023 inspection. Whenever it is next exposed by natural beach sand scour processes, it should be inspected. That may not be for a decade but could be possible during any winter.

Photograph 40: Showing Base of Stairway ST4 naturally buried in beach sand on December 22, 2022

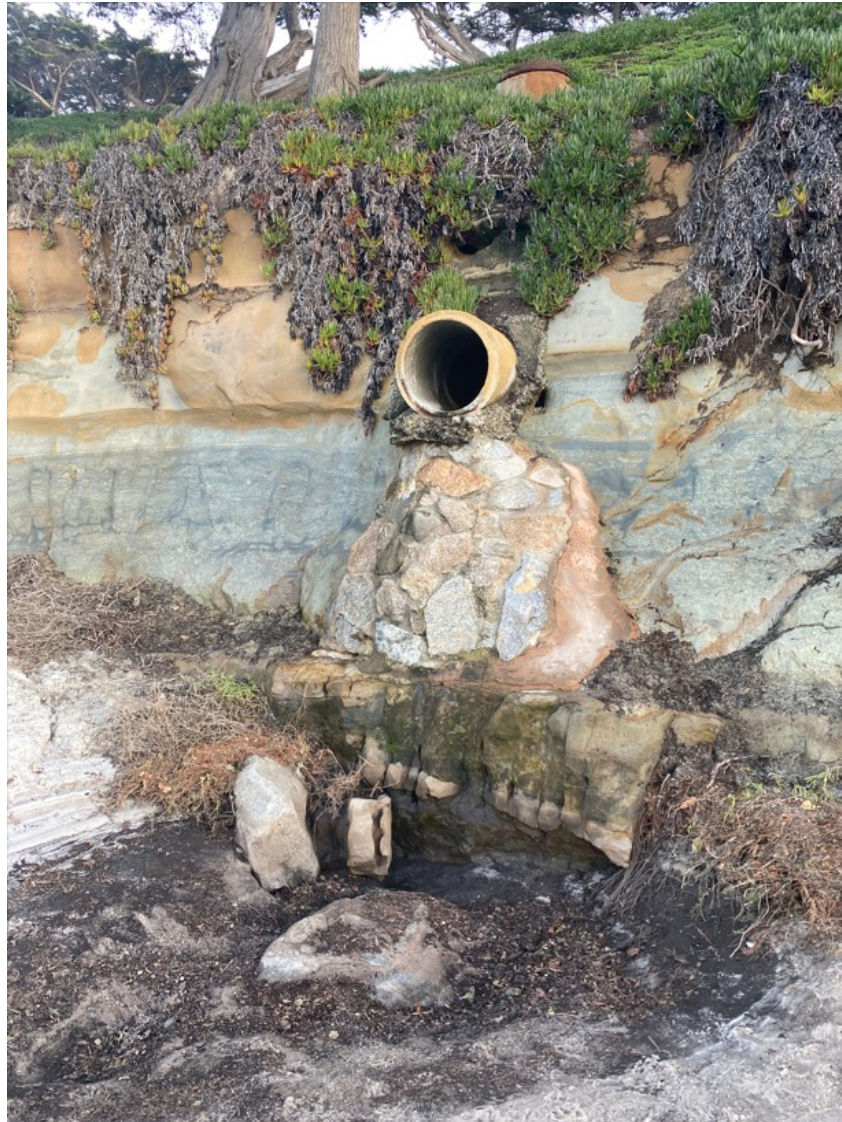
Photograph 43 (below) shows a storm drain outfall just northeast of Stairway ST4 with a rock and mortar seawall that armors the bluff face below the outfall that is Seawall S5. A small amount of riprap below the outfall and Seawall S5 was barely visible during our December 2022 inspection.

Photograph 43: Storm Drain Outfall and Seawall S5 Northeast from Stairway ST4 on December 22, 2022

Seawall S5 is immediately below the storm drain outfall near 12th Avenue.

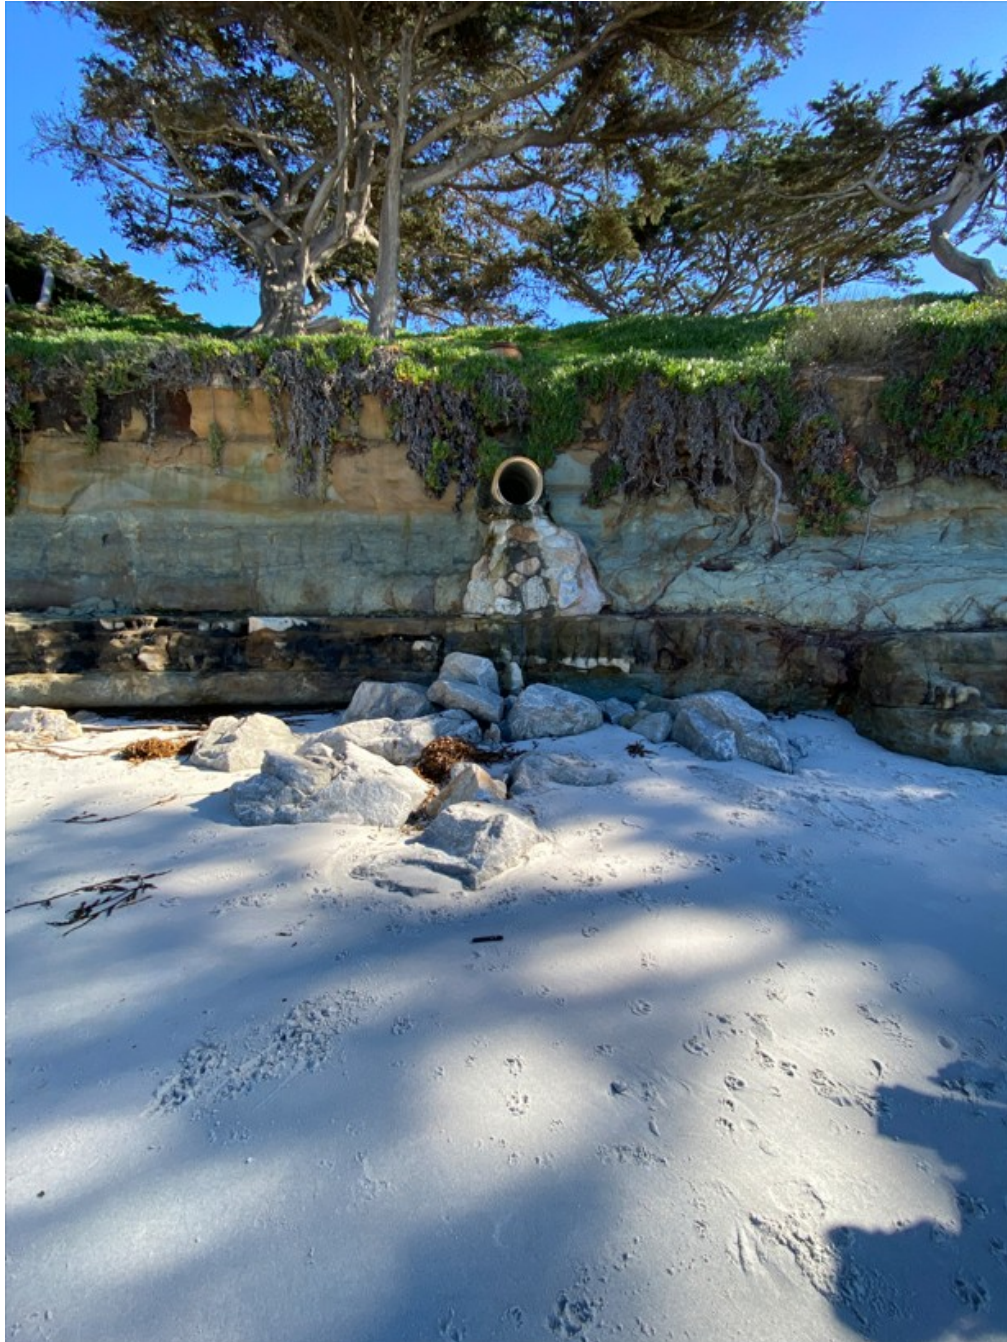
Photograph 44: Storm Drain Outfall with Minor Armoring Between ST4 and R3 on January 30, 2023

As Photograph 44 shows, a greater amount of riprap below the outfall and Seawall S5 was visible during our January 2022 inspection. The rip-rap dissipates the energy from the runoff flowing onto the beach and serves to reduce bedrock erosion during times of low beach elevation.

Photograph 43 shows a storm drain outfall with minor armoring (Seawall S5) south of Revetment R5 and Stairway ST4 on December 22, 2022. Photograph 44 shows the same outfall and Seawall S5 after during January 2023 when considerable additional sand scour had occurred, exposing the grouted riprap energy dissipater placed on the bedrock platform below the outfall. About 75% of the coastal bluff height consists of erosion resistant bedrock, and appears to be in good shape. A seawall may be needed to slow bluff retreat in the future. Photograph 45 by Easton Geology (above) shows the conditions in February 2016, and includes their recommendations regarding extending the culvert and restacking the rip-rap they made at that time. Seawall S5 has no maintenance recommended by HKA at this time. It appears to have at least 30 years remaining life.

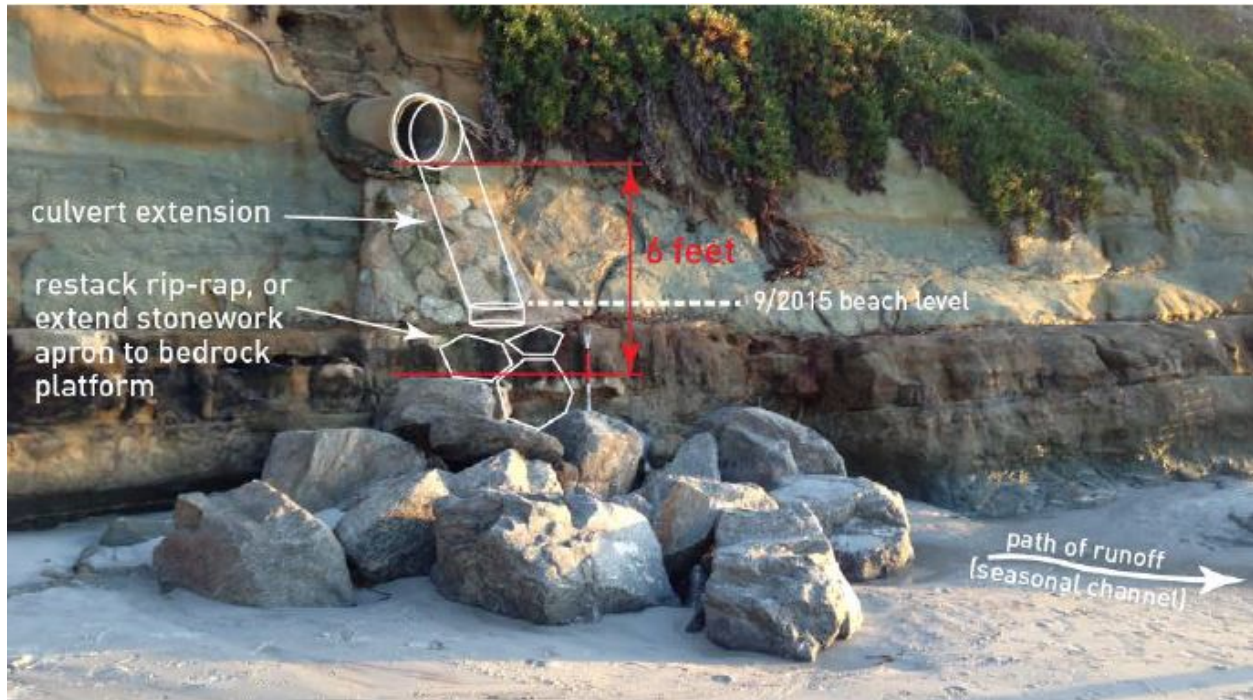
**Photograph 45: Seawall S5 Just North from ST4 in February 2016 (Easton Geology)
 Easton Geology's Recommendations Are Shown on the Photo**

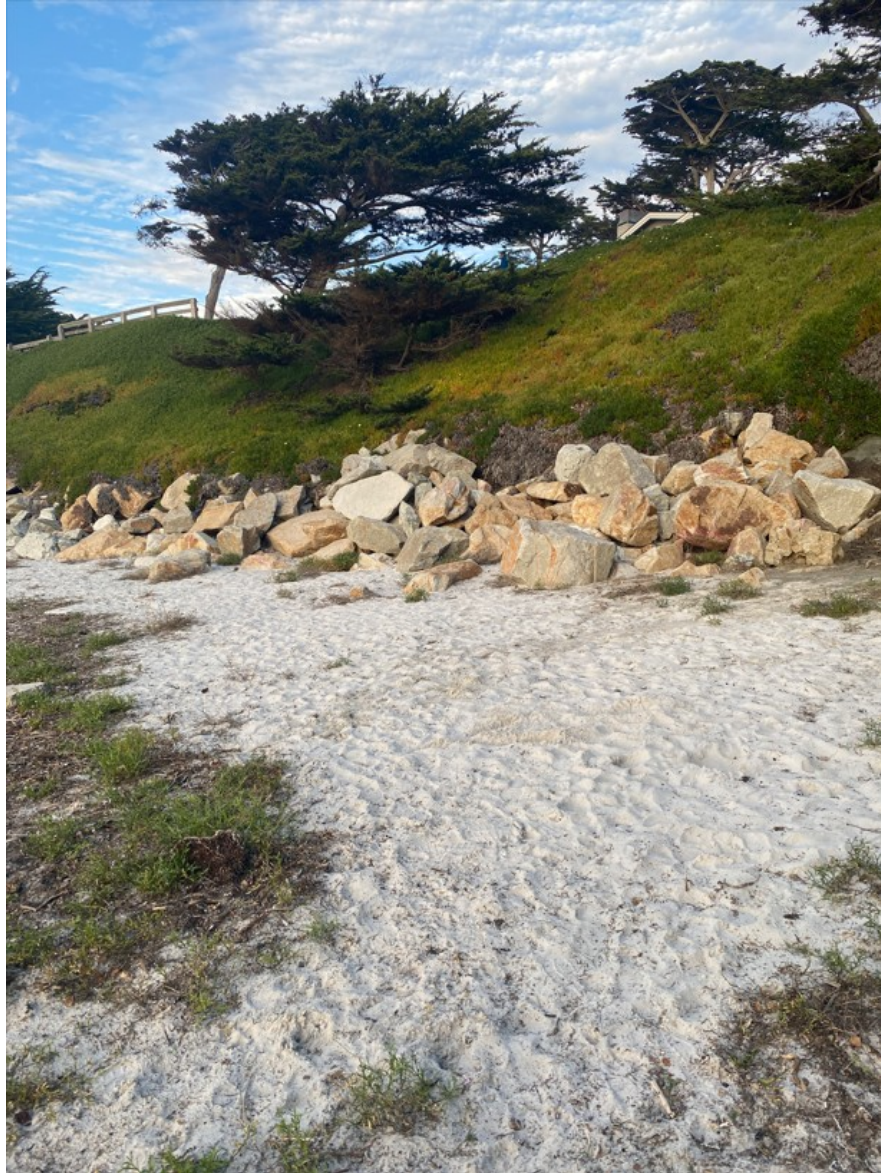
Photograph 47: Revetment R3 Showing Scattered Rip-rap Boulders on December 22, 2022

Photograph 47 shows Revetment R3 with scattered rip-rap boulders on December 22, 2022. We recommend that Revetment R3 be restacked to increase coastal protection and reduce the revetment footprint.

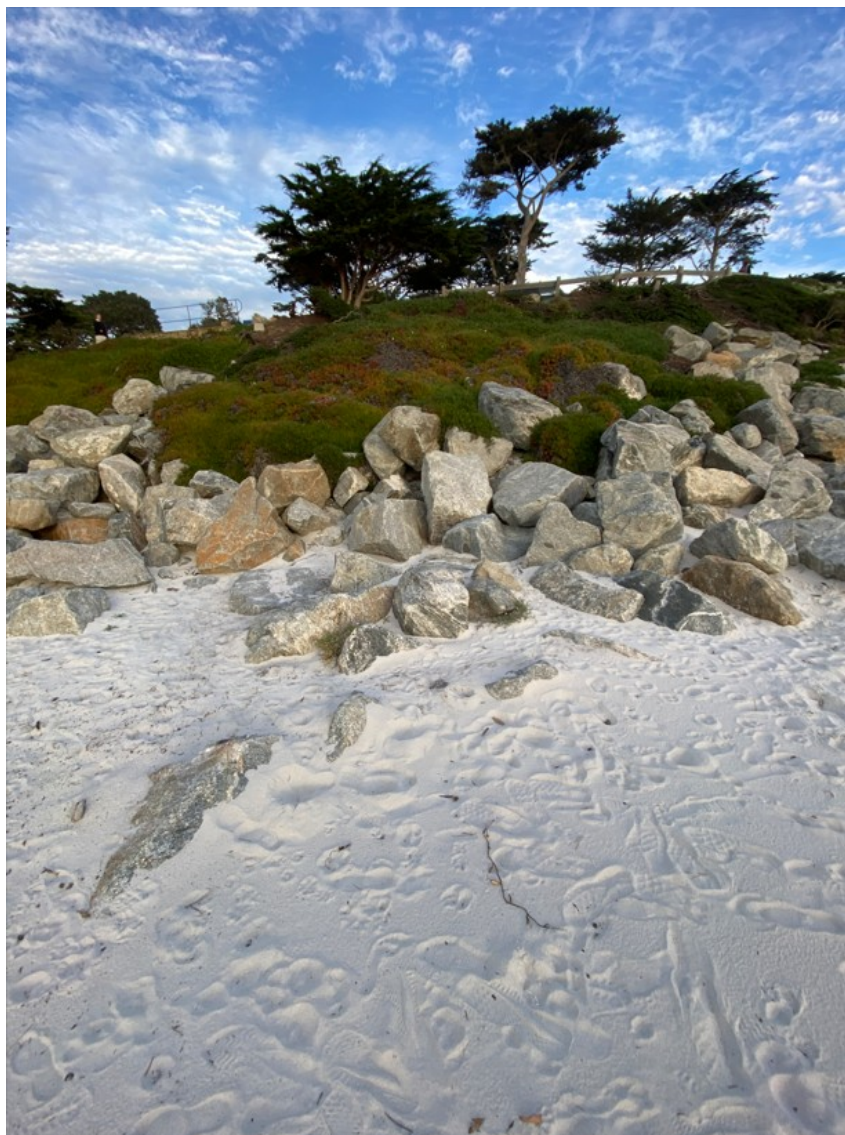
**Photograph 48: Revetment R3 Showing Area of Rip-rap on December 22, 2022
Where the Public Could Benefit from Quarystone Re-stacking**

The southern 1/4 of the Revetment R3 riprap unstable, poses risks to beach users, and we recommend it as a high priority for repair. The over-steepened portion of R3 should be re-stacked to a lower gradient to increase its stability and provide better coastal protection.

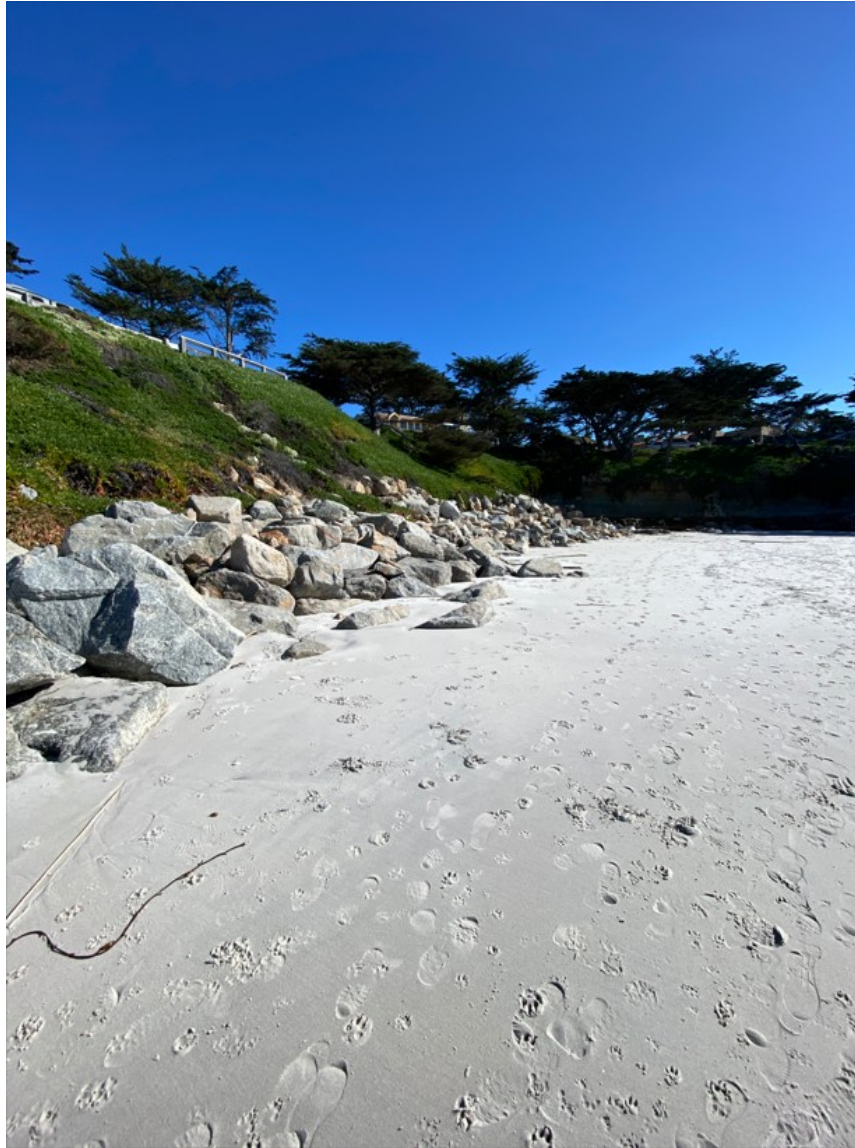
Photograph 49: Showing Revetment R3 Looking South on January 30, 2023

Most of the portion of R3 shown in Photograph 49 has begun to slump and requires routine maintenance. needs to be re-stacked. The portion of R3 shown in Photograph 48 appears to have been constructed at a different time using smaller rock that may have been dumped into place rather than placed boulder by boulder, perhaps due to emergency conditions during construction. There is displaced undersized rock at the toe of the revetment at a lower gradient, and the revetment appears to be founded on the sandstone bedrock platform and we expect it will continue to provide service for 10 to 20 years. However, the rip-rap boulders are subject to displacement from wave impact. We recommend a vertical reinforced concrete seawall with rock fascia be designed and planned for and considered as a replacement for this portion of the R3 Revetment. The public coastal access at the top of the bluff is reliant upon bluff toe stability, which is currently provided by the R3 rip-rap armoring.

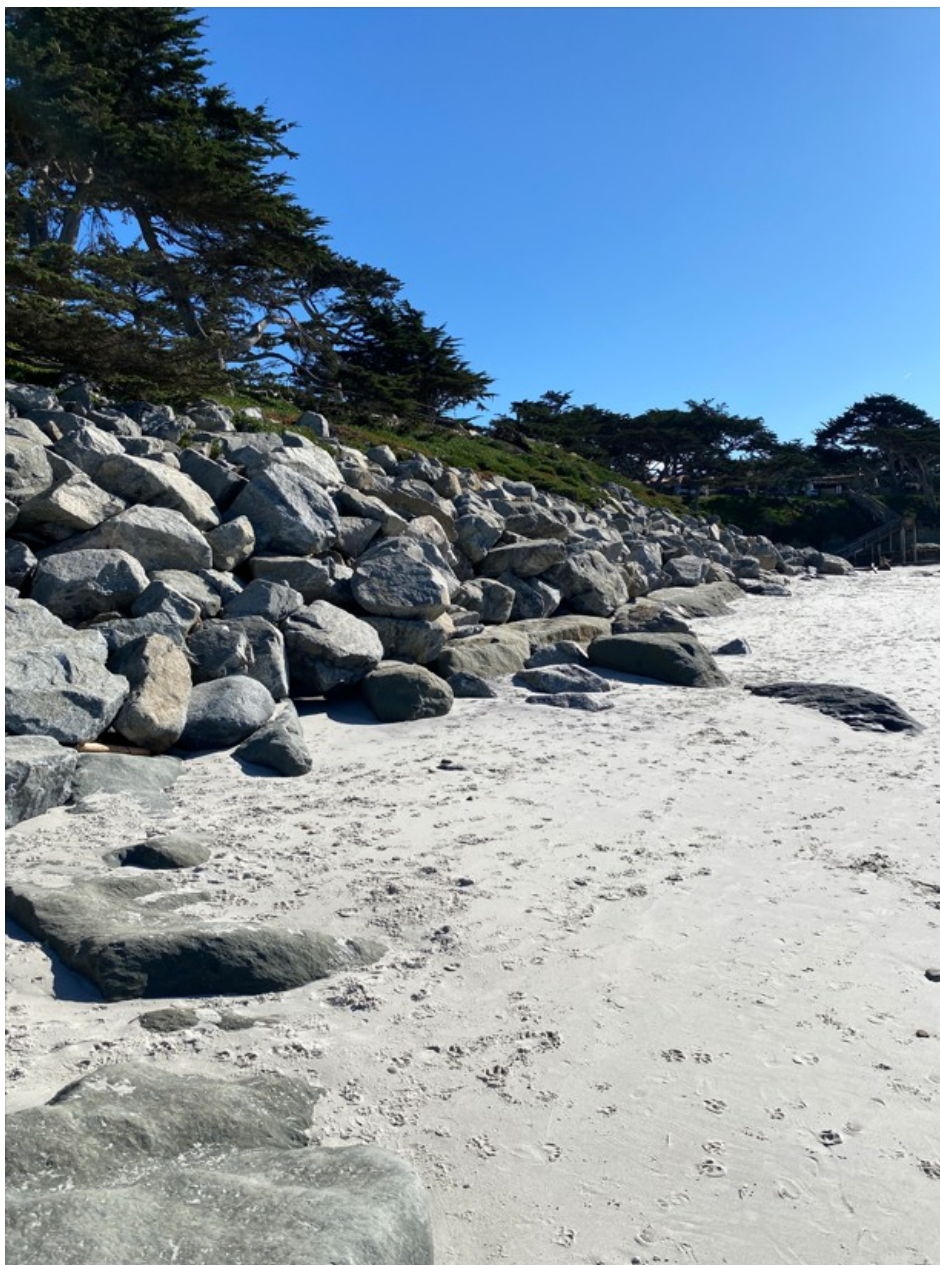
Photograph 51: Showing the Middle Portion of Revetment R3 on January 30, 2023

Photograph 51 shows the middle portion of Revetment R3 with bearing support on the bedrock platform and on the outboard side of keyway, with the bedrock still providing lateral support of the toe of the structure, except in a couple locations. Two over-steepened sections could benefit from re-stacking, however, this riprap revetment is in good condition and performing well.
