CITY OF CARMEL-BY-THE-SEA CLIMATE COMMITTEE

1. Receive a presentation from Integral Corp./Haro Kasunich & Associates/EMC Planning Group regarding the results of the Coastal Engineering Condition Evaluation, Task 1, and Shoreline and Beach Change Analysis, Task 2, which is part of the Coastal Engineering Study
2. Review list of Adaptation Strategies for Climate Action and Adaptation Plans and Provide Feedback for Monitoring the Implementation of the Plans

TO:	Climate Committee Members
SUBMITTED BY:	Mary Bilse, Environmental Programs Manager
SUBJECT:	Receive a presentation from Integral Corp./Haro Kasunich & Associates/EMC Planning Group regarding the results of the Coastal Engineering Condition Evaluation, Task 1, and Shoreline and Beach Change Analysis, Task 2, which is part of the Coastal Engineering Study

27 April 2023
Coastal Protection Evaluation 22 December 2022 thru 30 January 2023
Carmel Adaptation Plan - Carmel Beach All Areas
Project No. 12176
Page 19

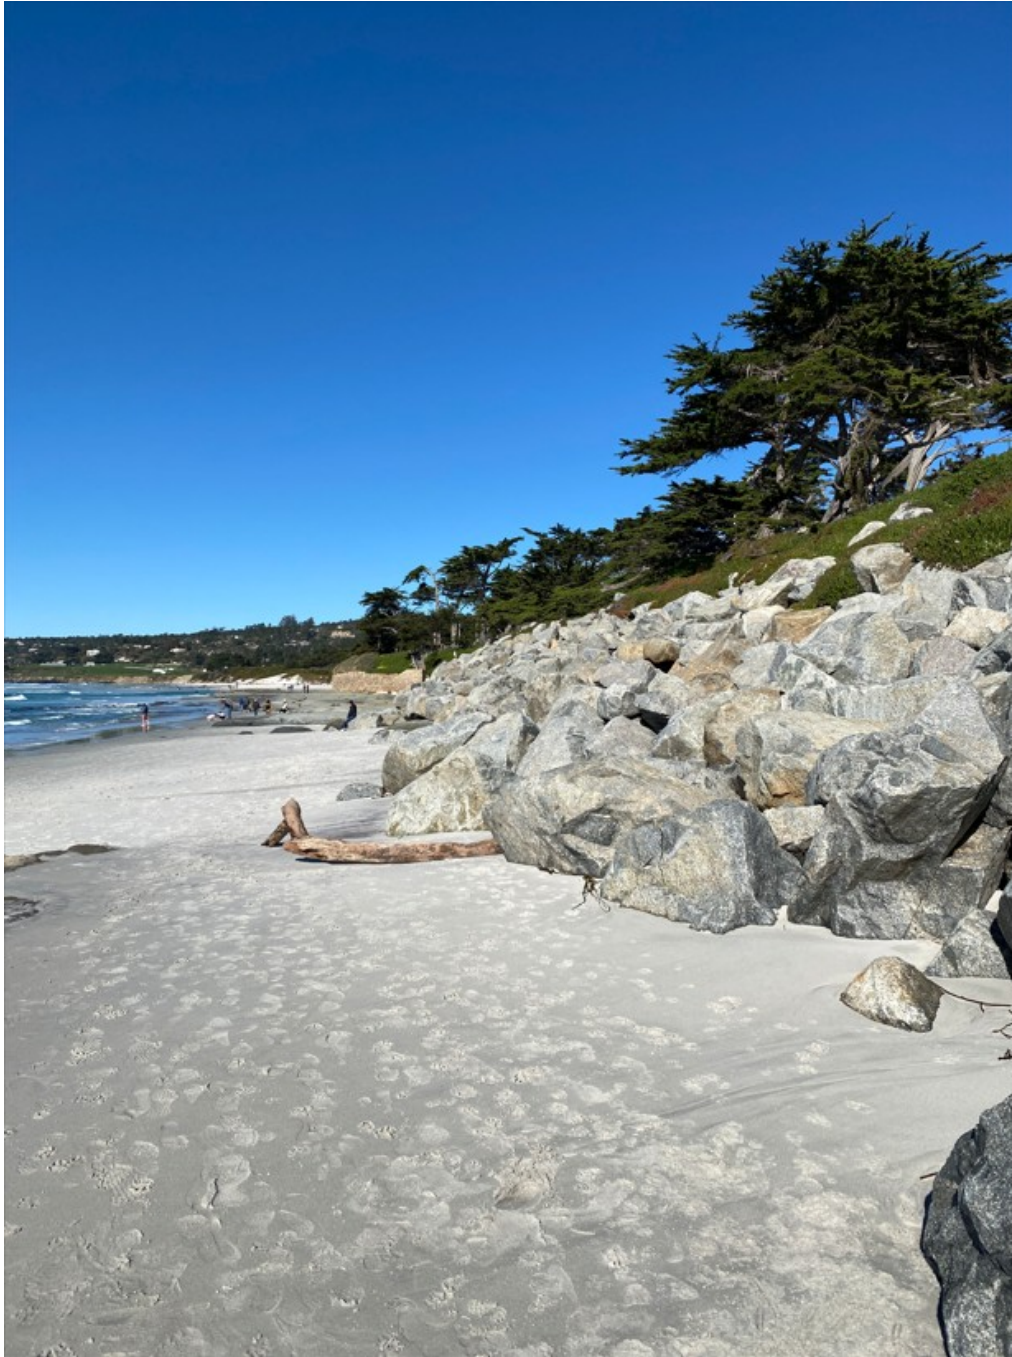
Photograph 52: Showing Revetment R3 Looking North on January 30, 2023

Photographs 51 and 52 show Revetment R3 looking north and south. The portion of R3 shown in Photograph 52 is in great condition.

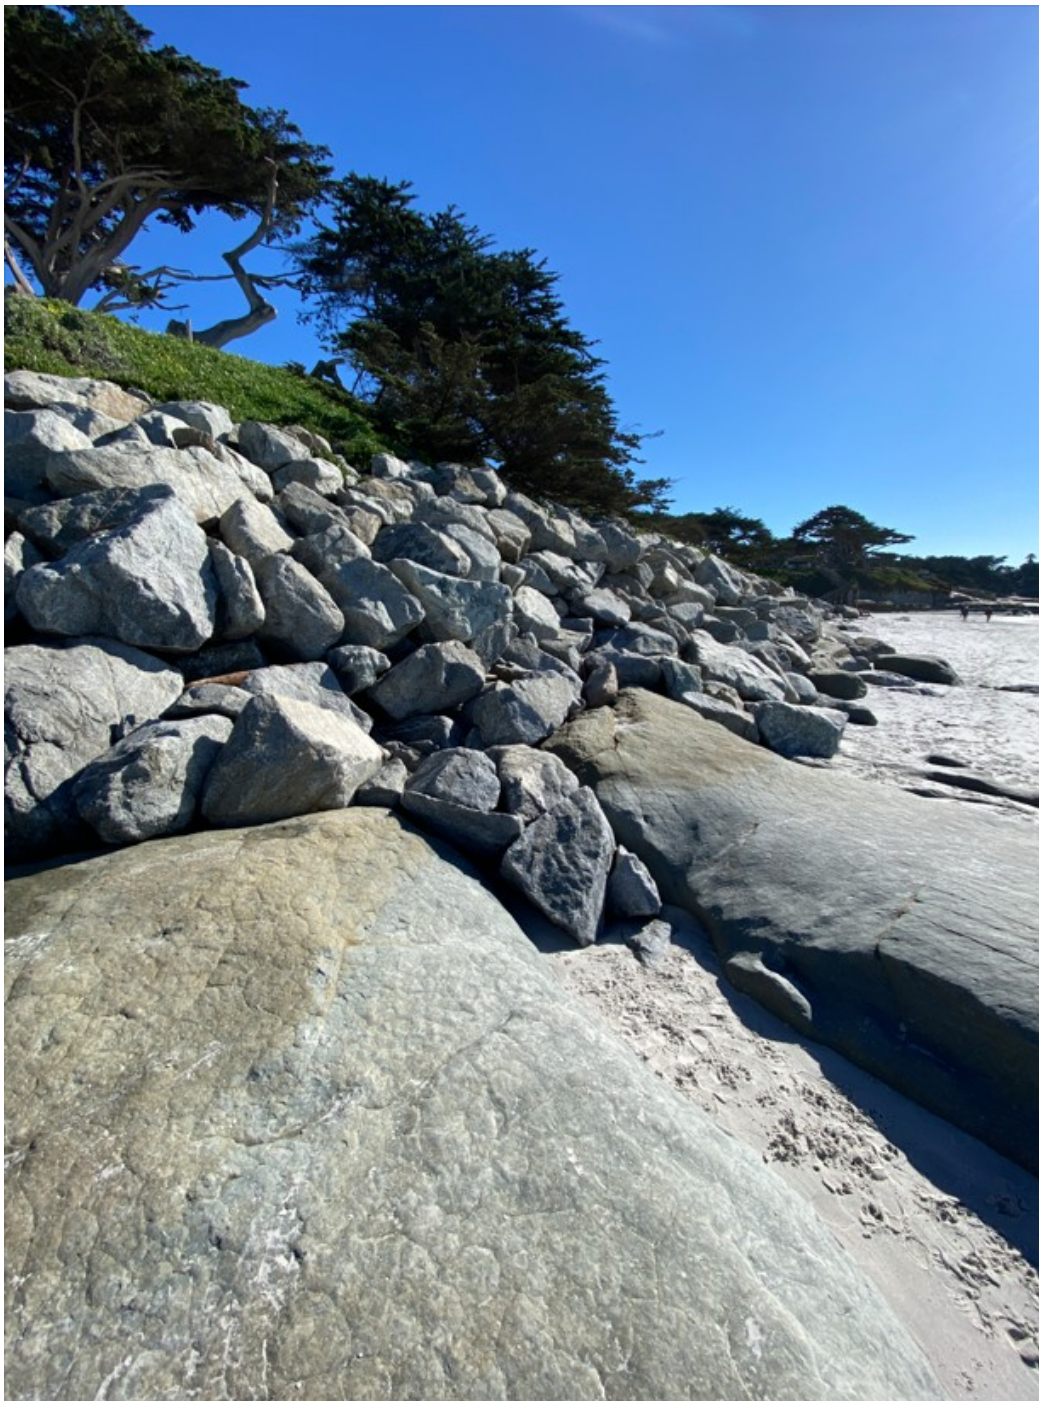
Photograph 53: Profile View of Revetment R3 on January 30, 2023

Photograph 53 is a profile view of Revetment R3. It was constructed following the severe 1983 storms with the toe of riprap revetment structure properly keyed into the bedrock platform, and still is performing well.

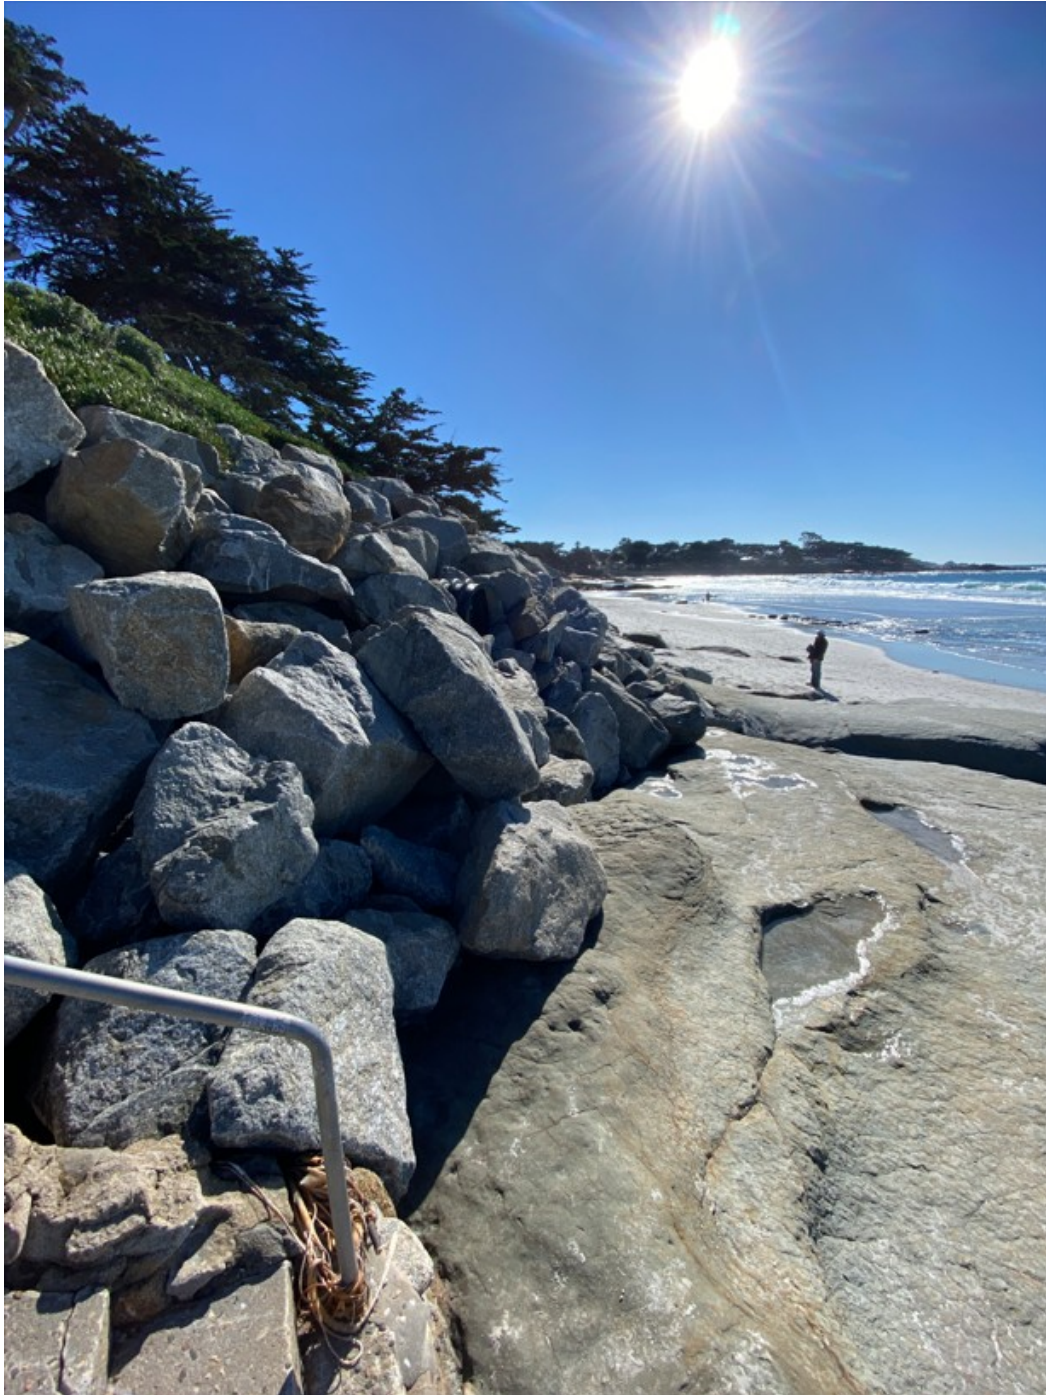
Photograph 55: Another Profile View of Revetment R3 on January 30, 2023

Photograph 55 shows that small portions near the north end of Revetment R3 are overly steep and could be re-stacked to be more stable and resistant to wave impact energy. During repair of the south 1/4 of R3, this area should be checked and the positions of a few boulders should be adjusted to improve boulder stability.

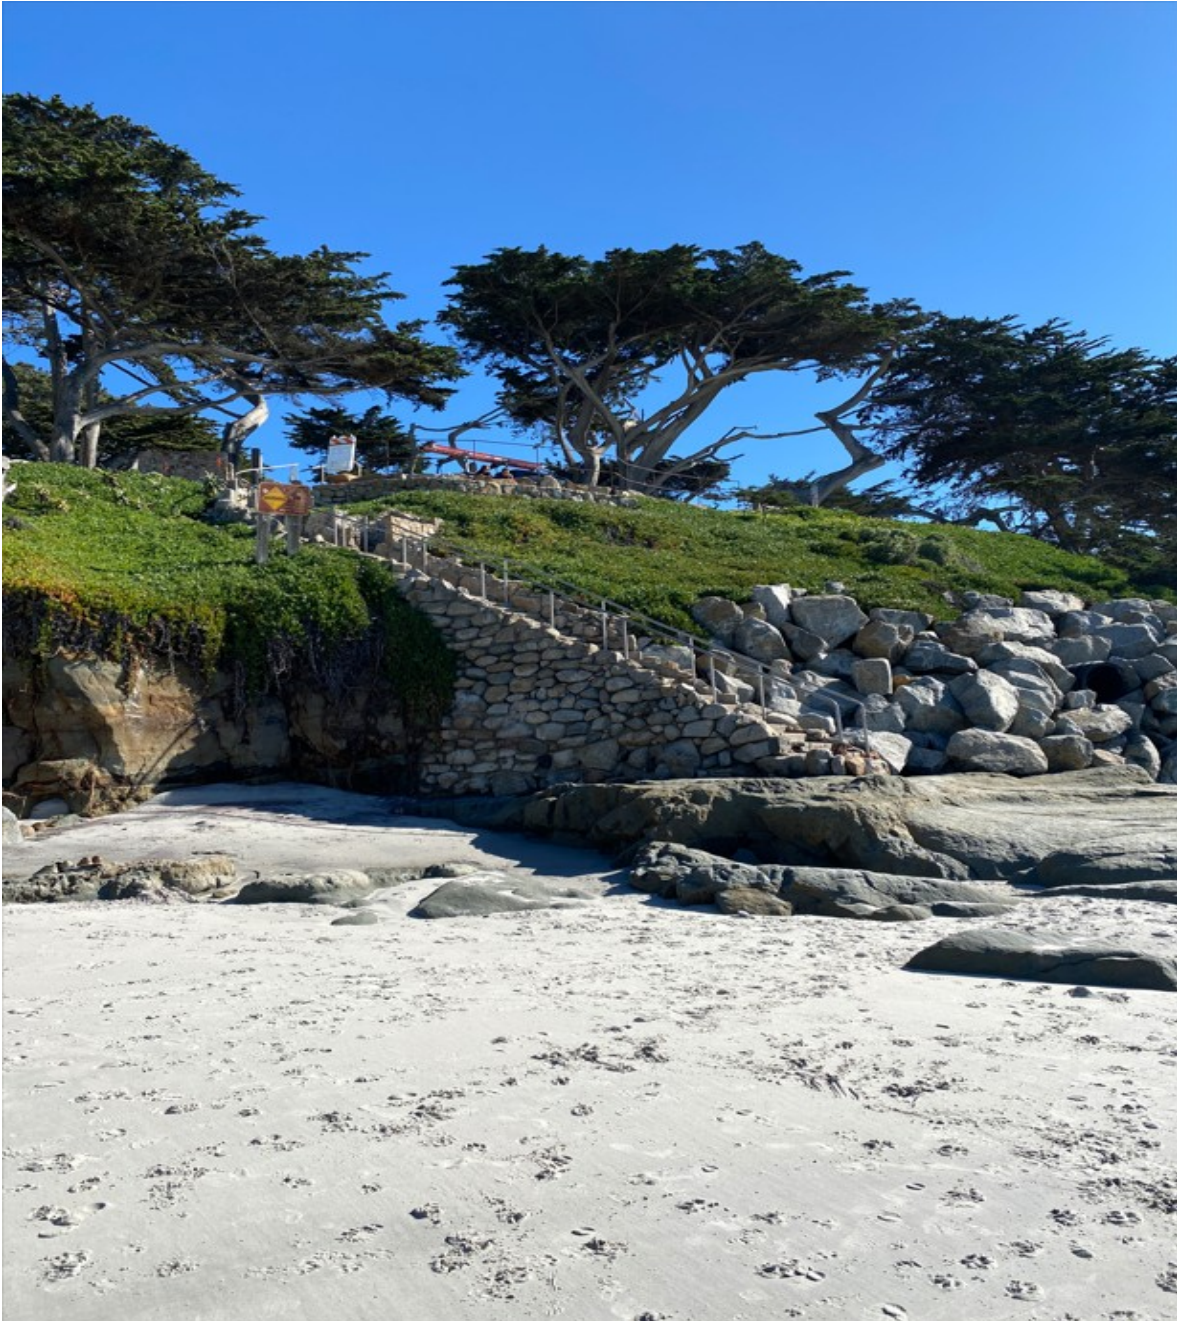
Photograph 56: Showing Stairway ST5 on January 30, 2023

Stairway ST5 is located at 11th Avenue and terminates on a bedrock platform, which is exposed when natural beach scour has lowered the beach elevation.

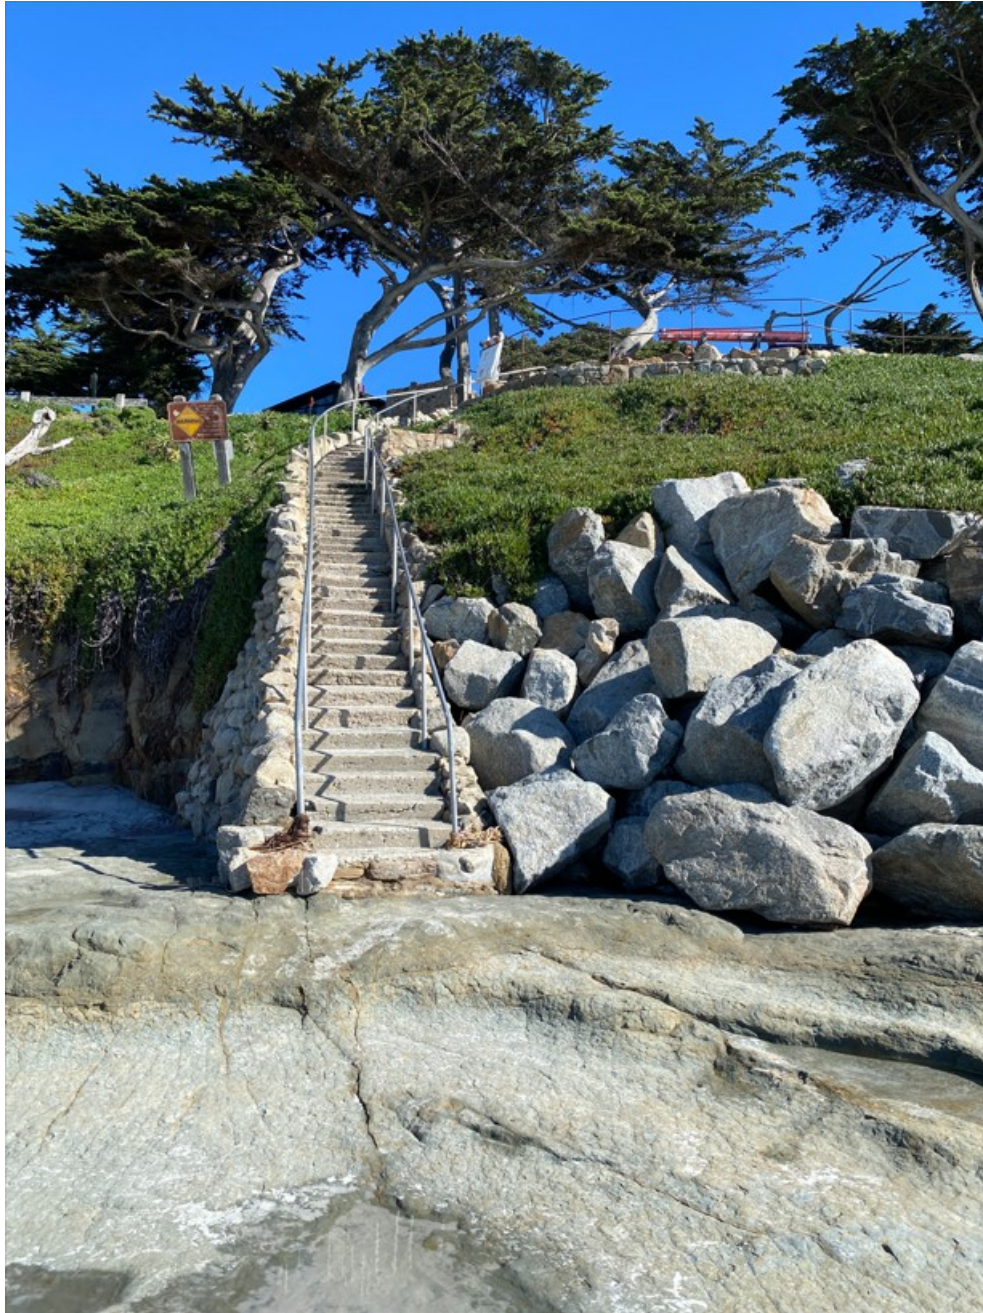
Photograph 57: Showing Stairway ST5 on January 30, 2023

Stairway ST5 repairs are needed due to corrosion of the concrete reinforcing, concrete spalling, and worn irregular concrete tread surfaces. We rank the concrete repair as a medium priority to abate slip and fall hazards. There is risk to users of the stairs because they do not extend to beach level during sand scour events. Extension of the stairs appears to be prudent. We rank extension of the stairs to beach level as a low priority if they are securely closed off at both the top and bottom during times when beach sand

elevations are low as a result of periodic natural beach scour.

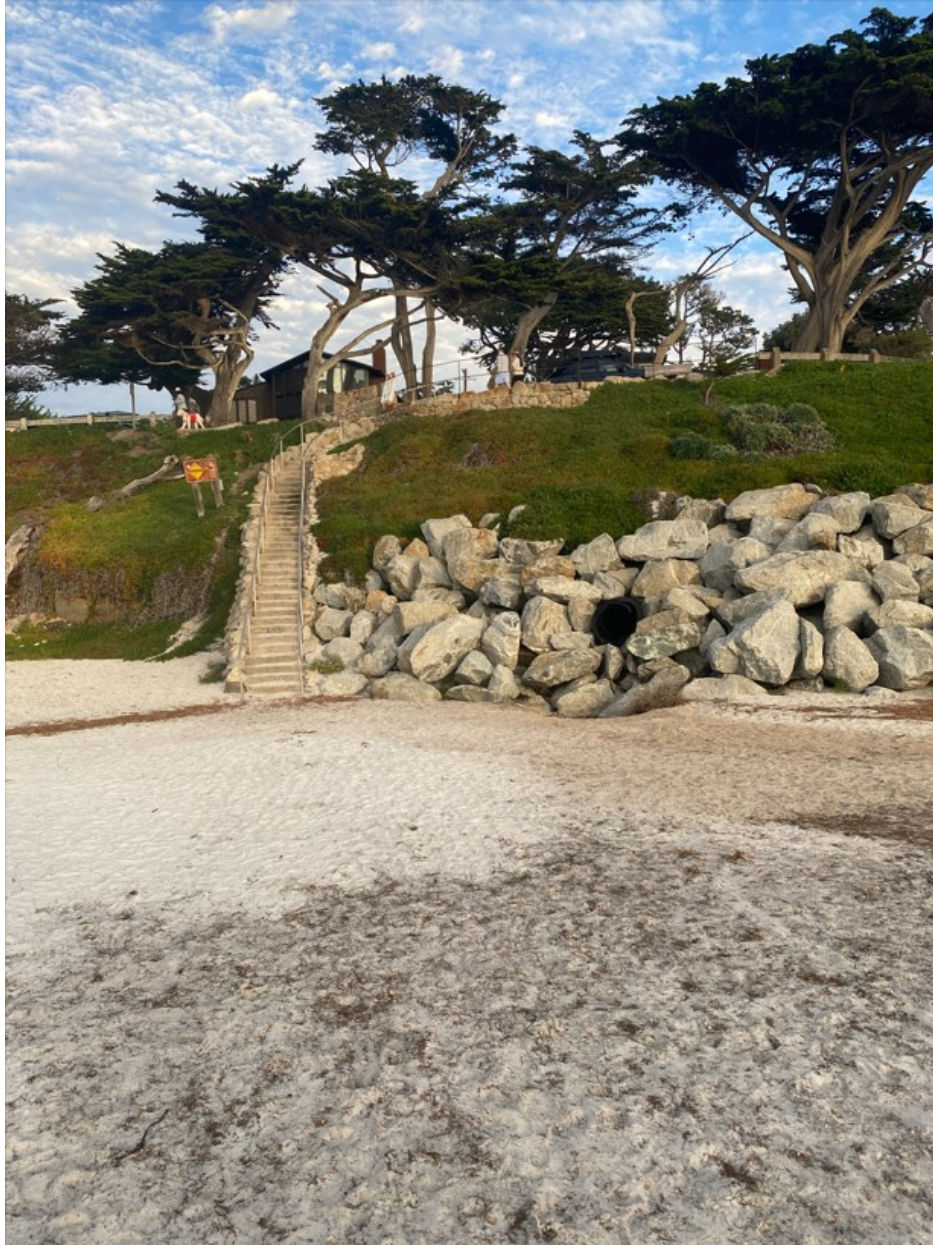
Photograph 58: Showing Stairway ST5 and North End of Revetment R6 on December 22, 2023

Photographs 57 and 58 show Stairway ST5 before and after the severe January 2023 coastal storms and ocean wave events that resulted in beach scouring. Photograph 58 is a December 2022 photo of ST5 to show the influence of the scour event on beach conditions. This staircase is bearing upon sandstone bedrock platform and appears to be stable. The handrails are in decent shape. The ST5 stair treads are

worn and cracked and should be resurfaced.

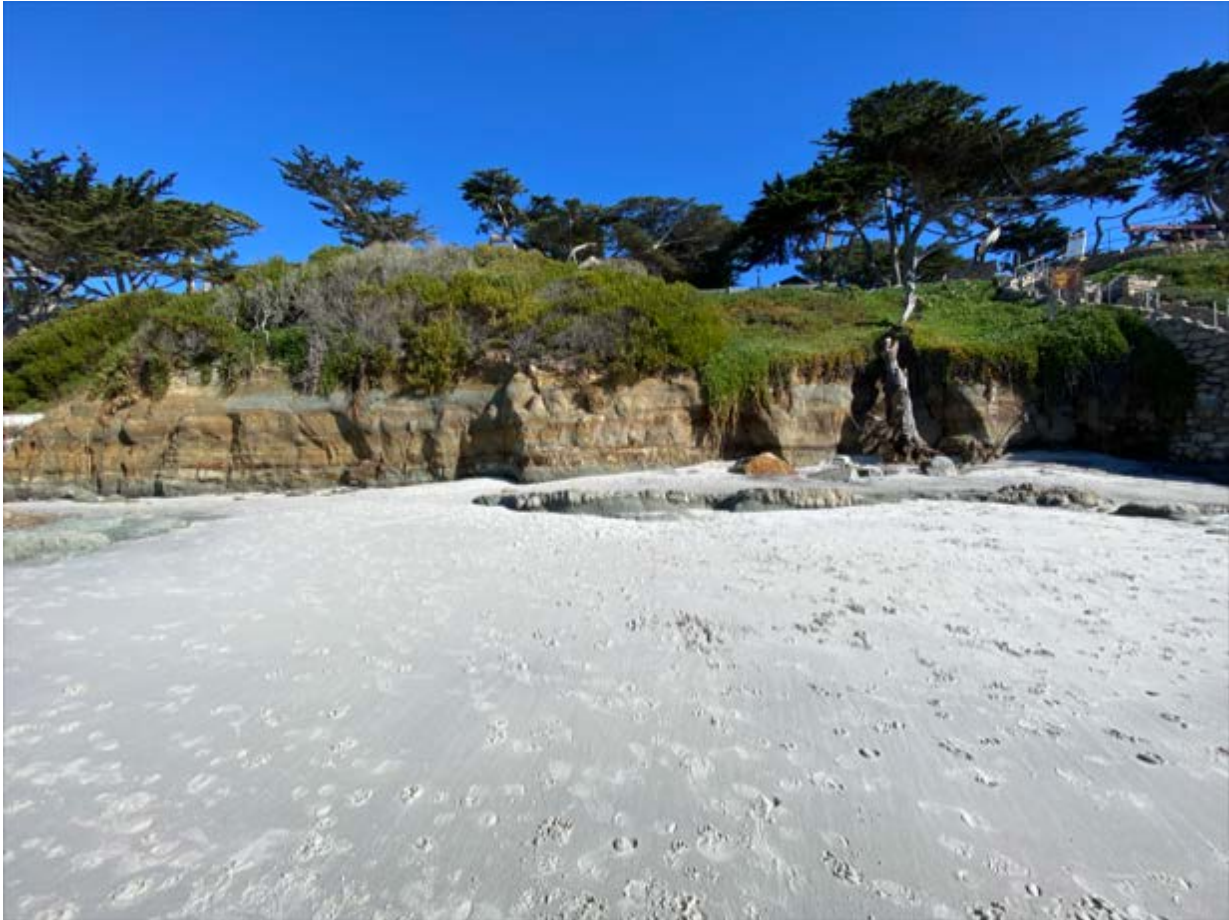
Photograph 59: Showing Bluff South of Revetment R4 on January 30, 2023

At the time of our inspection along the bluff face between Stairway ST5 and Revetment R4, a sandstone bedrock platform was discontinuously exposed, with very few fugitive riprap boulders exposed along the toe of the bluff at beach level. The bedrock exposed in the vertical lower bluff face appears to be erosion resistant and in good shape. No maintenance or armoring is necessary now. However, a future bluff face seawall with artificial rock fascia may be needed in the future to retard long-term erosion.

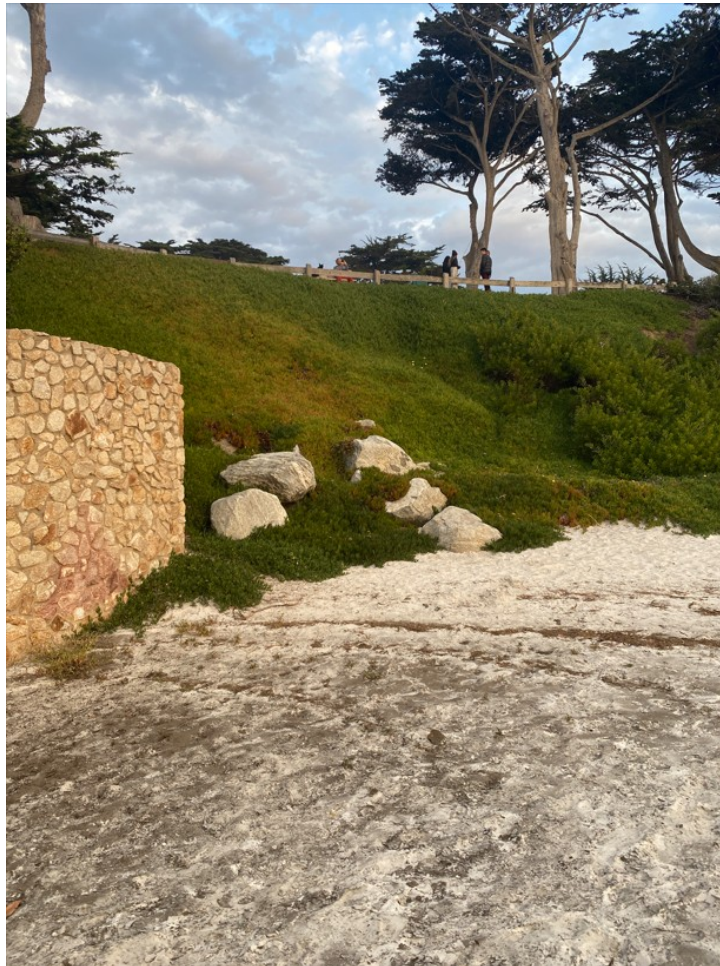
**Photograph 63: Showing Few Boulders Exposed at the North End of Revetment R4
On December 22, 2022**

Photographs 61, 62 and 63 show Revetment R4, which is comprised of mostly undersized rock and broken concrete debris. The exposed portion of R4 where we observed substantially undersized scattered rock is approximately 225 feet in length and 8 to 10 feet tall. This structure has been undermined and has collapsed. Undersized riprap has been tumbling around in the wave action and is abrading the bedrock platform seaward of the riprap revetment structure toe. Future wave action could cause the steep slope below the path to slump, undermining the large cypress trees and public pathway along Scenic Road. A vertical concrete seawall at the toe of the bluff would be a preferred alternative here, as opposed to the riprap revetment structure, which requires more maintenance, and takes up a larger footprint.

Recommended maintenance and repair is to clean up the undersized riprap and replace it with a properly engineered, riprap revetment structure, founded into the bedrock platform. Alternately, this revetment could be removed, uncovering beach area, and a vertical seawall could be constructed at the toe of the bluff to prevent Scenic Road from being undermined.

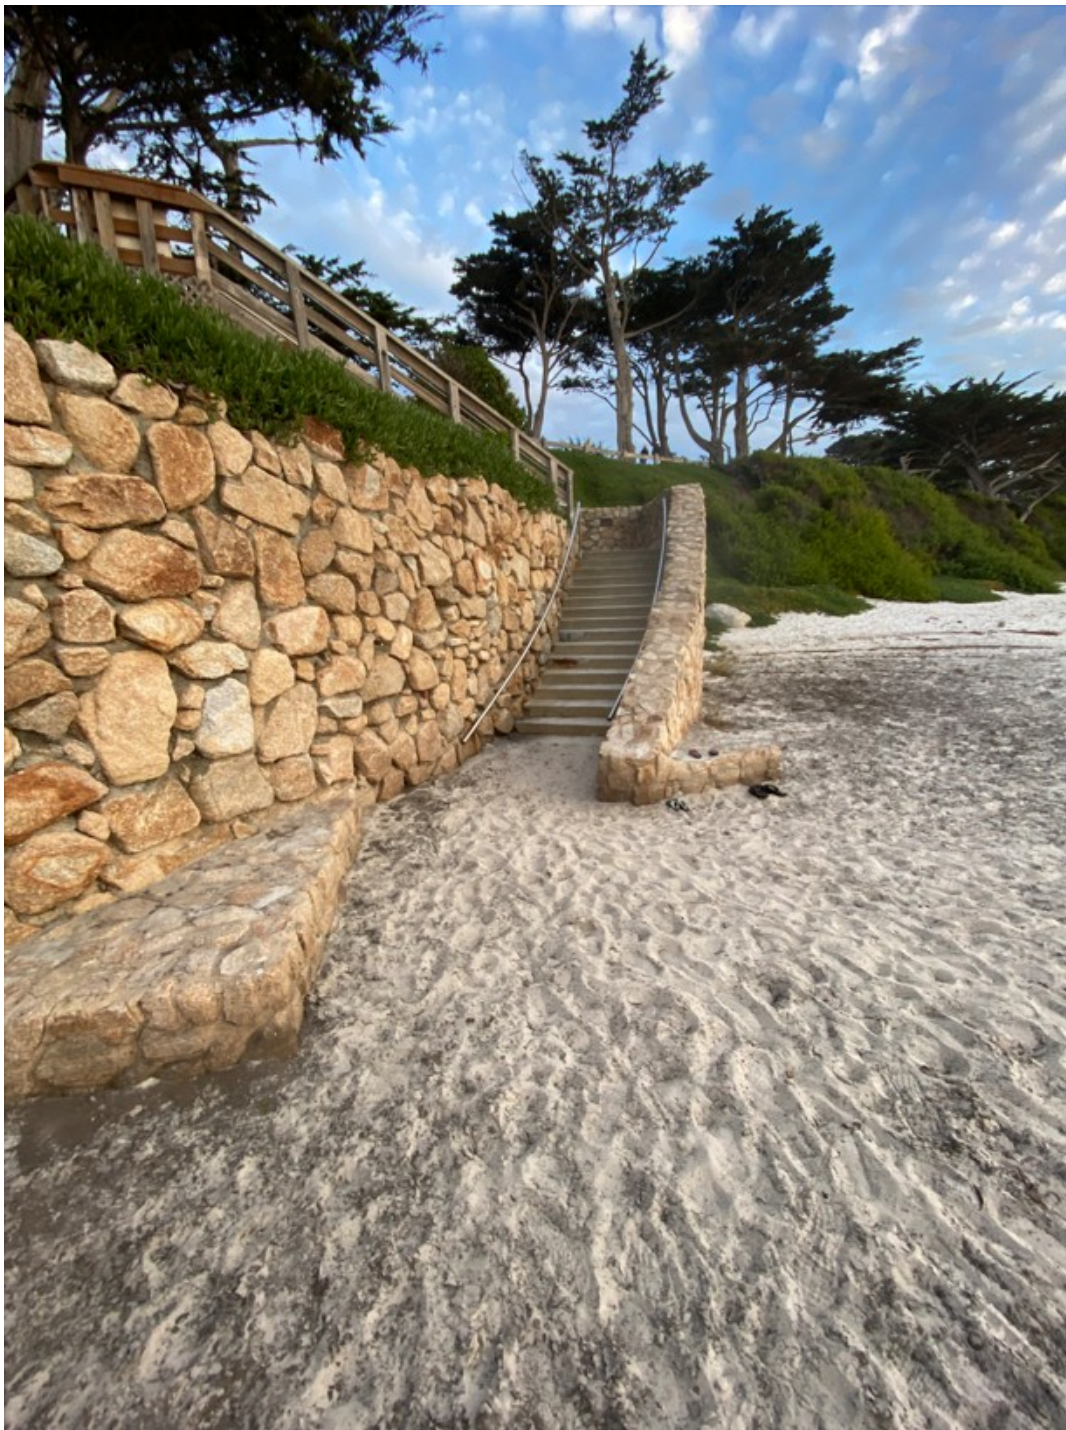
Photograph 64: Showing Stairway ST6 on December 22, 2022

Photograph 64 shows Stairway ST6 is located south of 10th Avenue. The base of the stairs was buried in beach sand.

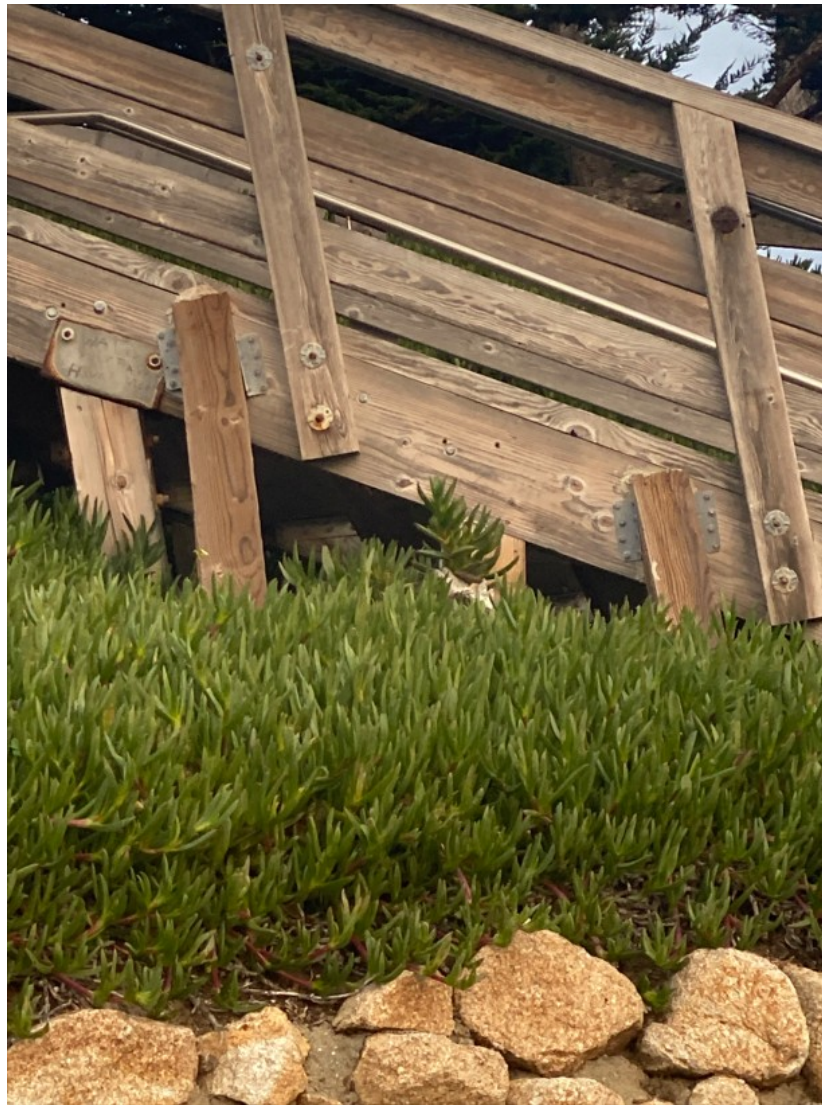
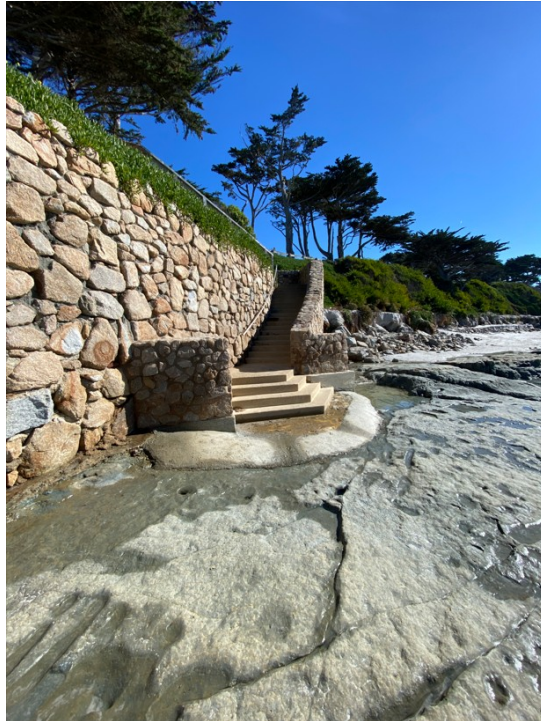
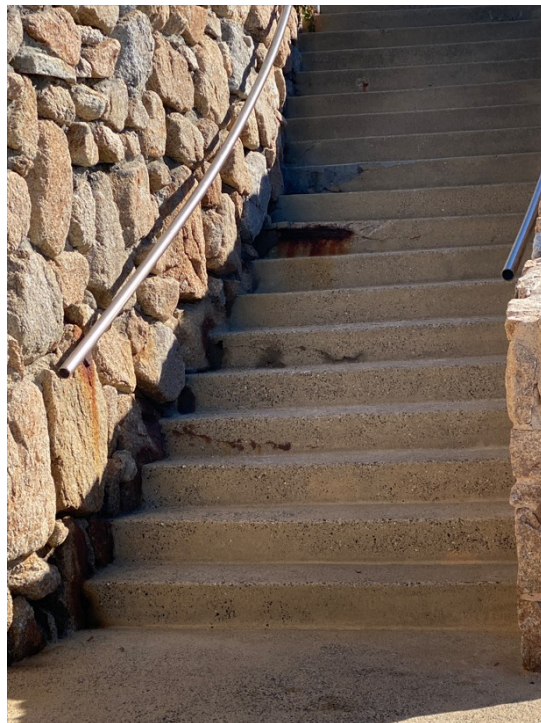
Photograph 65: Showing Recent Maintenance on Stairway ST6 on December 22, 2022

Photographs 65, 66 and 67 show Stairway ST6, which is a combination reinforced concrete (lower portion) to wooden (upper portion) public beach access staircase. The base of the staircase is founded on the sandstone bedrock platform below the beach sand. Several stair treads have spalled concrete areas, exposing highly corroded rebar, which is expanding, resulting in internal pressures within the concrete, which causes the stair treads to spall. This spalling creates a hazardous condition, and we recommend it be repaired and maintained to a safe standard for public use, using corrosion resistant reinforcing bar such as ChromX 4100 or 9100. Stairway ST5 repairs are needed due to corrosion of the concrete reinforcing, concrete spalling, and worn irregular concrete tread surfaces. We rank the concrete repair as a medium priority to abate slip and fall hazards.

Photograph 66: Stairway ST6 Well Founded in Bedrock on January 30, 2023

Photograph 67: Stairway ST6 with Tread Deterioration on January 30, 2023

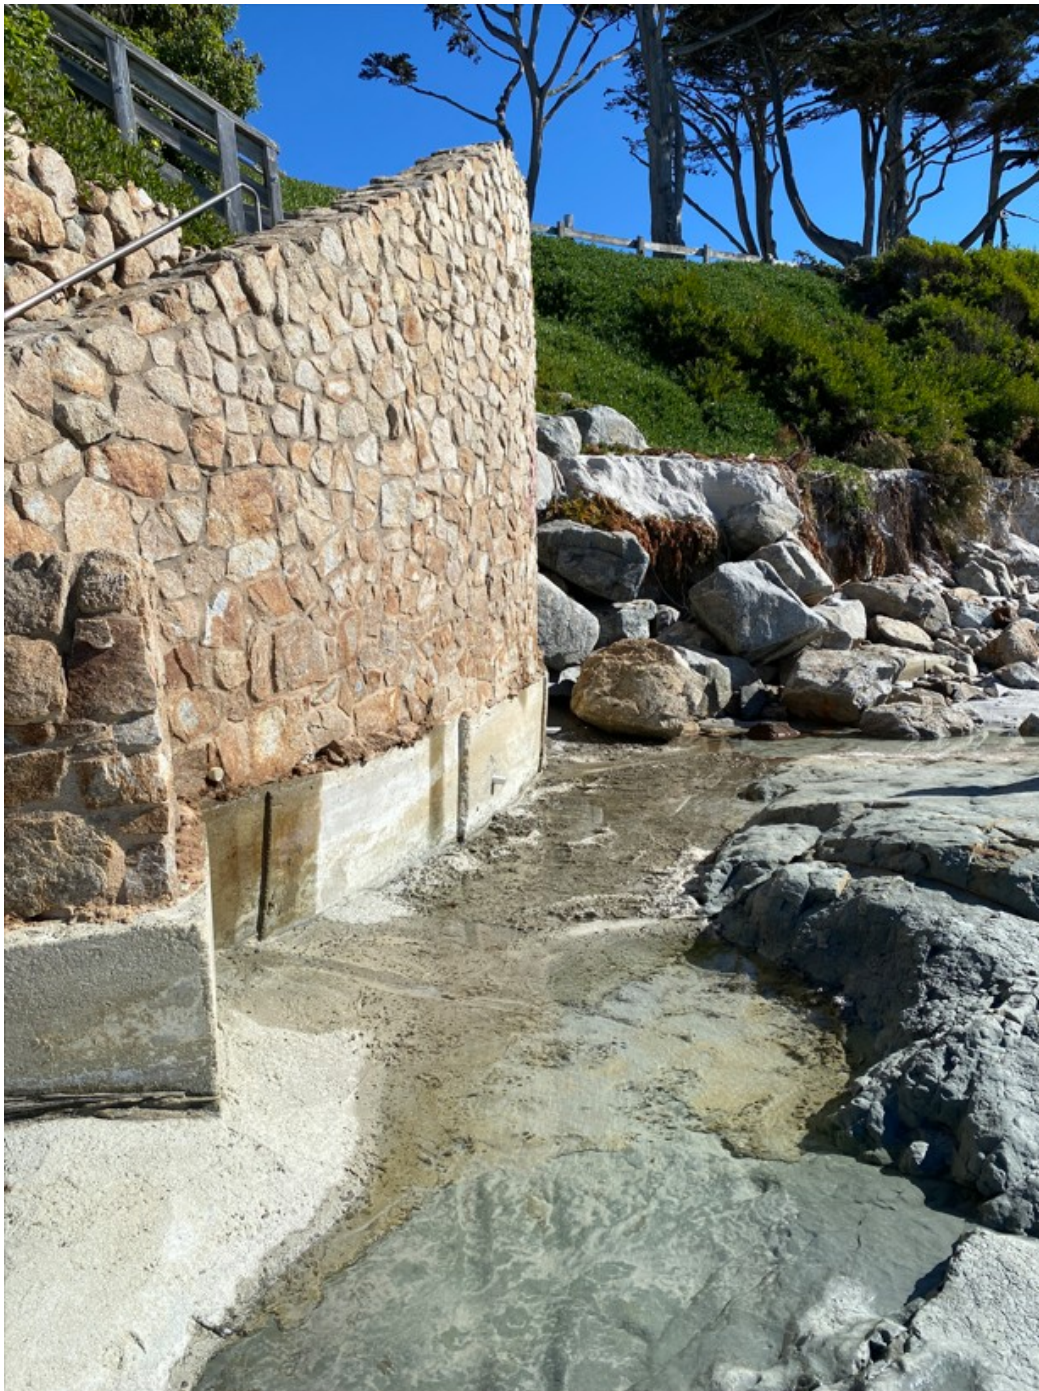
Photograph 68: South Foundation of Seawall S7 on January 30, 2023

Photograph 68 shows the south foundation of Seawall S7, located between Stairways ST6 and ST7, is bearing on the sandstone bedrock platform. The foundation is in good condition. Seawall S7 is flanked by the north end of R6.

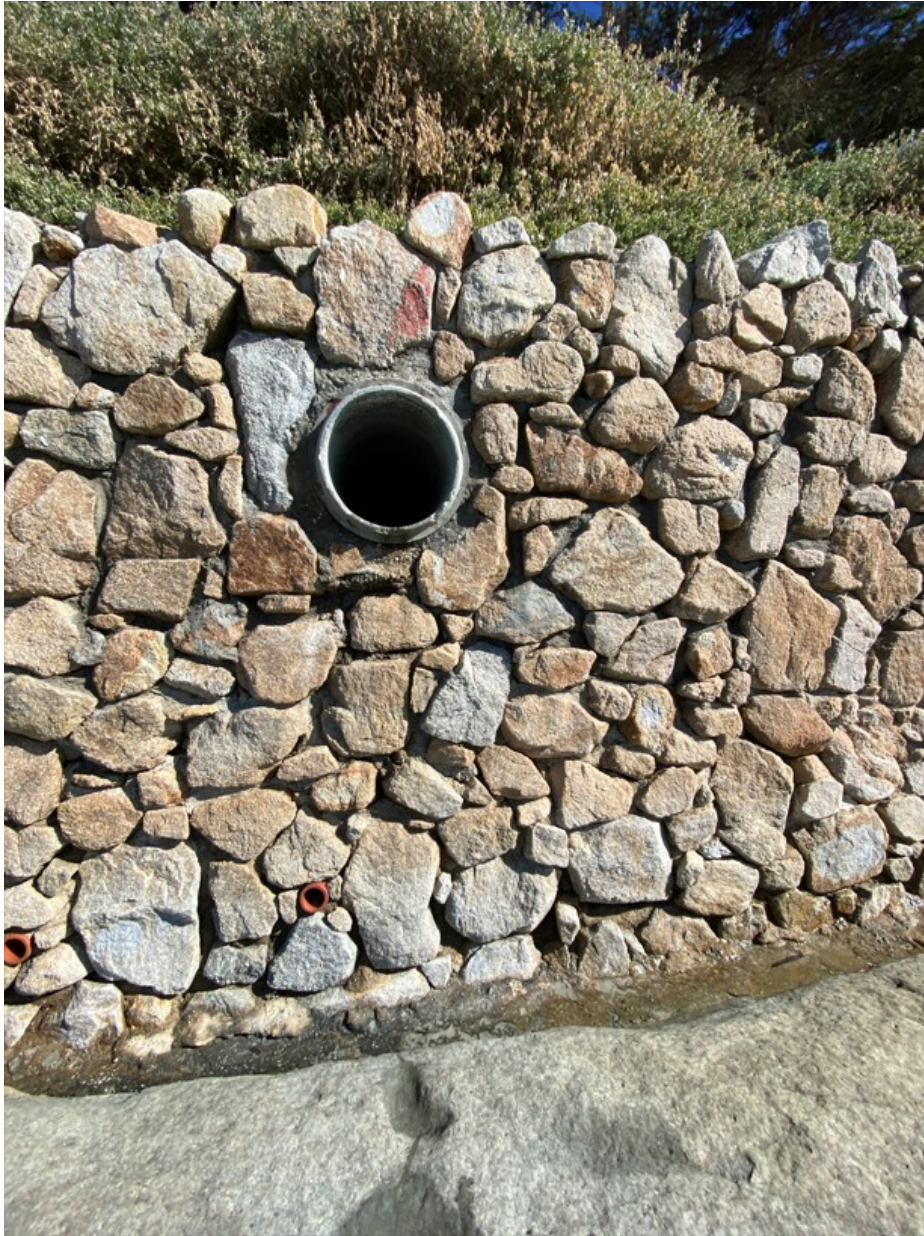
Photograph 69: Storm Drain Outfall near South End of Seawall S7 on January 30, 2023

Photograph 69 shows the south end of Seawall S7 where a 24-inch diameter concrete storm drain culvert outfall is in good condition. No maintenance is recommended here.

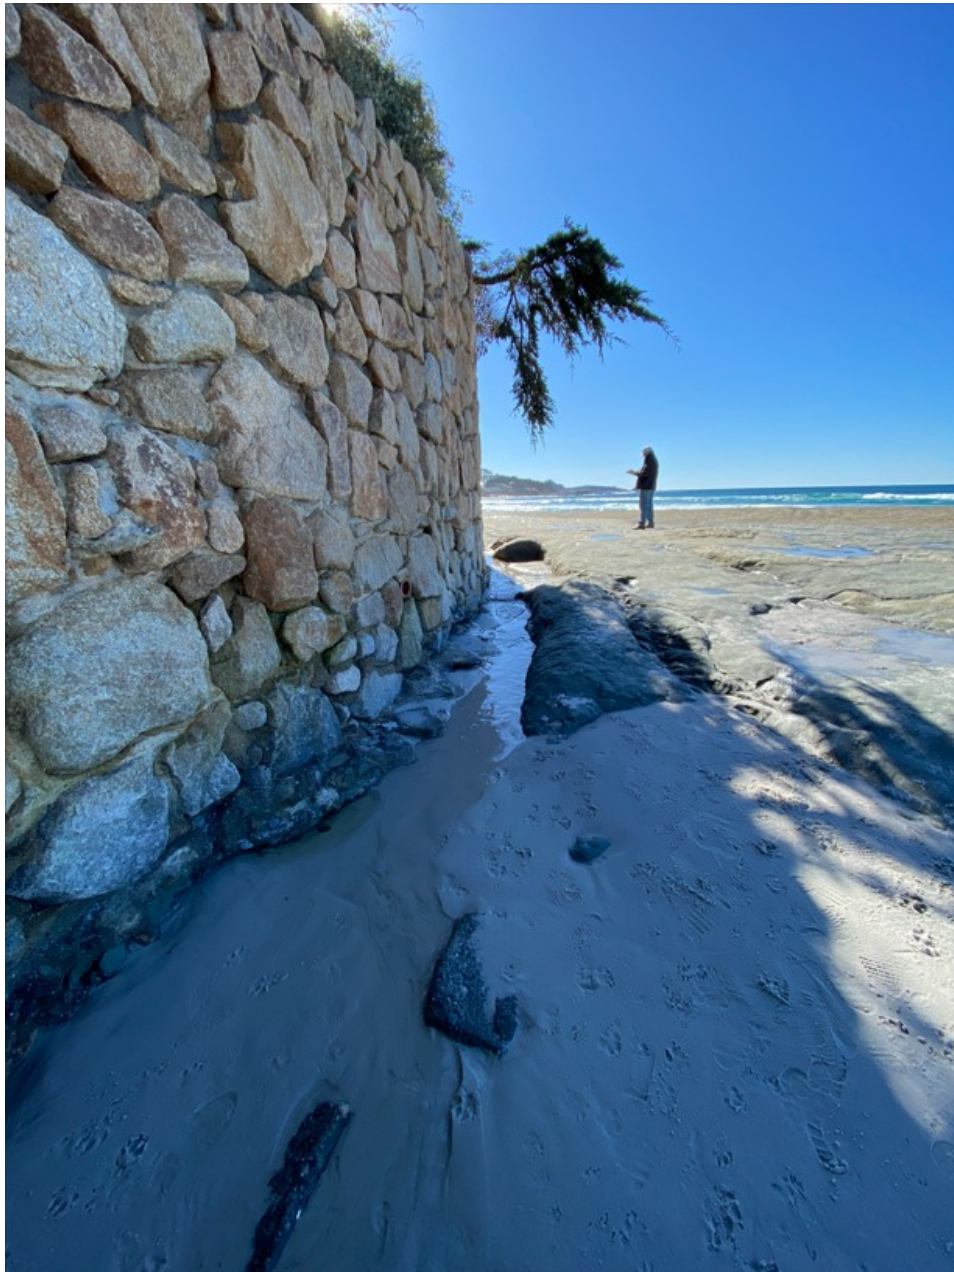
Photograph 70: Seawall S7 Foundation on January 30, 2023

Photograph 70 shows the Seawall S7 foundation, which was partially exposed during our inspection. This foundation appears to be a conventional spread footing foundation, approximately 20 inches wide at its toe and embedded in bearing upon the sandstone bedrock platform. The seawall above grade has slowly deteriorating mortar between individual rocks that form the wall face. The seawall foundation appears to be in good condition, and no maintenance is recommended at this time.

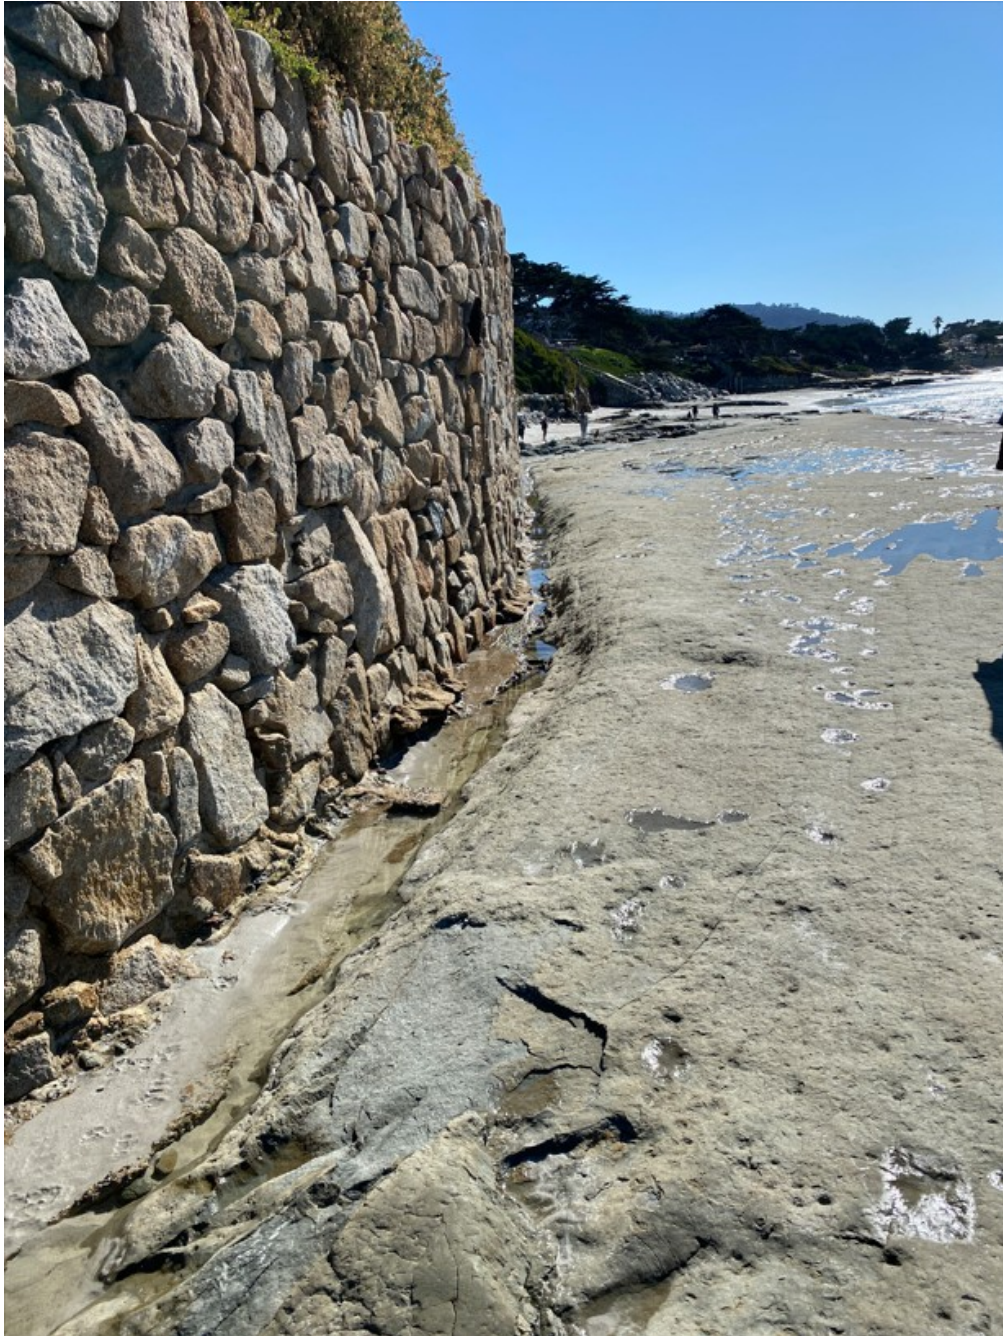
Photograph 71: Seawall S7 Foundation on January 30, 2023

Photograph 71 shows a view looking down coast at Seawall S7, showing additional exposed foundation area that is bearing on the sandstone bedrock platform.

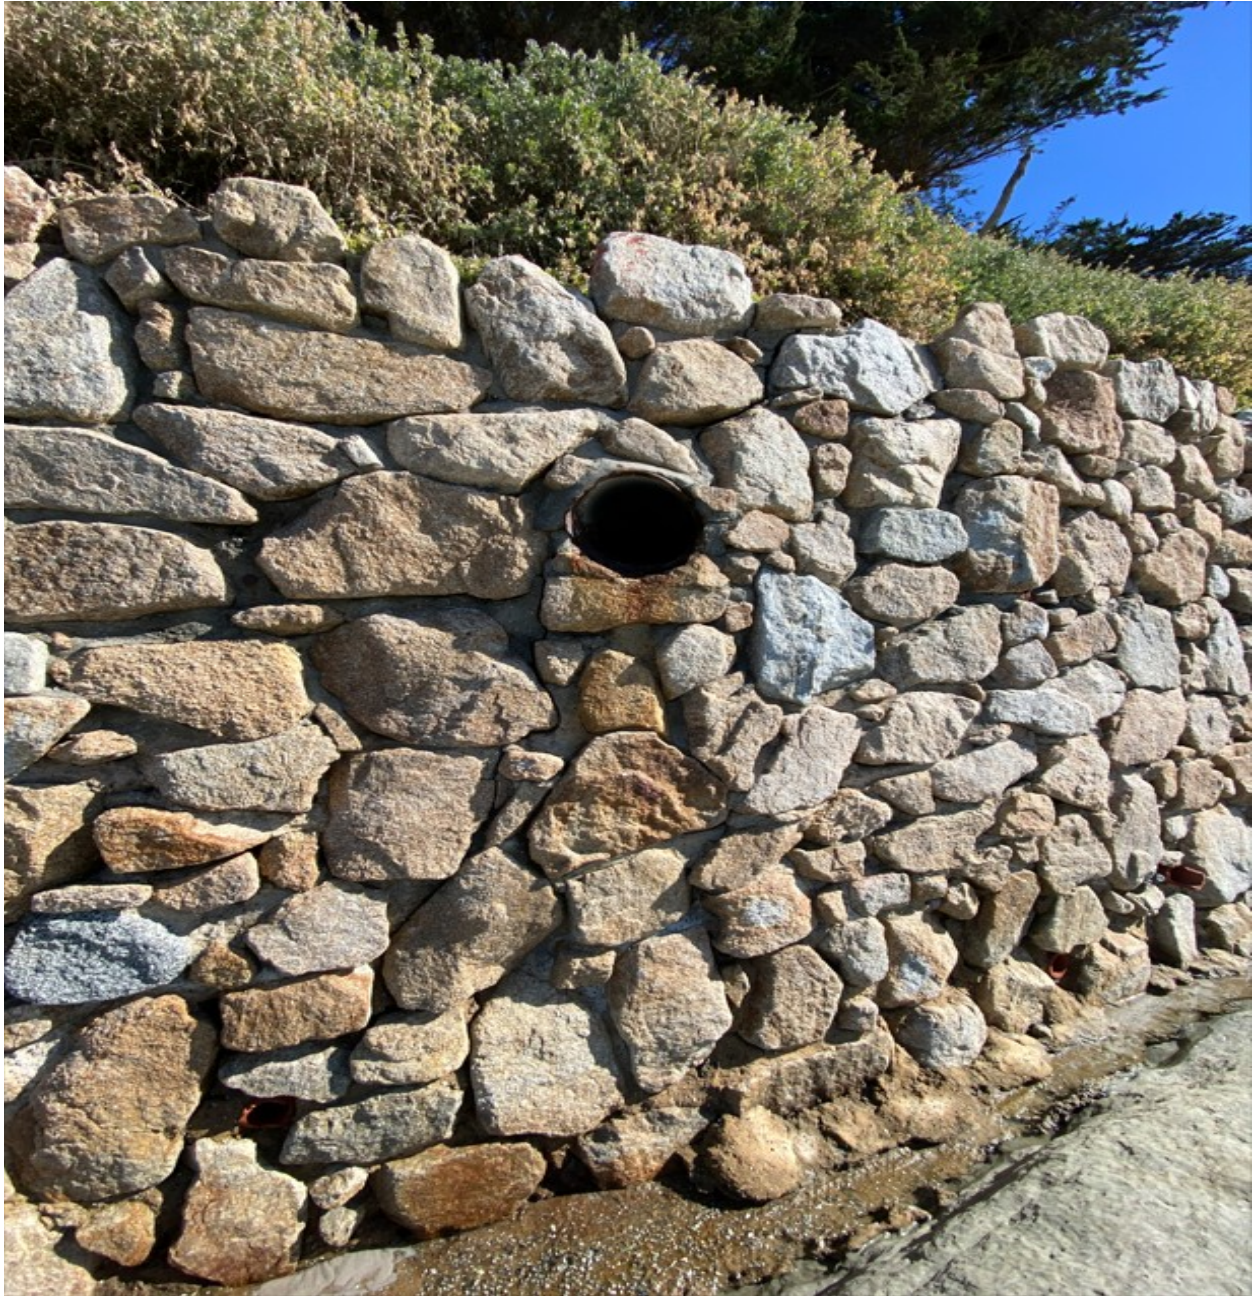
Photograph 72: Storm Drain in Seawall S7 on January 30, 2023

Photograph 72 shows a storm drain culvert projecting out of the top portion of S7. This culvert is composed of highly corroded corrugated metal pipe that is 16 inches in diameter and appears to be collapsed about 3 feet landward of the wall. We observed large cracks in the seawall just below the culvert outfall. We recommend replacing this corrugated metal culvert with watertight HDPE N-12 storm drainpipe. We classified this as a medium priority. Except for this area of recommended repair, Seawall S7 has 30 years of remaining life.
