CITY OF CARMEL-BY-THE-SEA CLIMATE COMMITTEE

1. Receive a presentation from Integral Corp./Haro Kasunich & Associates/EMC Planning Group regarding the results of the Coastal Engineering Condition Evaluation, Task 1, and Shoreline and Beach Change Analysis, Task 2, which is part of the Coastal Engineering Study
2. Review list of Adaptation Strategies for Climate Action and Adaptation Plans and Provide Feedback for Monitoring the Implementation of the Plans

TO:	Climate Committee Members
SUBMITTED BY:	Mary Bilse, Environmental Programs Manager
SUBJECT:	Receive a presentation from Integral Corp./Haro Kasunich & Associates/EMC Planning Group regarding the results of the Coastal Engineering Condition Evaluation, Task 1, and Shoreline and Beach Change Analysis, Task 2, which is part of the Coastal Engineering Study

27 April 2023
Coastal Protection Evaluation 22 December 2022 thru 30 January 2023
Carmel Adaptation Plan - Carmel Beach All Areas
Project No. 12176
Page 19

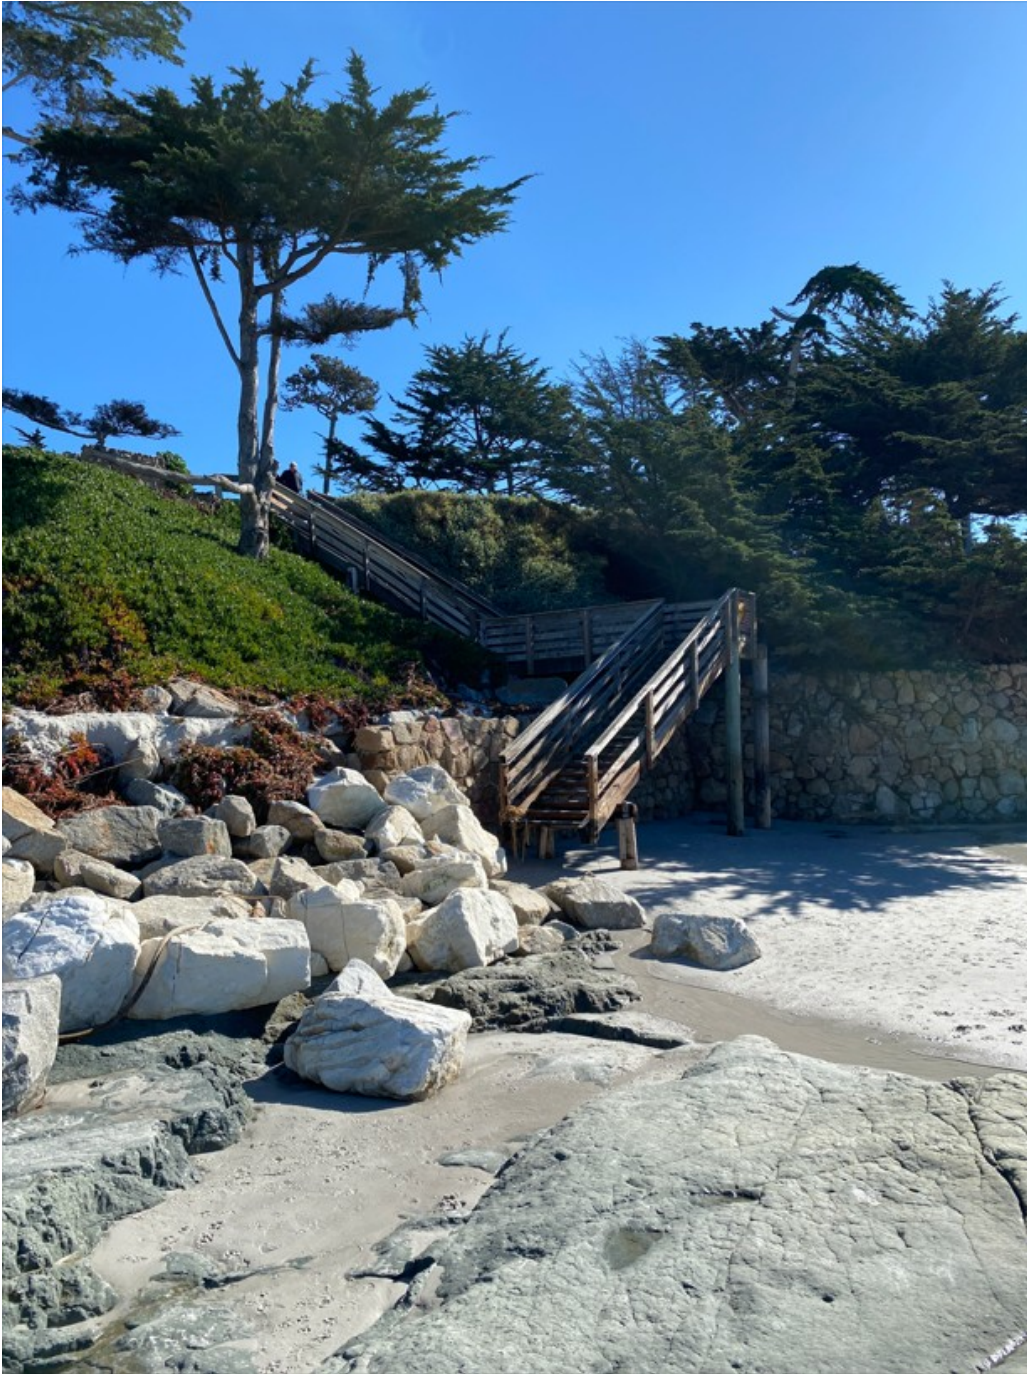
Photograph 73: Stairway ST7 on January 30, 2023

Photographs 72 and 73 show Stairway ST7 at different beach scour conditions. Photo 73 shows the lower end of the stairs ending in mid-air at the time of our January inspection. Stairway ST7 repairs are needed due to corrosion of fasteners and hardware, and the vertical drop off and lack of foundation support at the base of the stairs during times of low beach surface elevations from scour. We rank the repair as a high priority and recommend prompt structural and corrosion inspection. There is a high risk to users of the stairs.

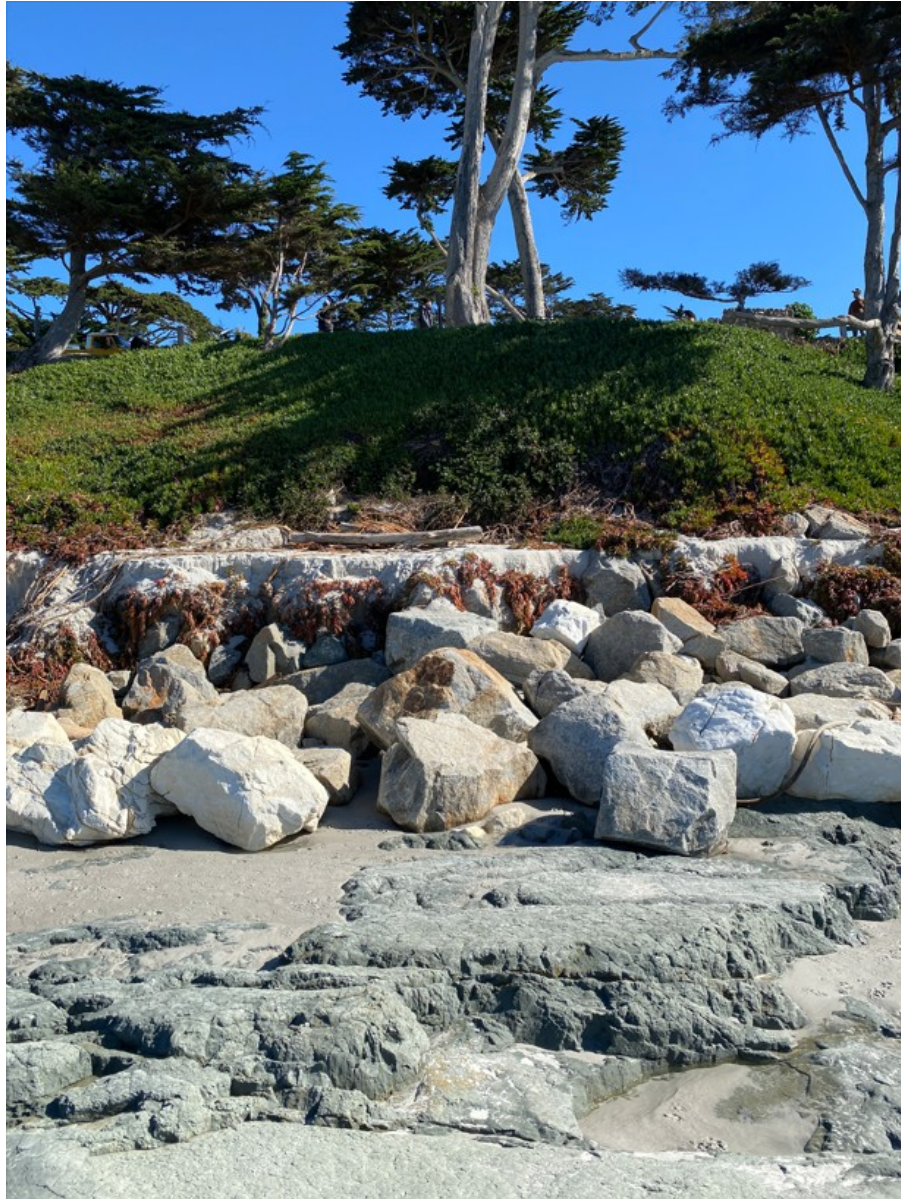
Photograph 75: South Portion of Revetment R5 on January 30, 2023 Showing Bedrock Platform Below Beach Sand and Old Erosional Scarp in Ice Plant Above Revetment

Photograph 75 shows the southern end of Revetment R5, which is located between 8th Avenue and 10th Avenue, and was possibly initially founded on beach sand in an emergency effort to buttress the bluff failure above it. The wave action then likely scoured away the beach sand, and undermined the emergency revetment, causing it to collapse, and spread boulders out onto the beach.

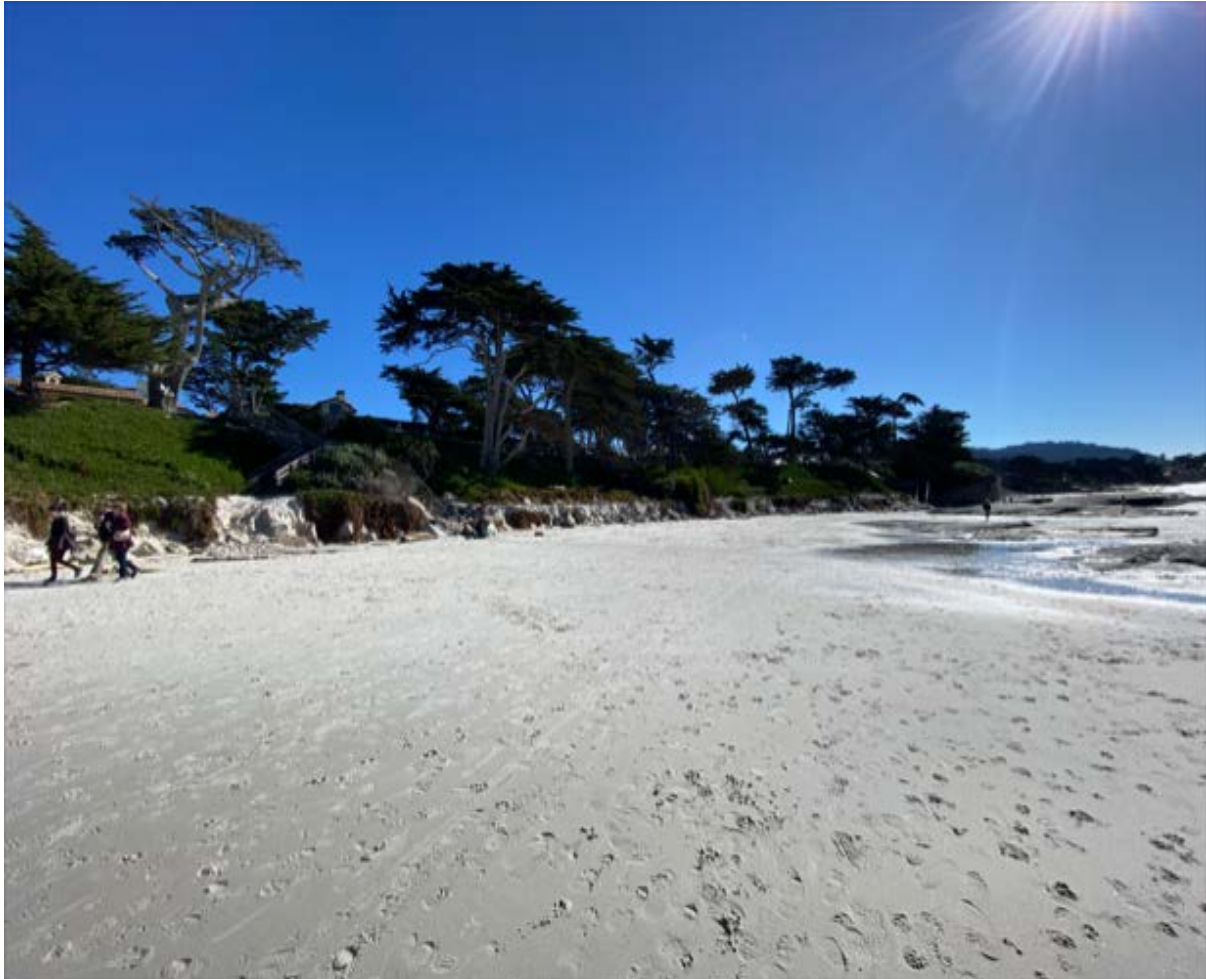
Photograph 78: Central Portion of Revetment R5 on January 30, 2023

Photograph 78 shows the central portion of Revetment R5, where the coastal access path at the top of the bluff is dependent on bluff toe armoring and stability. A riprap revetment structure which is armoring the toe of the bluff is barely visible. About 3 to 5 feet of the revetment height is visible. The total height of a revetment is unknown, but estimated at 12 to 15 feet. Future wave action could cause the steep slope below the path to slump, undermining the large cypress trees, and public pathway along Scenic Road. A vertical concrete seawall at the toe of the bluff would be a preferred alternative here, as opposed to the riprap revetment structure, which requires more maintenance, and takes up a larger footprint.

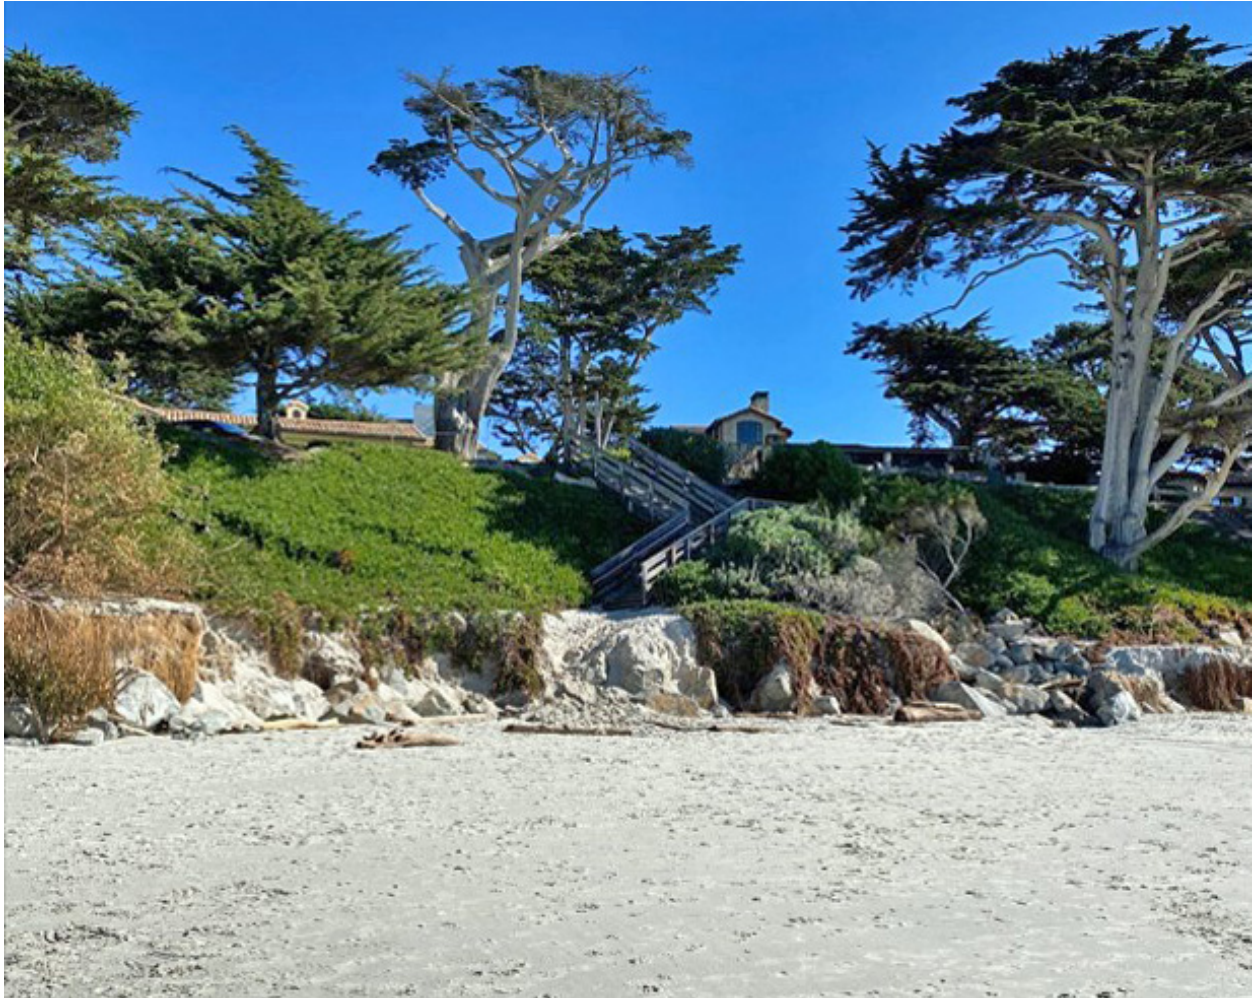
Photograph 79: Showing Beach Access Stairway ST8 on January 30, 2023

Photograph 79 shows Beach Access Stairway ST8, which is near 9th Avenue just south of the central part of Revetment R5. It is a wooden stairway that is in good condition; however, it terminates before reaching the beach when the beach sand levels are seasonally low. We recommend that that the stairway be extended approximately 12 vertical feet down to the bedrock platform (which is presently buried by beach sand) at beach level. The existing beach access path across the R5 rip-rap below these stairs is hazardous and poses risk to stair users attempting to cross the revetment. Extension of the stairs is a high priority. This stairway does not have any other maintenance recommended at this time. Extending the stairway across the rip-rap revetment should be done carefully. A detailed design study will be necessary to properly found the stairway in and seaward of Revetment R5.

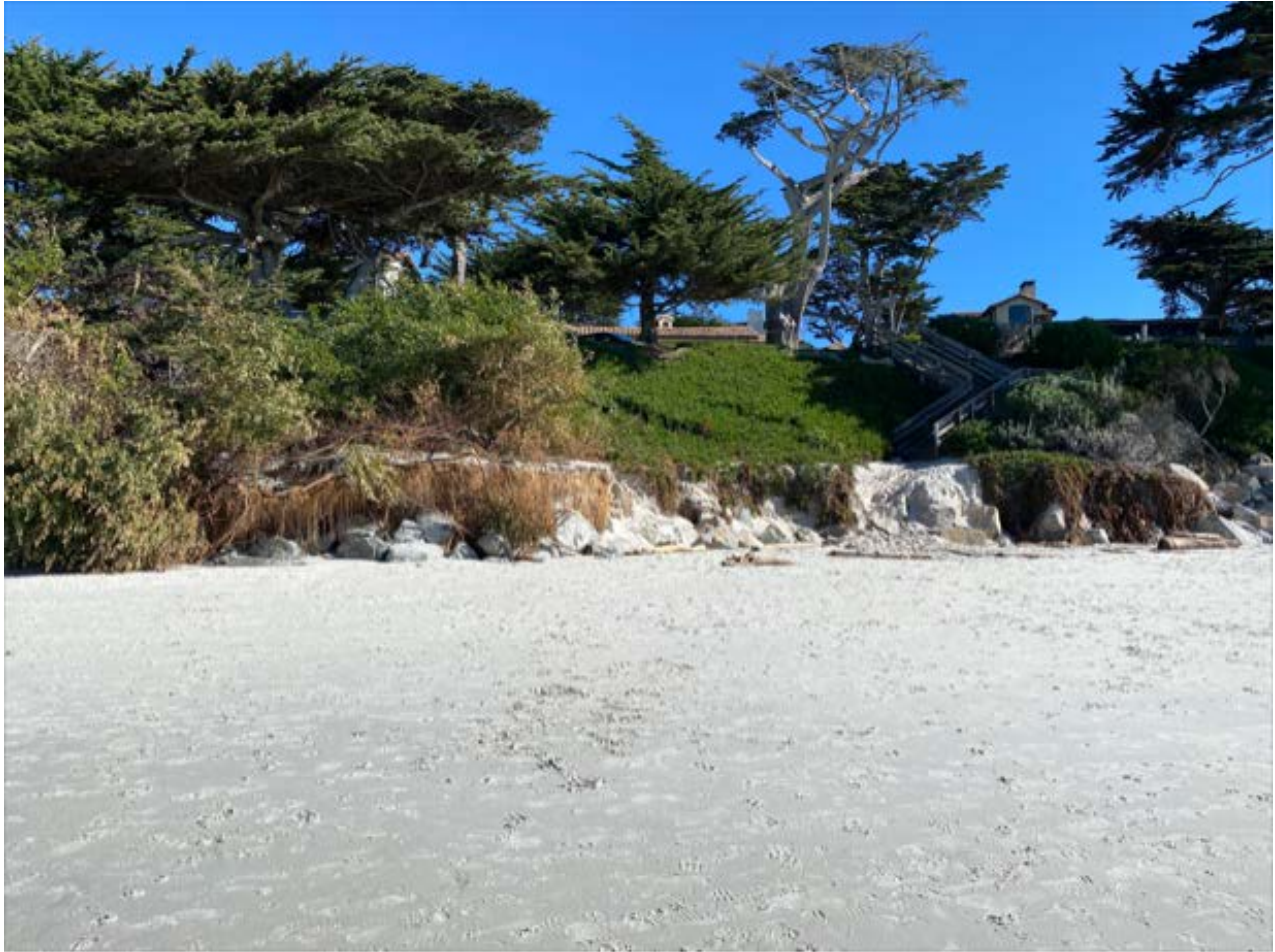
Photograph 80: Showing South End of Central Portion of Revetment R5 on January 30, 2023

Photograph 80 shows the south end of the central portion of Revetment R5 adjacent to Stairway ST8.

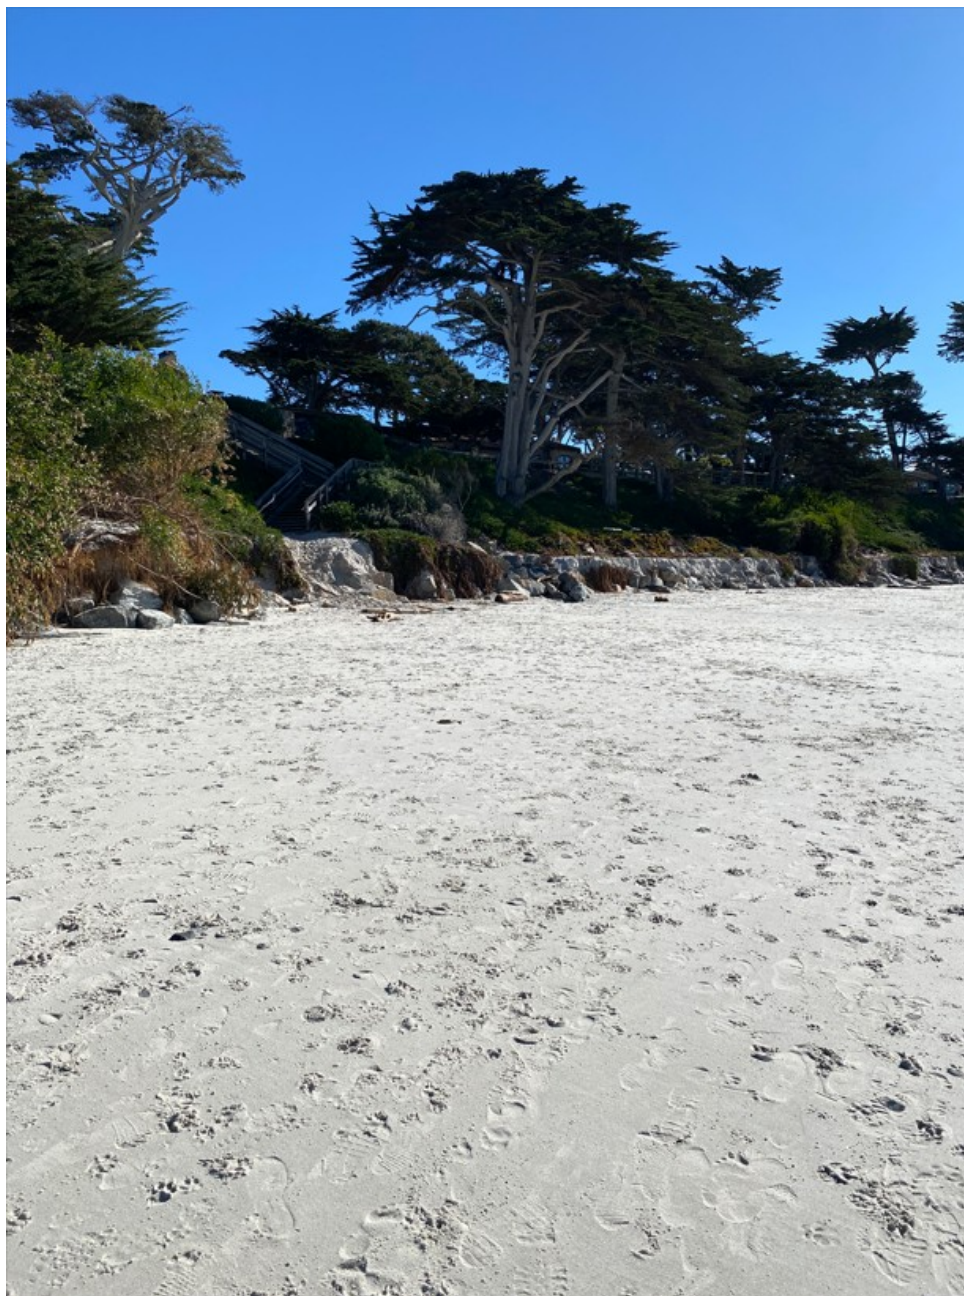
Photograph 83: Showing Additional Revetment R5 Rip-rap on January 30, 2023

Photograph 84: Showing a Small Amount of Revetment R5 Riprap on January 30, 2023

Photographs 82, 83 and 84 show the location of the center portion of Revetment R5 where we observed approximately 100 linear feet of 3- to 5-foot-high rip-rap that was exposed. It was not possible to see enough riprap to draw meaningful conclusions regarding the extent, dimensions and condition of this reported structure. We suspect most of this revetment structure is below sand level, not visible during our inspection.

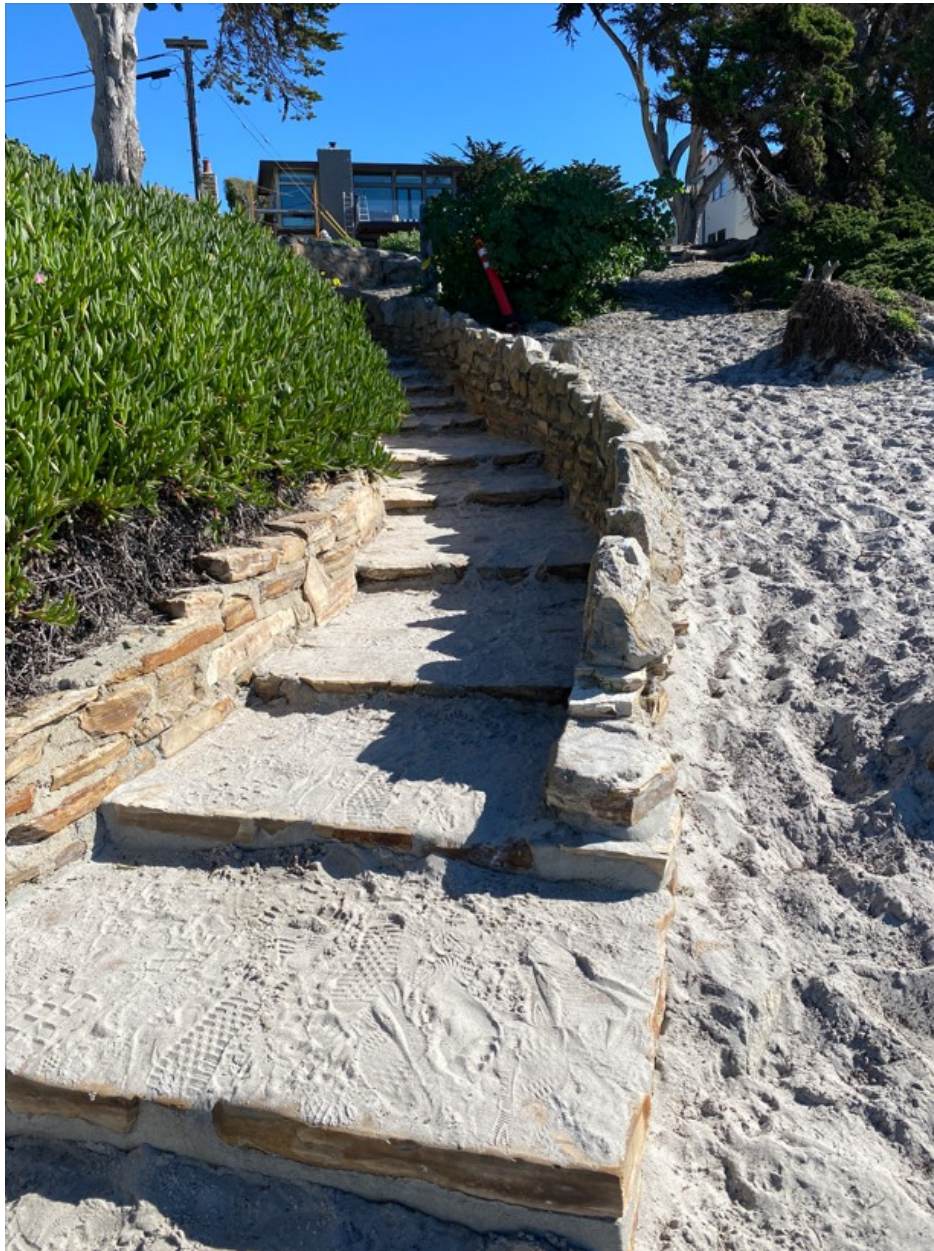
Photograph 86: Stairway ST9 on January 30, 2023

Photographs 86 and 87 show Stairway ST9, which is near 8th Avenue, is a set of rock and mortar landscape or decorative steps. No recommended maintenance at this time is needed. The natural rock (Carmel Stone) treads are becoming worn, and their irregular surface should be evaluated for safety and code compliance by a qualified professional. A detailed study would be required to assess how to protect the stairs from being undermined.

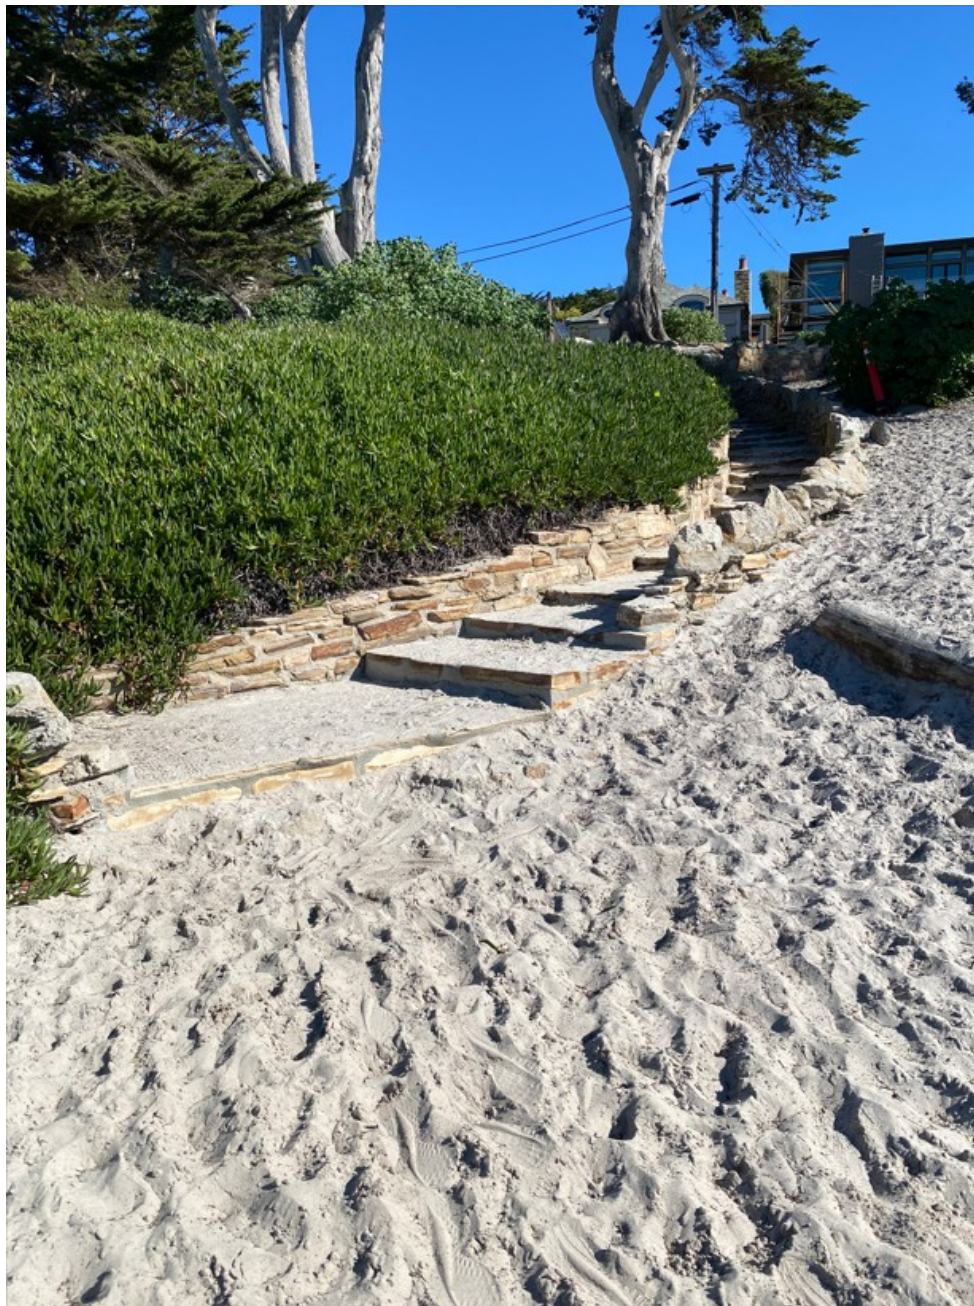
Photograph 87: Toe Conditions at Seaward End of Stairway ST9 on January 30, 2023

Because the treads of Stairway ST9 are worn and have an irregular (bumpy) surface that poses some slip and fall risks to stair users, we recommend they be repaired and classify that as a medium priority.

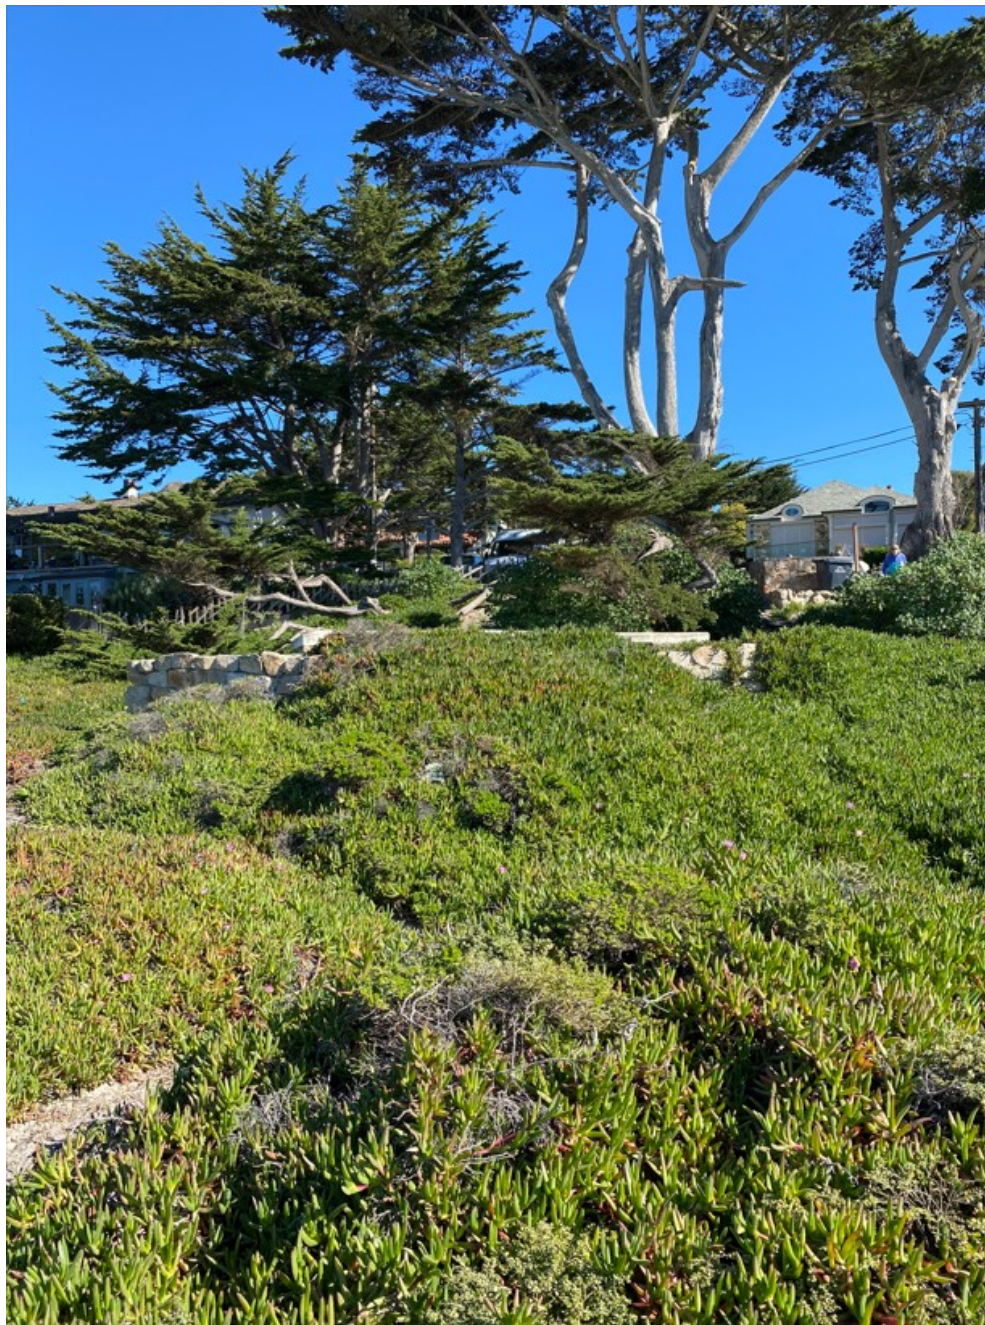
Photograph 88: Seawall S8 on January 30, 2023

Photograph 88 shows Seawall S8 on January 3, 2023. It is a retaining wall (not a seawall) near 8th Avenue and Stairway ST9 and appears to be supporting a cut slope created to construct a municipal infrastructure system. It is not influenced by ocean wave impact. Seawall S8 appears to have at least 30 years of remaining life and no repairs are needed now.

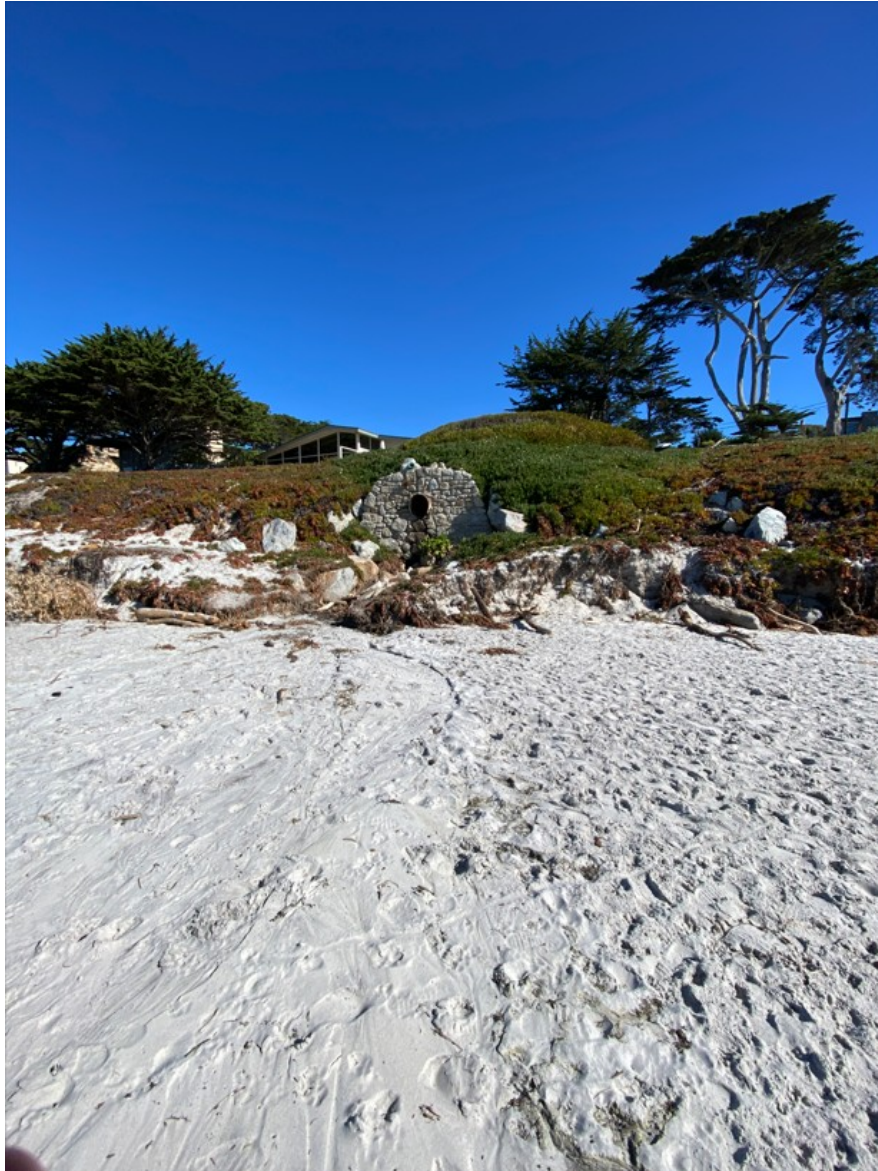
Photograph 89: Revetment R5 and Seawall S9, Showing Small Amount of Riprap Boulders on January 30, 2023

Photograph 89 shows that Seawall S9 is a storm drainpipe headwall just north of 8th Avenue. No noticeable maintenance is recommended at this time. As exposed during our inspection, the north end of Revetment R5 has scattered riprap in this location and it does not seem laterally continuous. During our inspection, only the crest of the revetment structure was visible during inspection. Seawall S9 appears to have 20 years of remaining life and no repairs are needed now.

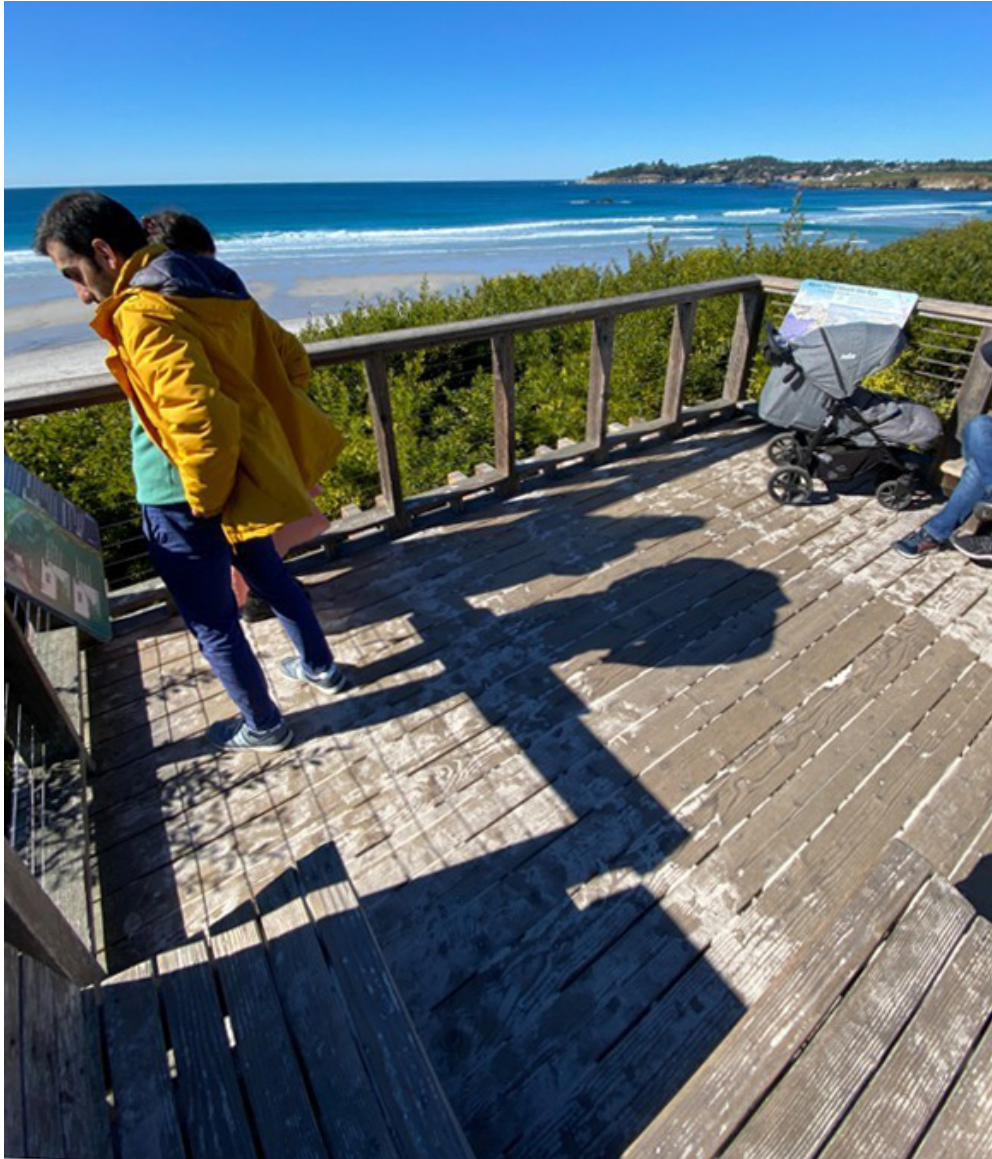
Photograph 90: Stairway ST10 Overlook Platform on January 30, 2023

Photograph 90 shows a Public Overlook Platform at the end of a boardwalk at the end of Ocean Avenue, we have named ST10, as seen on January 30, 2023. Our firm (Haro Kasunich and Associates Inc.) assisted in the design of this overlook in 2012. The ST10 wooden platform has reinforced concrete piers supporting it that appear to be performing reasonably well and we do not note the need for any maintenance at this time. We estimate the anticipated life of the structure is approximately 20 years. We recommend that the platform structure be monitored for deterioration of the wood and corrosion of the metallic hardware and reinforcing. If any problems are noted in the future, appropriate maintenance and repair should be done.

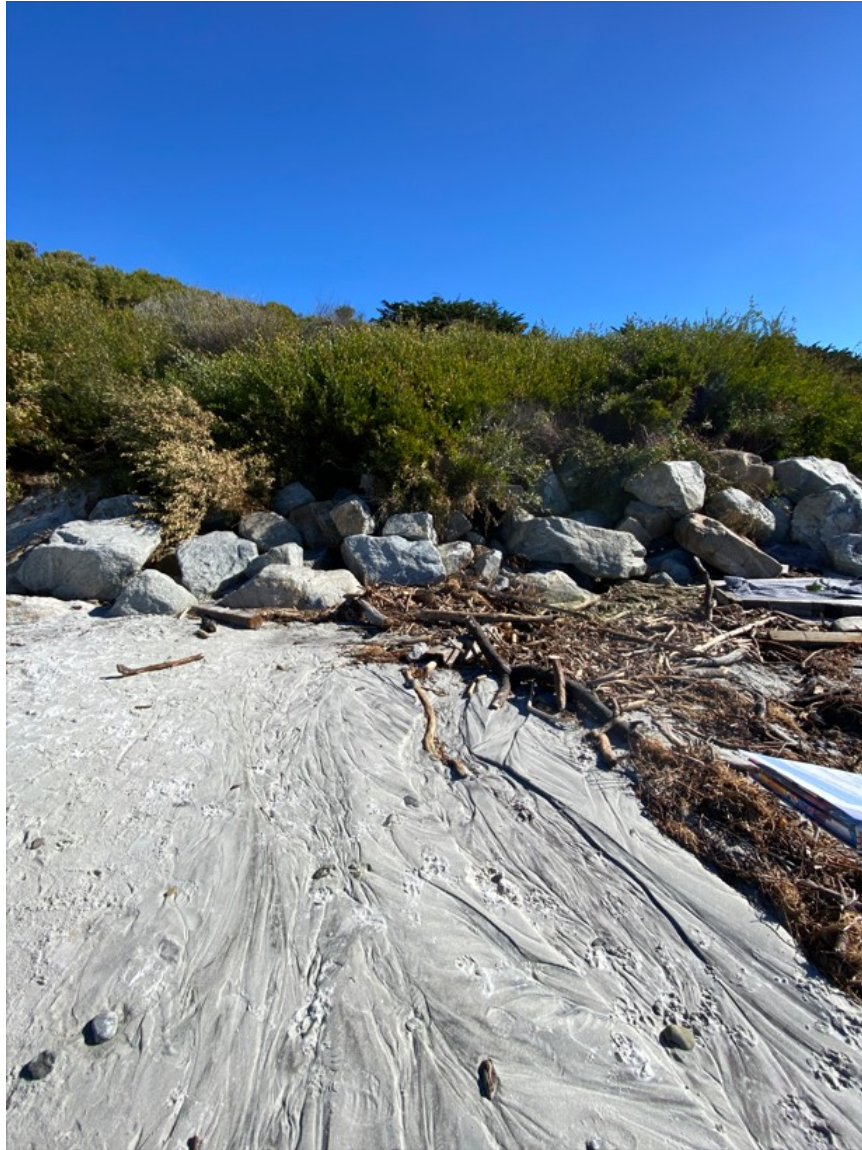
Photograph 91: Revetment R6 Showing Small Amount of Rip-rap Boulders on January 30, 2023

Photograph 91 shows riprap that forms part of the R6 Revetment structure seaward of the end of Ocean Avenue which incorporates a storm drain outfall, as seen on January 30, 2023. The rip rap has an approximately 2:1 (H to V) surface slope gradient and the exposed portion is 6 to 7 feet tall. The remainder of the revetment, including its foundation condition, is buried in sand and is unlikely to be visible until the next extreme scour event. Whenever it is next exposed by natural beach sand scour processes, it should be inspected. That may not be for a decade but could be possible during any winter. Based on what we observed, no maintenance is presently recommended. We estimate the lifespan of this structure is 10 to 30 years, depending upon its foundation condition.

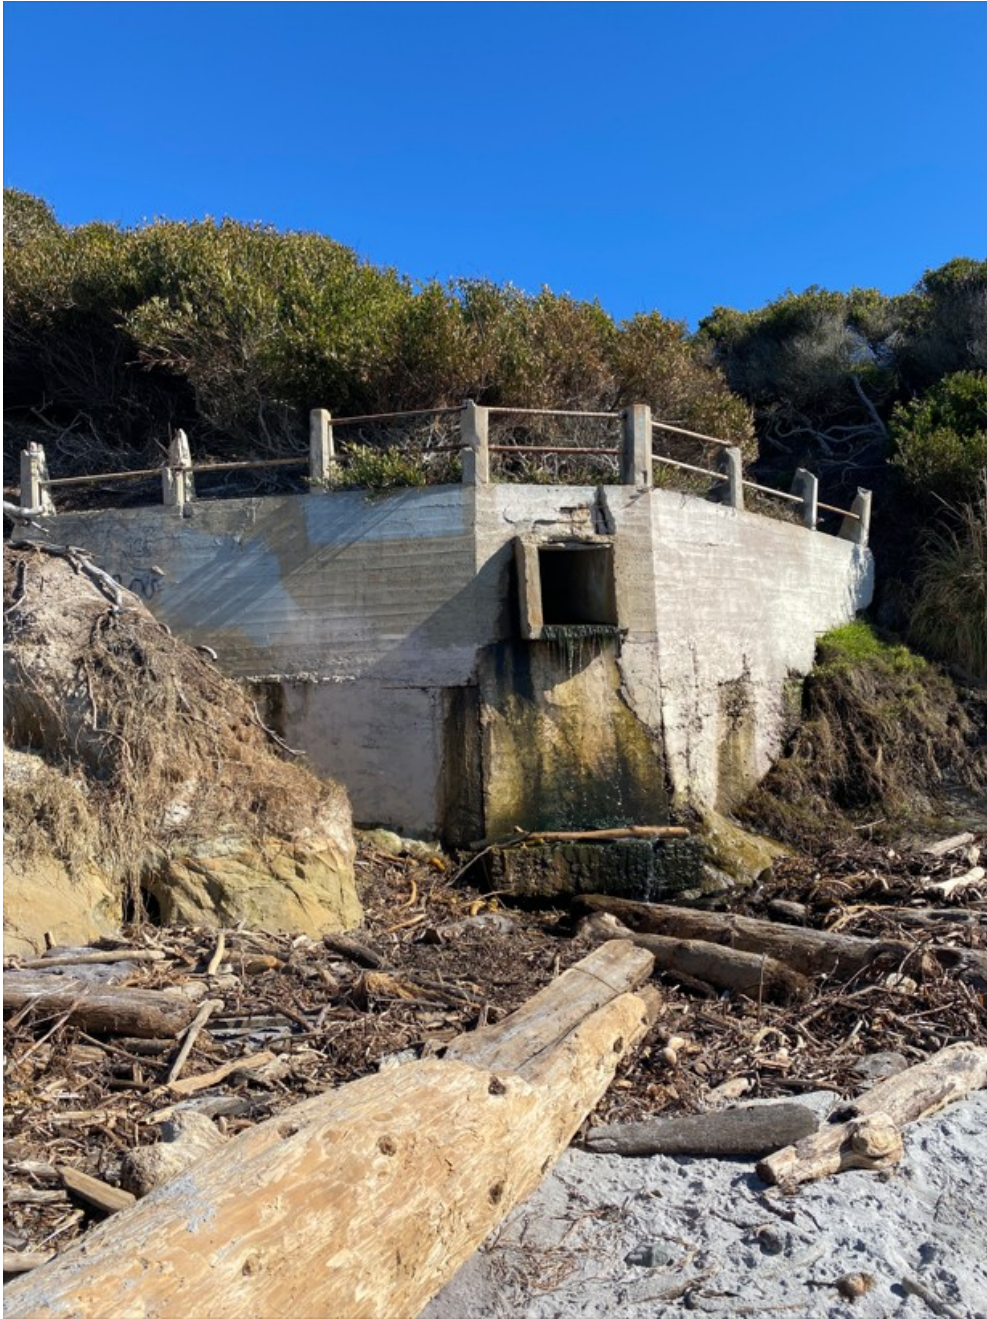
Photograph 92: Seawall S10 on January 30, 2023

Photographs 92, 93, 94 and 95 show Seawall S10 on January 30, 2022. This seawall is a storm drain headwall for a 3 by 3-foot reinforced concrete box culvert located in the dunes area north of Ocean Avenue. It is in poor condition. Photograph 92 shows that the central part of the Seawall S12 foundation is bearing upon sandstone bedrock. In adjacent areas the foundation is partially undermined horizontally up to 16 inches at the toe.

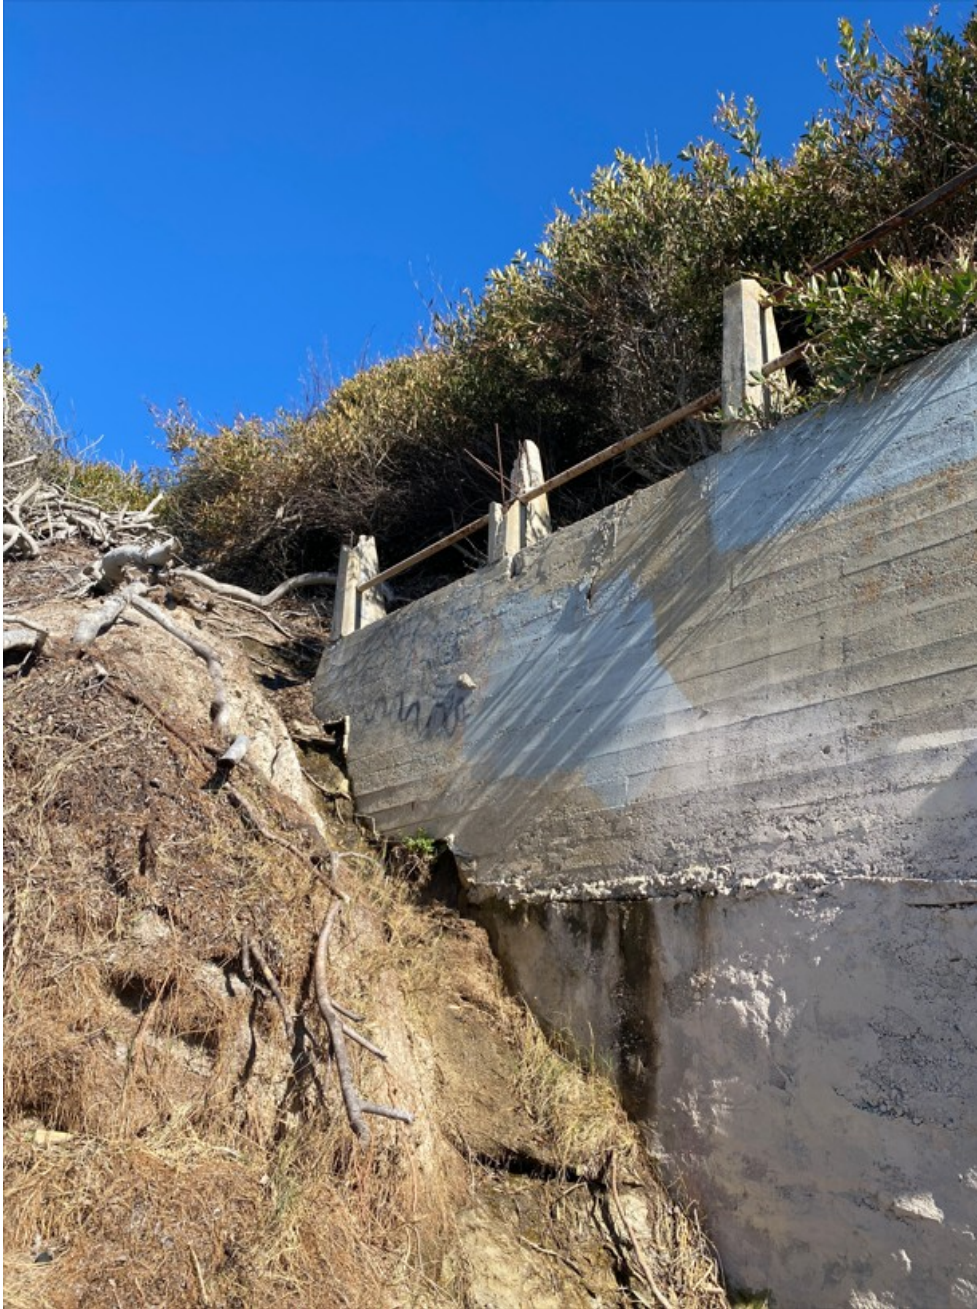
Photograph 94: Seawall S10 on January 30, 2023

Photograph 94 is a photograph that shows Seawall S12 being undermined where it steps up the coastal bluff on the north side. Also visible is that the guard at the top of the wall is broken creating an unsafe condition there that needs to be remedied.

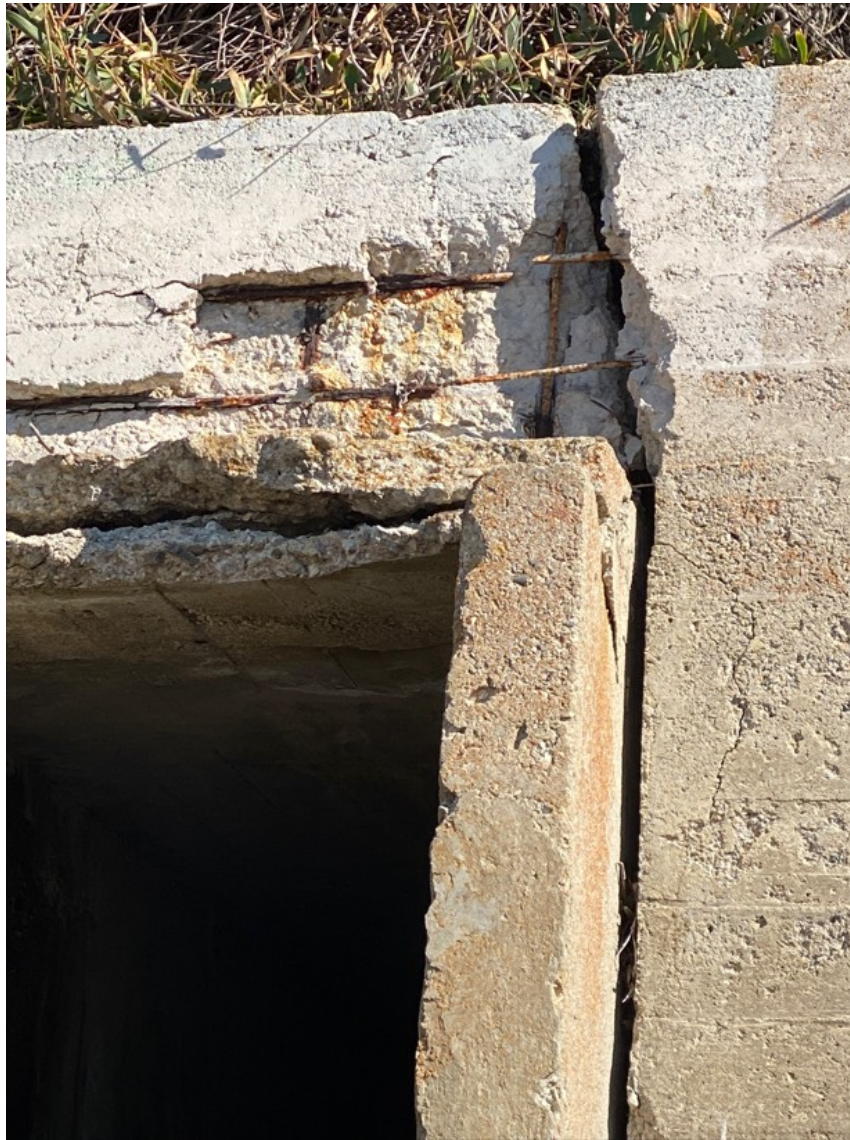
Photograph 95: Seawall S10 on January 30, 2023

Photograph 95 is a photograph that shows a large structural crack in Seawall S12 above the box. The crack is wider at the top than the bottom and the wall has been displaced. Reinforcing bars have been exposed by spalling concrete. It appears the south side of the seawall has rotated out in the seaward direction. The north side of the seawall appears to be vertical (plumb) and straight. Most of the rebar of the structure is corroded and not salvageable. We recommend reconstruction of the box culvert and seawall in its entirety. The down coast end of the seawall is outflanked and has been partially undermined, contributing to instability on that side of the structure. This structure has 0 to 10 years of remaining service life before it may collapse. It could collapse catastrophically this year. We do not expect it to survive 10 years. We recommend the City budget for and construct a new structure as soon as possible. This structure poses risks to beach users, and we recommend it have a high priority for replacement

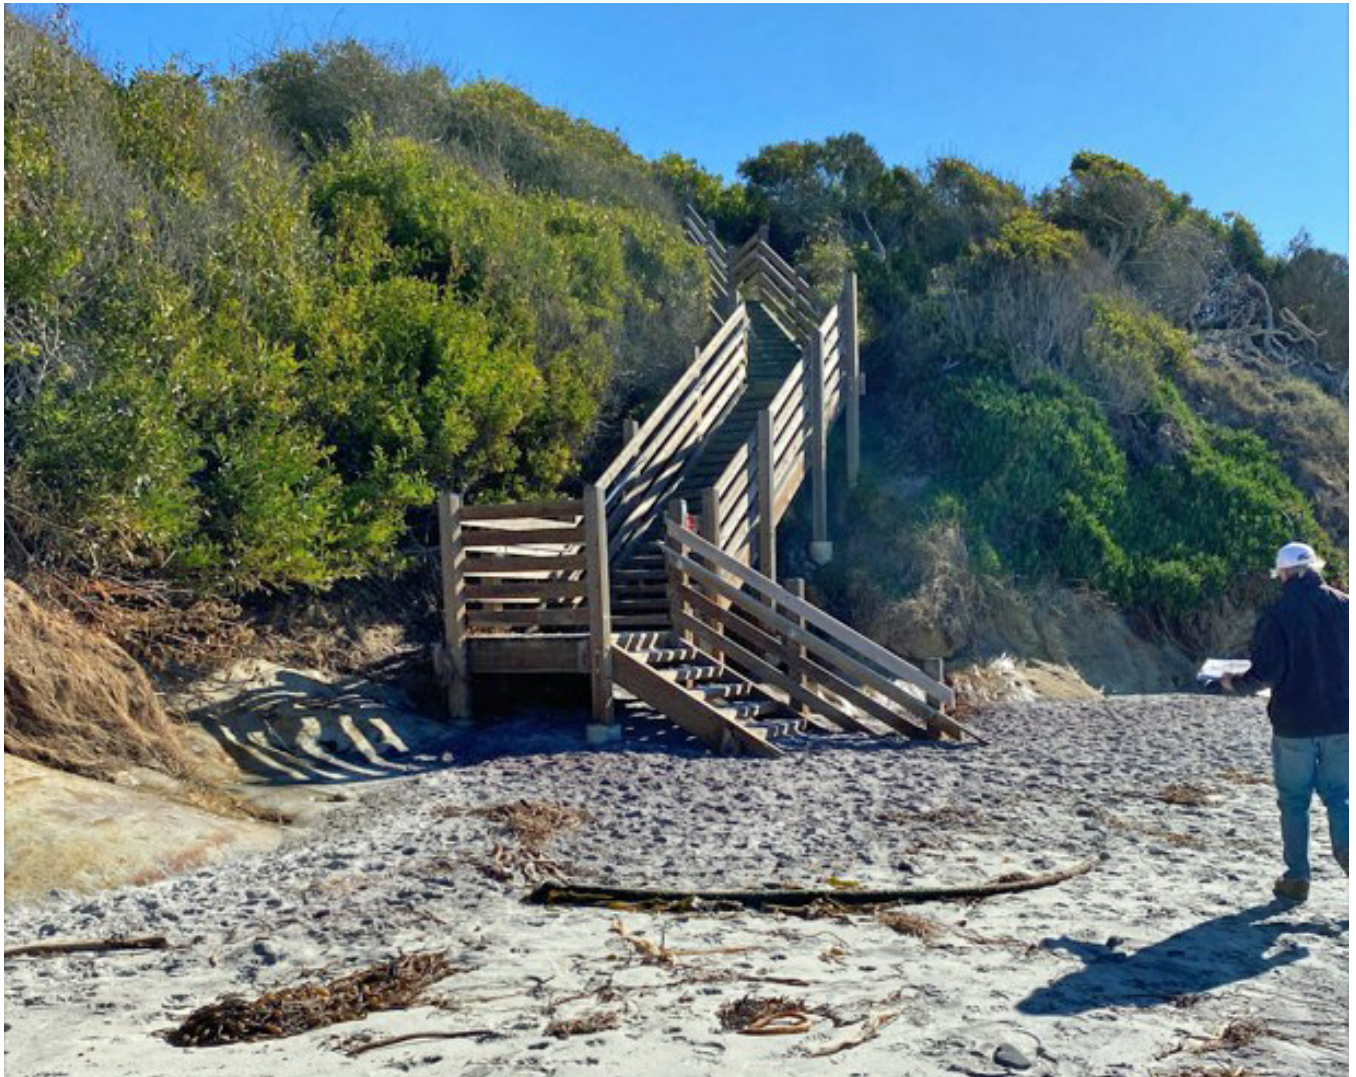
Photograph 96: Stairway ST11 on January 30, 2023

Photograph 96 shows Public Beach Access Stairway ST11, located in the dunes area north of Ocean Avenue, on January 30, 2022. Our firm (Haro Kasunich and Associates Inc.) designed this stairway. The lowest elevation run of the stairway has a damaged handrail, minor corrosion in a few spots along the handrail, a broken wooden guard and handrail on the north side of the lowest flight of stairs. The bottom 3 or so feet of the stairs were buried in beach sand at the time of our inspection. We recommend re-inspection during the next natural beach scour event that exposes the lowest portion of the stairs which were founded on bedrock at the time of initial construction. Further evaluation of the structure by an independent licensed structural engineer (and if need be, a licensed corrosion engineer) should be scheduled to verify the structure condition is safe for public use. We recommend the broken guard and handrail be repaired or replaced for the sake of pedestrian safety, and rank that as a high priority, since the current conditions pose slip and fall risks to stair users.

ST11	Dunes	1/30/2023	NA	NA	NA	NA	NA	NA	NA	NA	YES	YES	HIGH	Regular Maintenance is Essential	Hazardous; Broken Guard and Handrail on Upcoast Side of lowest Run	Maintenance is Essential for Pedestrian Safety
