CITY OF CARMEL-BY-THE-SEA CLIMATE COMMITTEE

1. Receive a presentation from Integral Corp./Haro Kasunich & Associates/EMC Planning Group regarding the results of the Coastal Engineering Condition Evaluation, Task 1, and Shoreline and Beach Change Analysis, Task 2, which is part of the Coastal Engineering Study
2. Review list of Adaptation Strategies for Climate Action and Adaptation Plans and Provide Feedback for Monitoring the Implementation of the Plans

TO:	Climate Committee Members
SUBMITTED BY:	Mary Bilse, Environmental Programs Manager
SUBJECT:	Receive a presentation from Integral Corp./Haro Kasunich & Associates/EMC Planning Group regarding the results of the Coastal Engineering Condition Evaluation, Task 1, and Shoreline and Beach Change Analysis, Task 2, which is part of the Coastal Engineering Study

27 April 2023
Coastal Protection Evaluation 22 December 2022 thru 30 January 2023
Carmel Adaptation Plan - Carmel Beach All Areas
Project No. 12176
Page 19

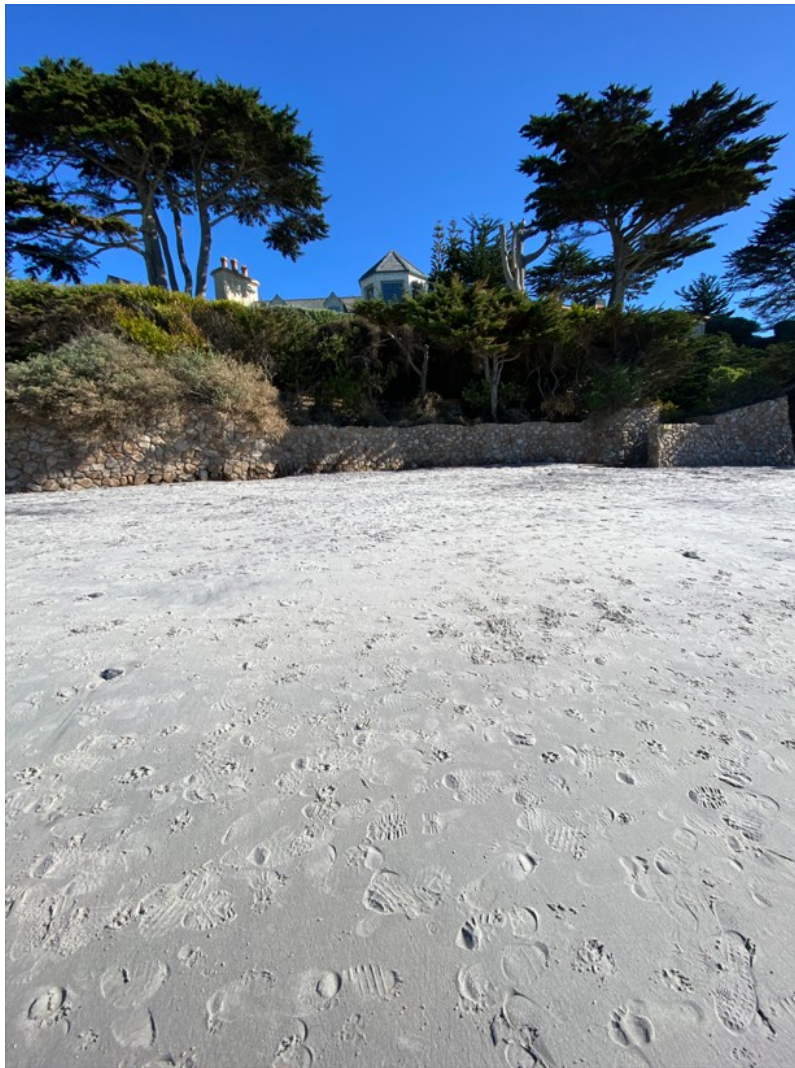
Photograph 97: South Portion of Privately Owned Seawall S11 on January 30, 2023

Photograph 97 shows the south part of Seawall S11 on January 30, 2022. The south portion is approximately 6 feet high. This portion includes a private access stairway at the south end. The seawall appeared to be in good condition, and we did not observe any maintenance or repair that was needed.

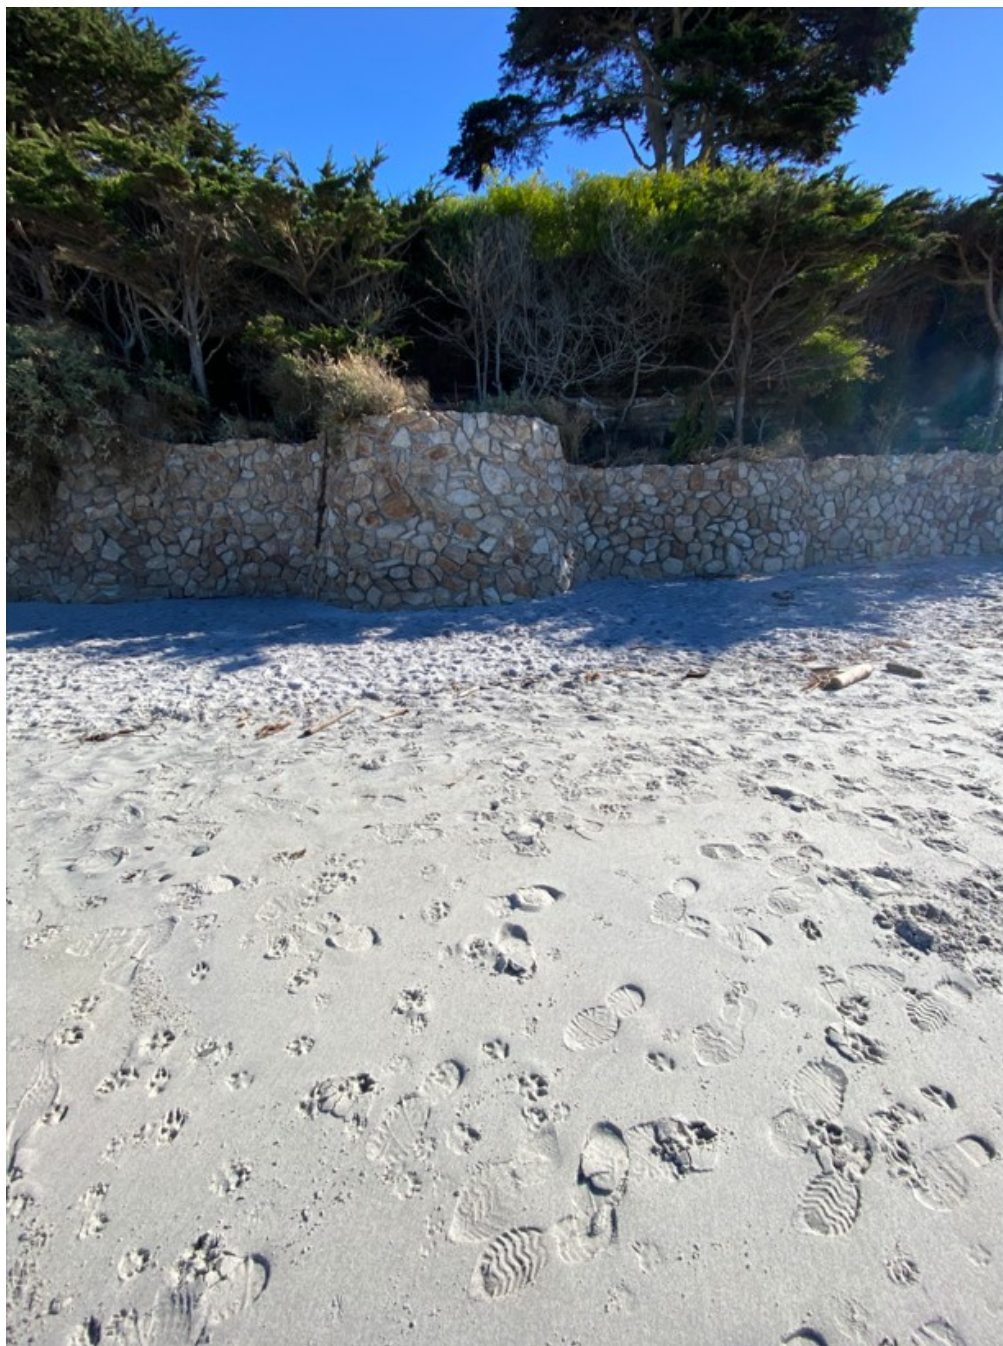
Photograph 98: Central Portion of Privately Owned Seawall S13 Center on January 30, 2023

Photograph 98 shows the central part of Seawall S11 on January 30, 2022. The center portion is approximately 6 feet high. The seawall appeared to be in good condition, and we did not observe any maintenance or repair that was needed.

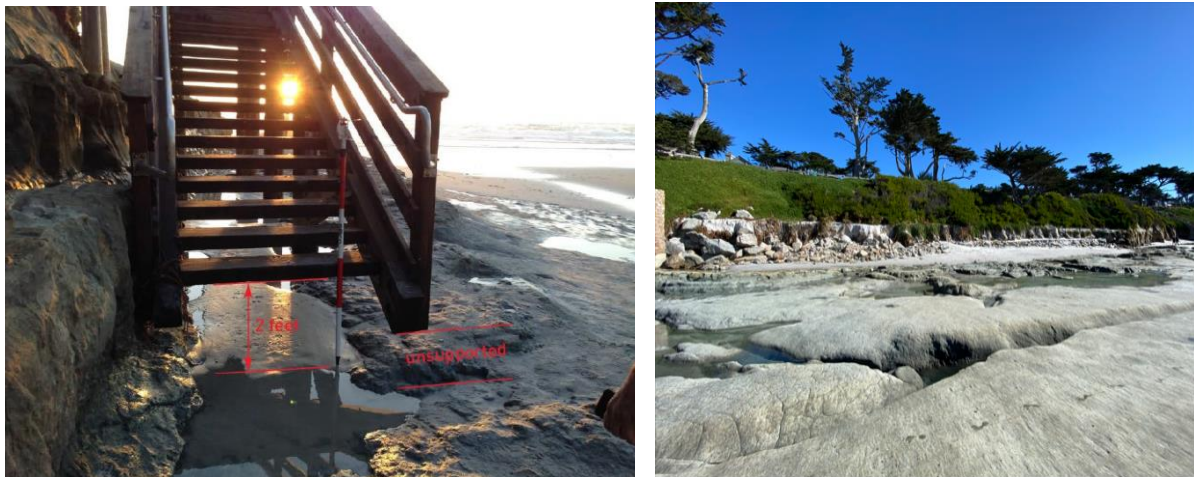
Figure 1. Left, undermined 12th Avenue stairway following the El Niño Winter of 2015–16 (January 24, 2016). Source: Easton Geology (2016)
 Right, the beach scoured down to bedrock near 10th and 11th avenues following strong winter storms of 2022–23 (January 30, 2023). Source: HKA (2023).

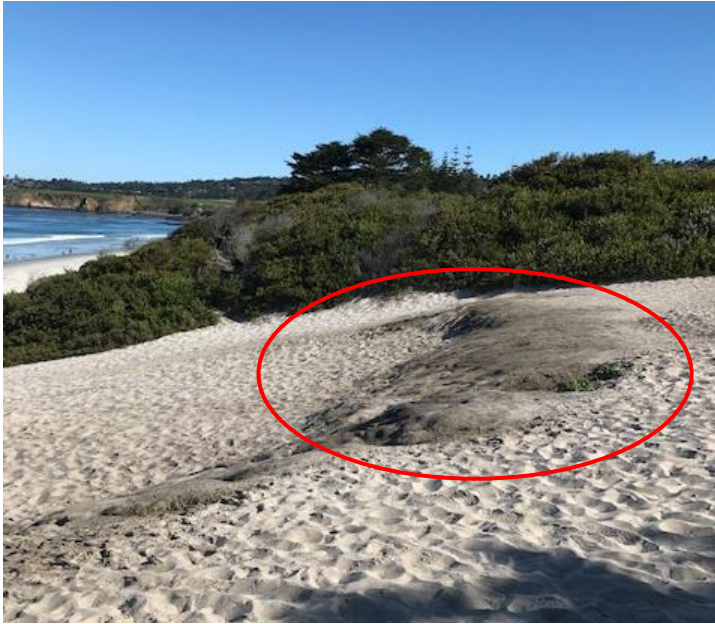
Figure 14. The exposed sandstone formation, indicated in red, located at the central sand ramp near the Del Mar Parking Lot.
